# Smell, Memory, and Heritage: A Sensory Approach to Adaptive Reuse in the Aya Payana Church

Mehmet Fatih Aydın

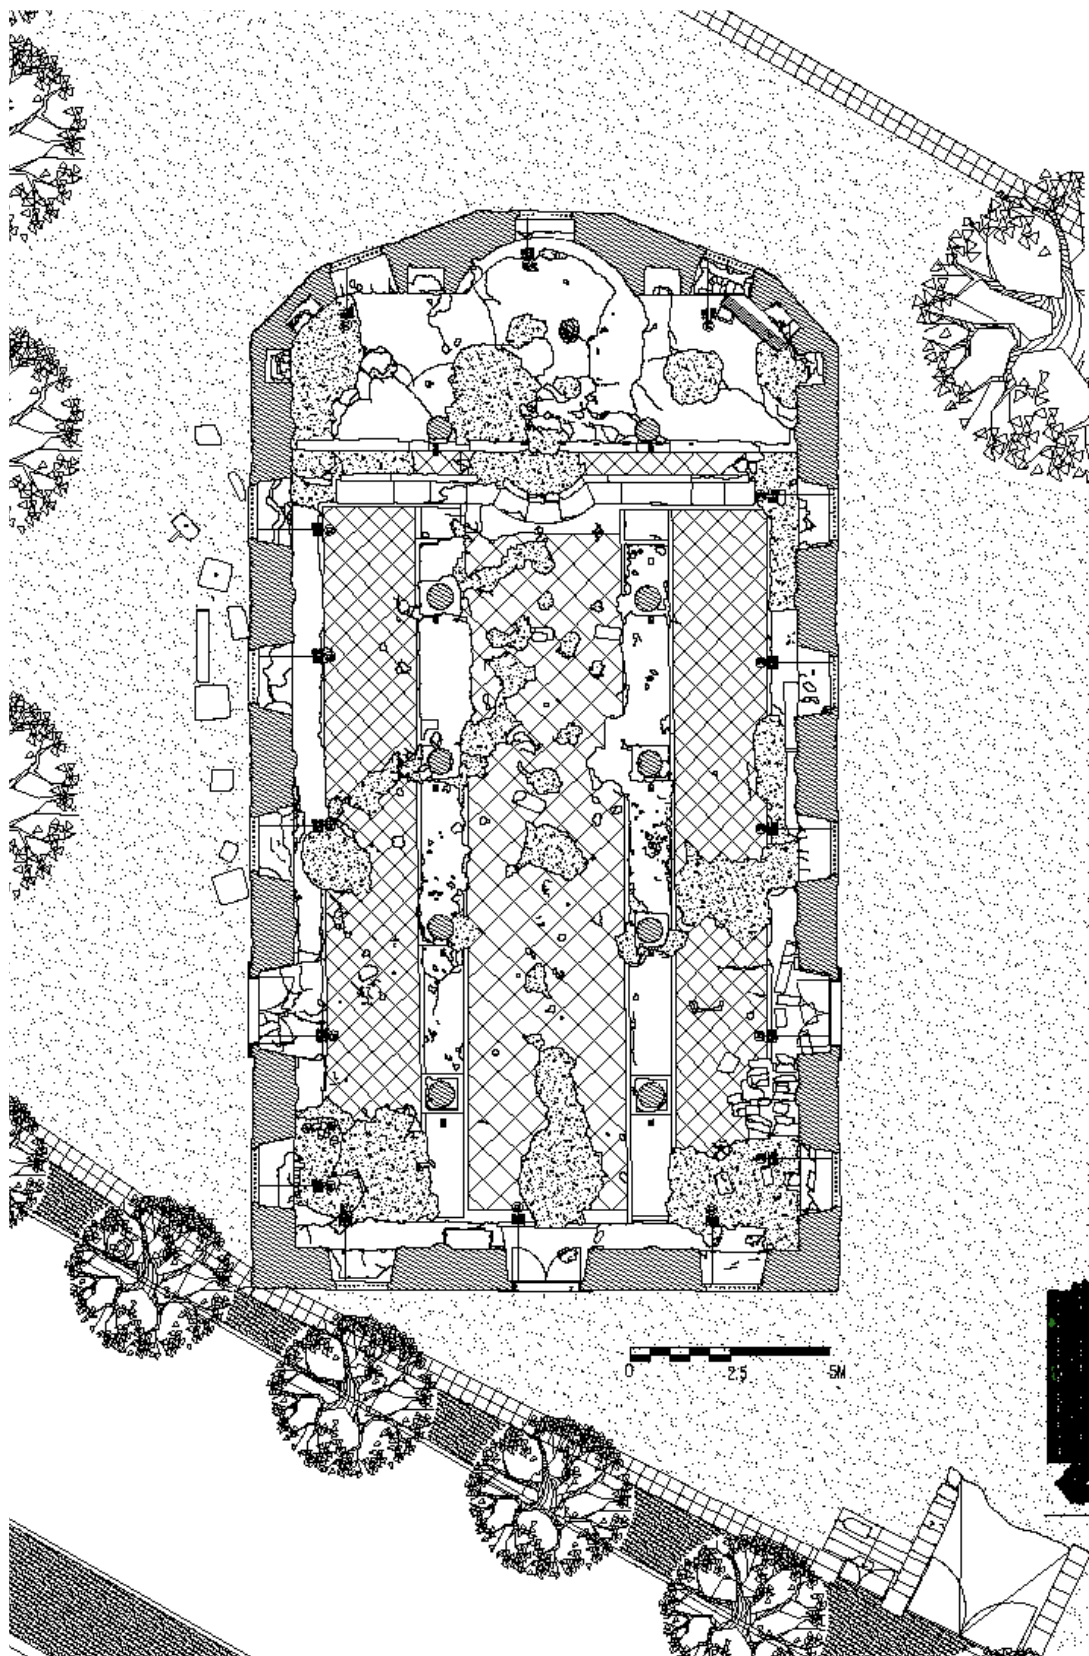
In the initial phase, the structure was documented using traditional measured drawing techniques. To assess the current state of the building, plans, sections, and elevations were produced; deformations, material differences, and deteriorations were recorded in detail through analytical survey methods (Letellier et al., 2007). Contemporary documentation technologies such as laser scanning and photogrammetric measurement were also employed as complementary tools during this process (Bryan, Andrews & Blake, 2013) (Figure 3).

**Figure 3.** Survey Plan of the Naos Elevation Level (Author's Personal Archive).

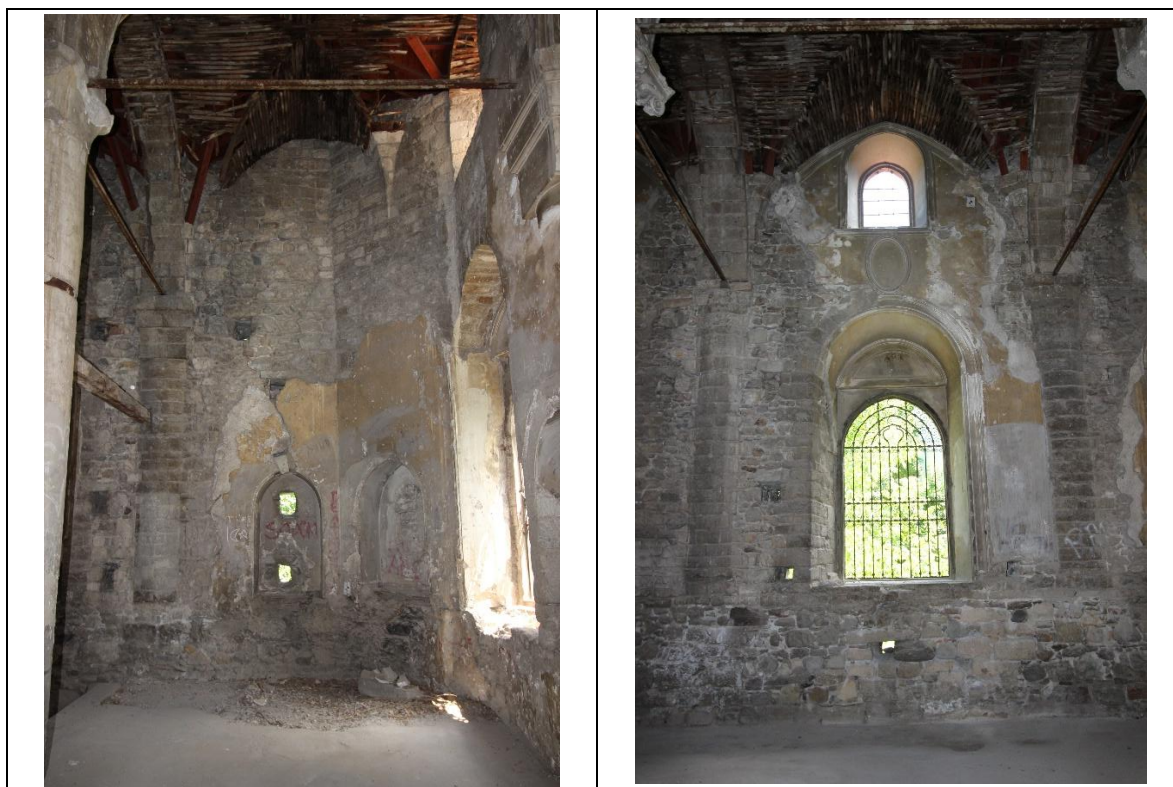
In terms of construction technique, the walls are primarily composed of roughly dressed stone blocks, with joints bonded using a locally produced lime-based mortar. The absence of reinforced concrete or steel components in the load-bearing system confirms that the structure was entirely built using traditional materials and techniques (Figure 7).

**Figure 7.** Wall Bonding Technique in the Naos (Author's Personal Archive).

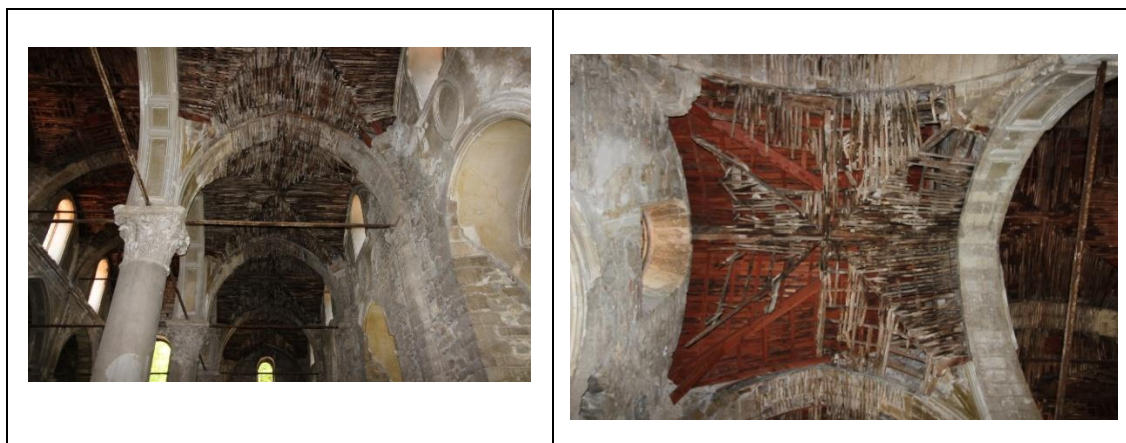
-By the mid-20th century, the church lost its religious function and was subsequently abandoned. As a result, the unprotected building materials suffered significant deterioration. In particular, the collapse of the roof covering exposed the structural system to prolonged moisture ingress, which began to compromise the integrity of the load-bearing components (Figure 8).

**Figure 8.** Damages and Material Losses in the Roof System (Author's Personal Archive).

A large portion of the roof covering has collapsed, and the remaining sections show evidence of biological deterioration in the timber load-bearing elements. Visual inspections have revealed typical forms of biological damage in the timber, including decay, insect infestation, and fiber separation (Watt, 2025).

As part of the intervention addressing the collapse of the roof covering, a new roof frame was constructed in accordance with the restitution of the original timber load-bearing system. The timber used was selected from low-density, impregnated species suitable for the local climatic conditions (Historic England, 2012).

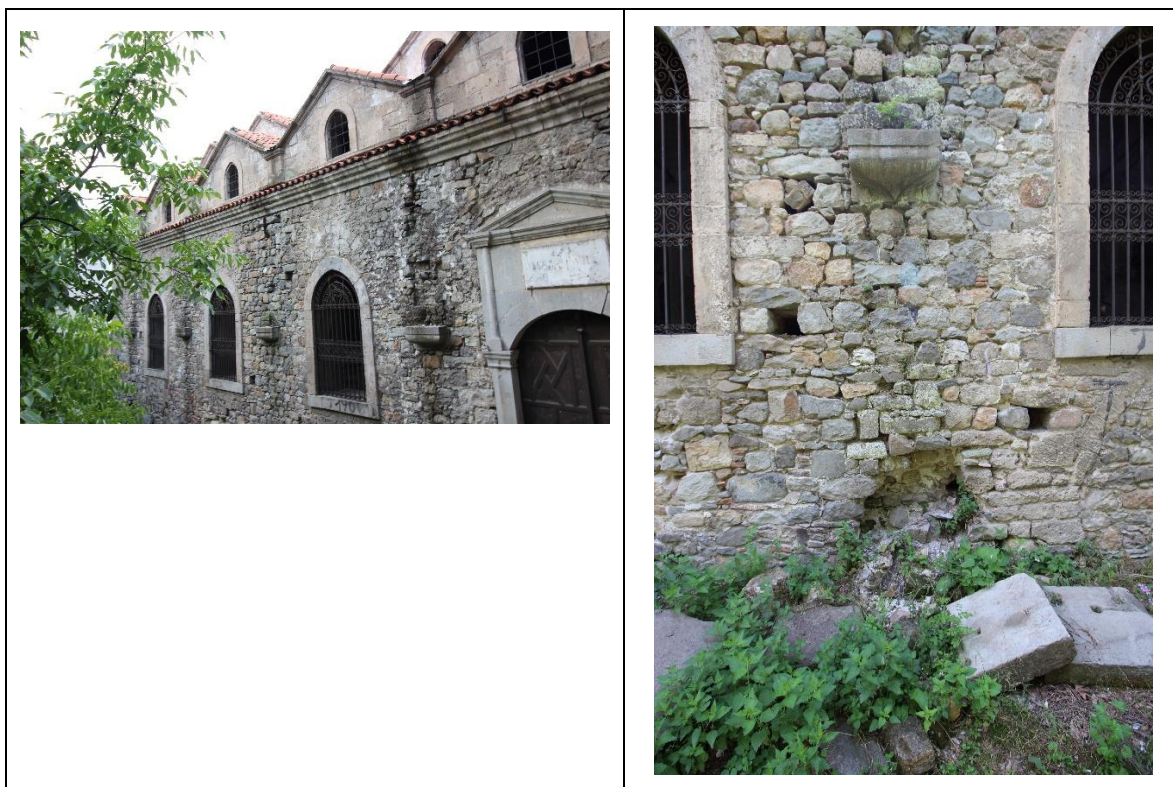
Extensive cracking, surface darkening, and biological growths (such as mosses and lichens) have been identified on the wall surfaces (Price & Doehne, 2011). Particularly on the northern façade, plaster detachment due to moisture exposure and signs of flaking on the stone surfaces have been observed (Figure 9).

**Figure 9.** Moss and Lichen Colonization with Surface Degradation on the Northern Elevation (Author's Personal Archive).

For surface stones showing signs of carbonation and material loss, micro-injection techniques and surface consolidation treatments were applied. Ethyl silicate-based consolidants were used in low concentrations and under controlled conditions (Price & Doehne, 2011).

Biological growth was removed through mechanical cleaning followed by the application of biocides (Ashurst, 2007).

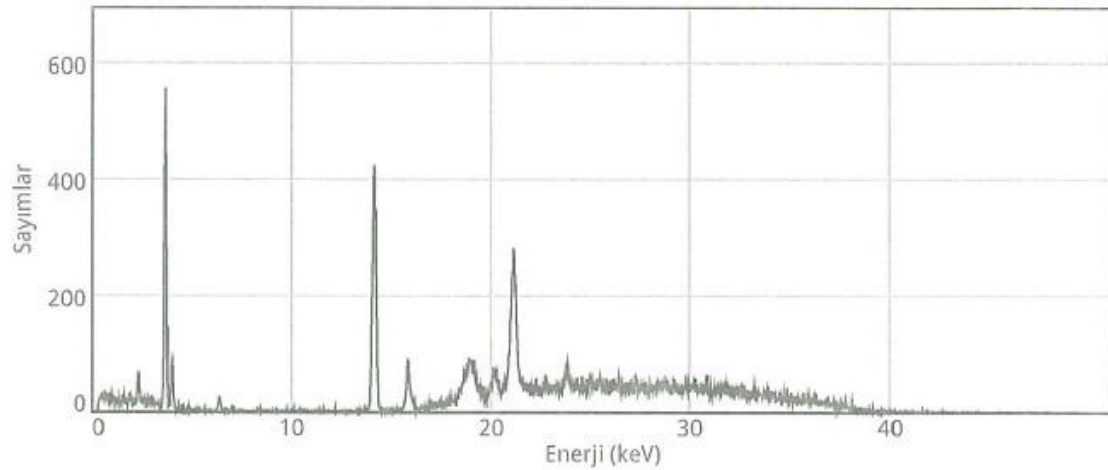
It was determined that the original plaster layers were based on hydraulic lime, whereas later interventions involved modern mortars containing cement additives (Figure 10).

Ad	Sınıf		Tarih	Saat	Süre					
aya bania h3 1	o MiningLE-FP		01/03/2022	10:48:43	30 s					
<b>Element</b>	Mg %	Al %	Si %	S %	Ca %	V %	Fe %	Co %	Ni %	Sr %
	1,88	0,28	0,67	39,85	32,05	0,20	0,25	0,02	0,02	0,25
±	0,530	0,068	0,024	0,086	0,070	0,010	0,023	0,006	0,004	0,004
<b>Element</b>	Zr %	Sn %	Sb %	Ba %						
	0,01	0,03	0,03	0,06						
±	0,001	0,006	0,006	0,020

**Figure 10.** Representative Sample Result from Portable X-Ray Fluorescence (XRF) Analysis (Author's Personal Archive).

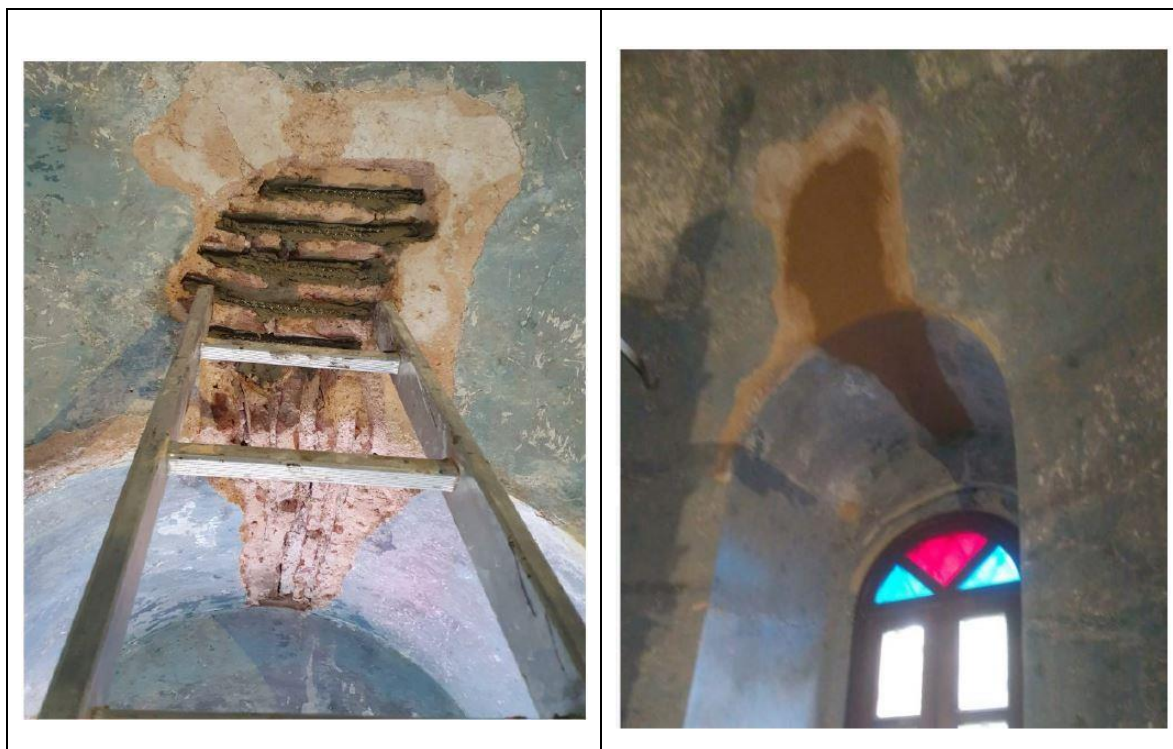
In areas where larger cracks were present—particularly at the intersection of the apse and the naos—stitching techniques were employed on both the interior and exterior faces. These repairs utilized a combination of stainless steel rods and natural stone anchors (Watt, 2025) (Figure 11).

**Figure 11.** Suggested Stitching Technique to Be Applied in the Apse Region (Author's Personal Archive).

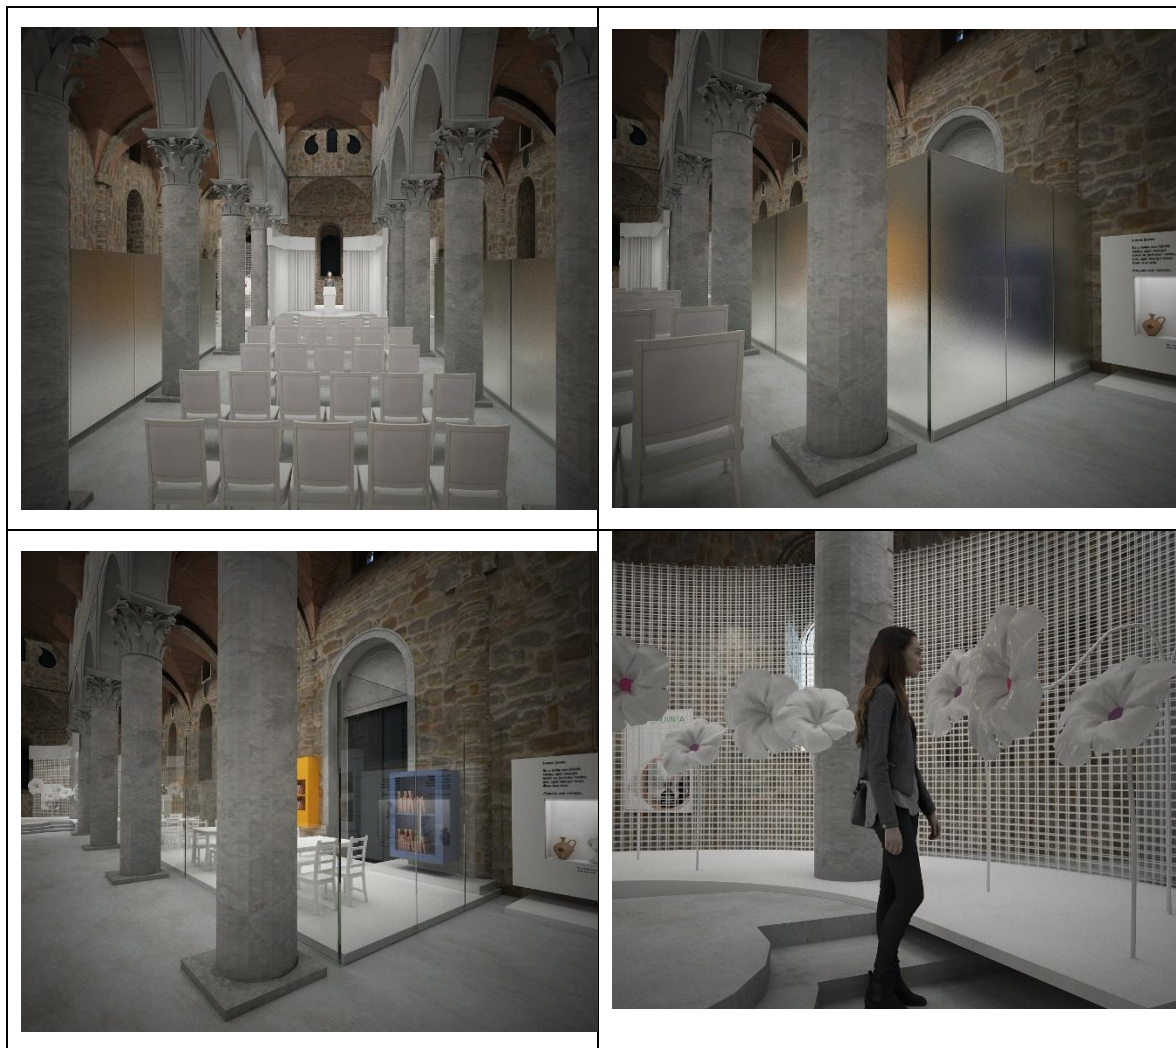
The Kokuhané installation was designed without introducing any structural alterations to the building, preserving its original architectural elements and enhancing the existing spatial atmosphere (Plevoets & Van Cleempoel, 2011) (Figure 13).

**Figure 13.** 3D Renderings of the Interior of the Scent Museum (Author's Personal Archive).

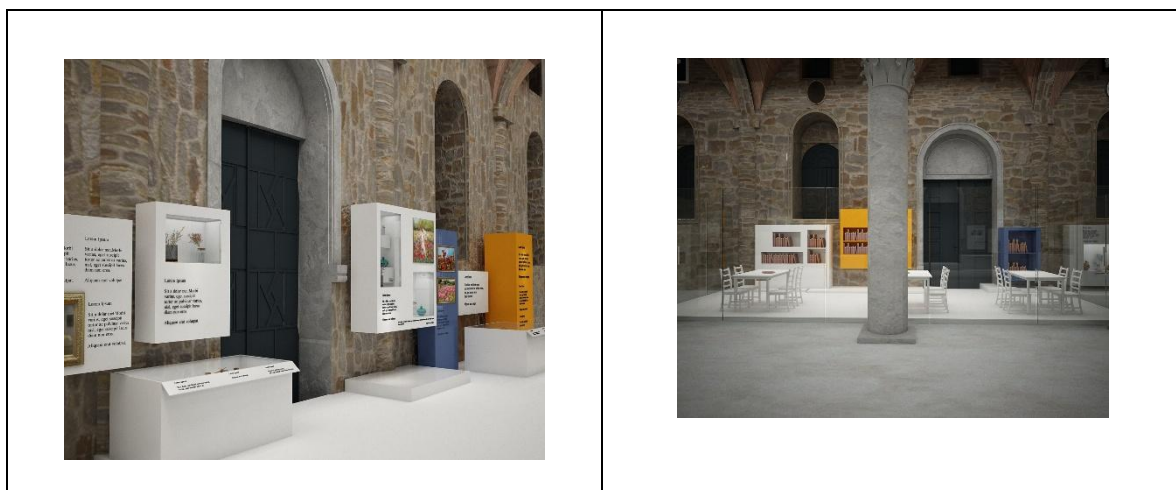
**Figure 14.** Interior View of Kokuhane – Including Exhibition and Workshop Sections of the Scent Museum (Author's Personal Archive).

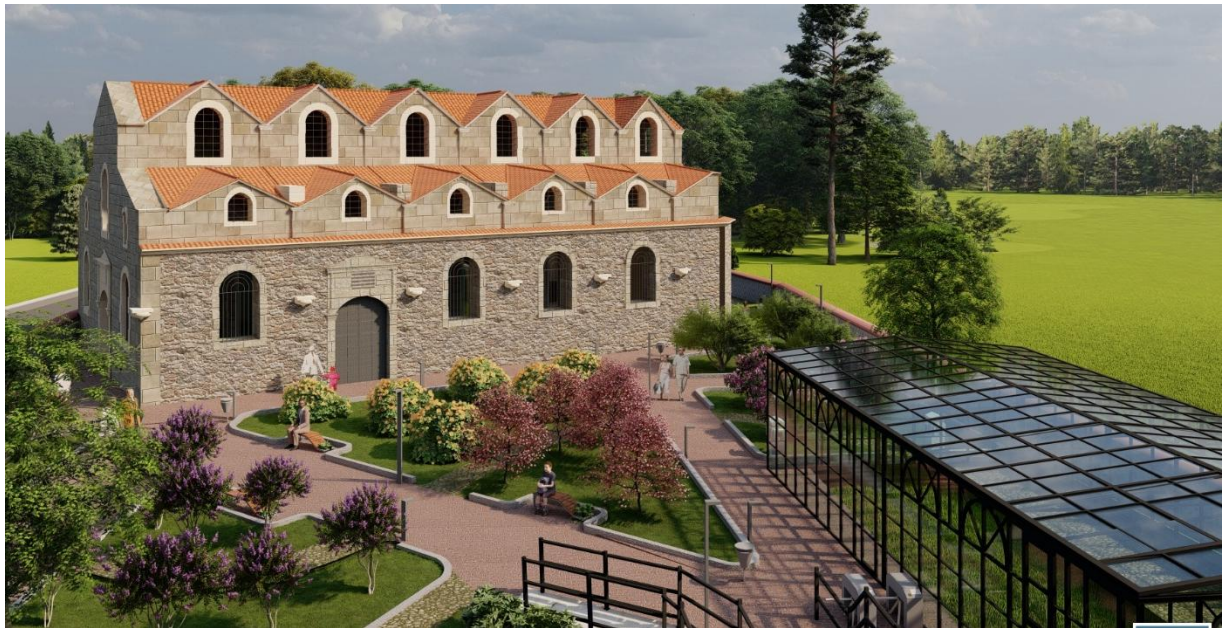
Transparent materials—such as glass and lightweight steel structures—enable new additions to be visually unobtrusive while maintaining a clear presence without overwhelming the historic mass. Through this approach:

- The silhouette, façade articulation, and volumetric impact of the historical building remain uninterrupted;
- Visitors' attention is guided toward the heritage structure;
- The distinction between historical and contemporary interventions is made clearly legible (Rodwell, 2008) (Figure 16).

**Figure 16.** Design of the Transparent Cafeteria in Relation to the Main Body of the Historical Building (Author's Personal Archive).
