# Remote Sensing-Based Revegetation Assessment at Post-Closure Mine Sites in Canada

Sam Gordon <sup>1</sup>, Xiaoyong Xu <sup>2,\*</sup> and Yanyu Wang <sup>3</sup>

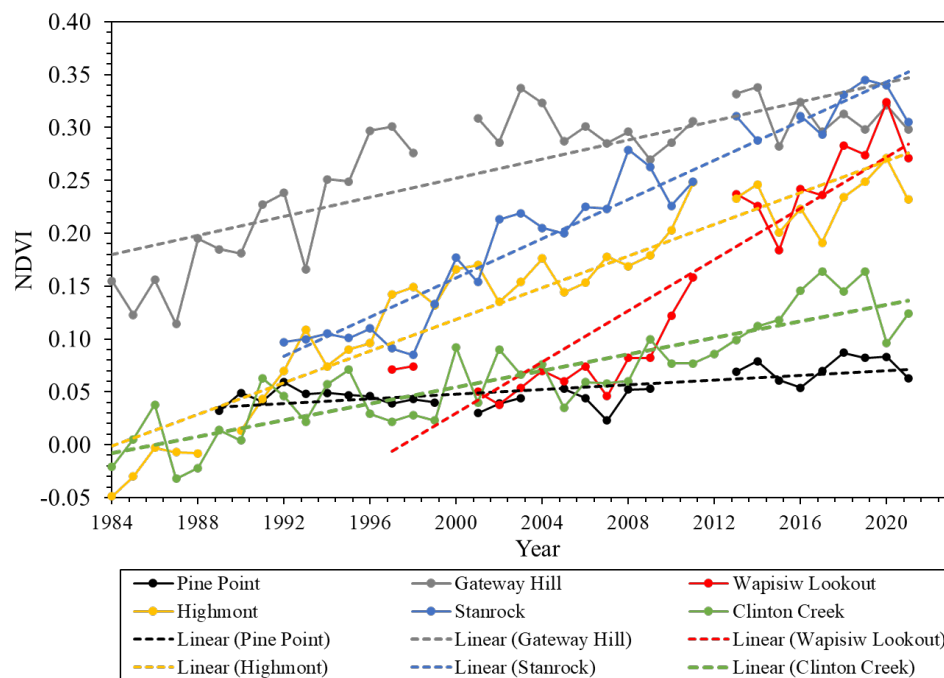
Figure 2 shows the NDVI changes for the five mine sites from their respective closure years to the present (year 2021). The corresponding linear regression slopes (i.e., annual change rate in NDVI) are provided in Table 2. Note that the NDVI is not computed when the corresponding cloud-free Landsat imagery is not available. Clearly, all mine sites show increasing NDVI trends, but with different change rates (Figure 2 and Table 2).

**Figure 2.** The NDVI changes with year (solid lines) for the study mine sites. The dash lines denote the linear regression trendlines for the NDVI changes.

The Wapisiw Lookout TMA site was closed later than other mine sites but showed the largest increasing trend in NDVI (Table 2). Note that although the Wapisiw Lookout TMA became inactive in 1997, the significant reclamation and planting efforts officially started between 2009-2010 [24]. Accordingly, starting from 2009, the NDVI of the site has increased rapidly (Figure 2, red). The NDVI

of Stanrock has the second highest growing rate with the speedy NDVI increase starting in 1998-1999 when the significant capital reclamation activities in the region had already completed (Figure 2, blue).

The Highmont and Gateway Hill were closed in the early 1980s, earlier than other sites. Although the Highmont site had the lowest NDVI (across the five sites) prior to the reclamation, a monotonic and substantial NDVI increasing trend has been detected for the site (Figure 2, yellow and Table 1). This may be attributed to the implementation of an efficient end land use plan at the site [27]. In contrast, the Gateway Hill site had the highest pre-revegetation NDVI across the five study sites. This is not surprising since unlike other sites, Gateway Hill was used as an overburden stockpile for mining operations rather than a storage of tailings. The NDVI of reclaimed Gateway Hill showed a strong upwards trend up to 2003 and then has remained relatively steady (Figure 2, gray).

The Pine Point TMA and the waste rock dumps of the Clinton Creek mine collectively showed the smallest change in NDVI over time. This is consistent with the findings in [13,32] and reflects the behavior of passive revegetation. However, note that the slow NDVI increasing is still statistically significant ( $p < 0.001$ ).

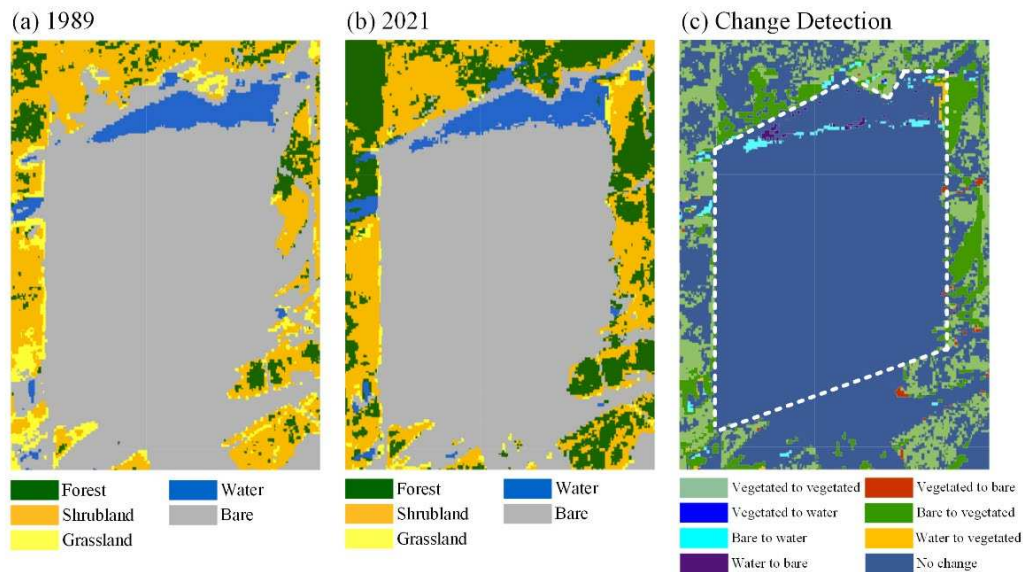
**Figure 3.** Classified land cover types from the years (a) 1989 and (b) 2021, as well as (c) the land cover change detection between the two years over the Pine Point Mine TMA. The dashed line denotes the TMA boundary.

Until the present, there is a lack of considerable vegetation cover over the main body of the Pine Point TMA (Figure 3b). Over the past decades, only limited patches of revegetation appeared on the periphery of the TMA (Figure 3c). This is consistent with the passive revegetation behavior [13,36,37], where early plant colonization mainly occurred at the perimeter and stems from existing vegetation. In addition, the marginal increase in the vegetated area is consistent with the small NDVI change quantified for the site (Figure 2, black).

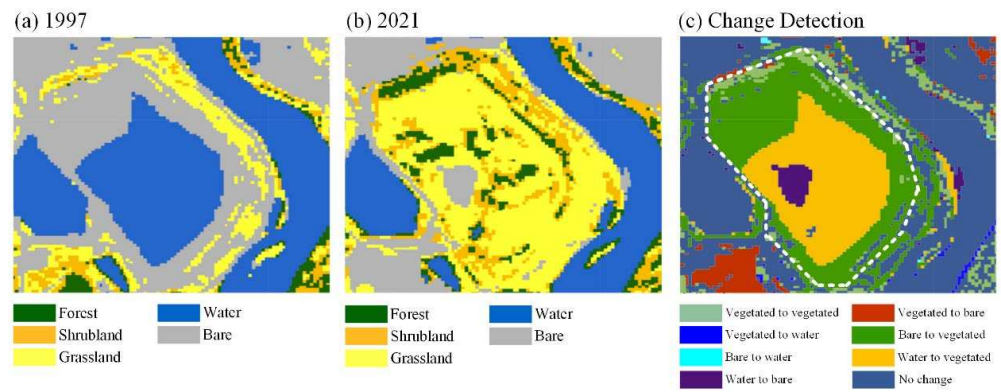
**Figure 4.** Classified land cover types from the years (a) 1997 and (b) 2021, as well as (c) the land cover change detection between the two years over the Wapisiw Lookout TMA. The dashed line denotes the TMA boundary.

The Wapisiw Lookout TMA at its closure was dominated by water surface (tailings pond) and bare soil or rock with limited vegetation cover only along the perimeter of the TMA (Figure 4a), while the vegetation covering is dominant at the contemporary site (Figure 4b). The land cover change clearly reveals the substantial extent of the revegetation over the Wapisiw Lookout TMA (Figure 4c).

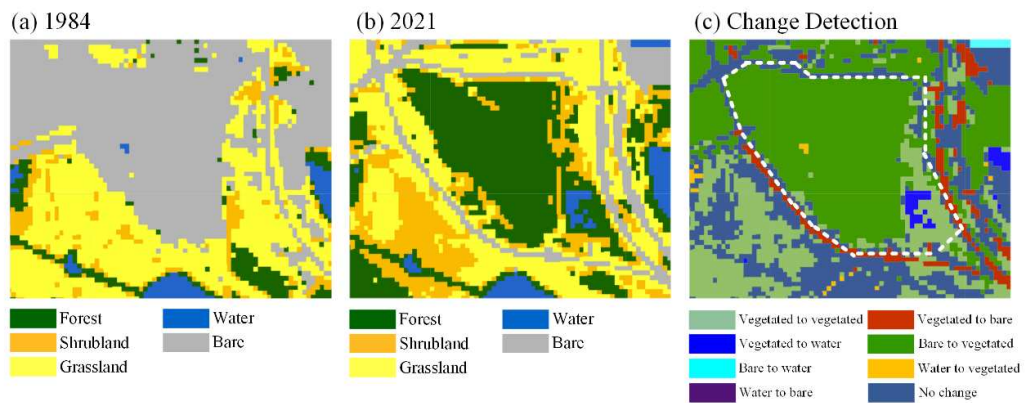
**Figure 5.** Classified land cover types from the years (a) 1984 and (b) 2021, as well as (c) the land cover change detection between the two years over the Gateway Hill site. The dashed line denotes the overburden site boundary.

A large patch of bare land was evident for the Gateway Hill site at its closure (Figure 5a). The bare land has largely turned into vegetated area through the site reclamation activities (Figures 5b and 5c). Except for the considerable increase in vegetated area, the new road network (triangle-shaped bare covering in Figure 5b and red patches in Figure 5c) has also been developed for the reclaimed Gateway Hill.

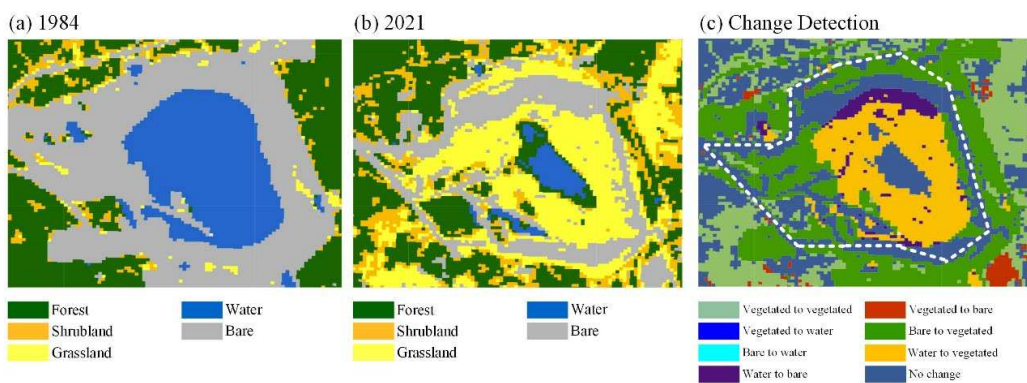
**Figure 6.** Classified land cover types from the years (a) 1984 and (b) 2021, as well as (c) the land cover change detection between the two years over the Highmont TMA. The dashed line denotes the TMA boundary.

The main body of the Highmont TMA was dominated by water surface (tailings pond) and bare soil or rock when the site was closed in 1984 (Figure 6a), which led to the near-zero NDVI for the site at its closure (Figure 2, yellow). The major portion of the tailing pond and bare land have been revegetated by 2021 (Figure 6b), although vegetation cover is still absent at the central portion of original tailings pond and along the boundary of the TMA (Figure 6b).

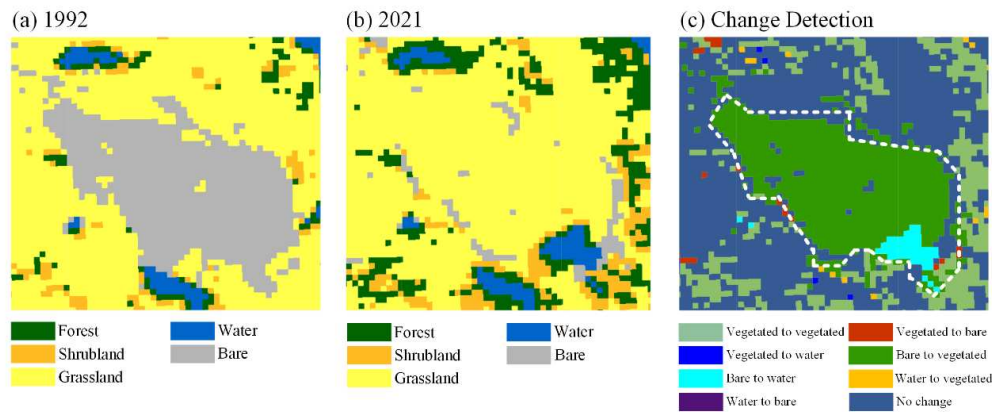
**Figure 7.** Classified land cover types from the years (a) 1992 and (b) 2021, as well as (c) the land cover change detection between the two years over the Stanrock TMA. The dashed line denotes the TMA boundary.

At the Stanrock TMA, the bare land (rather than tailing pond water surface) had been dominant by 1992 (Figure 7a) since the last deposition of tailings at the site happened in the early 1960s [30].

The post-classification change detection indicates that the Stanrock TMA had experienced a substantial revegetation over the past 30 years (Figure 7c). The bare land has largely turned into vegetated covering through the reclamation activities (Figure 7c). However, the small bare and water surface (tailing) fragments still exist at the present site (Figure 7b). This may be partially due to the existence of infrastructure (i.e., spillways) for the surface drainage from the acid generating tailings [30].

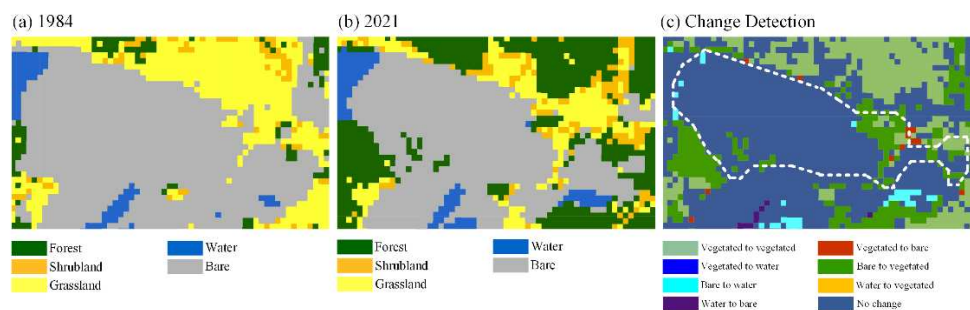
**Figure 8.** Classified land cover types from the years (a) 1984 and (b) 2021, as well as (c) the land cover change detection between the two years over the Clinton Creek mine. The dashed line denotes the Clinton Creek waste rock unit boundary.

Figure 8 clearly shows the revegetation that naturally occurred over the Clinton Creek waste rock dumps. The naturally occurring revegetation appears only on a small portion of the dumps. Most of the dump slopes still lack vegetation cover by 2021.

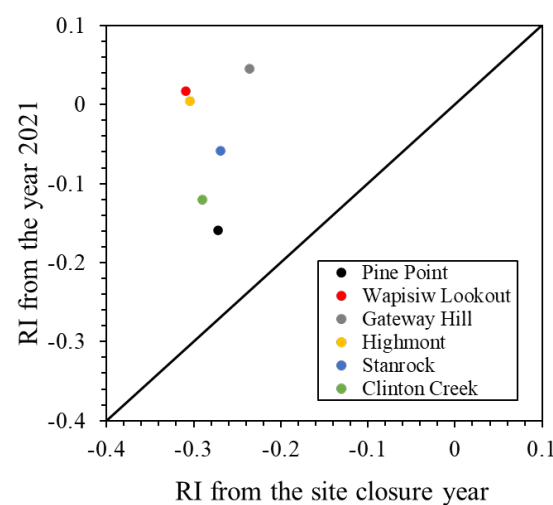
As stated earlier, the use of RI can help estimate the level of revegetation success. In this study, the RI values from the site closure year and year 2021 are calculated and compared across the five mine sites, as shown in Figure 9.

**Figure 9.** Scatterplot of the site closure year versus the year 2021 in terms of the RI values across the five mine sites.

The RI values from the respective closure years of the six mine sites are all below zero (around -0.31 to -0.23) (Figure 9). RI is defined as the NDVI departure of the mine site from the corresponding undisturbed reference site (Equation 2). Thus, the negative RI indicates that the disturbances existed for each site at its closure. A more negative RI means a higher degree of disturbance relative to the respective undisturbed reference site. As shown in Figure 9, the differences in the initial (site closure) RI value across the five sites are small (all falling within around -0.31 to -0.23) except that the overburden site Gateway Hill showed a slightly lower disturbance level (i.e., a slightly less negative RI) than other sites (open tailings areas). The revegetation procedure, if occurs, is expected to alleviate the disturbances and therefore raise the RI values. Accordingly, by 2021, all study sites had experienced an increase in RI with the largest (lowest) RI increase for Gateway Hill (Pine Point).

The RI values are close to or slightly above zero for the present Gateway Hill, Wapisiw Lookout, and Highmont sites (Figure 9). This indicates that the vegetation covering conditions of the three sites have already been restored to a level that is very close to or better than the undisturbed or pre-mining situation. For the reclaimed Stanrock site, although a substantial increase in RI is also observed, the latest RI value is still negative (about -0.06), which reflects the remaining disturbance, e.g., the observed fragments of water surface and bare land at the site (Figure 7b). Unsurprisingly, the present RI is still quite negative (about -0.16 to -0.12) at the passively revegetated sites (Pine Point and Clinton Creek), which collectively experienced the smallest RI increase.
