Performance Assessment of Irrigation Systems and Water Management Practices in Selected Irrigated Schemes in Rwanda

Sonia Ikundabayo ^{1,2,*}, Jean de Dieu Bazimenyera ¹ and Romuald Bagaragaza ¹

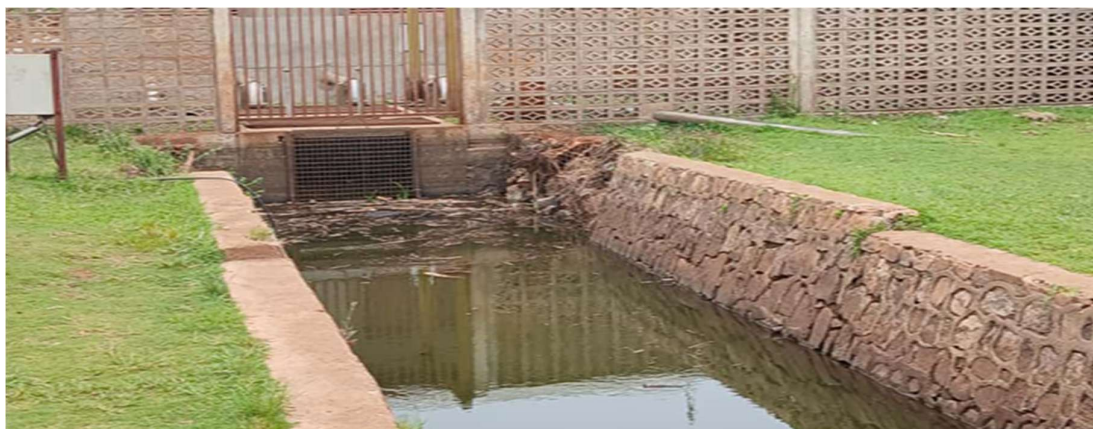
Figure 3. Conveyance canal at Nasho GFI scheme.

Existing lined concrete conveyance canals are there but with excessive sedimentation, silt deposits and encroachment of weeds along the side slope of canal. Field staff excavate sediments at the bottom of canal manually. Canal lining is generally good condition however flow efficiency is limited due to lack of proper operation and maintenance.

This condition of conveyance canals has distinct disadvantages including sedimentation, siltation and weed growth. Sedimentation deposition reduces conveyance capacity since canal flow is obstructed causing conveyance inefficiency. This means that water is not reliably available to farmers when needed. Weed growth and sedimentation also increase the frequency of clearing needed, which increases labor and operating costs. Also, weed growth creates additional resistance to flow and causes more sedimentation deposition.

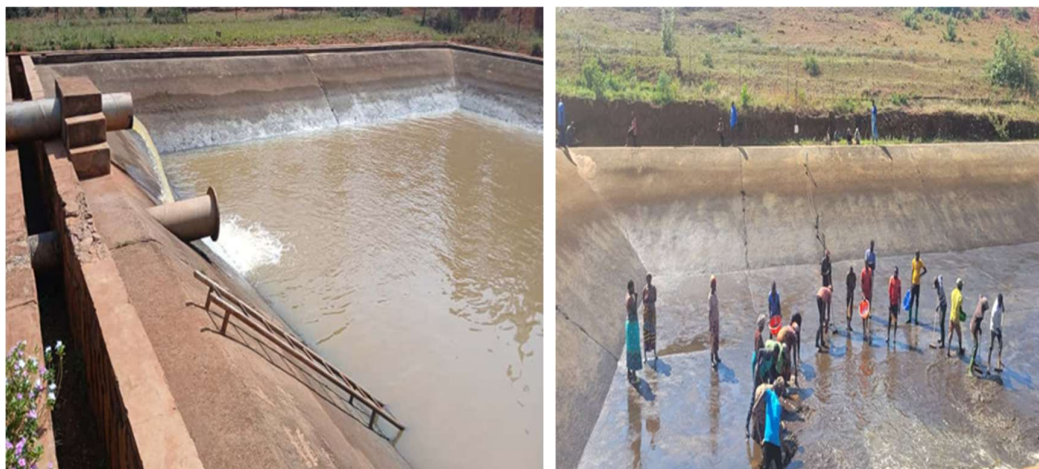
Figure 4. Storage reservoir at Nasho GFI scheme.

The storage reservoirs at Nasho GFI scheme show the presence of turbid water, silt deposits at the bottom, and signs of erosion around inlets. During the cleaning operations, some reservoirs were partially emptied, while muddy water in some reservoirs reduced the effective depth. This shows inadequate filtration upstream and an irregular cleaning schedule.

Higher water turbidity, more silt in reservoirs, and erosion at the inlets of the reservoirs observed during the cleaning operations not only decrease the quality of the water, but also the storage efficiency of the reservoirs. The bottom silt buildup decreases the active storage and effective storage capacity of the reservoirs. This means that the available water for irrigation decreases, and the water quality decreases making the water more unsuitable for agricultural purposes. Around the inlet, the situation is worsened by erosion, which increases the amount of sediment entering the reservoir and accelerates the siltation process. This increases the need for frequent cleaning. Irregularly cleaning the silt has shown to decrease reservoir depth and increased operational inefficiency.

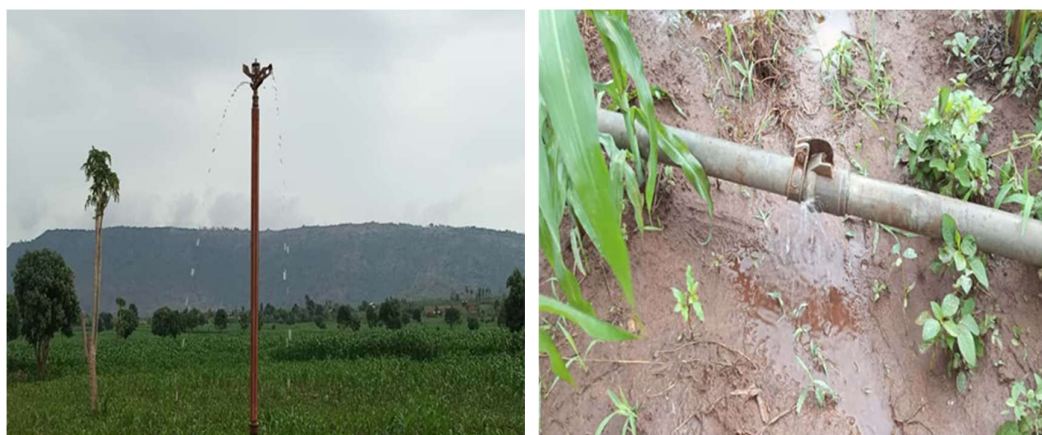
Figure 6. Semi portable sprinklers at Nasho GFI scheme.

Nasho Government Funded irrigation scheme have been using semi-portable sprinkler systems. Visible sprinkler risers show signs of rust. The operating sprinkler in field had poor spray pattern, indicating pressure fluctuations or nozzle wear. Some sprinklers heads looked outdated replacement heads may be needed.

Water distribution is also done through Hoseline irrigation. Water logging near the outlets of hoseline indicates localised runoff and weed growth. The Hoseline condition is fair but may have some leakage or uneven pressure distribution.

System is operational but there are observable deficiencies in performance due to pressure variation, sprinkler wear and poor water delivery from Hoseline.

Evaluation of system performance of these irrigation application systems indicates that while they appear to work adequately, they are performing below expectations based on mechanical deterioration, improper pressure, and poor water management. Distribution uniformity issues in the semi-portable sprinkler would cause various amounts of water to be applied throughout the system causing excess water in certain areas and water shortages in others which would influence crop yields. Some issues detected with the hoseline system also pointed towards problems with water application including waterlogging and runoff.

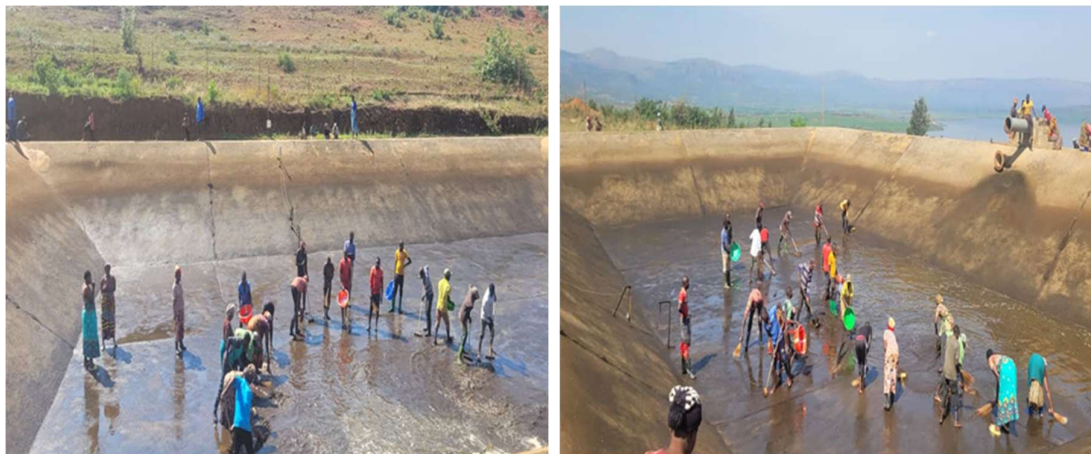
Figure 7. Desilting storage reservoir at Nasho GFI scheme.

In Nasho Government Funded irrigation scheme the maintenance activities depend deeply on manual labor, with workers cleaning canals and reservoirs using basic tools. Mechanized or calendar-based preventive maintenance is almost nonexistent. Maintenance operations seem to be done only when sediment build-up becomes excessive.

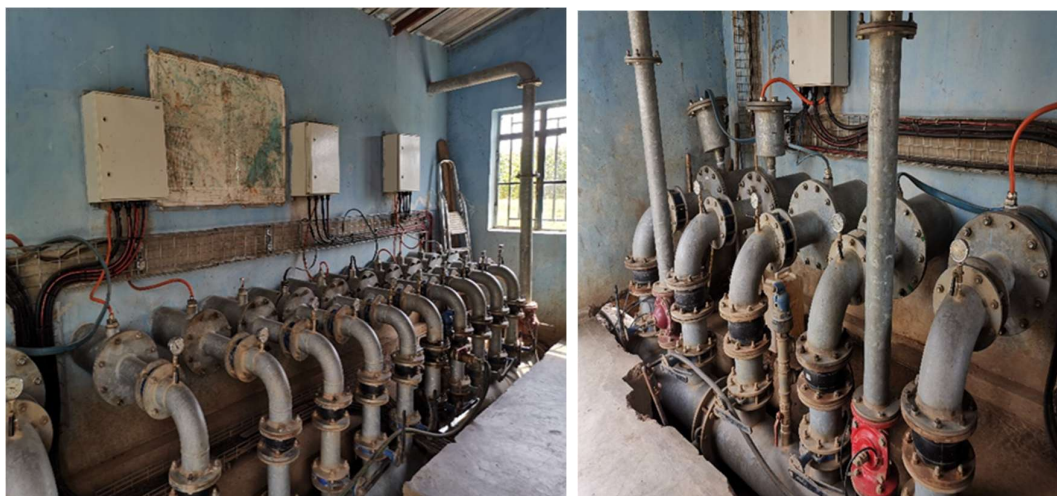
Figure 8. Conveyance pipeline Kagitumba irrigation scheme.

Field assessment showed that pressurized pipelines are used in Kagitumba Irrigation Scheme for water conveyance. The observation showed that pipes inside the pump station show clear signs of aging such as corrosion on flanges, rust around joints, and fading paint. These conditions display continuous use with insufficient rehabilitation. Even if major leakages were not visibly detected but the extent of rust and wear increases the likelihood of pressure losses and future pipeline failures if no preventive maintenance is undertaken. In increasing friction losses, reducing discharge capacity, and increasing maintenance costs.

In this scheme the conveyance system is working but runs below the optimum efficiency due to infrastructure deterioration and insufficient routine servicing.

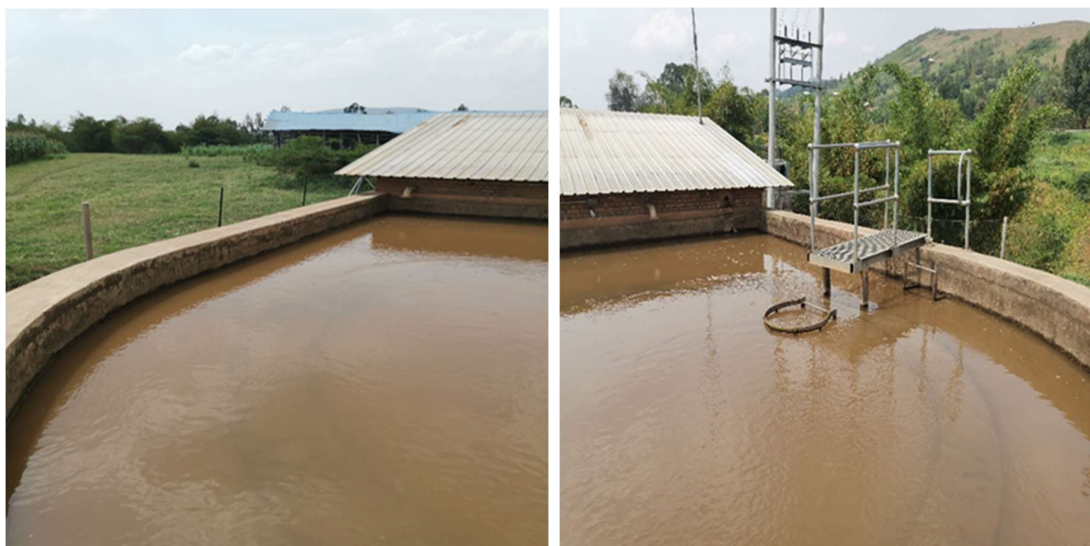
Figure 9. Storage reservoir at Kagitumba irrigation scheme.

Feld assessment showed that the storage reservoirs within Kagitumba irrigation scheme are functioning as both sedimentation and buffering structures. They were found to be functional but working below expected standards. Field observations showed the presence of highly turbid brown water which is indicating insufficient sedimentation processes and the quality of inflow entering the reservoirs is poor. This shows that the present sediment trapping efficiency is low because it allows suspended particles to stay in the water column rather than settling effectively.

Even though the concrete reservoir walls appear structurally stable but the metallic components such as ladders and guardrails show visible signs of corrosion. This show prolonged exposure to humidity and inadequate maintenance which may compromise safety and structural integrity over time.

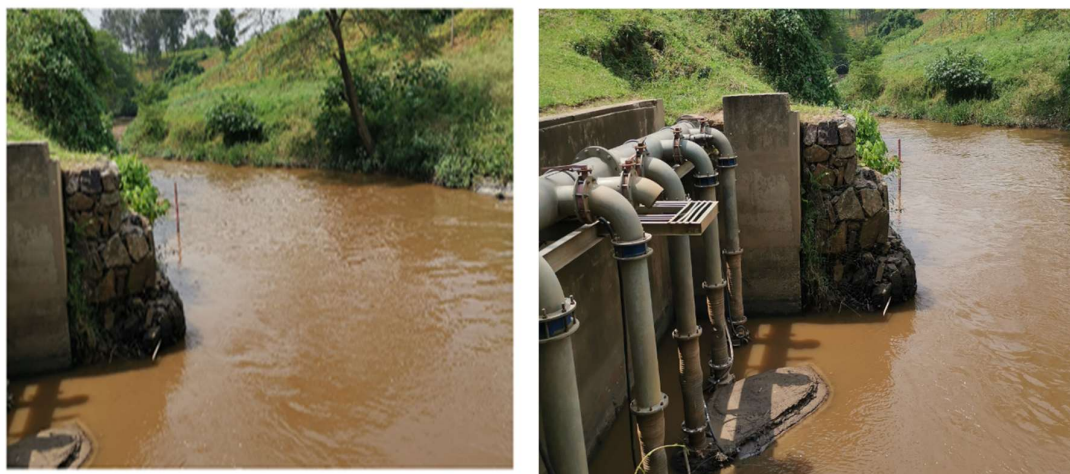
Figure 10. Intake structures at Kagitumba irrigation scheme.

Even though the concrete foundation of the intake structure seems structurally sound but the lack of sediment control measures restricts its functional effectiveness. Chala et al.,2024 said that poor intake design and insufficient sediment exclusion involve in the accumulation of sediments within conveyance systems which exacerbate maintenance challenges and decrease water delivery efficiency.

These results show that even the intake structure remains operational but its performance is being affected by inadequate sediment management and lack of protective infrastructure. To improve efficiency and sustainability the interventions such as upstream erosion control, installation of debris screens and filtration systems and implementation of routine cleaning schedules are necessary.

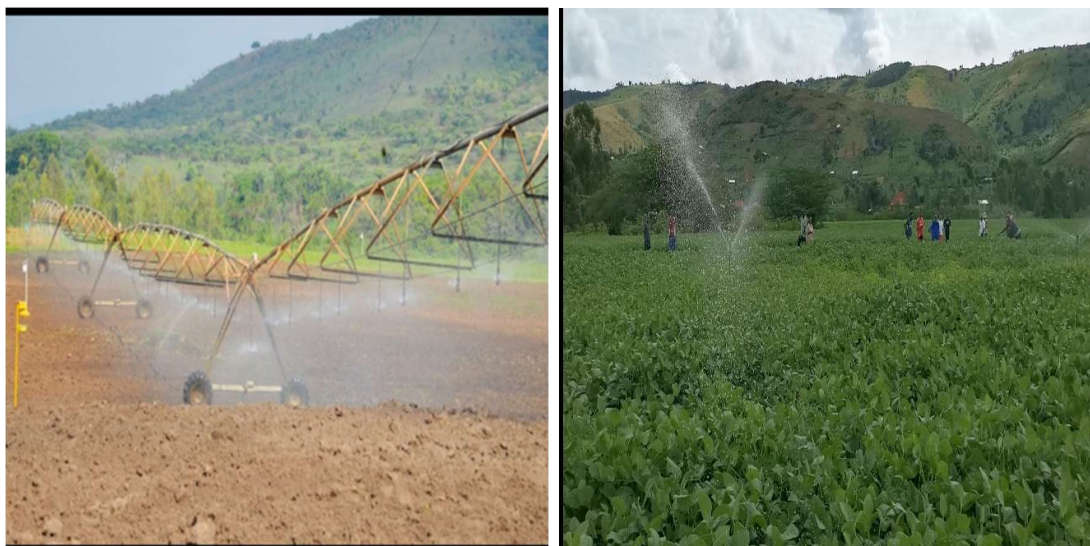
Figure 11. Irrigation system at Kagitumba irrigation scheme.

The irrigation systems which are installed in Kagitumba irrigation scheme include center pivot and portable sprinkler systems. During field assessment these systems were observed to be functional. Centre pivot systems were actively moving and applying water across the fields however variations in water application patterns were noted in some sections. These irregularities show the presence of pressure fluctuations and possible nozzle blockages which caused by water with sediments. The portable sprinkler systems were working but there was small uneven pressure distribution which was observed in certain fields resulted in non-uniform water application.

The physical irrigation infrastructure of that irrigation in the scheme includes irrigation control system which has electrical control panels, switches, and automated pump controls was found to be operational but outdated and poorly maintained. The control panels show clear signs of aging, including worn-out switches, faded labeling, and corrosion of electrical components. Disorganized electrical wiring was observed which presents safety hazards and increases the possibility of system failures.

The control system is functional but it doesn't have modern automation features such as real-time pressure monitoring, automated fault detection, and remote operation capabilities. Chala et al.,2024 said that the advantage of integrating smart control systems to improve operational efficiency, reduce water losses, and enhance system reliability and the absence of such technologies in the scheme limits its ability to respond effectively to changing field conditions and operational demands.
