# An Adverse Outcome Resulting from an Aftermarket Modification of a Suspension Seat: A Sentinel Health Event Investigation

Posted Date: 6 January 2026

Keywords: vibration; occupational health; seat; ergonomics; after-market alteration of suspension seat; ISO 2631(1); forensic; causation analysis; rail; maintenance-of-way

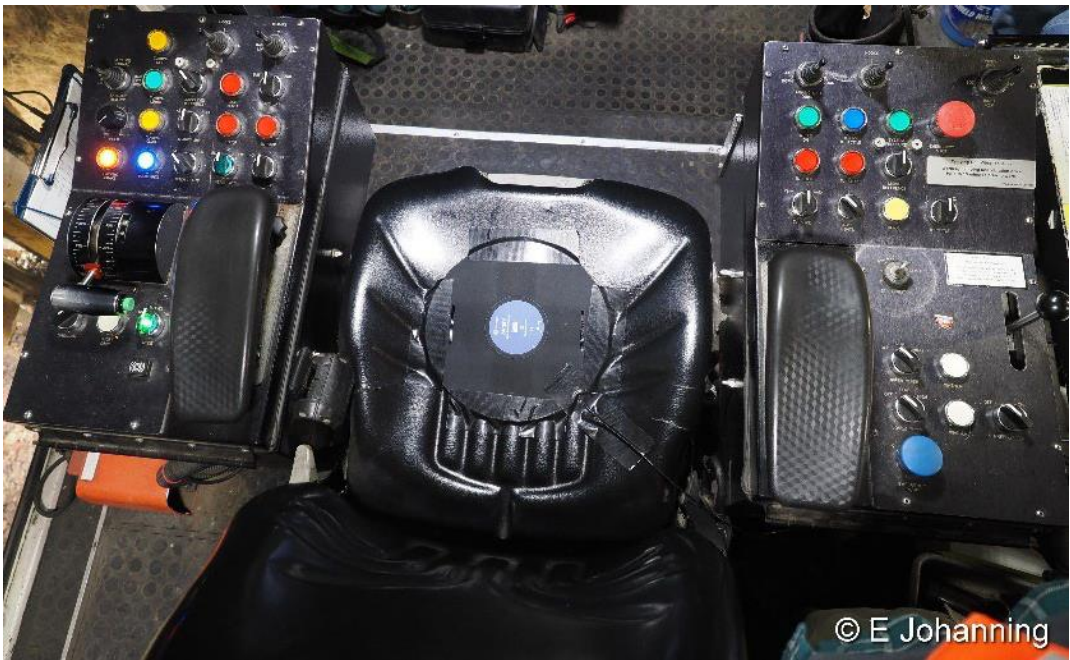
**Figure 1.** Operator seat system with attached side consoles and monitors showing seat pad location (view from top). (© E. Johanning).

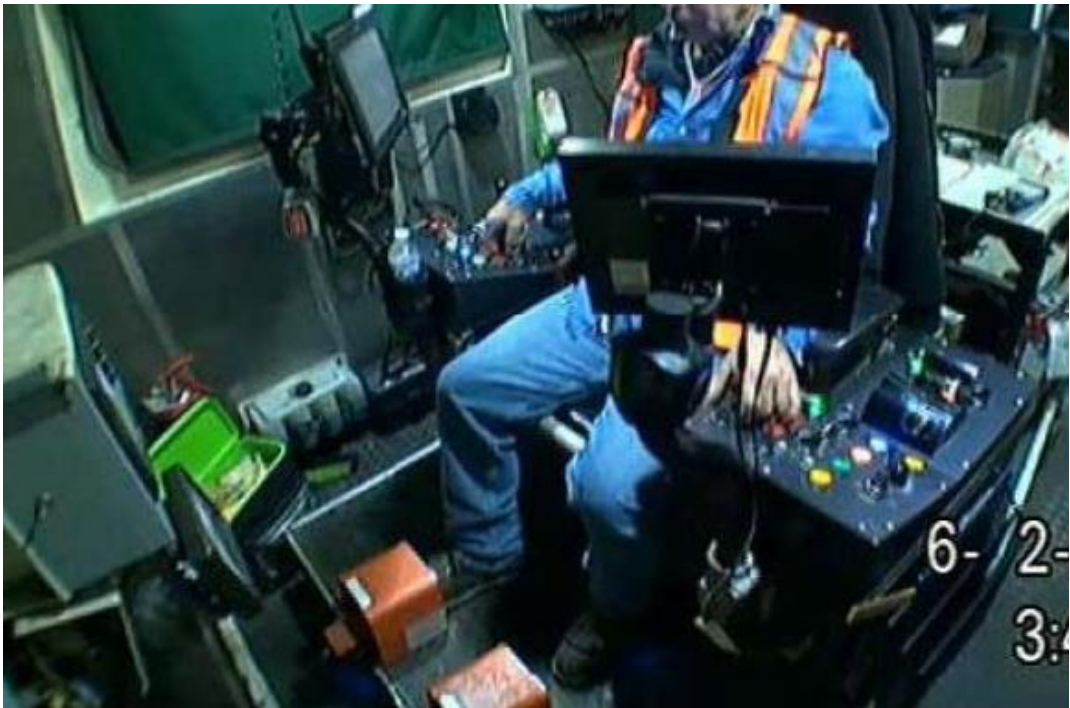
**Figure 2.** Operator using hand and foot controls of chair system with side monitors attached to consoles (front/side view). (© E. Johanning).

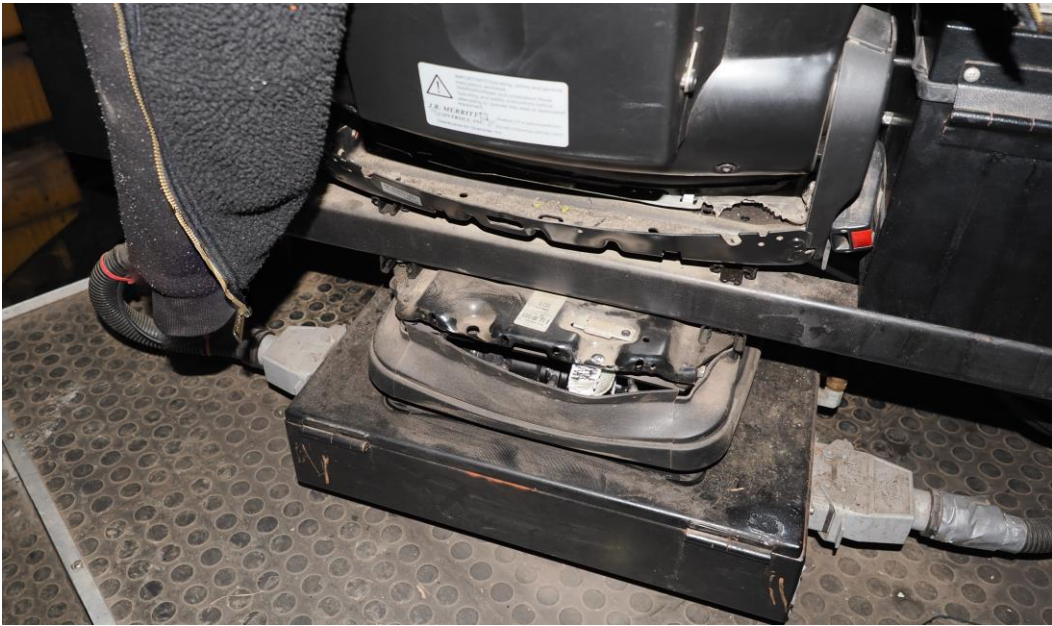
**Figure 3.** Operator seat spring system (rear view, bellows partially removed) with metal attachment bar of the side consoles mounted between seat pad/back rest and spring system and fixated on rotating platform. (© E. Johanning).

In this case investigation, the modified seat spring system of the tamper had several shortcomings. The additional attachments (control console on right and left side, the attached several monitors) added considerable weight additionally to the driver's weight and likely caused the seat suspension system to bottom out, which in turn caused the rubber end-stops to break and exposed the operator to added shocks. The seat had excessive wobble and was not securely mounted and braced as required by the US Federal Railroad Act (FRA 49 CFR Ch. II (10–1–23 Edition) § 229.119 Cabs, floors, and passageways). The workers explained that the tamper vehicle is transported on railcars to the working locations and that the railcar vibration and handling would cause equipment inside the cab to be tossed around and bounced during transport. The added side consoles increase stress on seat joints and bearings. Engineering best practice is to mount heavy consoles and monitors separately from the seat suspension, as their weight restricts seat adjustment and adds unnecessary load.

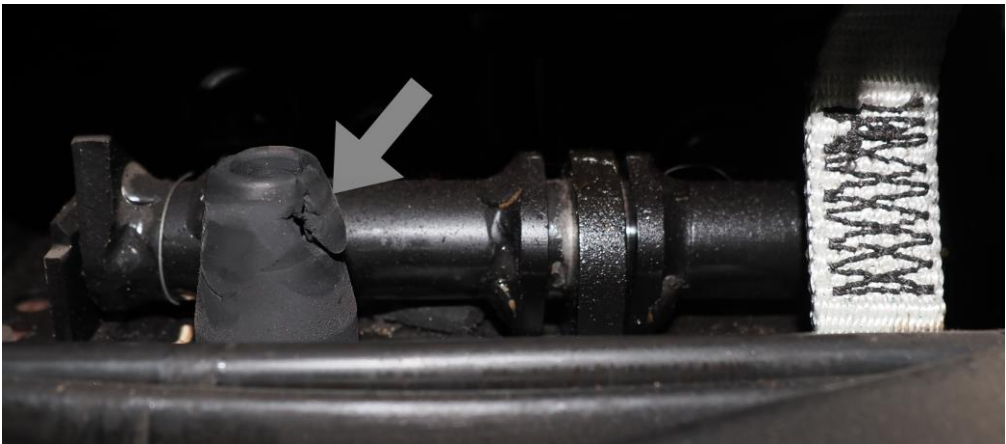
Importantly, as shown in Fig 4., a rubber buffer located in the lower part of the seat spring system designed to control and stop excessive downward movement of the seat was broken and defective (arrow) and more likely than not renders the suspension system ineffective and unsafe in absorbing high input vibrations and shocks.

**Figure 4.** Detail of rear lower seat system; bellows removed. Down-wards rubber buffer broken (arrow). On the right: showing the security upwards stopper belt (© E. Johanning).

This investigation found that the tamper's modified seat spring system was faulty and unsafe. The aftermarket attachments increased the load, causing the suspension to bottom out and break rubber end-stops, exposing the operator to more preventable vibration and shocks. The seat also wobbled excessively and was insecurely mounted, issues that could be fixed with proper maintenance. Mounting heavy consoles and monitors apart from seat suspension avoids limiting seat adjustment and improves the SEAT performance. Effective collaboration among vehicle users, seat and vehicle engineers can reduce WBV exposure risk and improve safety and efficiency.
