# Timber Frame Home Reconstruction After the 2016 Kumamoto Earthquake with a Community Asset Focus

Keywords: timber fitting connector; CLT; superimposed openwork beam; thinned wood; high strength timber shear wall; timber frame structure; multiple earthquakes; disaster reconstruction; recovery utilizing a public bath; community preparedness

Yuki Kuroiwa <sup>1,2</sup>

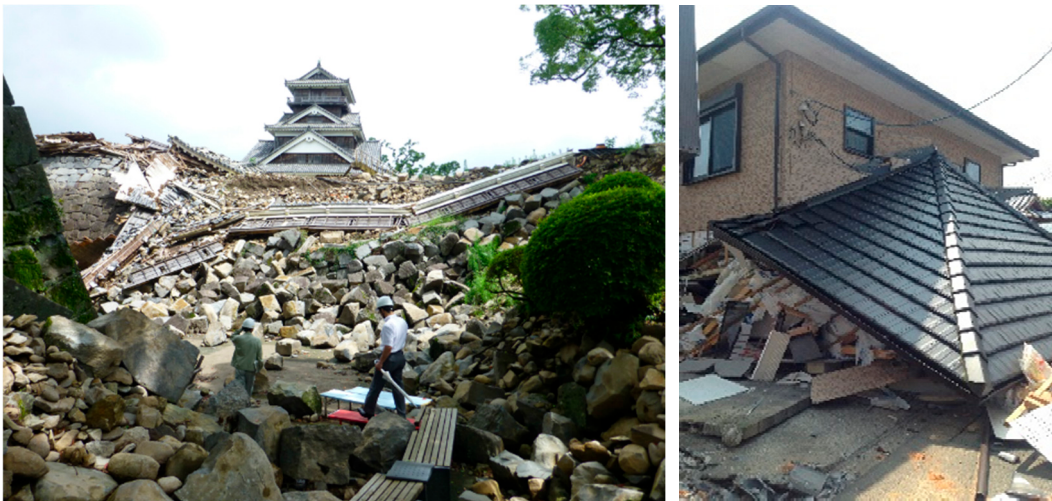
Figure 1. Consecutive Kumamoto earthquake damage (Authors).

In recent years, environmental issues have become a global concern, and natural disasters are occurring with increasing frequency amid the risk of resource depletion caused by excessive human consumption. Japan's southwestern region, particularly Kumamoto Prefecture, sits at the nexus of several converging tectonic plates and is therefore highly susceptible to seismic events. In April 2016, a sequence of Mw >7.0 earthquakes struck the area, causing extensive damage to the infrastructure and leaving many architectures, including our condominium, in partial or total ruin (Figure 1). Beyond the structural failures, prolonged disruptions to lifeline services—most notably a multi-month interruption of the municipal water supply—compounded hardships for residents forced to rely on overcrowded public bathhouses, where insufficient capacity and clogged drainage amplified health and hygiene concerns (Figure 2). Immediately after the shocks, I temporarily suspended my structural design practice to assist with building recovery, volunteering primarily in debris clearance. Concurrently, at the prefecture's request, I performed rapid safety screenings and affixed color-coded danger-level stickers to compromised structures (Figure 3). I then conducted detailed damage-classification surveys to assess necessary seismic retrofitting. These assessments informed seismic diagnoses in which the bearing capacity of affected structural elements was systematically reduced. Our condominium was ultimately classified as “large-scale half-collapse,” necessitating full

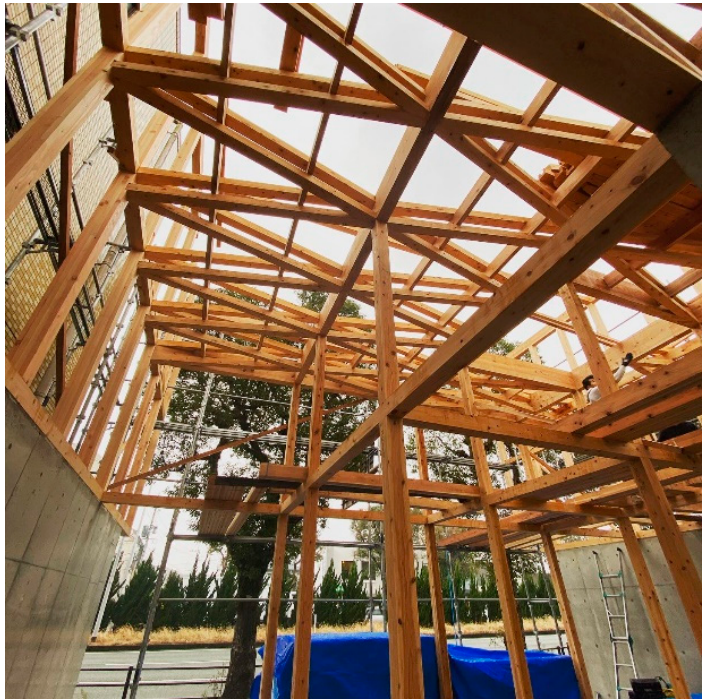
Figure 6. Erection of superimposed open-work girders (Authors).

The ground-floor public bath is a small-scale space, so we set an approximately 5.0 m ceiling height to create a more open bathing environment. In the post-Kumamoto market—where subcontractor premiums and material costs soared—we adopted a low-cost approach using ungraded Japanese cedar members (90 × 90 mm, 4.0 m long), which cost roughly one-third per cubic meter of engineered wood (E120-F330, 4.0 m). Columns are 105 × 105 mm cedar, with mid-height beams installed in both directions to prevent buckling. Because bathers naturally look upward for extended periods, the ceiling comprises superimposed triangular open-work beams. These overlapped members enhance structural rigidity and flexural capacity. Long screws connect the small square timbers, while the upper and lower flanges of the main girders—and the continuous perimeter columns—are engineered wood. Connections employ long screws (PS8-320) to resist shear forces and long screws (PX8-290) to provide tensile capacity at flange-to-column interfaces (Figure 5). Each girder is split into two branches to boost bending strength within a minimal beam depth, and end-grain joints are reinforced with structural adhesive as a fail-safe.

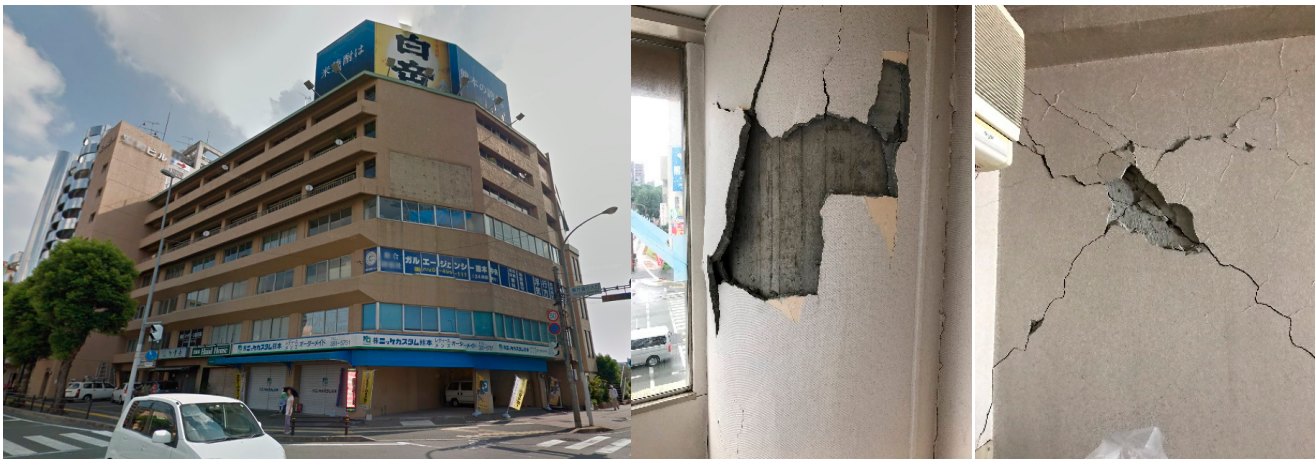
Figure 9. Shear-Failure Cracks in a Reinforced-Concrete Shear Wall (Authors).

I conducted damage-classification assessments—estimating remaining strength from settlement, tilt, and structural damage—on multiple RC condominiums, the Kumamoto Prefectural Civil Engineering Office, and the Prefectural Government Office. Based on this statistical evaluation, shear walls were assumed to retain only 60 % of their original strength. R is the residual seismic strength ratio, defined as the ratio of remaining bearing performance after damage. For the initial earthquake, the structure was designed using the allowable-stress design method; for the subsequent shock, we applied the same R = 60 % reduction and evaluated the residual ultimate lateral strength under the new loading. The composite moment frame hinges at the top of the shear wall (inflection point), combining the lower wall’s out-of-plane strength with the upper timber ramen system. Connections between shear walls and timber columns, as well as mid-story beams, are pinned (Figure 8). Although the triangular beam enhances horizontal strength, we provided horizontal load capacity solely with 24 mm structural plywood to simplify design assumptions.

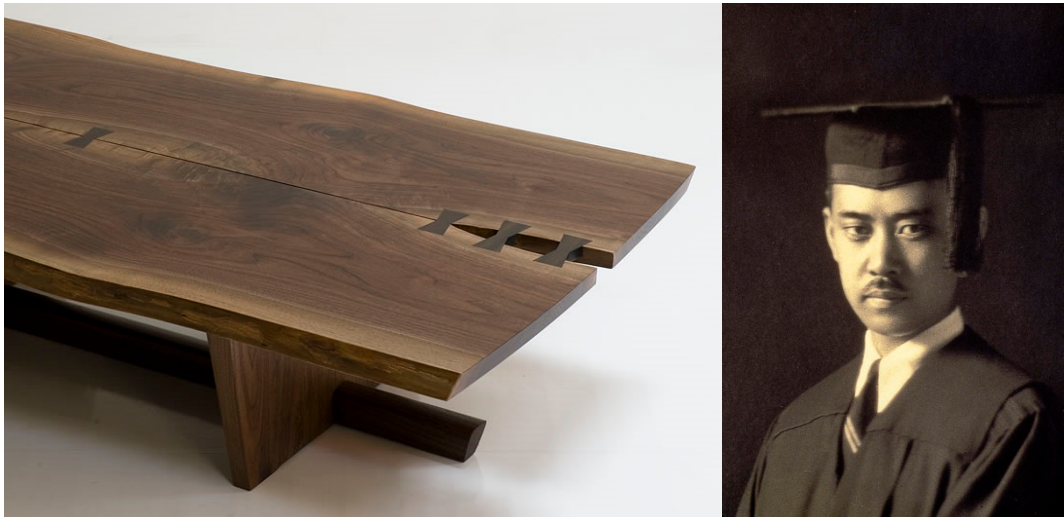
**Figure 14.** George Nakashima’s Butterfly-Fitting Table Joint (Sakura Seisakusho).

George Nakashima's 1968 desk incorporated a similar butterfly fitting to carry tensile loads generated by drying shrinkage; however, its bending performance was never characterized. During assembly, some connector keys caused localized chipping along the lamina glue lines. Although this chipping did not match the failure modes observed in tests, it was deemed non-critical and construction continued. Hammer-driven connectors at CLT panel edges can induce rolling-shear

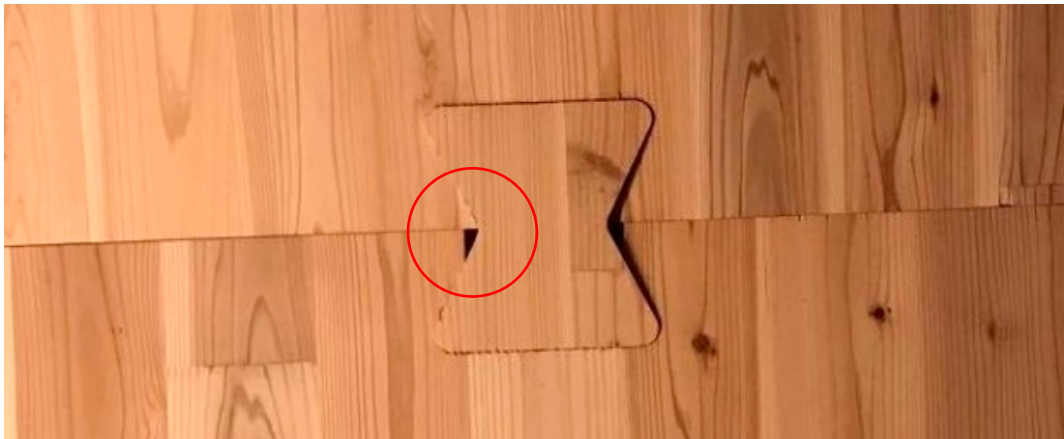
**Figure 15.** Localized Lamina Chipping at Connector Key Insertion (Authors).

damage along lamina layers. Japanese CLT fabrication does not apply epoxy resin to the side faces of the lamina, increasing edge vulnerability. The structural adhesive used between laminations is a resorcinol–phenol co-condensation resin; in tests the adhesive layer fractured before any wood substrate failure, confirming that the adhesive layer is weaker than the timber members under shear and tensile loading.

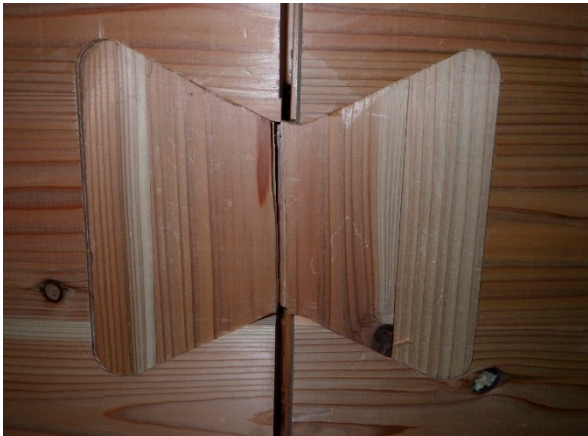
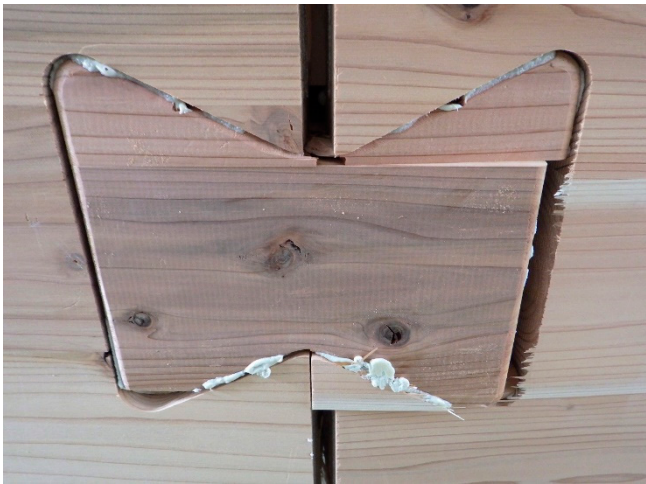
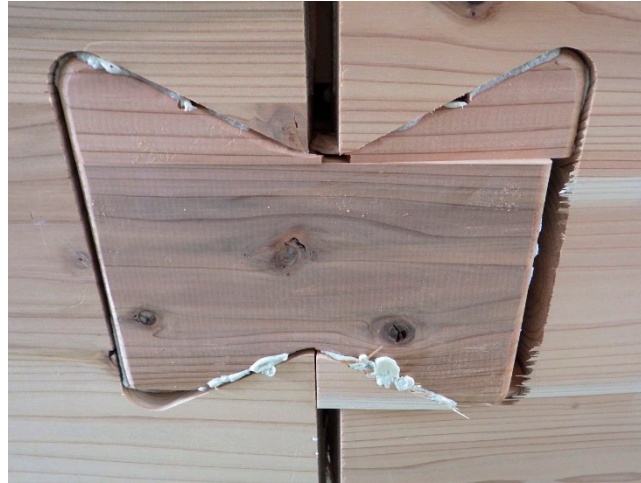
Crack fracture along fiber direction

Shear failure for snagging

Weak axial crack with shear key

**Figure 20.** Specimen after testing (Authors).

fitting connector, so there no combined proof stress at the end of the test. Since cracking occurred only in the weak axial direction of the CLT layer, the bearing capacity would have increased if the fittings were in the strong axial direction (Figures 20). Notably, seating the connector on a strong-axis lamina would markedly increase bending capacity. Unlike through-bolts or long screws—which create continuous load paths and require no layer-by-layer orientation fitting connectors in CLT concentrate stresses at each lamina. Therefore, connector design must be studied per layer to avoid weak-axis alignment at the interface. Moreover, for buildings like this one with predominantly unidirectional loading, it may be more rational to adopt a glulam-style layup—stacking laminations all in the fiber direction—instead of cross-lamination, thereby eliminating weak-axis layers and simplifying connector requirements.

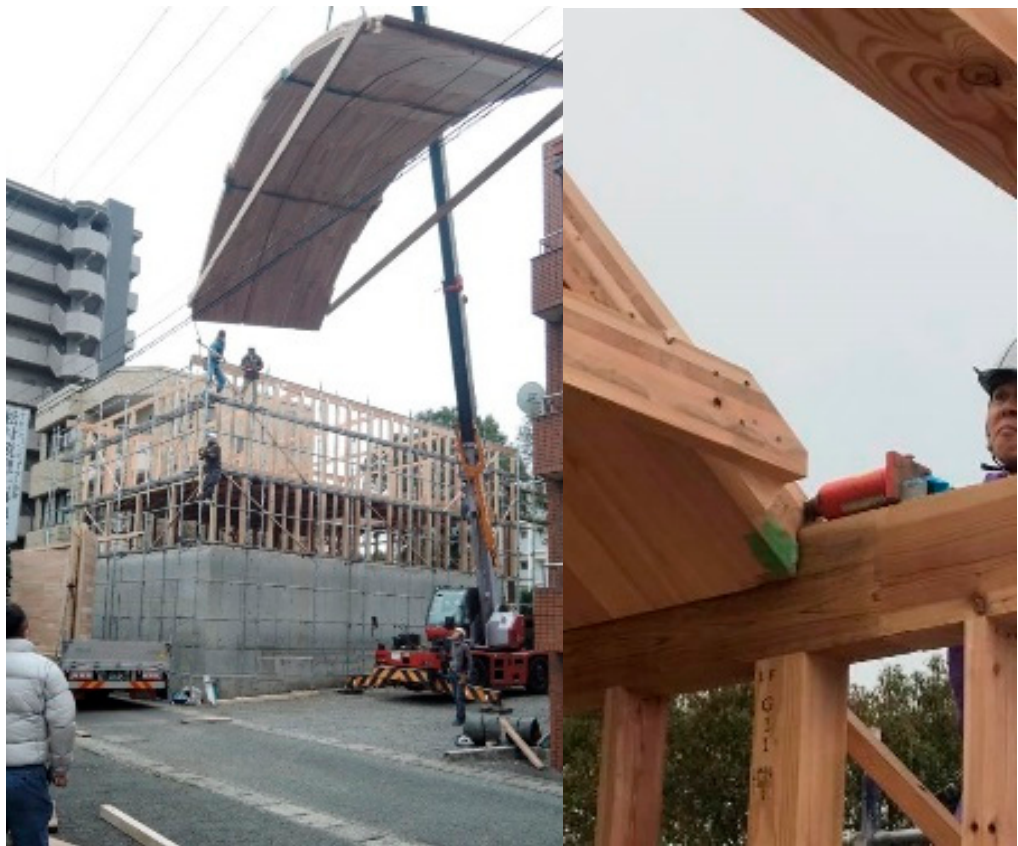
**Figure 23.** Erection and Alignment of CLT Arch Modules (Authors).

On-site, a crew of five carpenters completed erection in a single day on a narrow lot crisscrossed by overhead power lines. Modules measured 2.75–2.85 m in width and weighed 1.5 t each. A few carpenters guided each arch into place using a nylon sling and hydraulic jacks, then secured interfaces with long screws. Lightweight CLT enabled manual positioning when necessary (Figure 23).

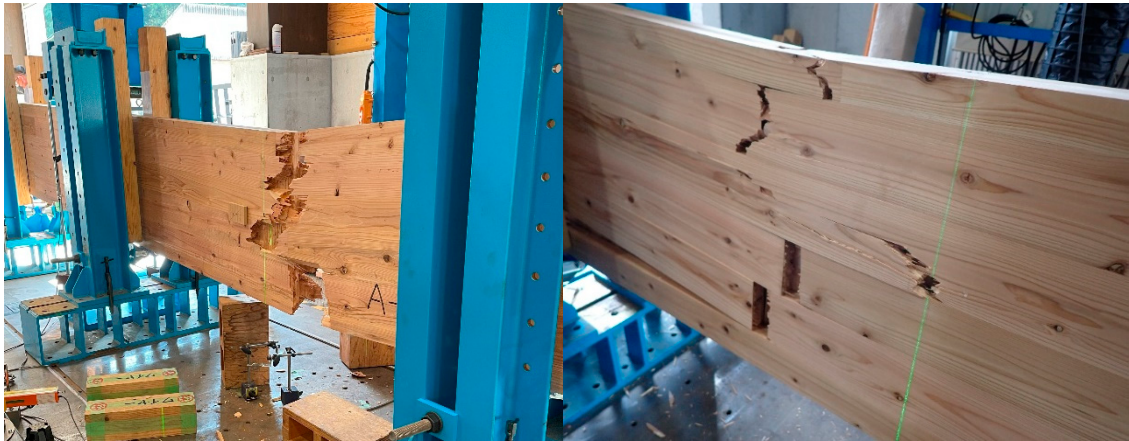
Figure 27. Failure Modes of Pressed (left) and Unpressed (right) Specimens (Authors).

Timber joint design encompasses numerous configurations, yet the timber fitting connector studied here offers distinct advantages and challenges for both new construction and adaptive reuse—including deconstruction and relocation. In a separate set of our experiments on edge compression of CLT panels, pressed (red and green line) specimens achieved approximately 20 % higher maximum loads compared to non-pressed (blue line) counterparts (Figure 26). In pressed specimens, cracks initiated at the finger-joint of the lowest lamina and propagated upward through adjacent layers, whereas non-pressed specimens exhibited selective propagation along finger-joints (Figure 27). These results of lamina-side compression to mitigate rolling-shear damage and indicate that, when aesthetic sensitivity is paramount, pre-compression of CLT edges is essential to preserve connector integrity.
