Weakness Identification of Wood Pillar Foundation: Indication of Foundation Failure to Avoid House Collapse in Swampland

[Nursyarif Agusniansyah](#) *

Posted Date: 3 July 2024

doi: 10.20944/preprints202407.0315.v1

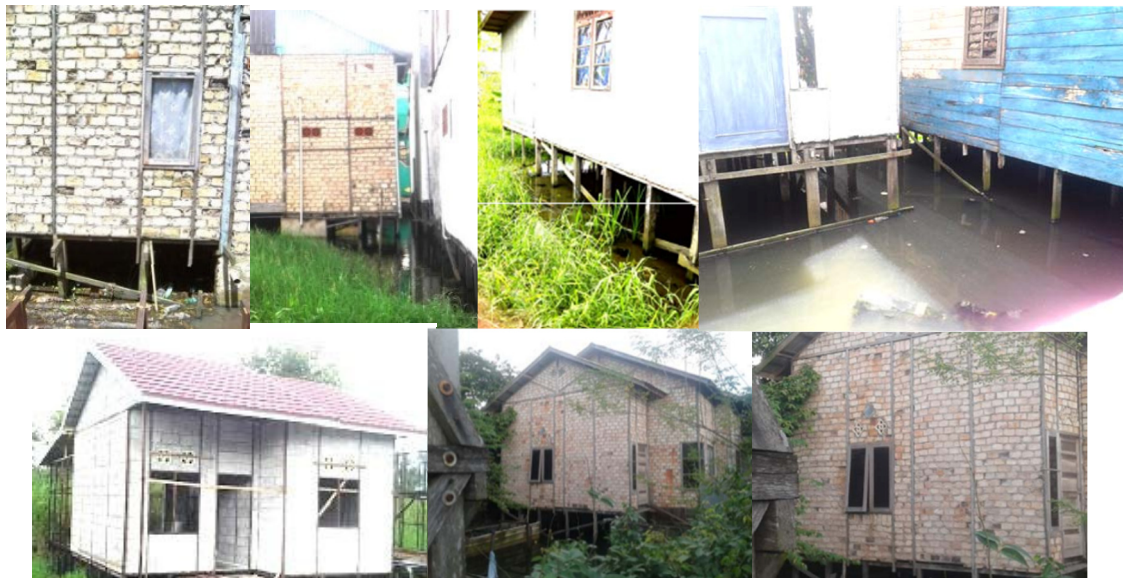
Figure 1. Wooden Pillar Home Development Issues.

The problem of the wooden pillar houses is not free from the conditions of the wood pillar and the condition of the wet soil. The development of the semi-permanent building type (Figure 1) with the construction of bricks standing as the intercolumn filling of the wall pillars. Treated as permanent building finishing, diplexer and acian, then painted. Then the wooden floor material is mounted on ceramic.

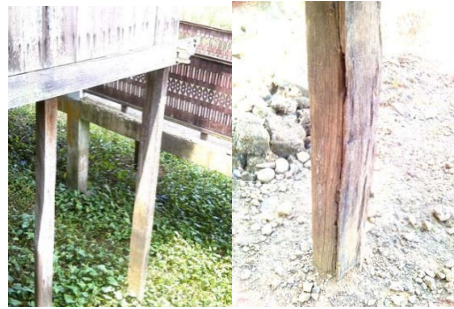
Figure 2. Damage to Wooden Pillars.

The source of the problem of building houses mostly comes from the wooden pillars. The strength of a wooden pillar is equivalent to the quality of the wood, so the damage to the material also affects the condition of the construction. The damage to the pillar may be due to the inability to carry the load on it, and it is also often due to soil and weather conditions (figure 2).

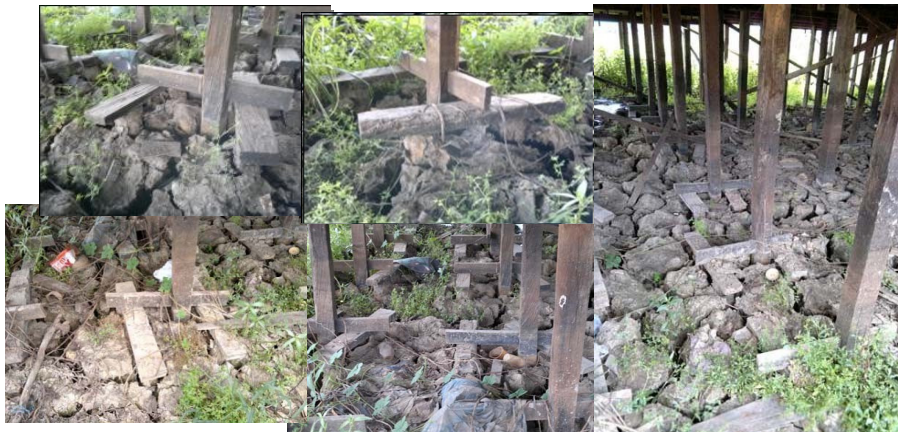
Figure 3. 'Sunduk' Arrangement.

The wooden pillar is connected to the foundation part as an integrated part of a single unit. For the Banjarmasin area, use the support beam ('kalang') and the horizontal beam ('sunduk') seen in the figure 3 and 4. After the hook, there's a hook element that's used to withstand the loads. In this element, there is usually a variation in the foundation and the presence of various other types of foundation.

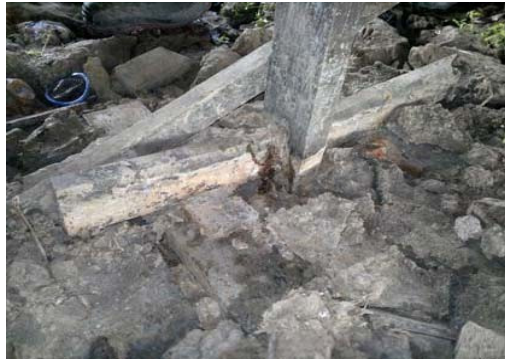
Figure 5. Broken 'Sunduk'.

Broken 'sunduk' from the picture, you can see the condition of the bottom of this wooden pillar. It appears that the mounting of the cuffs and braces when under the surface of the water becomes unclean by adjusting the position of the scissors. There is a field finding that there is a state of wood damage with the presence of a broken crown (figure 5). This could be the cause of the falling floor in the house anyway. Because of the quality conditions of the cane, often the remaining pieces of wood, small and have a wooden eye, resulting in a broken cane. However, because the position of these building elements is below the surface of the water, this often leads to invisibility. Photo taken from the field survey with the conditions of the dry land area, so it can be clearly seen this situation.

Improving 'sunduk' in wood foundations involves using durable materials, reinforcing the base, enhancing structural connections, and considering hybrid designs. By integrating modern construction techniques with traditional methods, it can create a stronger, more durable 'sunduk' that is resilient to moisture and environmental challenges. Regular maintenance and inspection are also essential to ensuring the structure's longevity. It is recommended to find a hybrid wood design with concrete material to improve wood foundation stability.

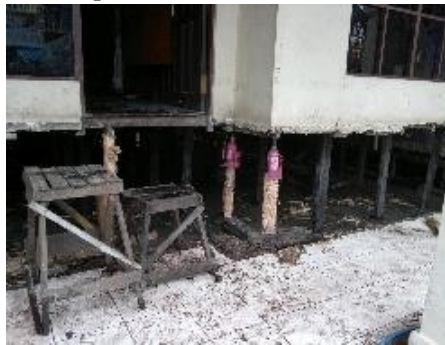
Figure 6. Scratching House Pillars.

Other field finds include the activity of replacing wooden pillars with a way of crushing houses (figure 6). It's done because the floor position of the house needs to be raised.

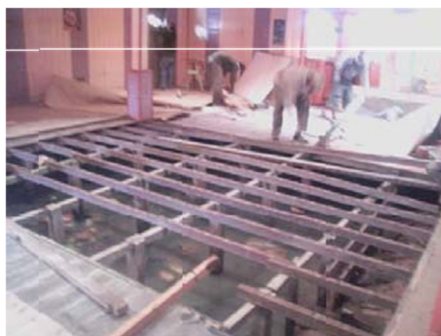
Figure 7. Falling And Folding Floor.

Damage to the wooden pillar element can cause falling and bending of the floor (figure 7). The construction of the floor is visible with a 50cm floor beam, and continues to be lifted by rows of wooden columns. The characteristic of the fall of the foundation and the bending of the floor of the building is the presence of the ceramic floor covering that is broken and raised like in the figure 8.

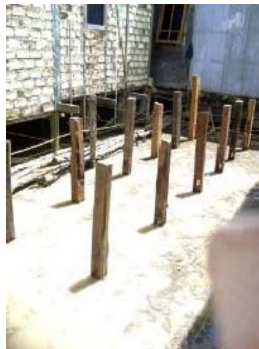
Figure 9. Horizontal Home Extension.

It was found that the development of the wooden pillar house was done by renovating horizontally to expand the space of the house with the addition of space (figure 9). A wooden pillar is added to an empty plot.

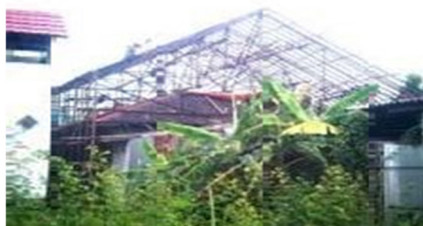
Figure 10. Vertical Renovation.

The most common thing about building houses with wooden frame structures is the repair or renovation of houses vertically (figure 10). By demolishing the roof of the building and making it into a flat-scale house, the building burden increases. Even with the consideration of replacing the top material of the building with an even lighter material, this will increase the burden on the foundation.

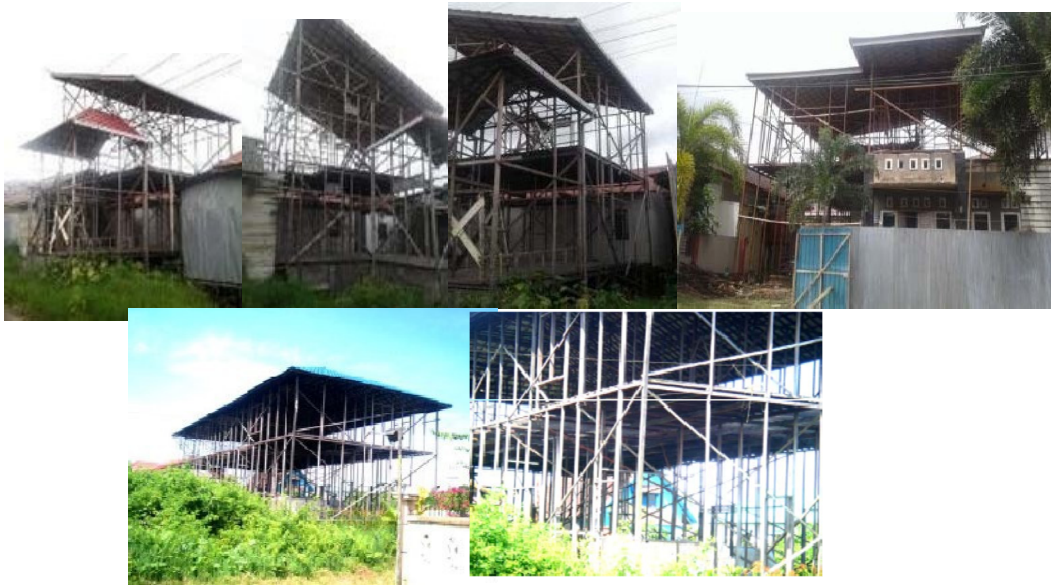
Figure 11. Construction of a two-storey house.

Besides, make the building of a house directly 2 (two) floors (figure 11) and frequently done. But the foundations of the buildings used seemed to remain the same as the foundation conditions of the one-story buildings. Because the construction system and the material remained a row of wooden pillars on the bottom and a wooden frame on the building, Both of these cases actually require reinforcement of a wooden pillar to accept the added building burden.

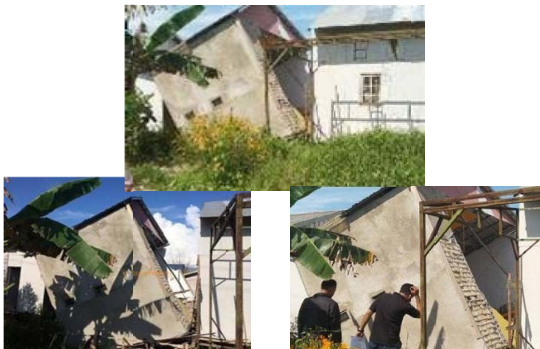
Figure 12. Tilted House Building.

With more severe damage to the wooden pillars, there could have been some cases of house buildings that were not only bent but even collapsed (figure 12 and 13). It is often said that this occurred because of the failure of the foundation of the house to follow its pillars.

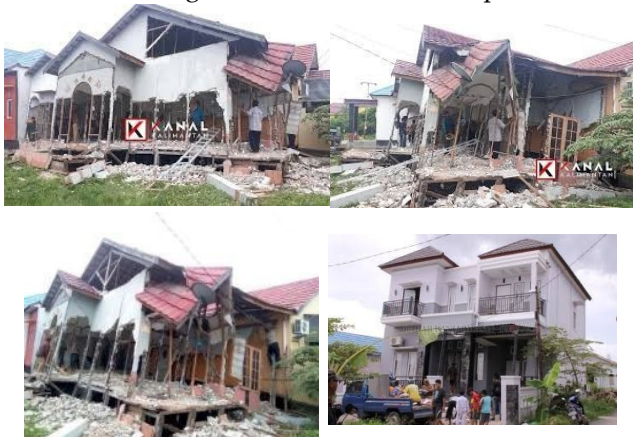
Figure 13. House Building's collapsed.

Errors in the selection of foundations, the lack of strength of the foundations and poles to carry the heavy building burden, or the depression and inexperience of the construction workers are often accused of being the cause. The wooden pillar is still involved.
