# Eddy Current-Based Identification and Depth Investigation of Microdefects in Steel Filaments

[Kim Sang Tran](#) , [Bijan Shirinzadeh](#) <sup>\*</sup> , [Julian Smith](#)

Keywords: microdefects; eddy current signal; reinforced fibers; depths of defects

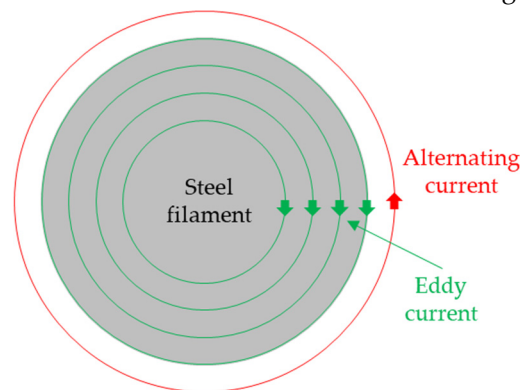
**Figure 1.** Eddy currents induced around steel filament.

The principle of electromagnetism underpins experiments involving eddy currents [39]. In the filament manufacturing process, a surrounding sensor is employed to detect surface imperfections in the steel filament. The sensor analyzes the eddy-current signal upon detecting imperfections in the wire, based on preset conditions. Activation of an input current induces an alternating magnetic field, generating eddy currents within the target object [40], as shown in Figure 1. Utilizing this principle, a sensor coil identifies abnormal signals induced by micro surface defects in the steel wire. Signal amplitude response is then utilized to establish thresholds for detecting desired micro surface defects.

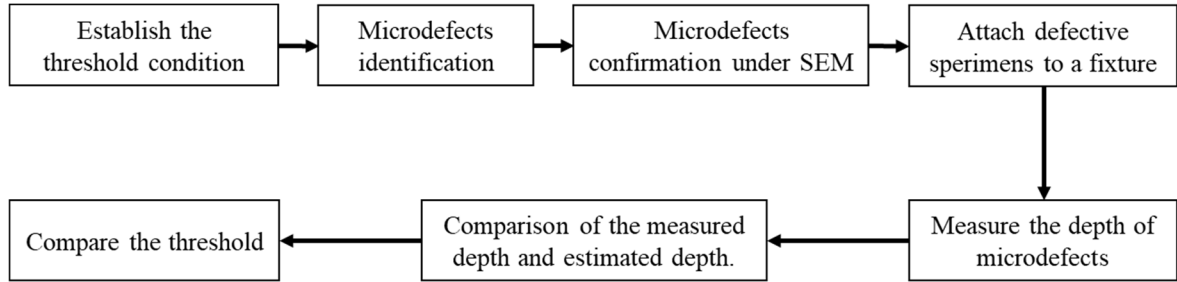
Figure 2. Experimental procedure.

The experiments commenced by establishing the threshold condition, which served to identify the microdefects in the filament. Subsequently, the defective specimens were verified under a scanning electron microscope. In the next step, these unacceptable samples were placed into a mold to secure them before depth measurement. Finally, the measured depth and threshold values were compared with those obtained from estimation, as outlined in Figure 2.

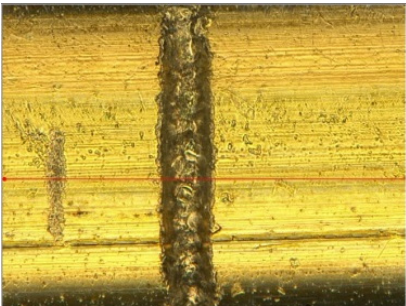
Figure 3. Defect created on steel filament.

In previous research, a crack with a depth of 20  $\mu\text{m}$  was intentionally created on the surface of a sample, as illustrated in Figure 3, and the threshold was set at 10%, corresponding to a depth of 20  $\mu\text{m}$  [28]. The experiment was conducted in two batches, with 15 defects selected per batch. Any specimens with imperfections having a depth exceeding 20  $\mu\text{m}$  were removed from the production batch, and these specimens containing these defects were analyzed to validate the set parameters. Additionally, the relationship between the defect depth and the monitored phase angle will be further validated against estimated values.

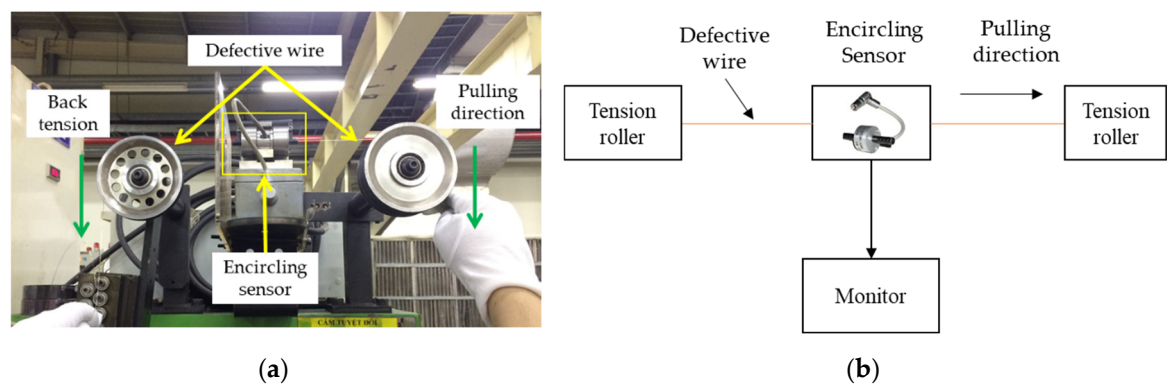
Figure 4. (a) Position of encircling sensor; (b) Block diagram of experiment.

The wire with surface defects was passed through the encircling sensor, allowing the monitor to detect the defect’s position as it passed through the sensor coil, as depicted in Figure 4.

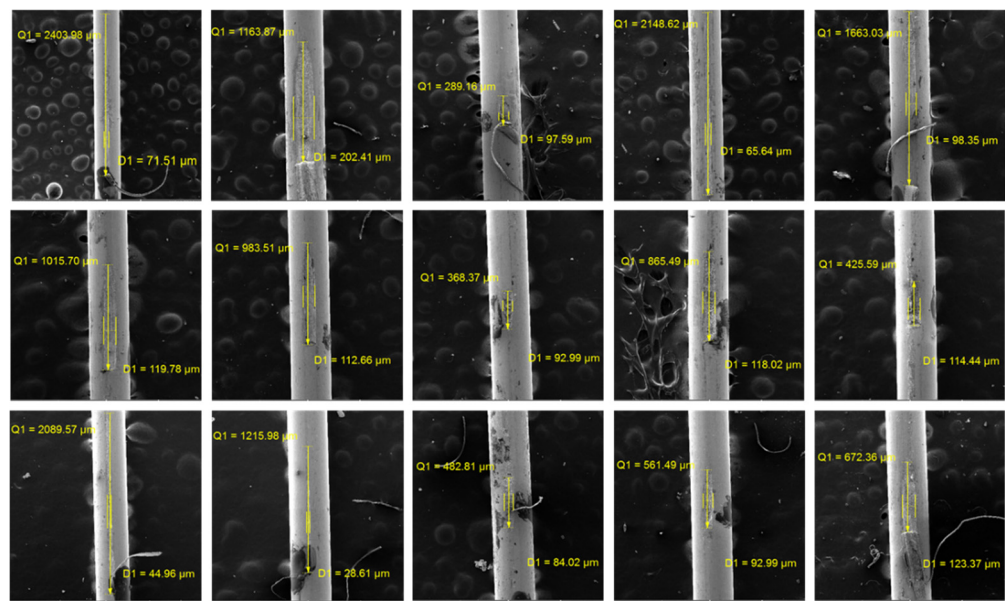
Figure 5. Defects detected under scanning electron microscope.

After identification, the defective specimens were localized, and their surface defect locations were marked and confirmed using scanning electron microscopy, as depicted in Figure 5. Subsequently, these specimens were cut into small pieces, attached to a fixture frame, and placed into a mold to stabilize their position and orientation prior to grinding, as illustrated in Figure 6. The length and width of these defects were then measured using scanning electron microscopy and energy dispersive spectroscopy.

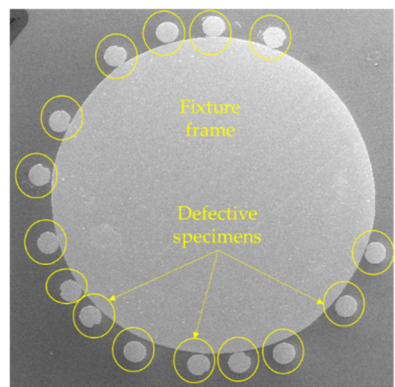
Figure 6. Specimens attached to a fixture frame.

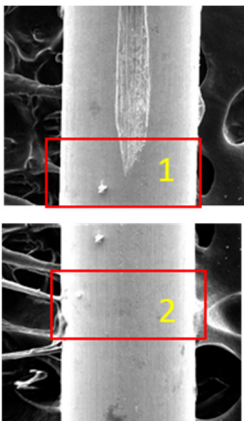
Figure 7. Locations of mapping analysis on a sample.

The scratching process performed during the drawing process, as confirmed by energy dispersive spectroscopy analysis conducted both inside and outside of the defect location, as detailed in previous research [28]. This result was further validated through mapping analysis at the head of the defect (rectangle 1) and the surrounding area (rectangle 2), as shown in Figure 7. Figure 8 illustrates the absence of copper (Cu) and zinc (Zn) in the vicinity of surface defects, consistent with the findings reported in [28]. This suggests that such failures occurred during the drawing process, as copper and zinc were coated on the steel wire surface prior to drawing.

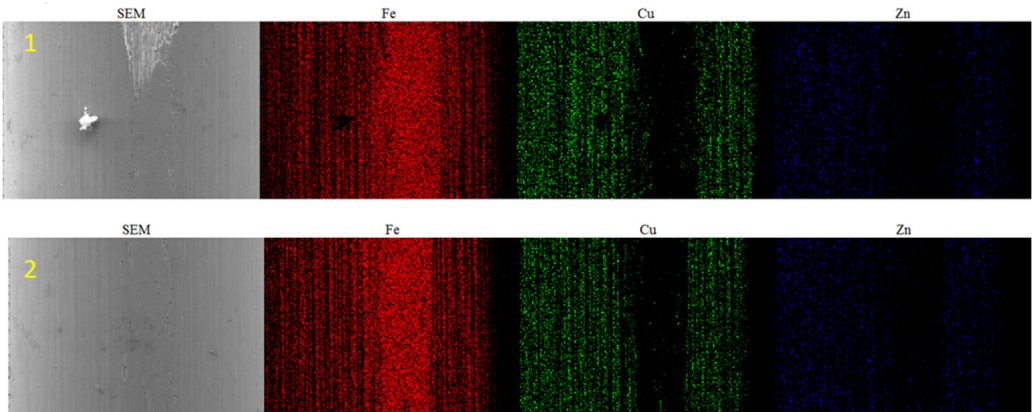
Figure 8. Mapping analysis of a sample containing defect.

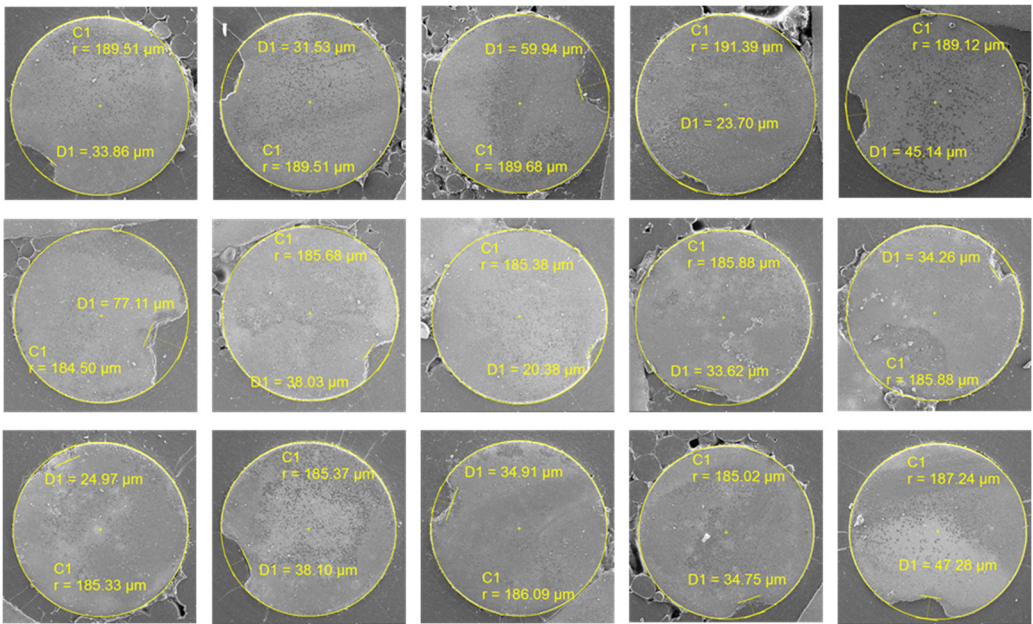
Figure 9. Cross-section of microdefects in Batch 1.

The defective samples were collected, and their cross-sections were captured using a scanning electron microscope. The depths of the cracks were measured as presented in Table 2 and the cross-sections of the defective positions are shown in Figures 9 and 10 corresponding to Batch 1 and Batch 2, respectively. The minimum and maximum measured depths are 20.38  $\mu\text{m}$  and 77.11  $\mu\text{m}$ , respectively, with an average defect depth of 35.07  $\mu\text{m}$ .

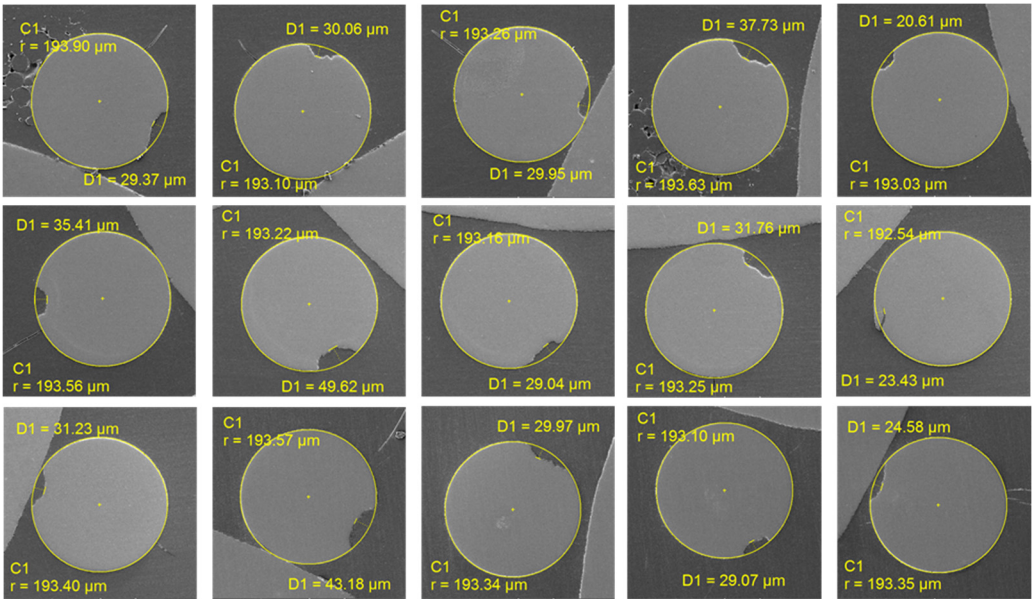
Figure 10. Cross-section of microdefects in Batch 2.

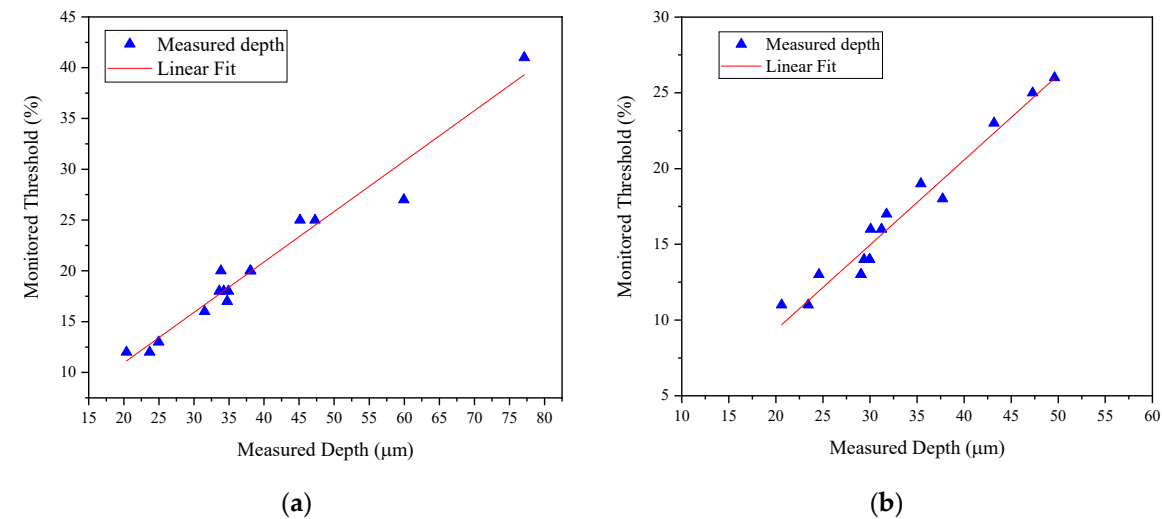
Figure 11. Depth and threshold of monitored defects: (a) Batch 1; (b) Batch 2.

The threshold of eddy current sensing was set at 10%, corresponding to an expected depth of 20  $\mu\text{m}$ , to identify defective specimens. Experimental depths were fitted with a linear function to calculate the threshold at 20  $\mu\text{m}$  of measured depth. The relationship between the threshold and measured depth for the first and second batches of samples is depicted in Figure 11a and 11b, respectively. The red line represents the linear fit between the monitored threshold and measured depth.

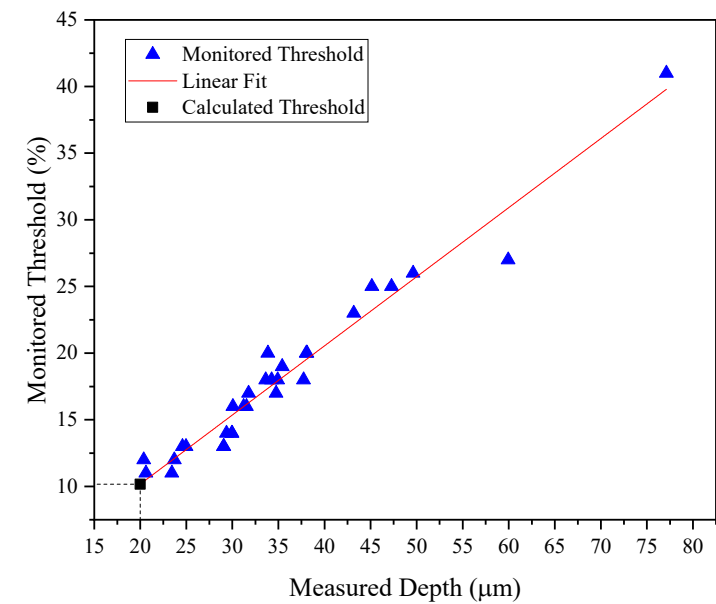
Figure 12. Threshold calculated for a depth of 20  $\mu\text{m}$ .

When the data was combined, a linear function was fitted to calculate the threshold. As depicted in Figure 12, the depths of defects ranged from over 20 to 60  $\mu\text{m}$ , with one sample having a depth exceeding 75  $\mu\text{m}$ . The black square in Figure 12 represents the calculated threshold corresponding to 20  $\mu\text{m}$ . The calculated threshold of 10.18% closely aligns with the set threshold of 10%, with a difference of only 1.77%.

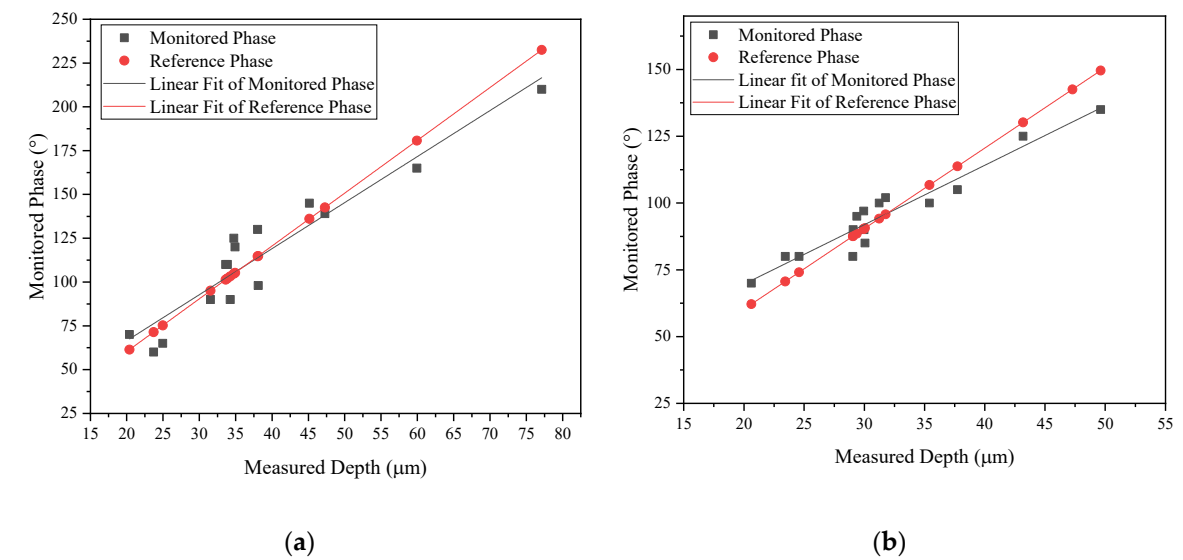
**Figure 13.** Depth and phase angle signal of monitored defects: (a) Batch 1; (b) Batch 2.

The relationship between the depth of the defect and the standard penetration depth was illustrated through Equations 1 and 2. This ratio establishes the defect’s position relative to the phase angle. The monitored phase angle is then compared to the reference phase angle, calculated from the ratio between the measured depth of defects and the standard penetration depth. This comparison is illustrated in Figure 13a,b, corresponding to samples in Batch 1 and Batch 2, respectively.

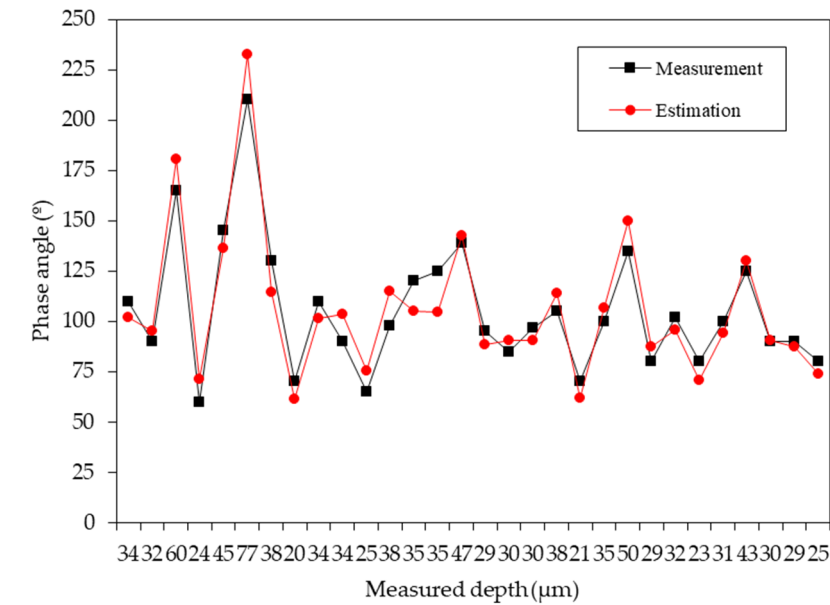
**Figure 14.** Comparison between measured phase signal and reference phase signal.

The depth of microdefects and the detected phase angles underwent comparison through estimation, as illustrated in Figure 14. These results, amalgamated from two batches of analysis, formed the basis of comparison. However, for a comprehensive evaluation of the measured data versus the estimated results, a precise rearrangement of the dataset was required. Thus, the data was carefully reorganized to align with the sequence depicted in Figure 15, ensuring a coherent comparison between measurement and estimation outcomes. This process aimed to enhance the accuracy and reliability of the findings, then facilitating a deeper understanding of the studied phenomena.

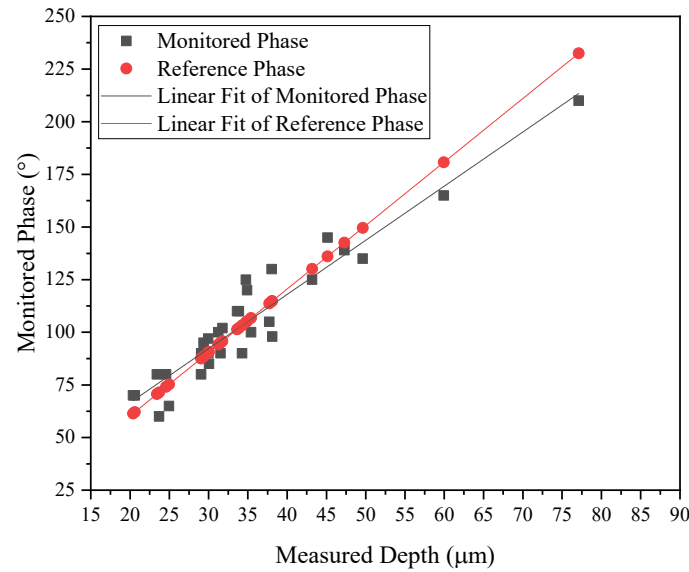
**Figure 15.** Comparison between measured phase signal and reference phase signal using RMSE.

A total of 30 defective samples were analyzed, and the phase angles between the experimental and theoretical results were compared. The red line represents the linear fit of the theoretical data, while the black line depicts the linear fit of the measured phase angles based on defective depth. The accuracy of this comparison was evaluated using the root mean square error (RMSE), which quantifies the difference between the measured phase angle and the reference angle. Figure 15 illustrates the comparison between the measured and reference phase angles for all samples. The resulting RMSE was found to be 10.53 degrees, equivalent to 3.49  $\mu\text{m}$ . This discrepancy can be attributed mainly to the manual handling of depth measurement.
