The Practice and Reflection on Rammed Earth Architecture: A Case Study of "Tiles Hill – New Reception Center for the Xiangshan Campus"

The Practice and Reflection on Rammed Earth Architecture: A Case Study of "Tiles Hill—New Reception Center for the Xiangshan Campus"

Abstract: This article documents the rammed earth construction practices undertaken by Wang Shu's team during the "Tiles Hill — New Reception Center for the Xiangshan Campus" project. This building not only embodies the principle of "learning from nature" inherent in traditional vernacular construction but also profoundly interprets the concept of "the craftsmanship way". Traditional rammed earth techniques represent a sustainable construction method, with a core focus on material composition and building techniques. Through more than a decade of continuous research, the team, combining modern technology, explored how to revive this nearly forgotten vernacular construction method in contemporary architecture. The article further highlights that the recyclability of rammed earth techniques is not only reflected in the reuse of materials but also in the material's inherent friendliness and non-destructive nature to the

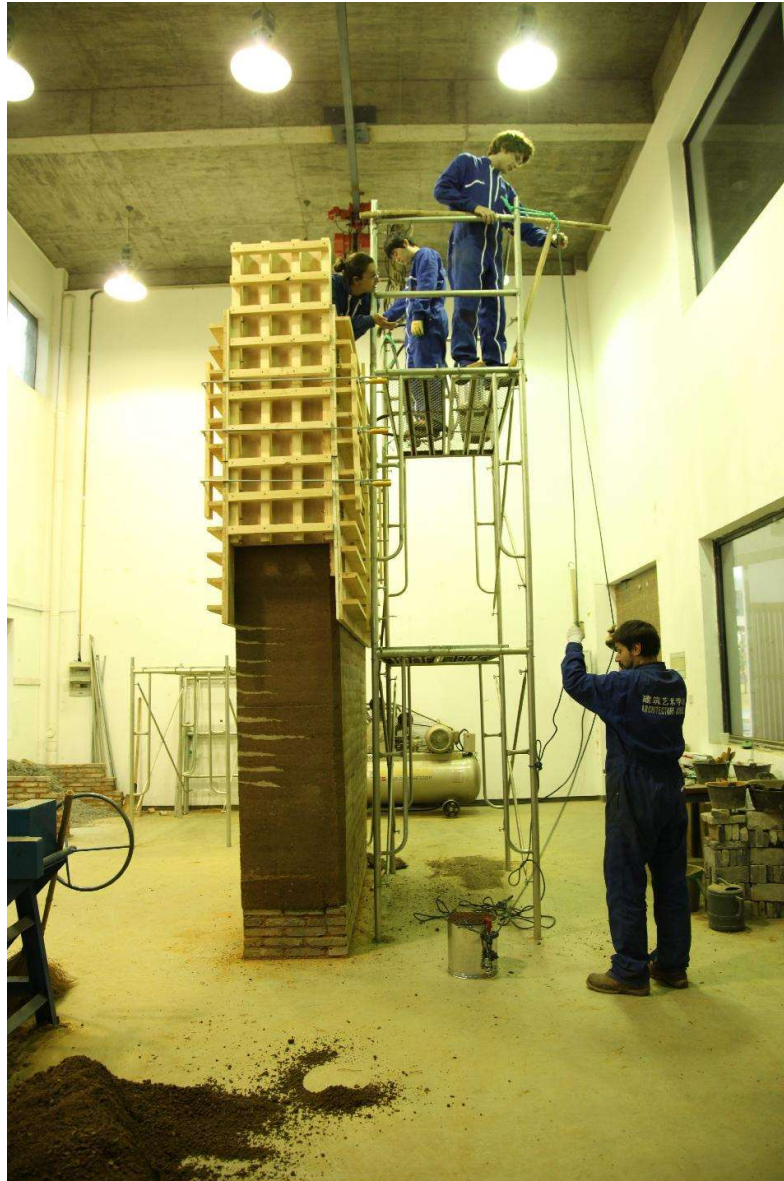
Figure 2. Construction of the first experimental earth wall at the Sustainable Construction Laboratory of China Academy of Art(©Chaochao Wei).

Before the construction of the "Tiles Hill — New Reception Center for the Xiangshan Campus" project commenced, the Sustainable Construction Laboratory, with assistance from the CRATER International Centre for Earthen Architecture in France, initiated an experimental project focused on rammed earth test walls. Two French researchers, Marc Auzet and Juliette Goudy, aided in the preparation of the test walls and provided technical training to the team. Prior to the official start of on-site construction, a complete rammed earth test wall was already built in the laboratory (Figure 2). The experiments included soil property analysis, the design, and optimization of rammed earth formwork. Through these experiments, the laboratory established a rammed earth construction process suited to modern building conditions.

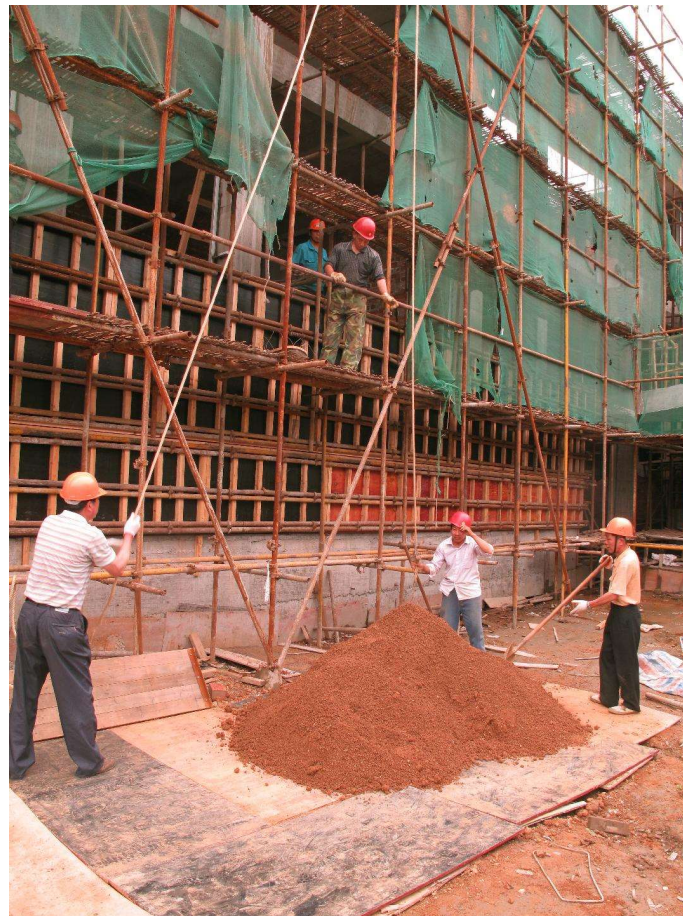
Figure 3. A rammed earth wall formwork technique akin to concrete pouring methods(Authors).

The dimensions of the formwork for the rammed earth walls were determined after multiple trials by the Sustainable Construction Laboratory. To prevent the formwork from expanding, cedar wood beams were used to create a reinforcing frame on its back. Horizontal scaffold steel pipes were placed outside this reinforcement, and several tie rods running through the wall were tightly secured

to hold everything in place. These layers of reinforcement ensured that the formwork frame used for rammed earth construction was extremely sturdy. Additionally, a tongue-and-groove system was designed between the upper and lower formwork layers to allow for quick installation and dismantling. This formwork arrangement closely resembles the "pouring-like" method used in concrete construction, where continuous formwork is used for single-stage molding[3]. The primary purpose of using large-scale formwork in this manner was twofold: first, to accelerate the construction process, and second, to ensure the integrity of the surface texture of the rammed earth walls after completion (Figure 3). In contrast to the "pouring-like" method, the traditional rammed earth construction in the villages of Zhejiang, Jiangsu, and Fujian regions employed a "bricklaying-like" approach. This method used a very small "wall bucket" formwork to complete the entire rammed earth construction of a house, where the ramming was limited to the size of the "wall bucket." For the walls, each section of the wall was rammed into large earthen blocks, which were then staggered and stacked, much like bricks in masonry. Using only one "wall bucket" formwork, the construction proceeded along the length of the wall, ramming from one end to the other in a bricklaying fashion (Figure 4). Moreover, due to the time difference in the formation of the upper and lower layers during the ramming process, the lower rammed earth blocks were exposed to air, accelerating their hardening and preparing them to support the next layer of rammed earth. This technique, passed down through generations of practical experience, reflects the ancestors' wisdom in developing a highly efficient and economical method of rammed earth construction.

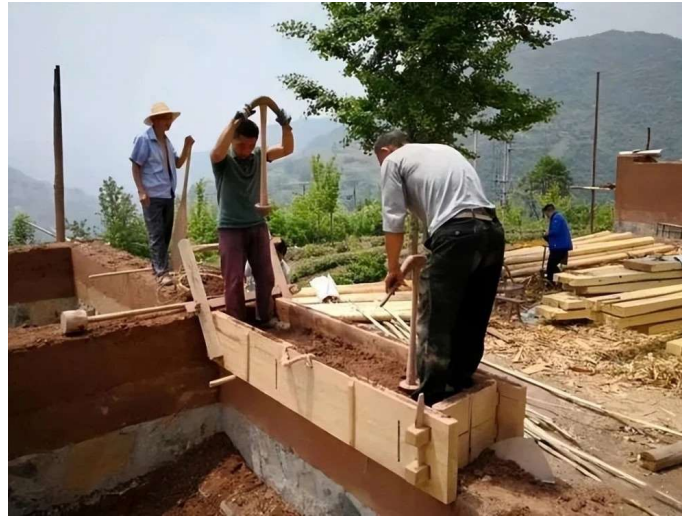
Figure 4. The traditional rammed earth wall formwork still in use in the village(Authors).

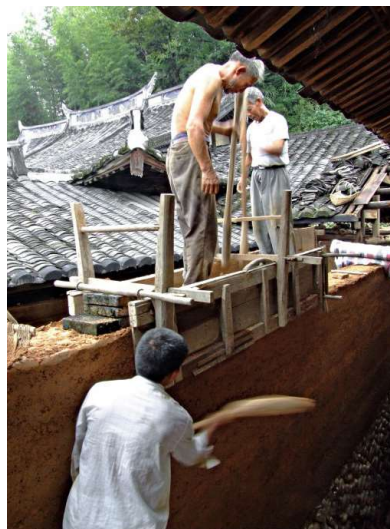
Figure 5. In the traditional practice, specialized craftsmen patted down the finished rammed walls(Authors).

During the team's research in the mountainous regions of southern Zhejiang, they discovered a particularly important aspect of traditional rammed earth techniques: the surface of the walls after ramming was not considered the final finish. Both the interior and exterior sides of the walls would typically undergo an additional layer of earth plaster. After each section of the rammed earth was completed and the formwork removed, a craftsman would follow up with a specialized wooden clapper to flatten a layer of very fine earth over the rammed surface (Figure 5). This process would be applied to both sides of the wall, resulting in a very smooth finished surface. This practice also explains why the "wall bucket" formwork used in traditional rammed earth construction was often quite simple. There was no need for high precision in the rammed surface once the formwork was removed, as achieving a perfectly smooth surface with such basic formwork was nearly impossible. The ancestors' understanding of rammed earth was primarily focused on fulfilling the structural needs of insulation, heat retention, theft prevention, and spatial enclosure, while the external appearance was left to be enhanced by subsequent finishing layers [4]. This approach aligns with the principles of traditional rammed earth construction in the Jiangsu, Zhejiang, and Fujian regions, where cost-saving and ease of operation were prioritized. The use of small, modular formwork for section-by-section assembly was a key factor in this approach.

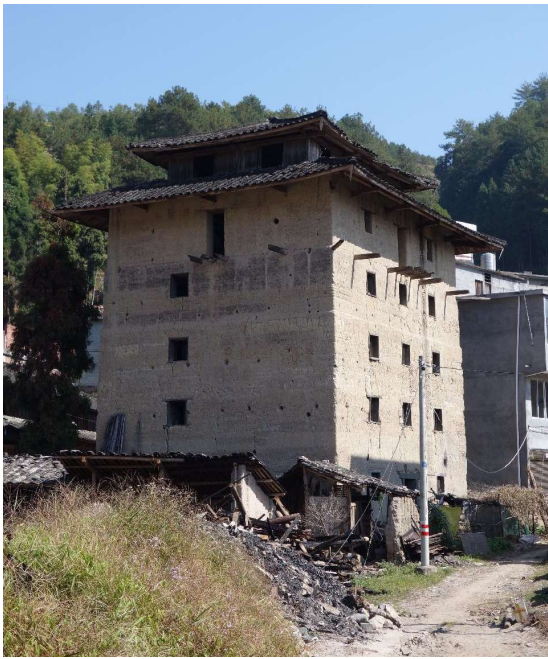
Figure 6. A small earthen building in a mountainous village in southern Zhejiang, constructed to a height of five stories(Authors).

Once the rammed earth construction method was determined, the overall dimensions and structural mechanics of the rammed earth walls became crucial topics of study. Previously, assessments of the structural integrity of rammed earth walls relied entirely on the accumulation of traditional knowledge, as this material had never been formally used in new buildings within China, leaving no established formulas or methods for reference. The traditional villages that still employ rammed earth construction served as the best data samples for our team’s research and learning. In the traditional villages of the southern Zhejiang mountainous region, the height-to-thickness ratio of rammed earth walls typically ranges from 1:10 to 1:12, with most residential walls not exceeding two stories. However, there are exceptions, such as in the village of Maozhuyuan in Taishun County, near the Fujian border. This village features small, square earthen towers, designed with three bays both horizontally and vertically, yet reaching a height of up to five stories, approximately 13 meters tall (Figure 6). The walls of these towers employ a stepped design that tapers upward, presenting a slightly trapezoidal profile, which enhances stability[5]. Additionally, the four-sided enclosed layout further reinforces the integrity of the structure. In contrast, the current project involves a total of 16 independent north-south oriented rammed earth walls (Figure 7), which presents a significantly greater risk to stability compared to the typical four-sided enclosed structures found in traditional villages, thereby introducing substantial safety concerns.

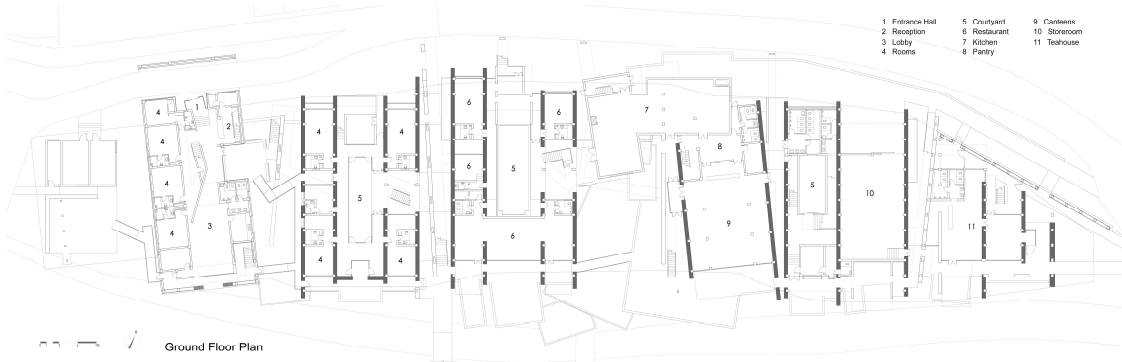
Figure 7. The floor plan of the "Tiles Hill — New Reception Center for the Xiangshan Campus" Project.

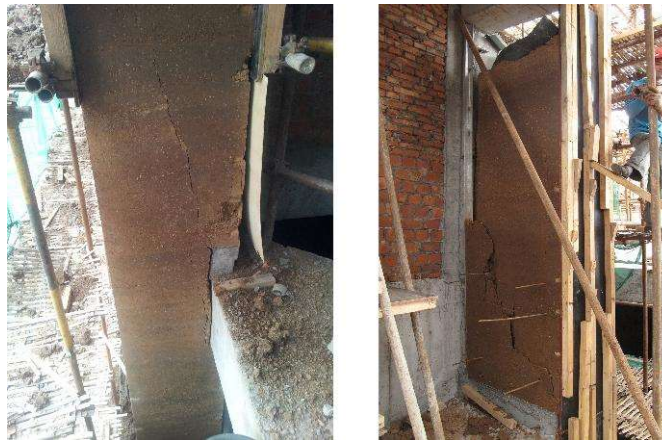
Figure 8. The wall has developed an outward tilt, leading to a large crack(Authors).

Before proceeding with large-scale rammed earth construction, Wang Shu insisted on conducting a test ramming on one of the site's larger walls. This wall was structurally representative, measuring over 30 meters in length and more than 10 meters in height. The wall was rammed as quickly as possible, while the speed of construction on the other walls was controlled to await the results of this trial. However, when ramming reached above the third floor level, issues of wall leaning and cracking became apparent. First, a large diagonal crack appeared near the second and third floor positions, with the lower part of the crack showing a tendency to bulge outward (Figure 8). This crack was structurally deep, posing a significant risk to the stability of the wall. Secondly, several small vertical cracks were observed on the wall surface between the floor slabs (Figure 9). The edges of these cracks were clean, with no outward bulging on either side, leading to the preliminary conclusion that these fine cracks were likely caused by shrinkage due to the excessive length of the wall. These smaller cracks were judged to have no impact on the overall structural stability of the wall.

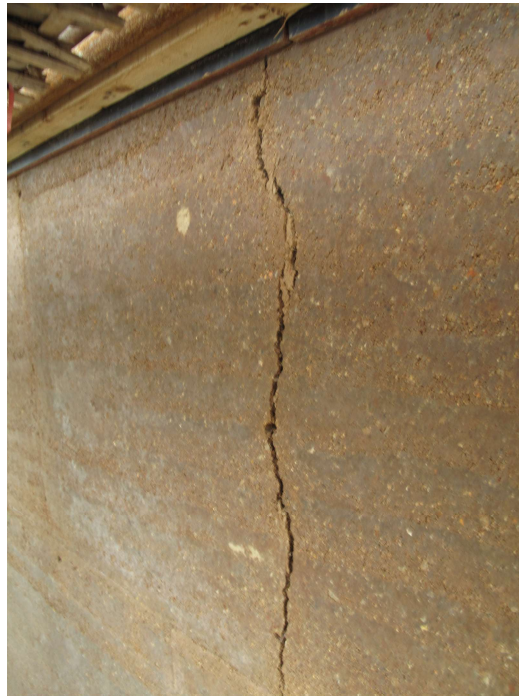
Figure 9. The wall exhibits vertical fine cracks(Authors).

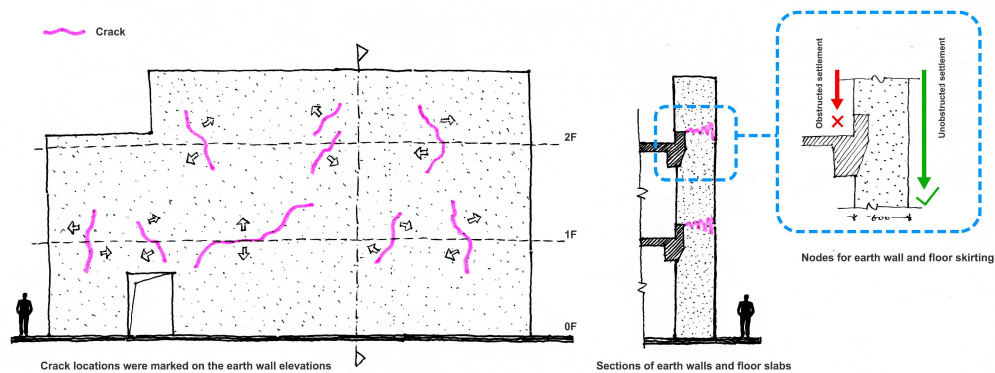
Figure 10. Analyzing the structural joints to determine the cause of the cracks in the earth wall(Authors).

To make a more precise assessment, the team carefully marked the locations of all cracks on the elevation drawings of the wall. It became evident that the cracks showing signs of outward leaning were primarily concentrated around the second floor and third floor slabs. Based on the detailed drawings of the wall-slab joints, we speculated that the problem might stem from the kickplate (baseboard) edging at the floor-slab interface (Figure 10). This recessed kickplate design, which the team had discussed extensively before construction, was intended to prevent water from the interior floor from seeping into the earthen wall and to ensure that the kickplate and the wall would be flush after completion. However, during the actual construction process, it became apparent that when the rammed earth wall settled, the settlement on the side with the kickplate was restricted, causing the wall to lean towards the side without the kickplate. If not addressed in time, this could eventually lead to wall collapse. The small cracks between the floor slabs, on the other hand, were primarily shrinkage cracks caused by the excessive length of the wall[6]. Observations from the site indicated that the lower level exhibited fewer shrinkage cracks than the second level, likely due to the greater pressure exerted by the wall's own weight, which reduced the potential for shrinkage. We concluded that these natural shrinkage cracks did not affect the stability of the wall, and the issue could be resolved by introducing expansion joints at intervals along the wall.

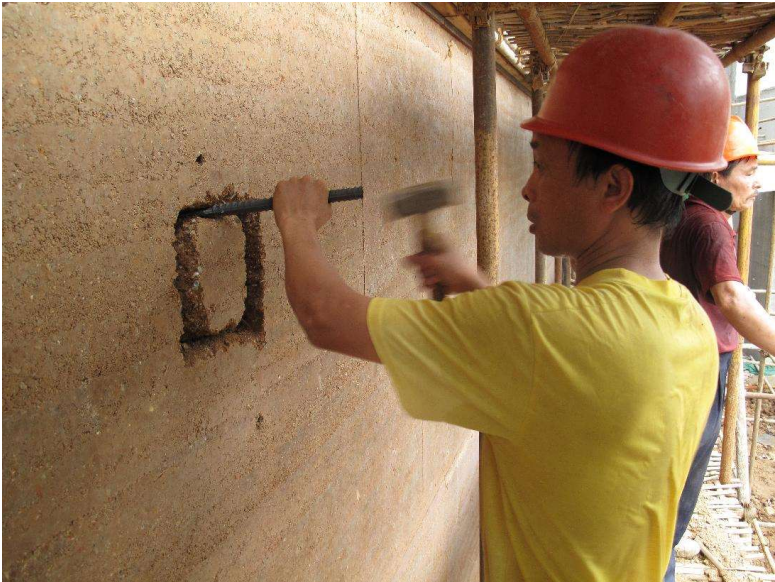
Figure 11. Specimen blocks in walls(Authors).

Before completely dismantling the outward-leaning wall, the laboratory took samples of the rammed earth blocks to test their compressive strength, ensuring that the leaning and cracking were not caused by inadequate material grading (Figure 11). After several rounds of testing, the results confirmed that there were no issues with the material composition, conclusively pointing to the kickplate design as the source of the problem. The next step was to remove the recessed kickplate that was connected to the main structural framework, allowing the rammed earth wall to be decoupled from the frame, thus preventing interference between the two structures and allowing the wall to settle naturally (Figure 12). However, this solution raised a new challenge: how to prevent the wall from leaning outward once it was detached. According to Wang Shu's design, the wall was over 10 meters high but only 0.6 meters thick, resulting in a height-to-thickness ratio of 1:17. Additionally, one side of the wall was entirely exposed, making it difficult to balance detaching the wall from the structural frame while ensuring it wouldn't lean or collapse. This presented a particularly tricky problem at the time.

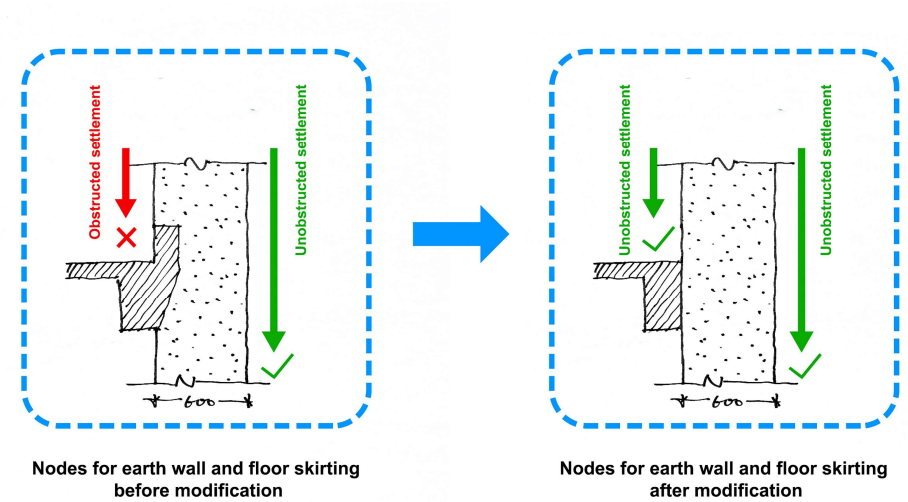
Figure 12. Modification of the construction details for cracked joints(Authors).

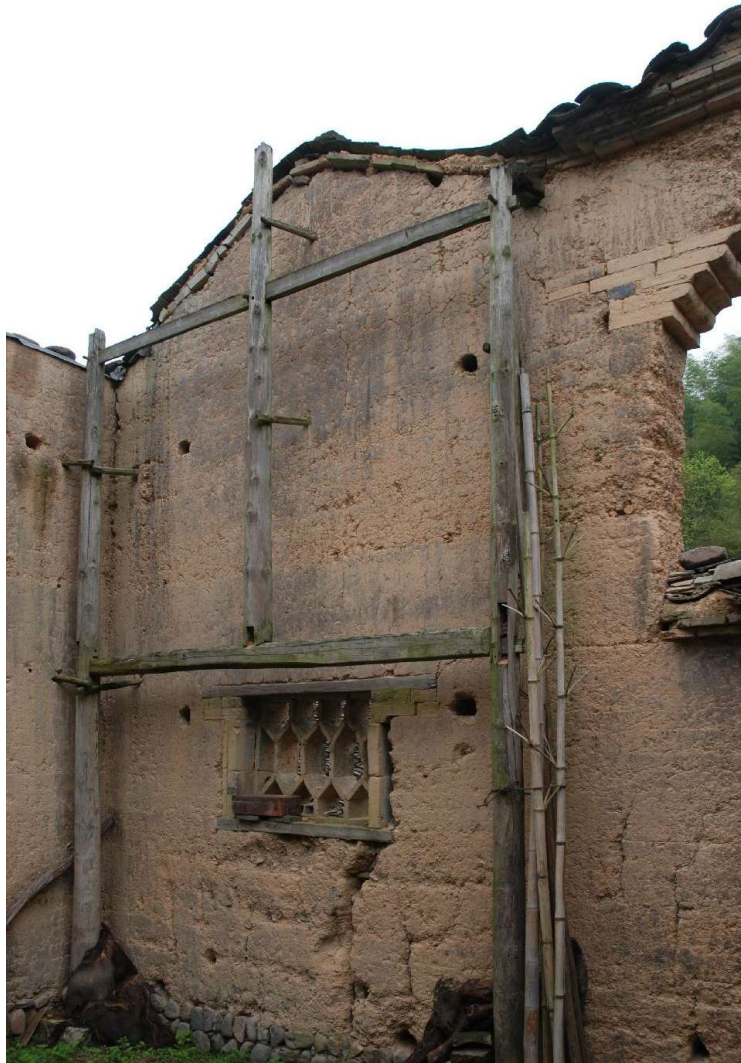
Figure 13. Connection between traditional rammed earth walls and the main wood structure(Authors).

To solve this problem, our team turned once again to the traditional villages in the mountainous regions of southern Zhejiang for inspiration. In the village of Shanxia Bao in Wuyi County, Jinhua, we found a collapsed house with a hybrid structure of rammed earth and timber. On the remaining two-story rammed earth gable wall, parts of the timber frame were still visible, with several wooden tie rods extending from the wall to securely anchor it to the main timber structure (Figure 13). The connection points between the timber rods and the main framework had a certain degree of flexibility, allowing the rammed earth wall to settle slightly without causing damage. This offered us an ingenious solution to our problem. Additionally, some of the more sophisticated nodes in the village design featured tie rods that extended entirely through the rammed earth wall, where a long, flat wooden beam would be inserted horizontally or vertically, forming a mortise-and-tenon structure. This created a "T-shaped" tie component that provided an anchor for the wall. With this external tie structure in place, the wall could be adjusted to correct any outward leaning. An elderly carpenter in the village shared with us a fascinating method for repairing rammed earth walls: when they noticed a wall leaning outward, they would position a long, slanted pole against the head of the "T-shaped" tie component, providing a ground support for the pole. Using a lever, they would slowly push the leaning wall back into place. After the wall returned to its original position and had stabilized, they

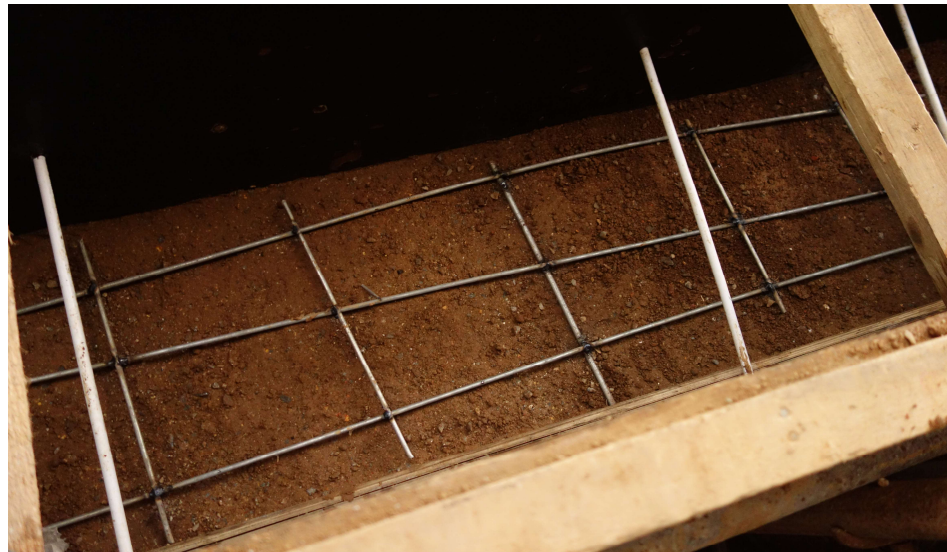
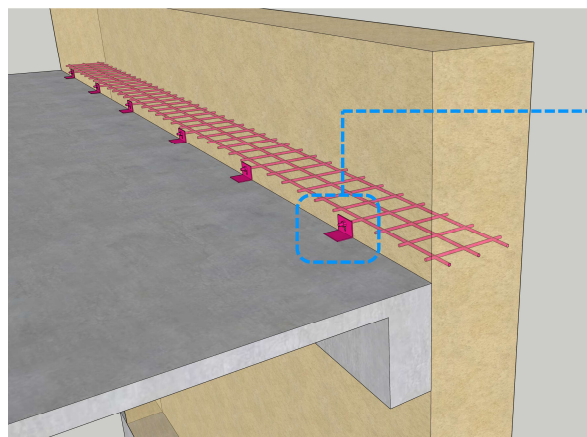
When rammed to the floor level, an additional layer of rebar lattice is added to the earth wall, through which the wall is pulled

Tie relationship between a lattice of rebar buried in an earth wall and the floor slab

The rebar was located above the hole when the tamping was just completed

After a month the rebar sank with the wall below the hole

Figure 15. tructural joints used in modern construction systems to prevent outward tilting of earth walls(Authors).

So our team came up with the idea of making exposed tensioned structural components by borrowing traditional methods, and after consulting with the project management engineers on site, We absorbed their suggestions and decided to use another, more subtle approach to tie rods. The revised solution involved embedding a mesh structure of steel bars, arranged both horizontally and vertically, at the level of the floor slabs during the ramming process. The horizontal steel bars extended outward and were anchored to the floor slab at an adjustable fixed point, with sufficient room for the bars to move vertically to accommodate settlement. This design effectively addressed the problem of the wall's outward leaning while allowing for the natural settlement of the rammed earth wall. At the same time, it preserved the integrity of the exposed side of the earthen wall, maintaining its aesthetic and structural coherence (Figure 15).

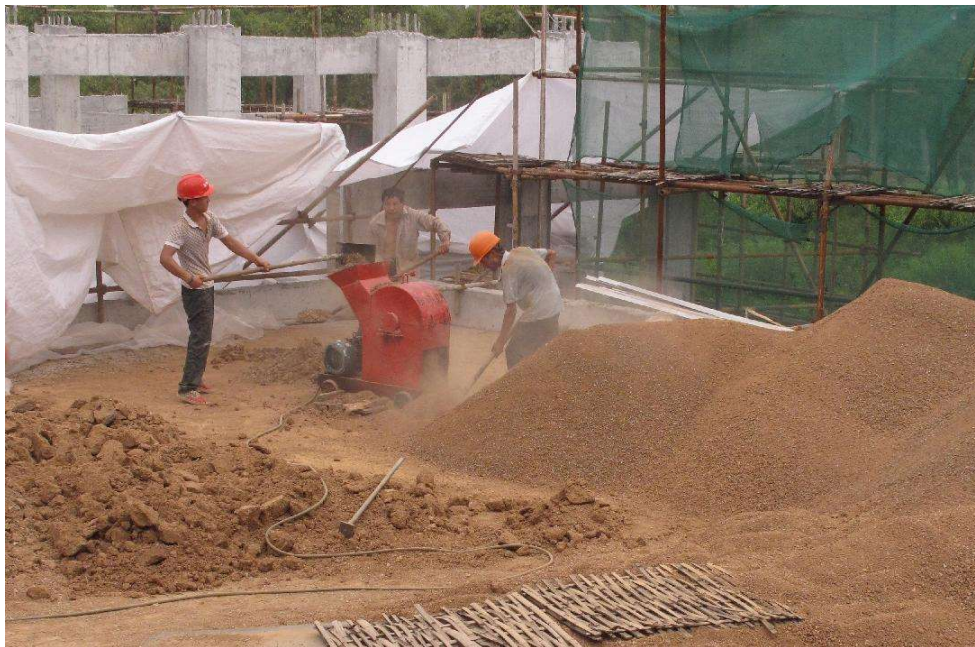
Figure 16. Earth blocks, after being crushed, await reuse(Authors).

After dismantling the trial rammed earth wall, a significant amount of leftover soil was scattered at the site. The workers gathered this material for reuse in the subsequent ramming process. However, these dismantled earth blocks varied in size and couldn't be directly mixed with water for ramming. Therefore, they were first processed through a crusher to be ground into a fine powder (Figure 16). This powder was a mixture of soil and sand. The sand content could be divided into two parts: first, the sand that was part of the original mix, and second, gravel from the original mixture that had been crushed into sand by the machine. Our team tested this soil and sand mixture in the laboratory using specialized instruments, which allowed us to adjust the internal composition ratios to make this recycled material suitable for reuse[8]. This process highlights the most essential characteristic of rammed earth construction—its recyclability. This recyclability holds two significant implications: first, the materials can be reused repeatedly. Even after a wall is dismantled, the materials can be repurposed for construction elsewhere, a quality that most modern building materials lack. It is also the centerpiece of the nature-oriented vernacular construction system, aligned with traditional philosophical views on eternity. The concept of endless cycles, epitomized in Daoist thought and texts such as the I Ching, reflects the belief in continuous renewal—"cyclical regeneration, eternal life". If we think about it today, this sustainable construction method is also a strategy to resist the gradual scarcity of resources caused by the rough use of materials under the current mainstream construction system. Second, the composition of the rammed earth itself is naturally recyclable. It consists entirely of materials sourced directly from nature, with no added chemicals like lime. This means that when these materials eventually return to the earth, they cause no environmental pollution or damage. They originate from the earth and will, in time, seamlessly return to it[9].

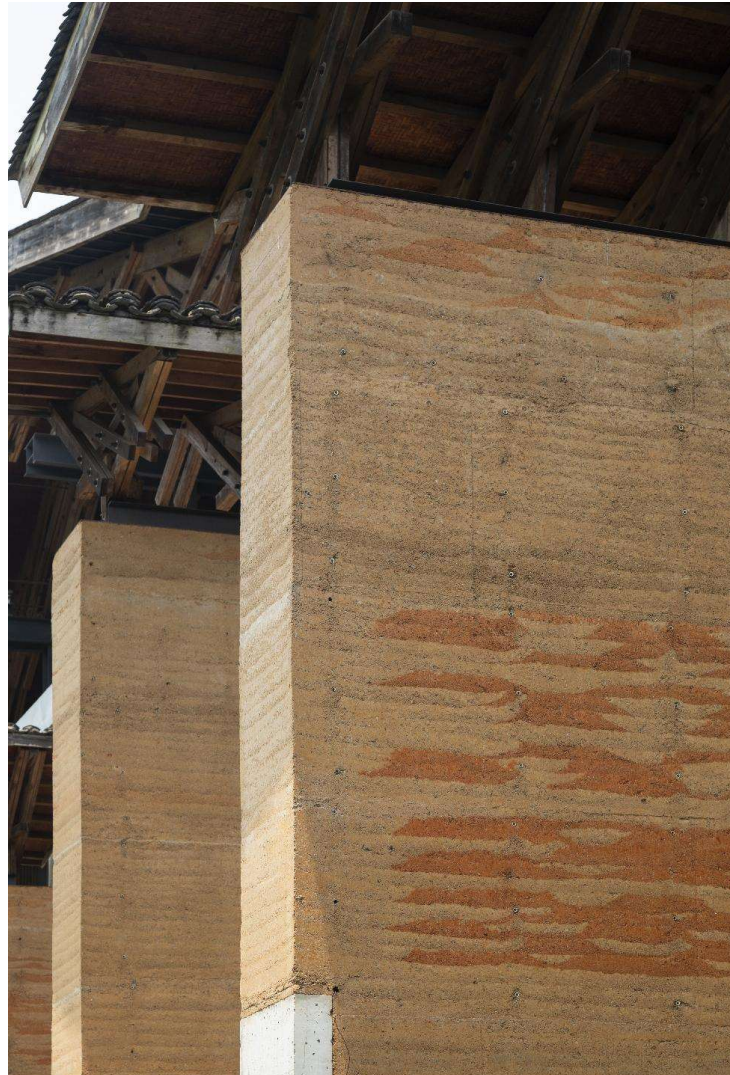
Figure 17. The textured effect of the colored rammed earth wall(©Chaochao Wei).

After learning from the previous setbacks, the subsequent rammed earth construction work gradually progressed smoothly. Once the ramming was completed and the formwork was removed, the exterior surface of the walls revealed a fine, horizontal layered texture. Within each compacted layer, there were subtle differences in texture from top to bottom. The upper parts, being more compacted by the vertical blows of the ramming hammer, had a denser surface than the lower parts. This stratification is reminiscent of the depiction of layered mountains in traditional Chinese landscape paintings. It's a fascinating characteristic of the material, as the construction process leaves

visible traces of craftsmanship. However, due to the constraints of the formwork on both sides, these delicate variations are difficult to control during construction [10], much like the traditional firing process of ceramics. In ceramic production, the final appearance of the glaze is only roughly predictable based on experience, since the transformation in color and shape occurs out of sight in the kiln. When the kiln is opened, there is a sense of anticipation—one can generally control the outcome, but the finer details are always uncertain. This concept applies to the control of texture and color in rammed earth walls as well. From the soil excavated at the site, we identified two distinct color types: a yellowish soil near the foot of the mountain, and a red soil found beneath the cultivated layers on the slopes. After laboratory testing, we selected the yellow soil as the primary source for the ramming, but Wang Shu requested that some areas of the walls exhibit a mixed effect with red soil. During the construction process, the workers were instructed to follow the design plans, which marked the locations for incorporating red soil into the walls (Figure 17). Although the team carefully mapped the precise locations, shapes, and sizes of the red soil areas on both sides of each wall, the presence of the formwork prevented the workers from seeing the surface as they worked. As a result, they had to rely largely on their experience and intuition, rather than direct observation, when executing the design. Consequently, when the formwork was removed, the final result differed somewhat from the intended design in the drawings. However, this outcome, though unintended, reflects a kind of serendipitous craftsmanship that is both lively and rich with character, a hallmark of traditional building methods where "objective chance" plays a significant and creative role.

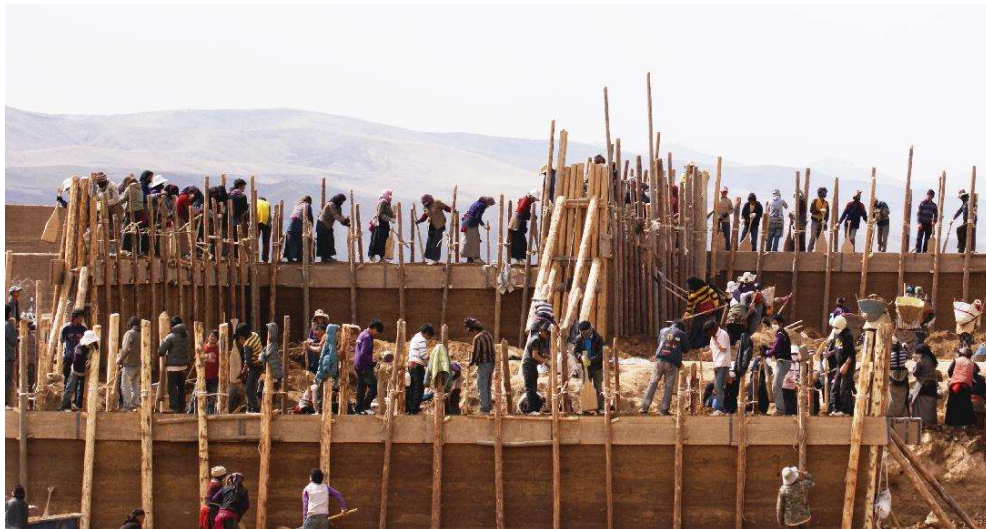
Figure 18. A scene of villagers in the Tibetan region engaged in the rammed earth construction process[12].

"Manual labor" is an especially precise word to describe the kind of construction activities within the vernacular architecture system. In our laboratory, there is a photograph on the wall depicting villagers from a Tibetan area in northwest China building a house (Figure 18). Both men and women participate in the rammed earth construction, their faces glowing with the joy of a festive occasion. I can vividly imagine them chanting rhythmically, working together in unison, layer by layer, ramming the earth to raise the structure. This collective activity, imbued with a strong sense of ritual, allowed everyone, regardless of skill level, to participate. It is an experience that rapid industrial production cannot provide—an experience that only exists within traditional labor, deeply tied to the bodily imagination. The philosophical separation of body and mind has caused modern architectural theory to overlook the tangible experiences of building[11]. Architecture is often discussed in terms of symbols and meanings, focusing so heavily on conceptual understanding that the actual experience of constructing buildings is ignored. Experience, while linked to cognition, is reduced to visual records of coded information. As a result, the eye can detach from the material existence of the architecture, with written descriptions serving as substitutes. Even when the body is considered in architectural theory, it is unfortunately reduced to a collection of needs and constraints, awaiting solutions derived from behavioral studies and ergonomics. Consequently, the body's real, lived experience is excluded from the construction and meaning of architecture. This intellectual approach ignores the richness of the labor experience embodied in traditional building practices.
