# Innovative Approach and Challenges in the Demolition of Large-Span Post-tensioned Beams: Insights from a Case Study

Posted Date: 15 April 2024

Keywords: concrete; post-tensioned; prestressed; demolition; tendons; cables; bursting

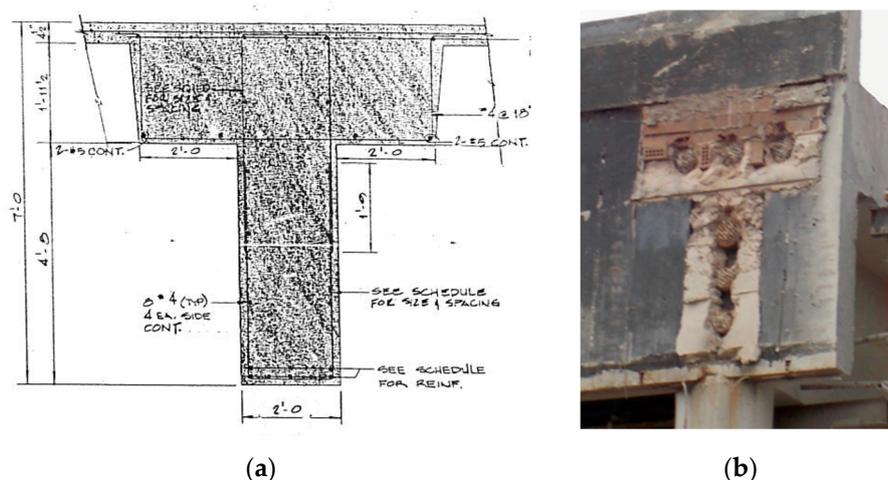
**Figure 1.** (a) The cross section of the beam; (b) End view of the beam showing the PT anchors.

A total of 160 tendons were used, distributed among six ducts with a diameter of 4 inches. Figure 1(b) depicts the end-view of the beam. The number of tendons per duct varied to ensure that the center of gravity of the tendons aligned with the centroid of the T-section. To analyze the beam's condition at different loading stages, a computer model was created using Ram Concept software from Bentley Systems, Inc [5]. The primary focus was to determine stress levels at the top and bottom of the T-beam when the dead load of topsoil is removed. Additionally, the 24-inch diameter columns were included in the modeling.

During the saw-cutting of the roof slab, initial cuts were made through the 6'-0" wide top section of the girder. This pre-cut, with a depth of 28 inches, facilitated the efficient use of a cable/wire saw once the adjoining sections of the roof were removed. Subsequently, a wire saw was employed from the top of the girder, wrapped around the 2'-0" x 4'-8" bottom section of the beam (Figure 1(a)), to complete the cutting of the entire beam section.

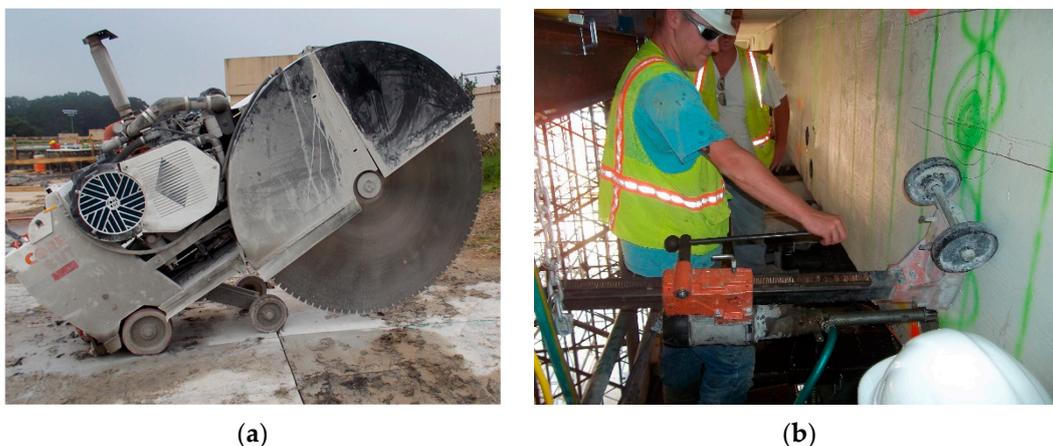
**Figure 2.** (a) Diesel-operated slab saw; (b) The drilling operation conducted on the side of the beam.

The demolition was carried out using a modern and well-maintained fleet of equipment, operated by skilled personnel. Large hydraulic and diesel-operated slab saws, as well as cable or wire saws, were employed to cut through the 28-inch-deep joists of the waffle slab and the 7-foot-deep concrete PT beams. Figure 2(a) depicts the placement of the large saw atop the slab to penetrate the thick concrete. The drilling operation conducted on the side of the beam, using a 6-inch-diameter hydraulic drill, is depicted in Figure 2(b). The materials slated for demolition were initially reduced in height and dimensions as necessary to ensure safe removal. Subsequently, they were further reduced in size to facilitate efficient transport from the site.

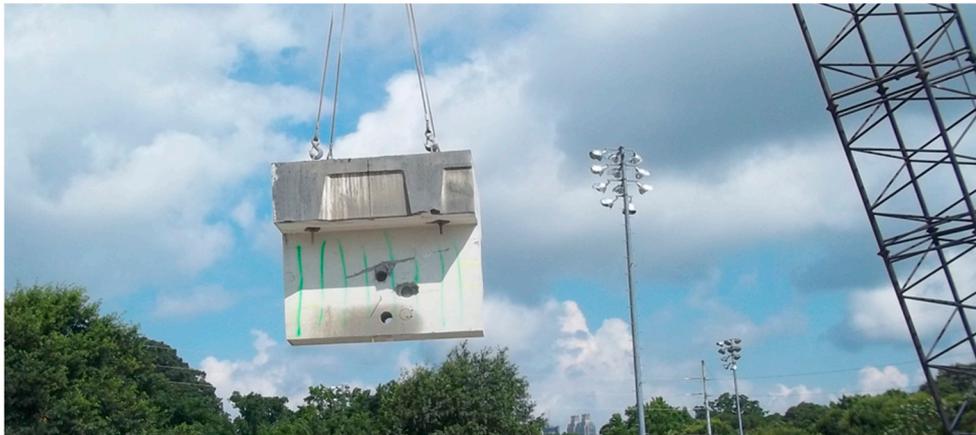
**Figure 3.** Lifting of a cut segment of the PT beam.

four anchors were carefully designed with attention to the impact effect, and drilled on the top to be connected to the crane hook. Figure 3 illustrates the lifting of a cut segment.

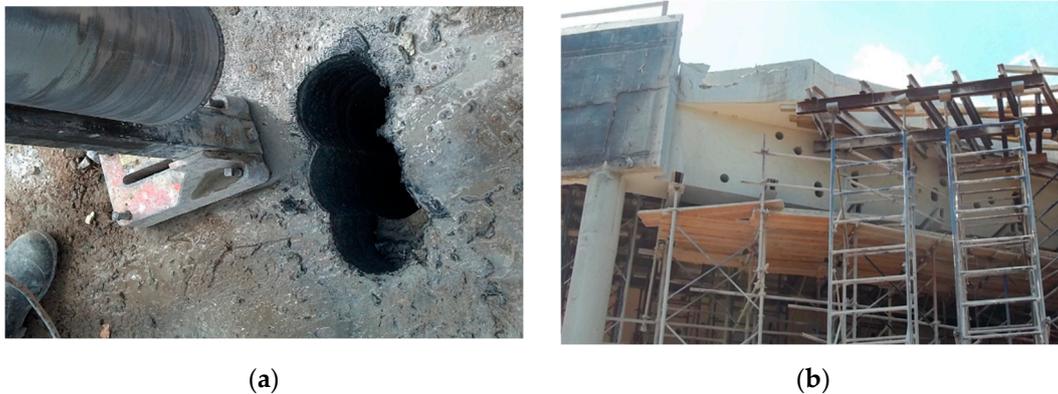
**Figure 4.** (a) Drill and holes on top; (b) Side view of one of the beams showing considerable number of drillings to locate and cut the PT ducts.

To address both above-mentioned scenarios, an innovative approach was adopted: cutting each duct individually, one by one, using a powerful drill. A specialized 6-inch diameter drill was employed for the drilling process. This drill, being heavy, required mounting to the concrete using anchor bolts. Based on the tendon profile provided in the structural drawings, it was determined that the first drilling should be performed at the top of the beam near the end. This decision was made because three ducts were expected to be closer to the top of the beam, as depicted in picture 1 (b). Drilling near the end would also mitigate the risk of anchors popping out, especially if the grouting was not done adequately. Figure 4(a) depicts the drill and the holes on the top of one of the beams. It is evident from this image that three holes were drilled to locate one duct. The challenge of locating the PT ducts became more pronounced, especially when drilling on the side of the beam, as seen in Figure 4(b), which shows many holes drilled to locate tendon ducts. This is also evident in Figure 3 showing several holes in a cut segment. Although Ground Penetrating Radar (GPR) scanning of concrete was employed to locate the rebar and tendon ducts, many ducts were not positioned close

enough to the surface to be accurately located. This issue arose due to discrepancies between the design drawings and the as-built conditions. Such discrepancies need to be carefully considered when undertaking demolition projects of this nature.

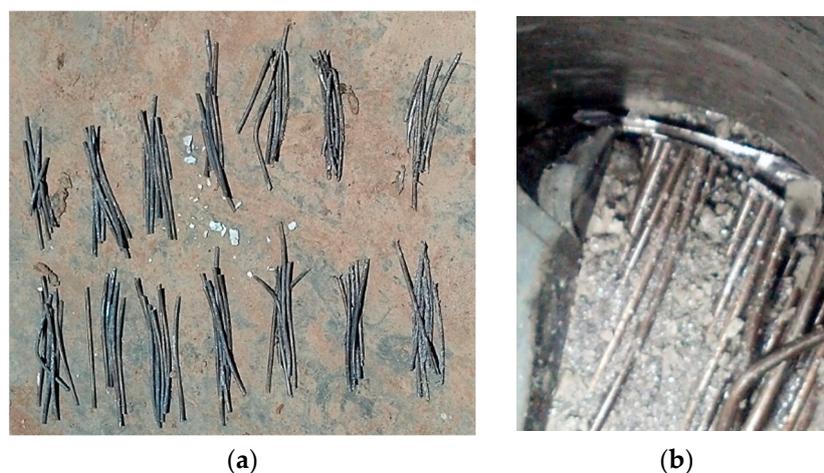
**Figure 5.** (a) The loose pieces of strands after cutting through the duct; (b) Strands inside the duct.

The task of drilling, cutting, and demolishing the large PT beams in this project, with its inherent complexity, posed several challenges but also yielded valuable insights into construction issues and the behavior of PT beams from both design and engineering perspectives. A review of one of the report provided by the field operations manager sheds light on some of these challenges. According to the report, coring progress has been hindered by several factors, including difficulties in locating ducts, leading to guesswork and inefficiencies. The actual number of cores required were two to three times higher than initially estimated, for example with three cores needed to locate just one duct, each up to 26 inches deep. Moreover, the presence of four to six 1-inch diameter steel rebars on top necessitated careful drilling. Extensive cord lengths, reaching several hundred feet to the power box, have also posed logistical challenges including placing strain on the drills. Additionally, when reaching the duct and starting to cut strands, the loose pieces, 3 to 4 inches long, rotated, resulting in drilling through the same strand multiple times. (Figure 5) When this occurred, the drill had to be pulled out, the hole cleaned, and the loose strands removed before starting again. This necessitated frequent drill removal, hole cleaning, and strand removal, adding to operational complexities.

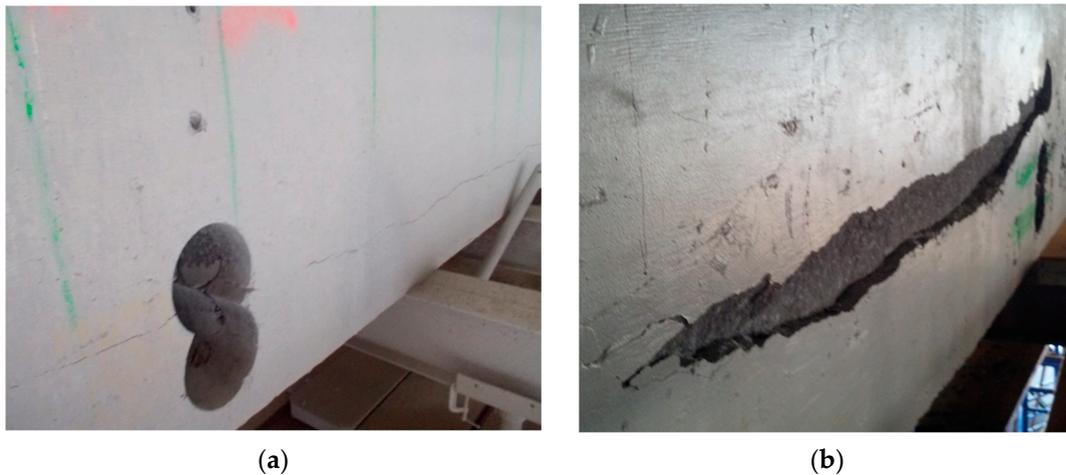
**Figure 6.** Horizontal cracking (a) and spalling of concrete (b) on the side of the beams as the result of drilling and cutting tendons.

The act of cutting multiple tendons during drilling through a duct applies a significant force to the beam, similar to bursting. Unlike the anchorage zone with adequate reinforcement, the absence of substantial reinforcement in a location along the beam exacerbates the development of horizontal cracking. Once the concrete cracks, the tension is released, and since the beam is no longer subjected to the same loading conditions, the concern regarding the cracking diminishes. This explanation aligns with theoretical principles and offers insights into the observed behavior, highlighting the importance of understanding structural responses during demolition processes to ensure structural integrity and safety.

The horizontal cracking observed on the side of the beam after cutting tendons in a duct is depicted in Figure 6(a). Additionally, Figure 6(b) illustrates the spalling of concrete in another beam. The presence of stirrups of #4 at 12” on center along the beam has proven effective in preventing catastrophic bursting of concrete and has limited the width of cracking.

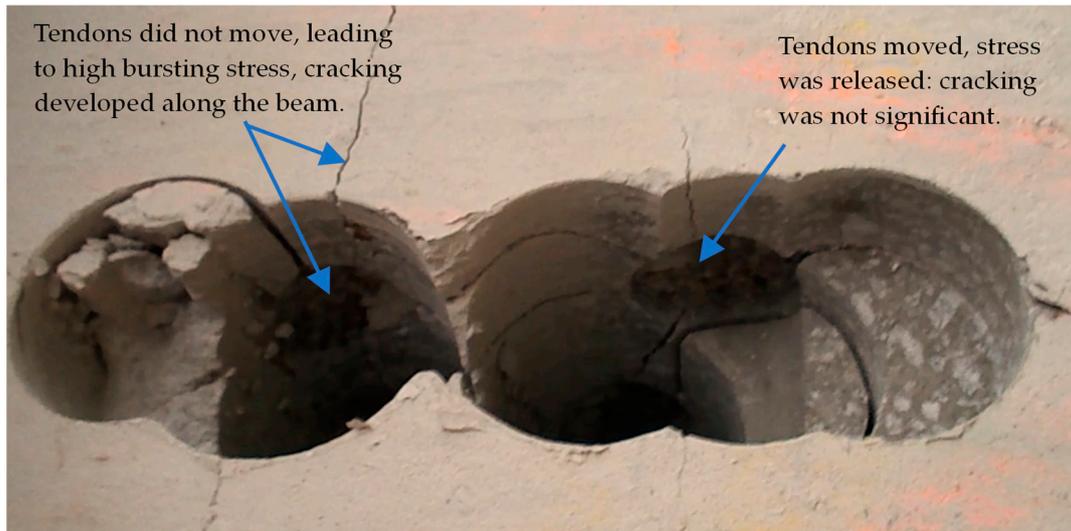
**Figure 7.** Cracking due to bursting effect depending on the tendons movement.

Depending on the effectiveness of the grouting, the tendons inside the duct moved approximately up to ½ inch in some cases, while in others, there was no movement, as illustrated in Figure 7.

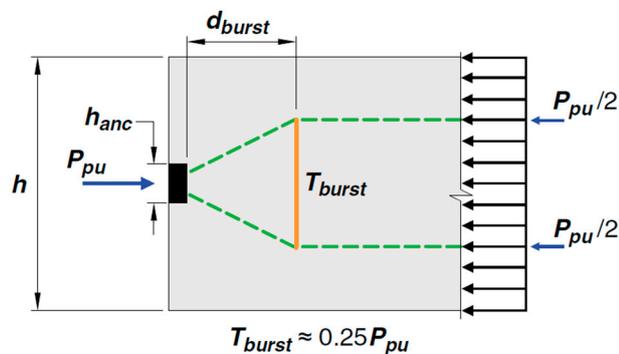
**Figure 8.** Tensile stress (bursting) zone in the PT beam, after ACI 318-19.

The significance of the tension stresses (bursting) behind the anchorage zone is a function of the ratio of the size of the anchor and the depth of the beam ( $h_{anc} / h$ ) as specified in ACI 318-19. In the case of cutting one duct, this ratio is the duct diameter (4") to the beam depth (84"), which is negligible. Hence,  $T_{burst}$  can be considered as 25% of the released force of tendons in one duct, as illustrated in Figure 8 provided by ACI 318-19. Assuming there are 25 tendons in one duct, and utilizing the typical force of 27 kips per tendon (commonly used in PT design), the calculated bursting force would amount to  $0.25 \times 25 \times 27 = 169$  kips. This represents a substantial tension force capable of inducing cracking, especially upon sudden release.

It's crucial to note that the scenario of cutting one duct, as encountered in this demolition project, differs slightly from the depiction in Figure 8. When a duct is cut, the released force is transferred to the concrete over a certain length of the duct, albeit suddenly and with impact. Therefore, the concept of bursting force behind an anchor (Figure 8) is used solely to explain the phenomenon of bursting that results in horizontal cracking in the beam during demolition.
