Article

Analysing the Vulnerability State of The Cultural Heritage by Geomorphological and Geophysical Methods: A Case Study on The Black Sea Coast, The Roman Edifice With Mosaic Site of Constanța, Romania

Keywords: cultural heritage; Roman Mosaic; geomorphological hazard; geophysical survey; geo-morphological methods; vulnerability zoning

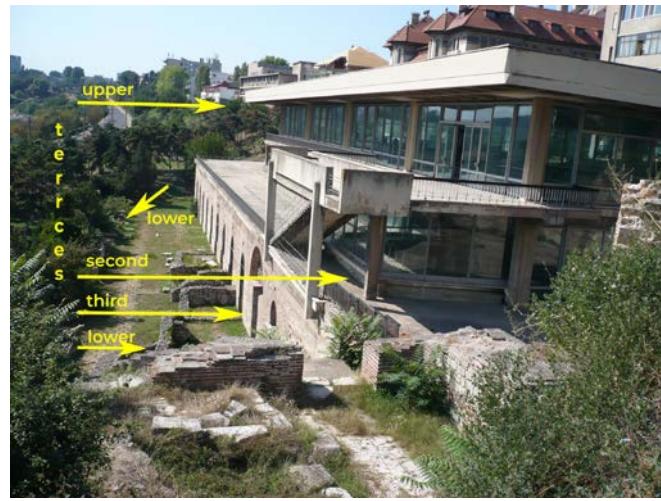
The Roman Edifice with Mosaic was built on four anthropic terraces on the Black Sea front cliff, including one terrace below actual ground level (Figure 3). The upper terrace is the level of ancient town Tomis, the second terrace with mosaic pavement was built on loess sedimentary layer, the third terrace, an indoor hall with ancient wall soldering cliff ($L=100$) and vaulted warehouses, was erected on thin loess sedimentary layer and limestone and the lowest terrace with commercial pavilions, built on limestone (Figure 2 b),

Figure 3. The Roman Edifice with Mosaic built on four anthropic terraces on the Black Sea front cliff.

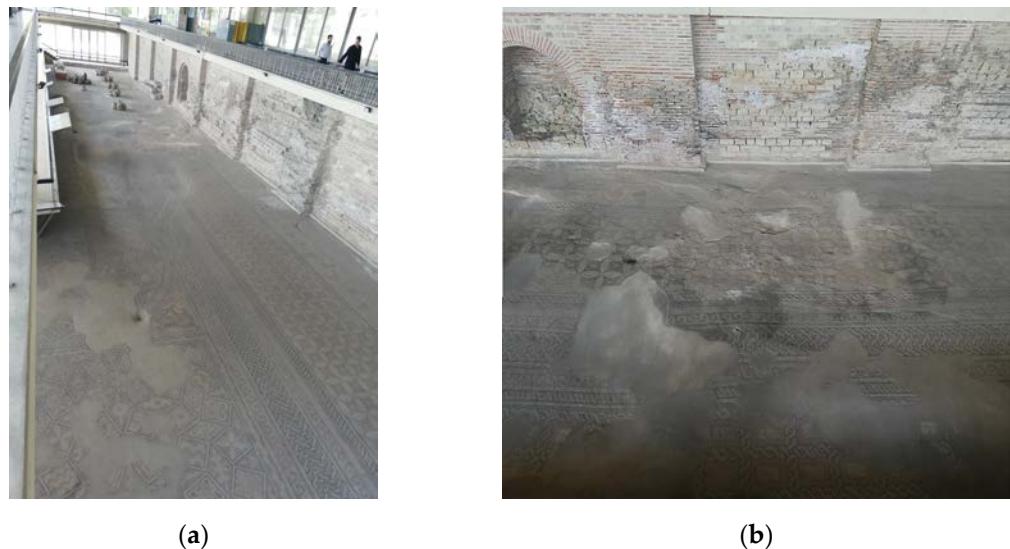
As a consequence, the Roman Edifice with Mosaic was damaged due to geomorphological and hydrogeological processes through slow sliding movements of a quite large sector of the relict abrasion cliff (Figure 5 a, b).

Figure 5. Degradation of (a) the roman mosaic pavement through geomorphological and hydrogeological processes (2019), (b) detail of the most damaged part of mosaic pavement and ancient wall.

Therefore, the mosaic pavement, the ancient wall and the retaining walls were affected by: leakages, local failures, suffusion, erosion and differential settlements.

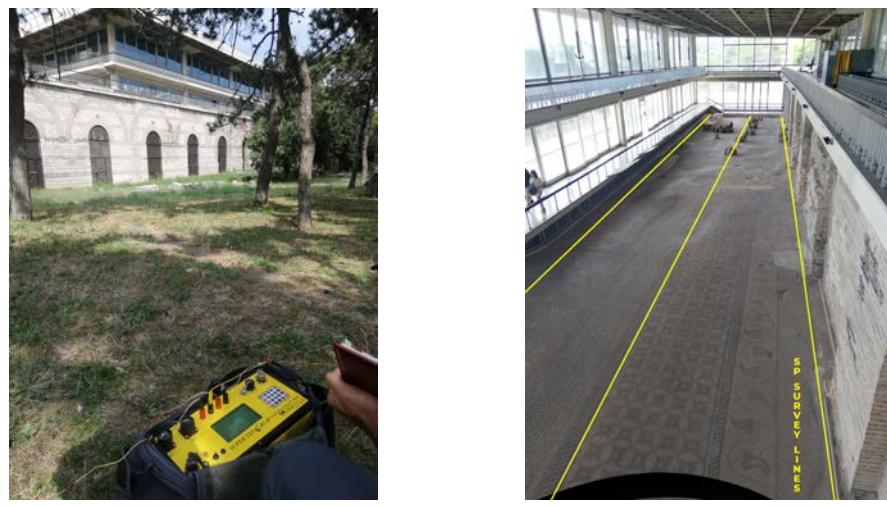
Figure 6. (a) Vertical electric soundings (VES) readings made in front of roman edifice and (b) self-potential surveys made on roman mosaic pavement.
