# Assessing Soil and Water Pollution: A Case Study of an Abandoned Coal Mine for Remediation and Repurposing in Mpumalanga Province, South Africa

University of South Africa, School of Engineering, Department of Mechanical, Bioresources & Biomedical Engineering

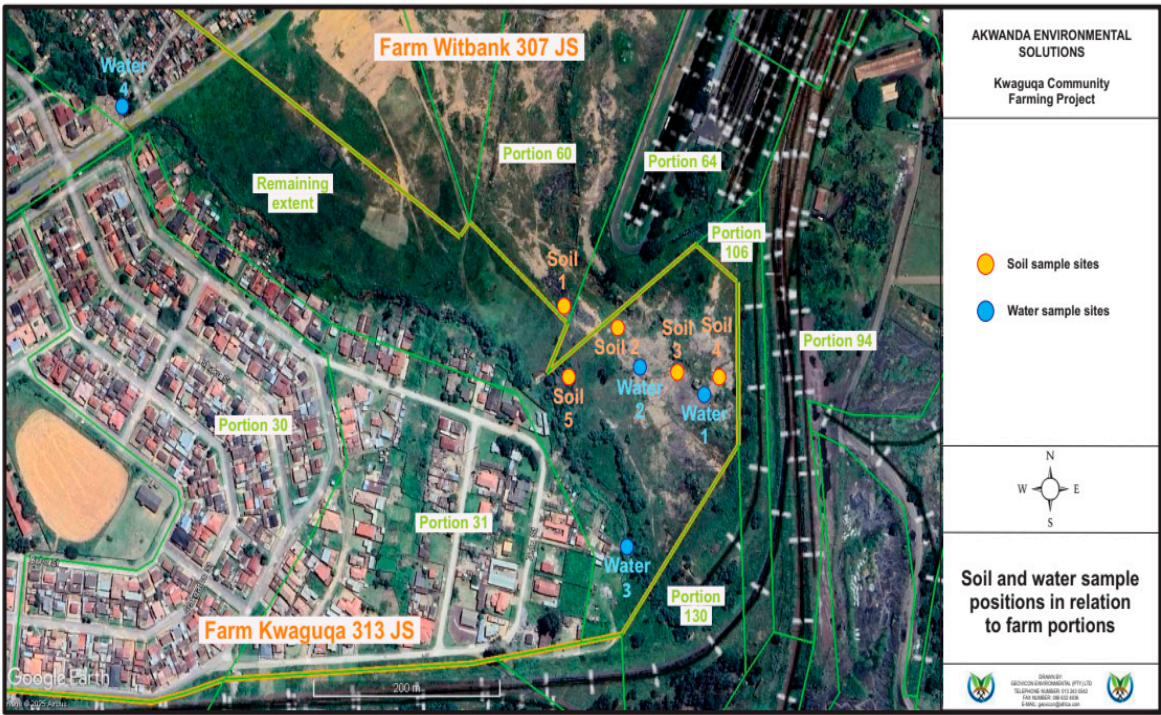
The sampling points effectively represented the objectives of the study. **Error! Reference source not found.** shows the soil sampling locations and surface water sampling points within the surface water drainage system.

Figure 2. Surface water and soil sampling points within the study site and the water drainage system.

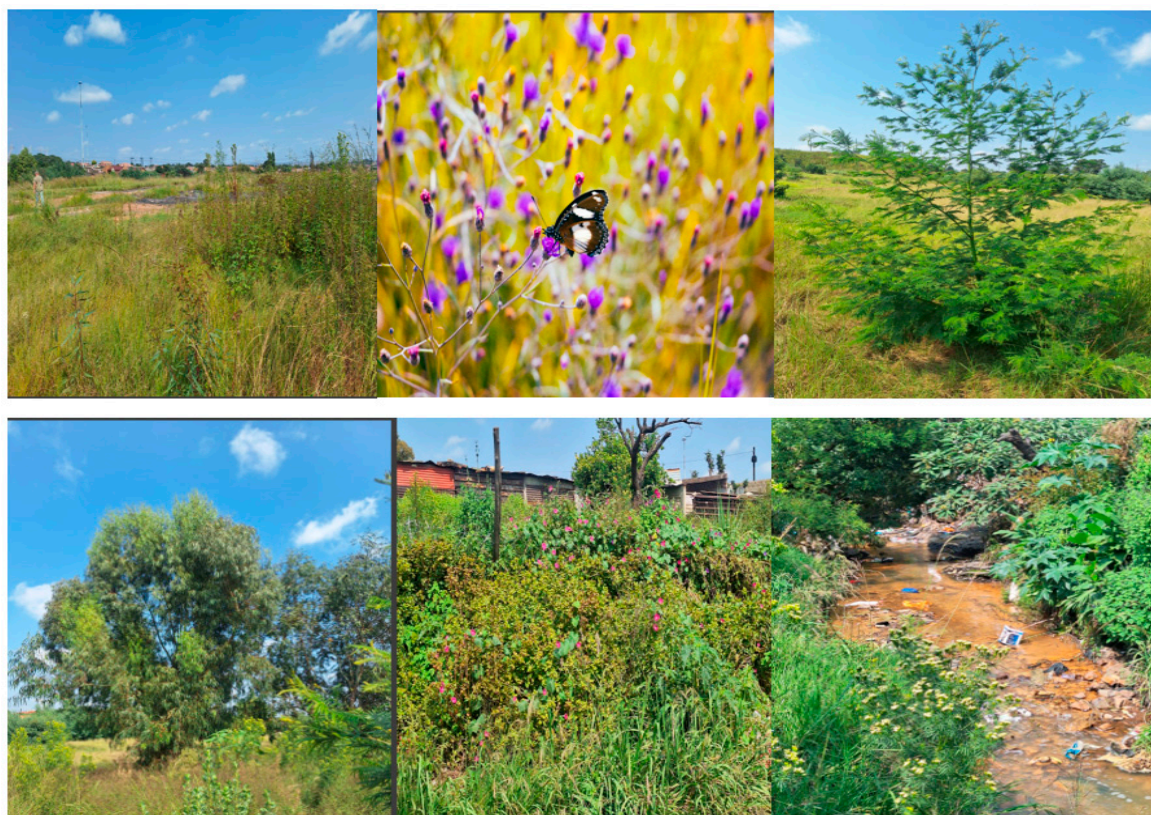
**Figure 5.** Alien and invasive plant species concentrated on the western side of the study site where the soil sample S5 was taken from, adjacent to a water course.

The presence of the invasive and alien plant species is a symptom of a highly modified ecosystem. The invasive species on the study site include *Acacia mearnsii* (black wattle), *Eupatorium macrocephalum* (Pom pom), *Ipomoea purpurea* (common morning glory), *Solanum mauritianum* (bug weed), *Mirabilis jalapa* (Four o'clock), *Eucalyptus diversicolor* (Karri), *Pennisetum clandestinum* (Kikuyu grass). Alien and invasive species pose a serious threat to native ecosystems, competing with and replacing indigenous plant species, leading to veld degradation, reduction in biodiversity, and alteration of ecosystem processes (van Wilgen et al., 2001; Richardson & van Wilgen, 2004). These invasive species can invade various habitats, including woodlands, waste areas, arable land, roadsides, riverbanks, and coastal dunes, outcompeting native vegetation and altering community composition and ecosystem function (Henderson, 2001). Species along watercourses, in particular, can reduce stream flow, while species like kikuyu can crowd out desirable species, further exacerbating ecosystem degradation (Le Maitre et al., 2000). The alteration of ecosystems can have far-reaching impacts on livelihoods, food security, and cultural practices, emphasizing the need for effective management and control of invasive species.
