Crowd Evacuation During Fire at the Gdańsk Shipyard Arena in 1994: An Event Study and Extended Analysis

Abstract

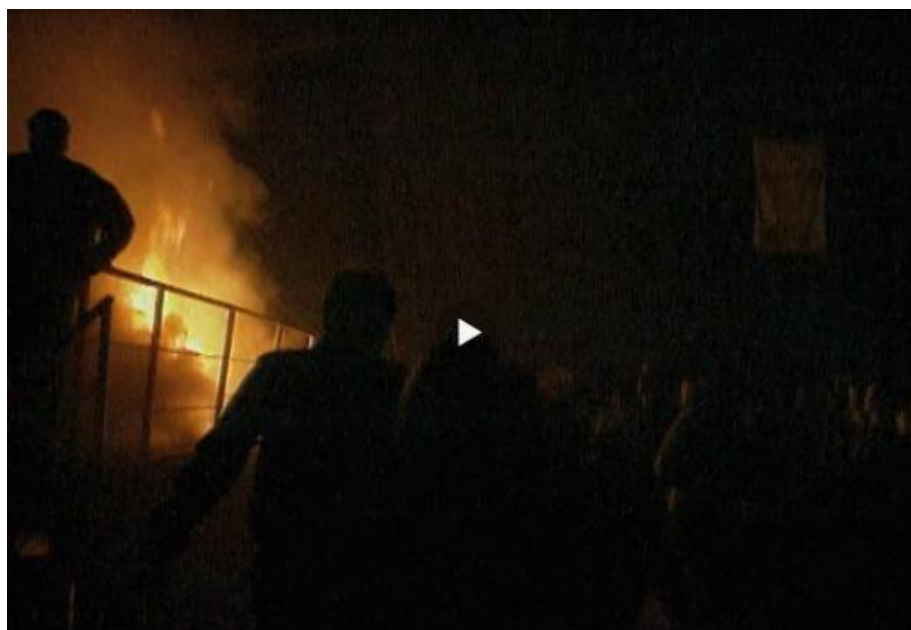
Figure 3. Video still from inside the hall at the beginning of the fire, showing people watching the flames [14].

According to statements from participants and rescuers and collected source material, when the evacuation was announced, most people (out of approximately 1500) had already left the event, and approximately 600 people remained inside the hall, approximately half of which safely evacuated, while the other half was trapped near the hall's main exit and could not leave. The first visible signs of the fire were noticed at approximately 20:54 [12,15]. Notably, at the beginning of the fire, the gathered crowd of young people did not recognise the danger [12,14]: some observed the fire (Figure 3), while others ignored the danger.

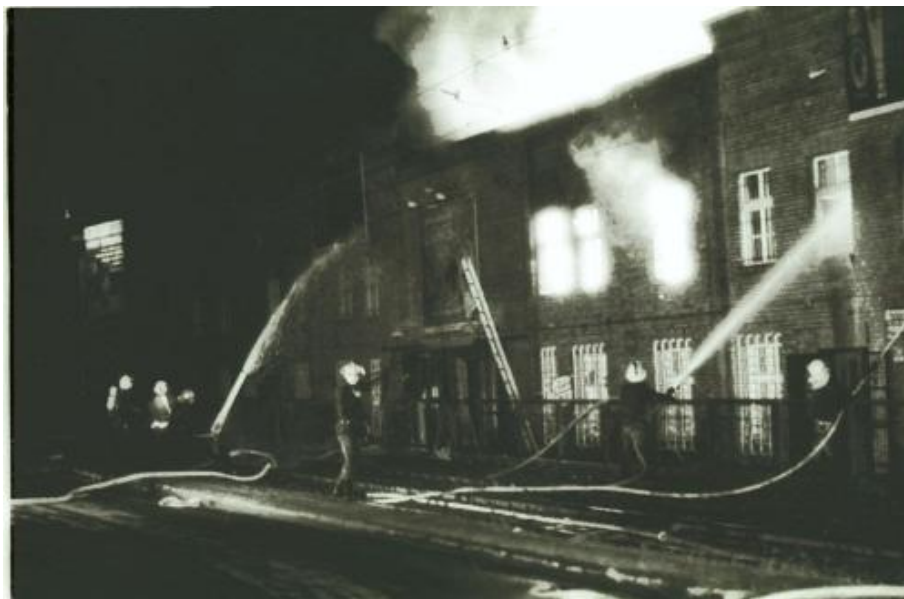
Figure 4. Fire-extinguishing operation from the Jana z Kolna Street side of the building [16].

Only after the last people had been evacuated from the area near the main emergency exit, at approximately 21:14, was the firefighting operation started from Jana z Kolna Street (Figure 4), when the hall's roof collapsed.

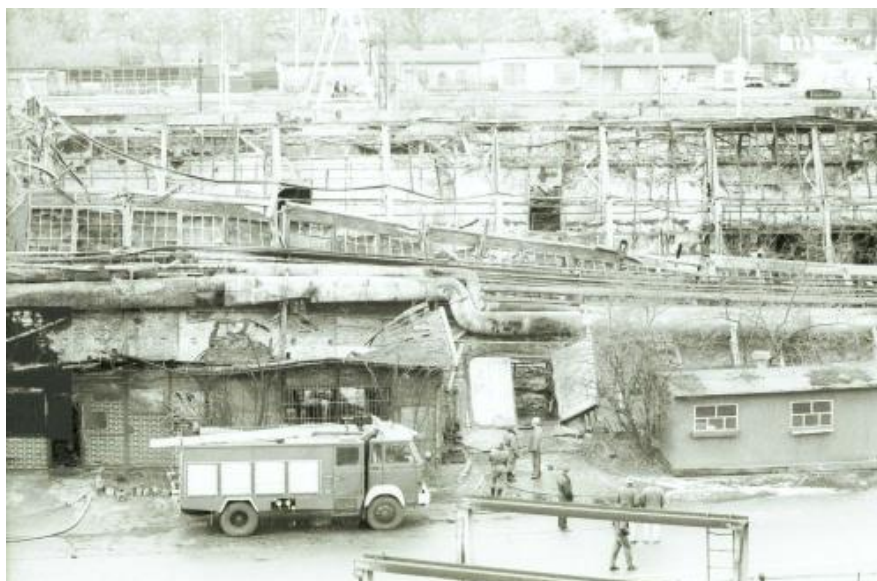
Figure 5. Burnt hall viewed from the shipyard side [19].

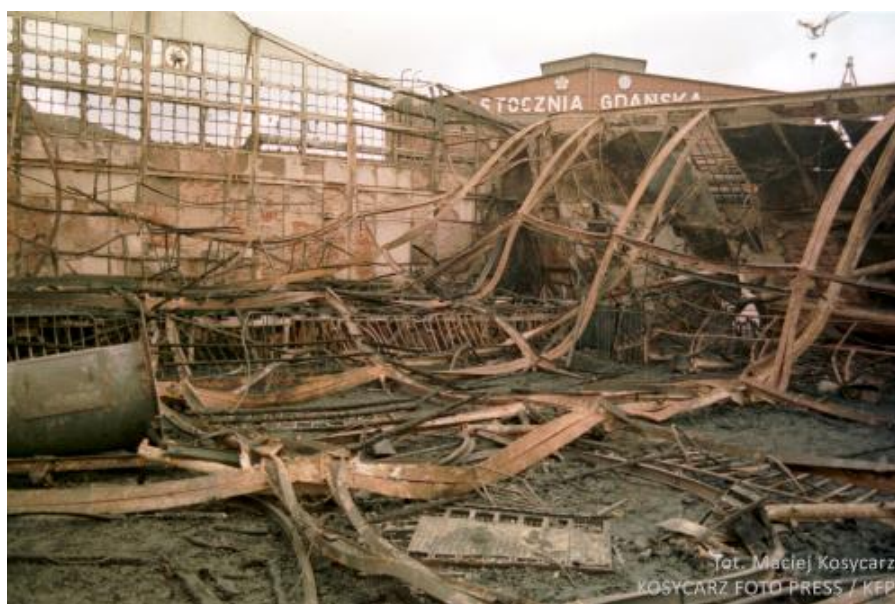
Figure 6. Burnt hall viewed from the inside (Maciej Kosycarz/KFP).

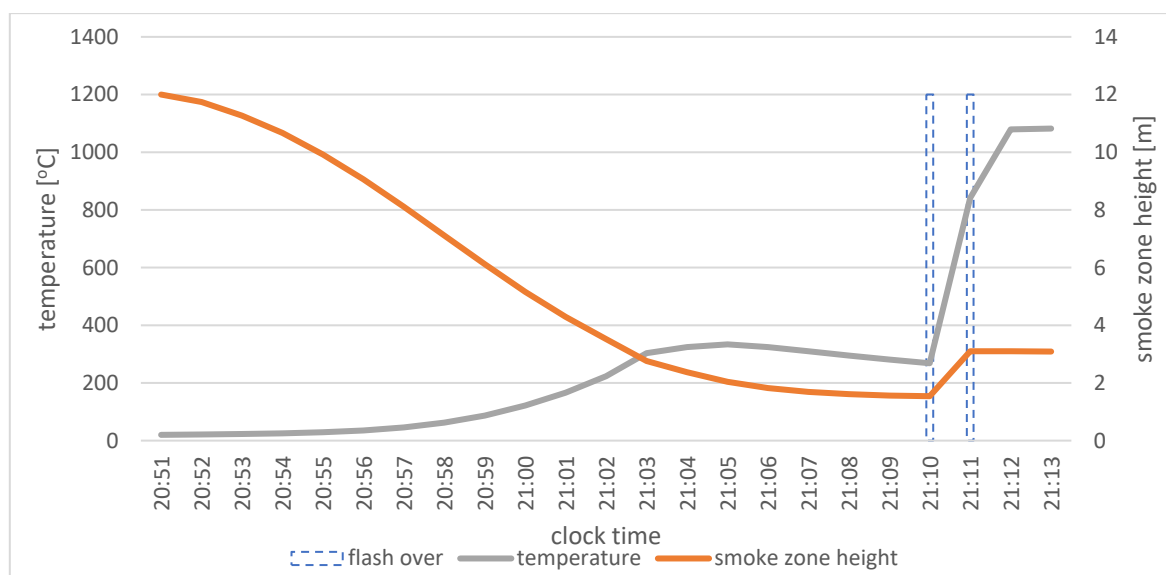
The calculated parameters are shown in Table 1 and Figure 7.

Figure 7. Variation of the reconstructed fire parameters.

A comparative analysis of the calculated parameters and those reported in the operational documentation of the rescue and firefighting operation course [12] as well as eyewitness statements of the event timeline showed that the reconstructed fire course faithfully reflected the parameters of the actual fire course. Therefore, a reconstruction of the fire course using currently available, more complex computer models was not attempted. The data obtained from the model developed at that time [15] were then used for further evacuation analyses.

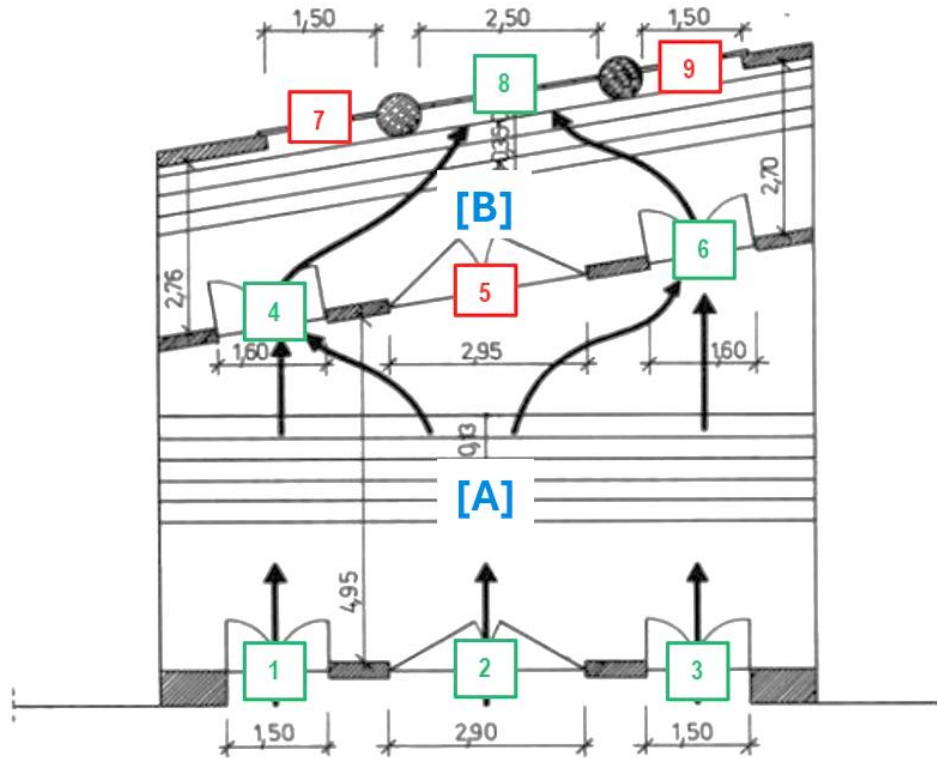
The analysis of the main escape route from the hall towards Jana z Kolna Street (the only escape route used), revealed the following groups of doors en route (Figure 8):

- Three pairs of swinging doors from the hall to the atrium (A), comprising a 2.9-m-wide central door (2) and two pairs of 1.5-m-wide side doors (1) and (3). All these doors were open. The closed doors (1) and (2) are shown in Figure 9;
- Three pairs of swinging doors from hall (A) to hall (B), comprising a 2.95-m-wide central door (5) and two pairs of 1.6-m-wide side doors (4) and (6). The outer and central doors were open and closed, respectively;
- Three pairs of lattice doors from the vestibule (B) to the building's exterior, comprising a sliding and folding 2.5-m-wide central door (8) and two pairs of sliding 1.5-m-wide side doors (7) and (9). The central and side doors were open and closed, respectively.

Figure 8. Diagram showing the accessibility of the hall's emergency exits [10].

Two people died in the fire: a young girl who was trampled in the vestibule (A) in front of the blocked door (5) (Figure 8) and a journalist who returned to the building to retrieve his equipment and was crushed by the collapsed roof. Five more fire victims died later in the hospital because of their injuries. Two-hundred-fifty people required hospital treatment, including everyone who was stuck in the blocking pile.

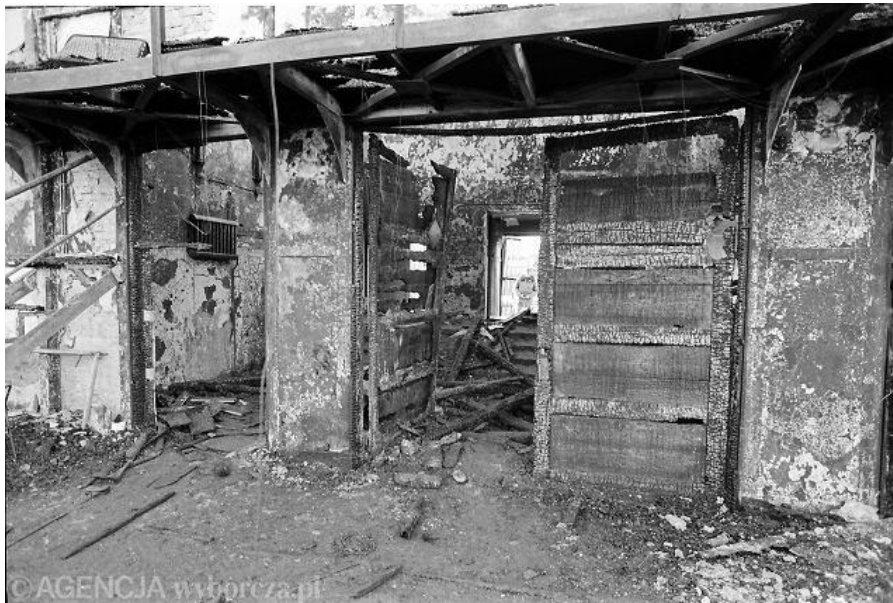
Figure 9. Burnt first emergency exits (1) and (2) of the hall [21].

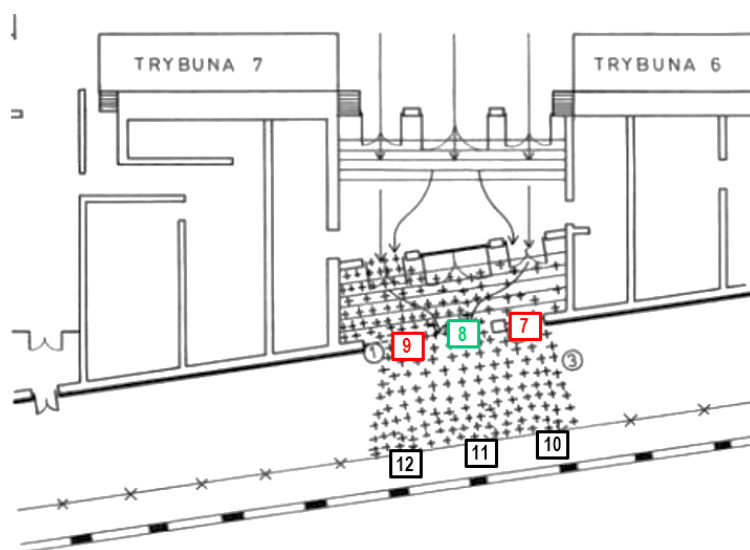
At approximately 20:57, the lights went out, drastically changing the evacuation. In addition to the severely limited visibility, the fire was already noticeably impacting the people, causing them to panic. The situation was exacerbated by the limited flow of people through the partially blocked emergency exits, producing congestion. At this stage, the greatest crowd pressure and lack of movement were in front of the blocked doors (7) and (9). According to a report from a rescuer in the unit that arrived at the scene at 21:02: 'The side bars on the left and right are locked in a way that prevents them from being opened. The hands of those trapped in the entrance hall are sticking out of the bars, calling for help' [12]. At that time, a phenomenon not previously described in detail in the literature was developing behind the main emergency exit (8). Exiting through the open main external door (8) did not guarantee safety and, even worse, could have caused additional injuries. Before exiting, 'between the hall and the fence by the railway track, there is a pile of people, about 3 bays wide, entangled in several layers. There are approximately 70 people in the pile', according to a report from a rescuer in the unit that arrived at the scene at 21:02 [12]. Ultimately, with inadequate space behind the emergency exit, the crowd could not unload the blocking pile on its own (Figures 11 and 24).

Figure 11. Situation at the peak of the evacuation, with crosses marking intertwined, immobilised people (a blocking pile) [10].

The people stuck in the jam near the main evacuation exit could not free themselves from the crowd in any direction. This situation required immediate intervention by the firefighters, who were

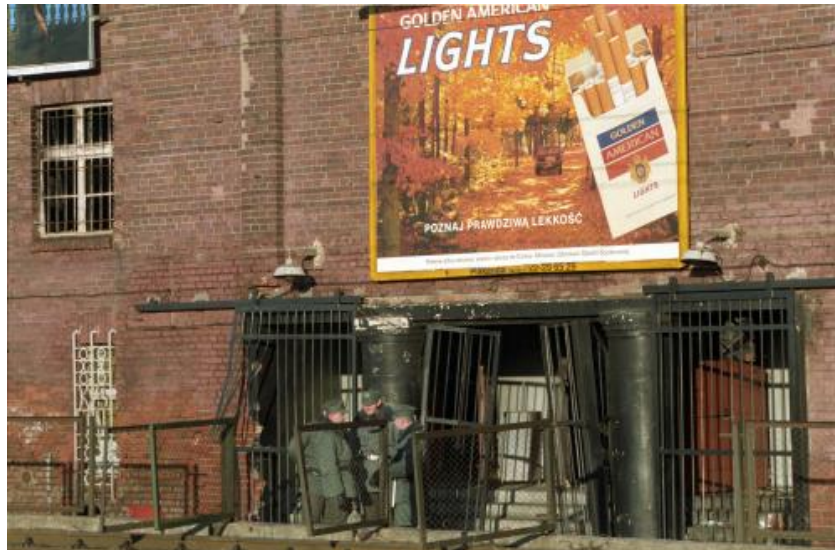
the first to arrive at the scene. They did not start extinguishing the fire; their actions were focused on freeing the people trapped in front of the building and, consequently, in the vestibule (B). The firefighters tried to cut the grates blocking exits no. (7) and (9) and dismantle spans (10), (11) and (12) of the fence separating the sidewalk from the tracks (Figure 11). In this direction, work began at approximately 21:03. The first task was only partially effective: Although a few rods could be bent, the second task was successfully implemented. After the spans were removed, the body tangle partially slid onto the tram tracks, which somewhat relieved the pressure around the main exit from the building [10]. A view of the external lattice, emergency exit door and removed fence panels is shown in Figure 12.

Figure 12. External emergency exit from the hall onto Jana z Kolna street. The photo shows the results of the rescue teams' efforts: bent grating bars and fence sections removed from the tram line (PAP/Alamy Stock Photo).

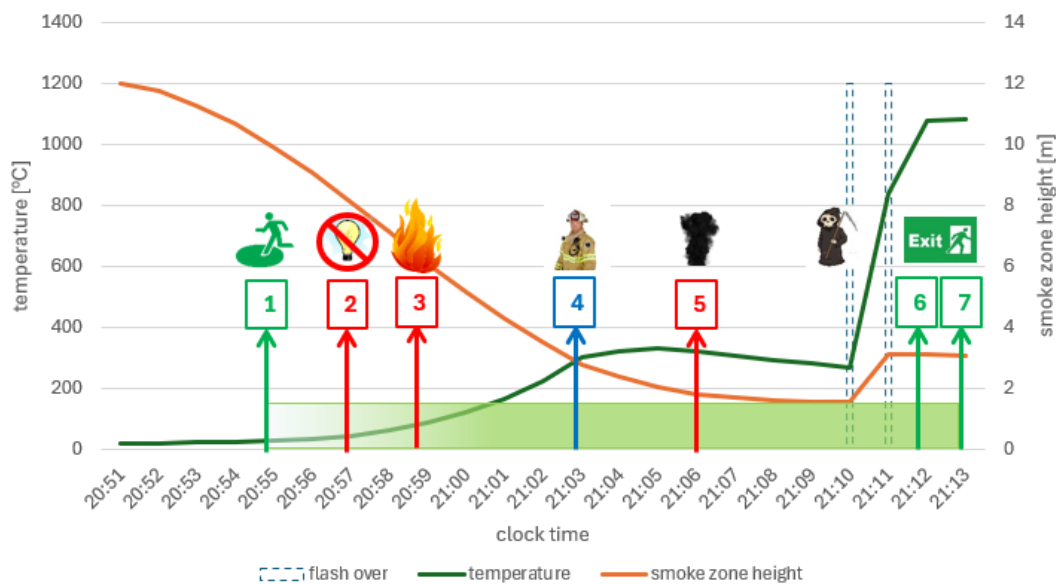
The following evacuation timeline is shown in Figure 13:

- 1) 20:55: (0 s) The evacuation started and was proceeding smoothly;
- 2) 20:57: (120 s) The lights went out, the evacuation area was congested and the evacuation routes were blocked;
- 3) 20:59: (240 s) A critical condition was satisfied when the temperature exceeded 60 °C;
- 4) 21:03: (480 s) Firefighters started to support the evacuation;
- 5) 21:06: (660 s) Another critical condition was satisfied when the smoke layer descended below 1.8 m above the floor;
- 21:10: (900 s) A flashover occurred;
- 6) 21:12: (1020 s) The hall's exits were clearing;
- 7) 21:13: (1080 s) The evacuation ended;
- 21:14: (1140 s) The hall's roof collapsed.

Figure 13. Evacuation timeline.

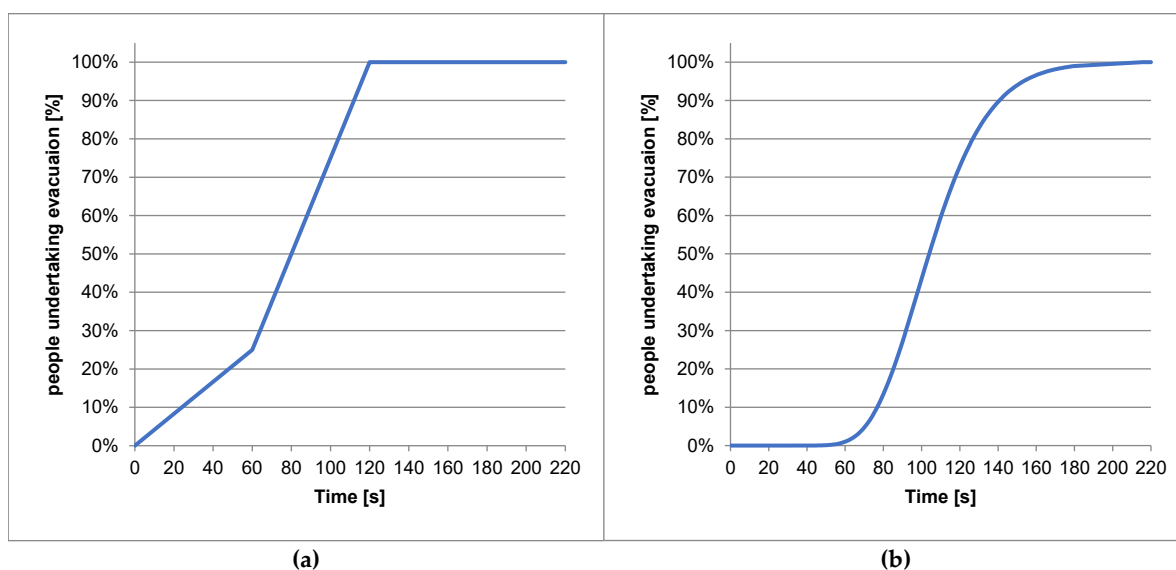
The pedestrian reaction curve in Figure 14a was based on data from a real event. About 25% of the participants started evacuating within the first 60 seconds by themselves. The rest were either passively watching the fire start or were not interrupting the fun. After about this time, the staff called the participants to evacuate, which increased the number of people starting to evacuate. After 120 seconds from the start of the fire, the lights went out, which caused a sudden call to evacuate all the remaining participants at the same time. The distribution of evacuation times shown in Figure 14b concerns scenarios 5a, 5b and 6, i.e., hypothetical events that did not occur in reality. It was not possible to obtain experimental data and therefore a lognormal distribution was adopted, which is typical for this type of research.

Figure 14. Reaction time profiles for scenarios (a) 1a, 1b, 2, 3a, 3b and 4 as well as (b) 5a, 5b and 6.

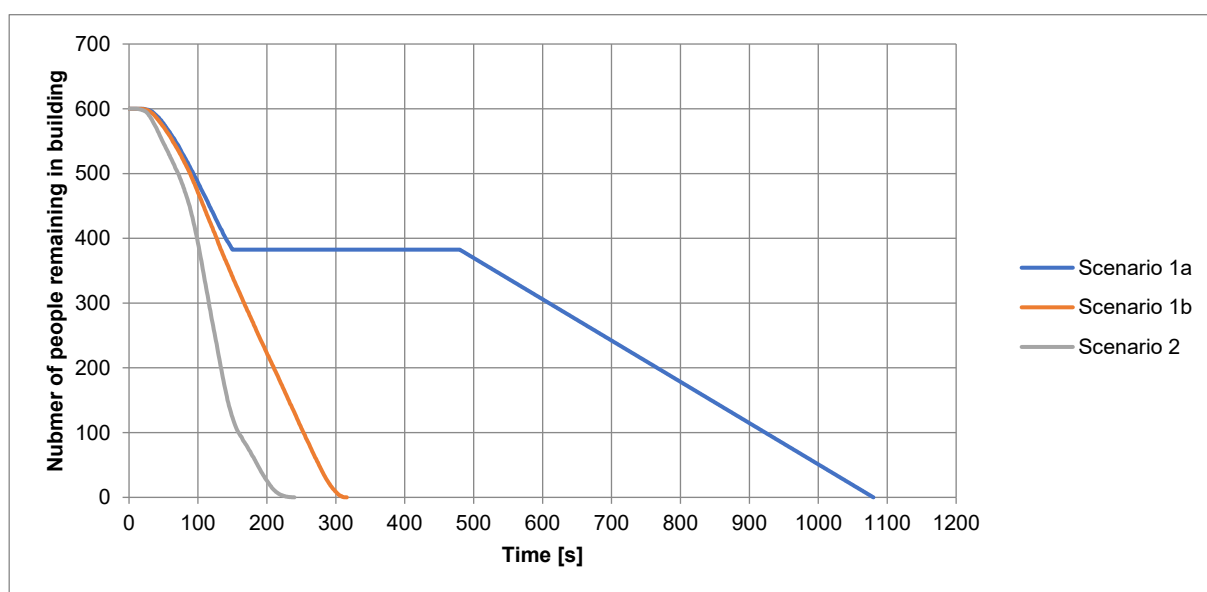
Figure 15 shows that in the scenarios where no blocking piles are formed (1b) and all emergency exits are open (2), the evacuation times (309 and 220 s, respectively) are much shorter than the evacuation time (1080 s) in the reference scenario (1). In Figure 15, the curve for scenario 1a consists of three segments. The first segment (from 0 to 150 s) is the evacuation until the blocking pile occurs. The second segment is the horizontal line between 150 and 480 s caused by the formation of a blocking pile behind the main emergency exit (WE-5), which stopped the evacuation. The third segment (after 480 s) is the unloading of the blocking pile by the rescue services at a rate of about 0.65 persons/s (actual data).

Figure 15. Evacuation profiles in scenarios 1a, 1b and 2.

(actual data). The second and third segments are identical to the phenomenon that occurred in scenario 1a (Figure 15), but there were a much larger number of people to unload.

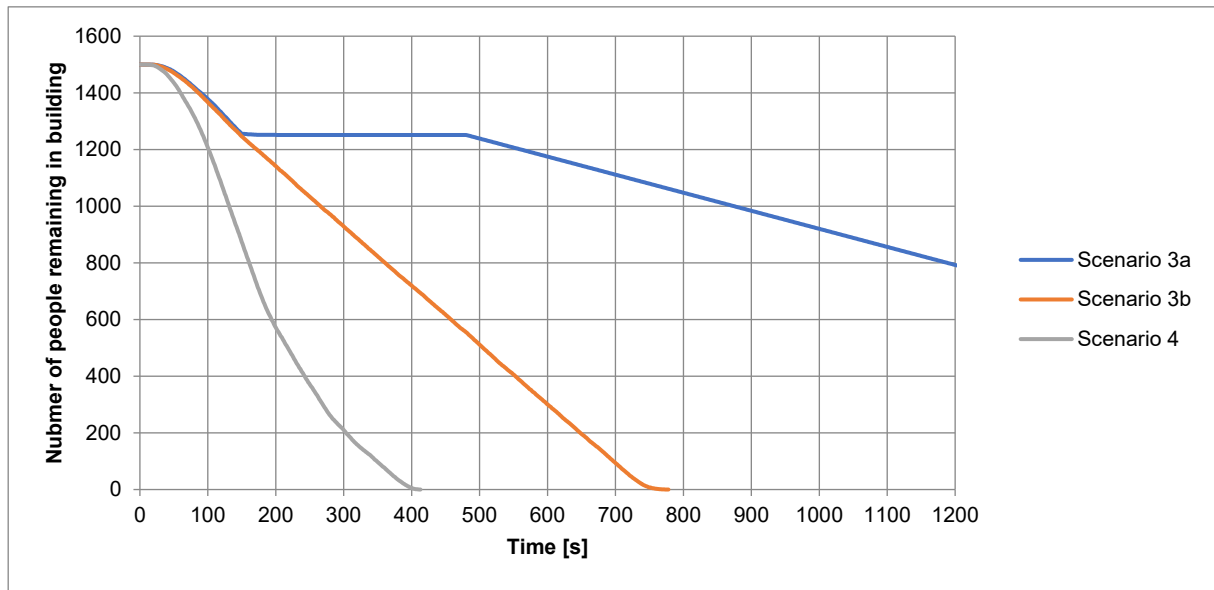
The simulated evacuation profiles in scenarios 3a, 3b and 4 are shown in Figure 16. The general result was the same as that for the first series of simulations. In scenarios 3b and 4, where no blocking piles form, the evacuation times were much shorter (755 and 405 s, respectively) than that (2444 s) in scenario 3a, where a blocking pile is formed. Among all the analysed scenarios, scenario 3a showed the longest average evacuation time. This is particularly noteworthy because scenario 3a is similar to the actual event and would have happened if the fire had occurred an hour earlier. The findings show that at the moment the roof collapsed, ~800 people would still have been inside the building. Notably, the graphs do not show people's locations in the building, which are quite important in the analysis and therefore will be discussed in Section 4.5. In Figure 16, the curve for scenario 3a consists of three segments. The first segment (from 0 to 150 s) is the evacuation until the blocking pile occurs. The second segment is the horizontal line between 150 and 480 s caused by the formation of a blocking pile behind the main emergency exit (WE-5), which stopped the evacuation. The third segment (after 480 s) is the unloading of the blocking pile by the rescue services at a rate of about 0.65 people/s

Figure 16. Evacuation profiles in scenarios 3a, 3b and 4.

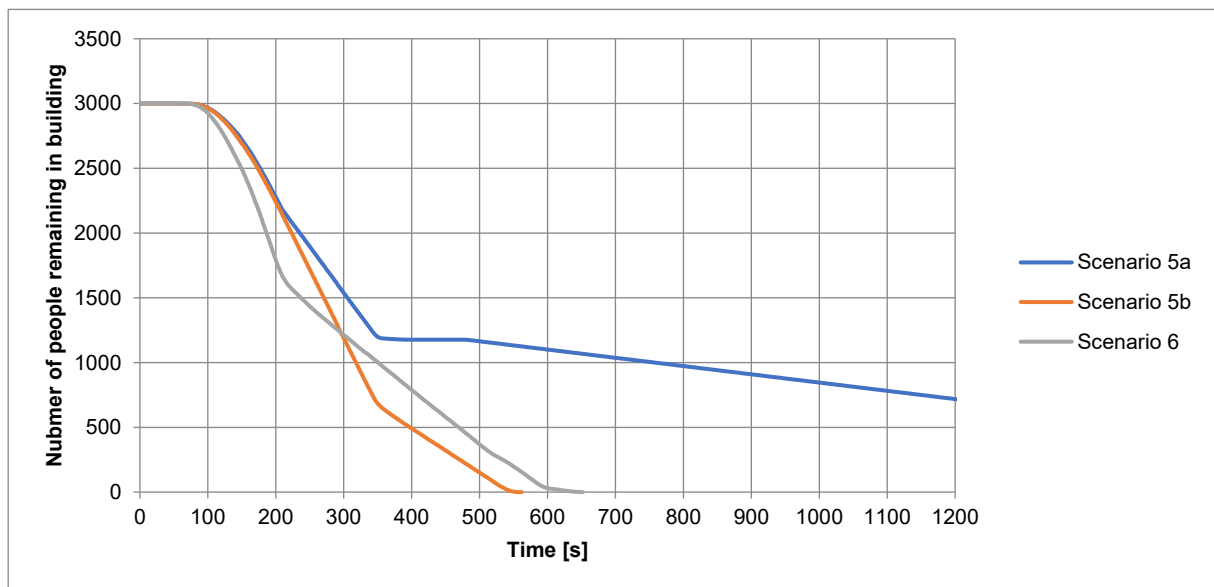
Scenarios 5a, 5b and 6 (Figure 17) concern the building's maximum audience capacity, which, according to available sources, could have been over 3,000 people. This assumption forced further changes in the scenarios because a different event had to be analysed (without a curtain and with additional stands available). In these scenarios, at least two evacuation exits were assumed to always be open. Additionally, at exit WE-4, a blocking pile forms in scenario 5a, no blocking piles form in scenario 5b, and all the evacuation exits are open in scenario 6.

Figure 17. Evacuation profiles in scenarios 5a, 5b and 6.

In Figure 17, segments can be distinguished for all three curves. In scenario 5a, the first segment (up to 210 s) is the time of free evacuation until the formation of a blocking pile. The next point (350 s) is the end of using exit WE-2, evacuation is possible only through WE-5, where a blocking pile has occurred (evacuation halted). Then the rescue services start to unload the blocking pile (480 s). In

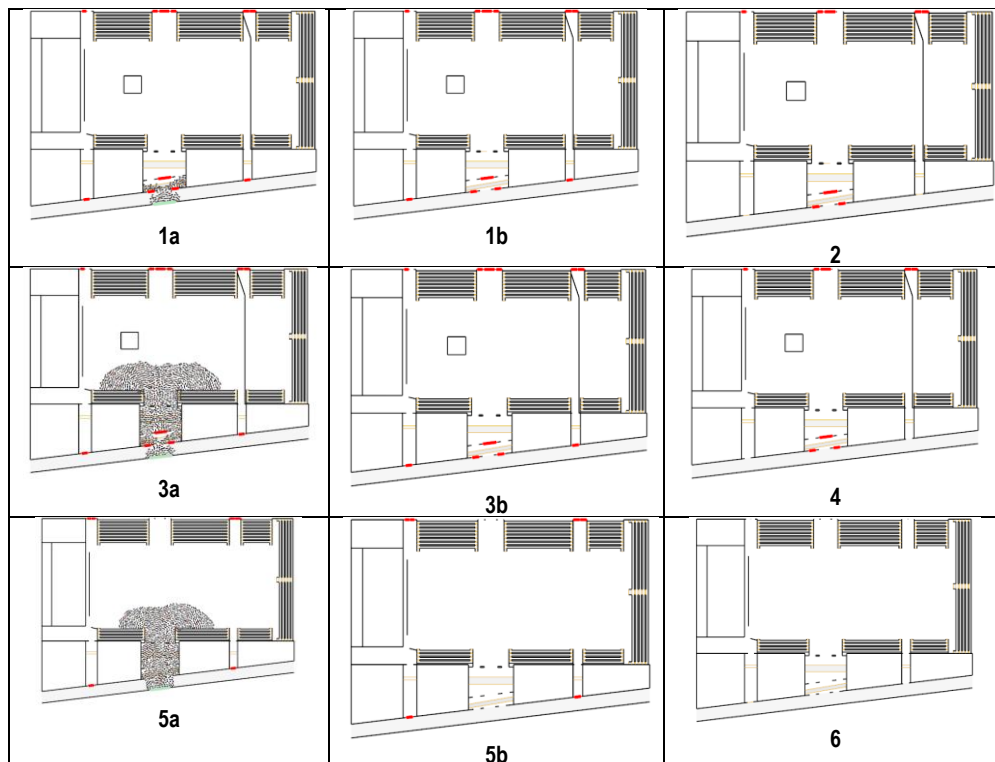
At 900 s, a flashover occurred in the building. The situation at that moment is shown in Figure 21. At that time, in scenarios 3a and 5a, where blocking piles had formed, people still remained in the building. In reality (scenario 1a), however, no people remained inside the hall at 900 s, and flames (according to eyewitness statements) appeared in the south-side evacuation corridor's upper part and burned many faces and hands. In scenarios 3a and 5a, people remained in the hall space, suggesting that the injuries would have been much more numerous and severe, including many fatalities.

Figure 21. Views of the evacuation after 900 s in different scenarios (flashover).

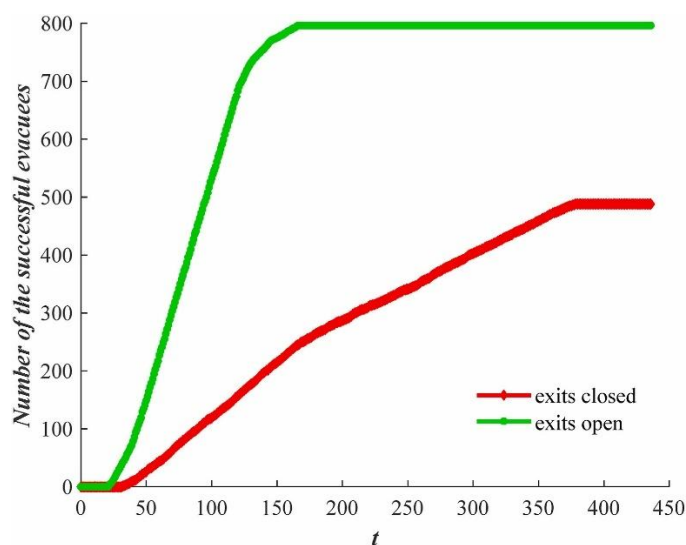
This last reason may seem to be counterintuitive because in theory, changing the blocked evacuation exit to an open one should improve the evacuation outcome. In these specific cases, however, the change resulted in exposure to smoke and heat, which was (among other aspects) the reason for the high number of casualties in China.

Figure 22. Difference in the evacuation outcomes in the Chinese incident depending on the availability of emergency exits [32].

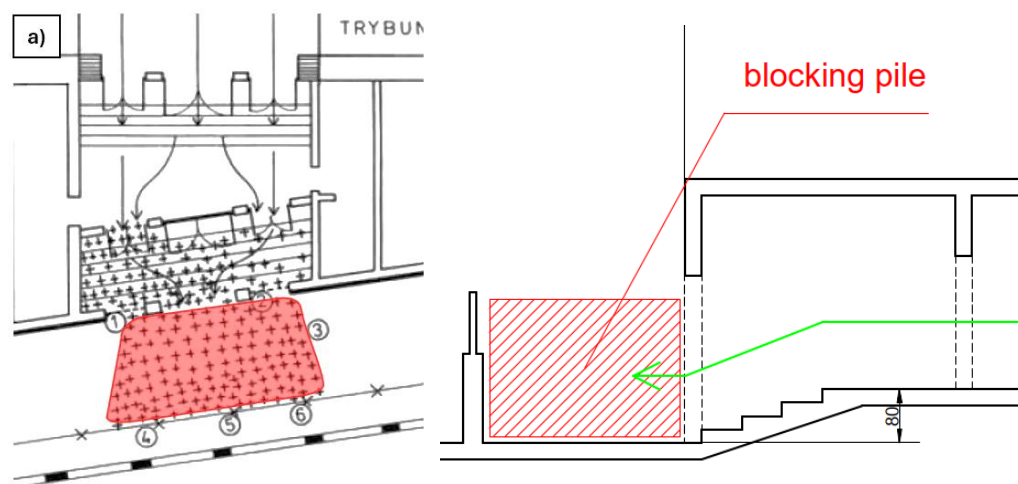
During event analysis, a phenomenon called blocking pile formation was observed, which was previously been described in detail in the literature. However, the literature survey revealed that a similar phenomenon occurred, alongside others, at the The Who concert in Cincinnati in 1979. In the available description of this event [13], because the physical effects of crowd interaction were not the subject of the analysis, no attention was likely paid to these aspects. Moreover, these aspects were not considered during the reporting and explanation of the Gdańsk event. In the author's opinion, a blocking pile is one of the critical phenomena that can occur when crowds are evacuating from confined spaces. Notably, if sufficiently large spaces are not provided for bottlenecks, the crowd will not be able to release the pressure on its own, even if the pressure is as high as 4450 N m^{-1} [33]. This will cause a blocking pile comprising a pile of people who have fallen over (Figure 11). According to the testimony of many eyewitnesses [12], rescuers encountered a pile of ~70 people about 1.5-m high in front of the main emergency exit in Gdańsk, from which the people could not escape on their own (Figures 23a and 23b).

Although a blocking pile cannot be accurately recreated in any simulation programme or experiment, attempts can be made to describe its characteristics and causes. A blocking pile occurs when a person in a moving crowd cannot maintain an upright position and starts to fall over. Subsequently, other people trip and fall over them, creating a blocking pile that grows to a height of the height of the average person in the crowd.

Figure 23. Plane (a) and cross-sectional views (b) of the blocking pile that was generated in front of an emergency exit.

- The critical crowd density is exceeded, preventing controlled movement on the floor surface, which is often additionally supported by an overcoming the difference in levels;
- Inadequate space is available around the blocking pile for the pile to naturally self-disperse;
- The crowd surrounding the blocking pile in the outer circles is unaware of the emerging danger (and is still pushing). In the inner circles, a rational reaction is impossible.

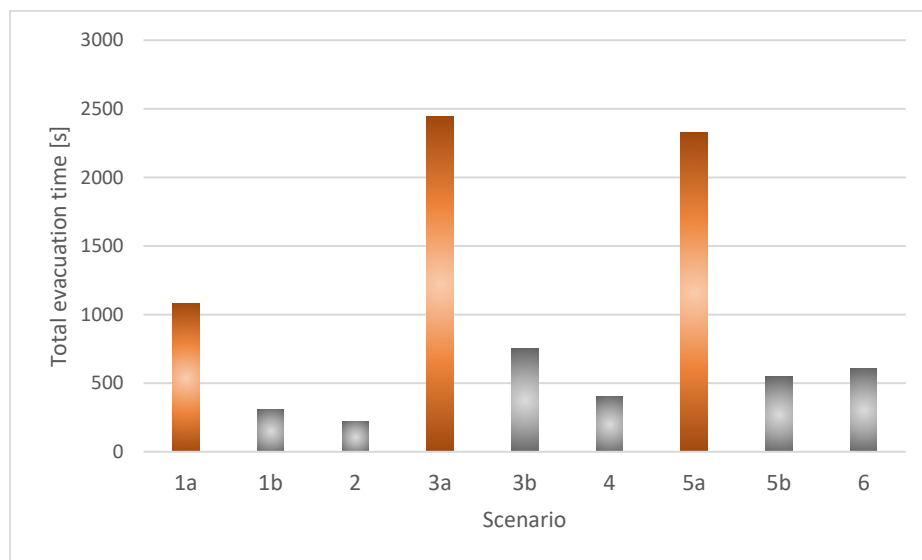
The high risk of a substantial increase in the number of people injured is also shown by the summary of the total evacuation times in the individual scenarios (Figure 24).

Figure 24. Total evacuation times in all the scenarios. Blocking piles formed in scenarios 3a and 5a.

Figure 24 shows that the three longest total evacuation times (clearly distinguishable from the other evacuation times) are for scenarios 1a, 3a and 5a, i.e., in scenarios wherein a blocking pile occurred or was assumed to have occurred.
