Not peer-reviewed version

Influence of the Layout of Cells in a Traction Battery on the Evolution of a Fire in the Event of a Failure

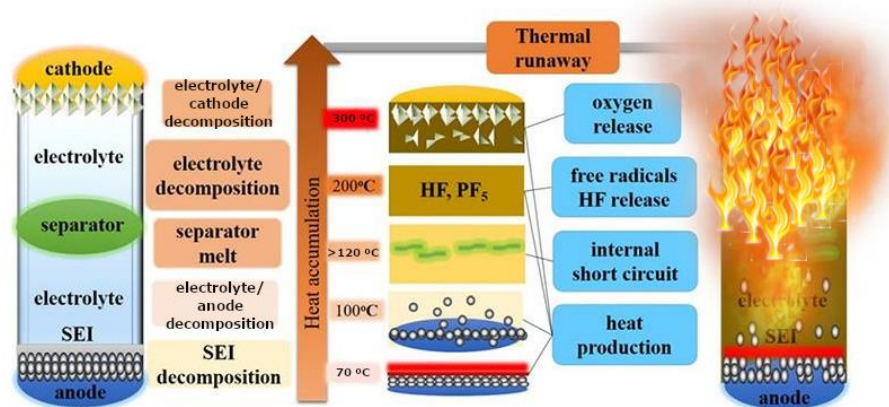
Figure 1. Schematic of the Thermal Runaway processes in a Lithium Cobalt Oxide (LCO)/graphite cell [4].

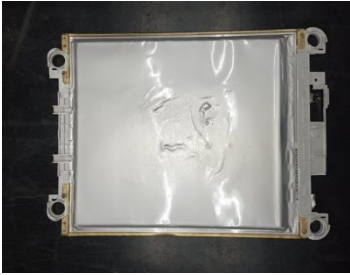
| Cell type | Parameters | Image |
|---|---|--|
| Pouch AESC Nissan Leaf (2018) Battery structure: 24 modules 8 cells for each module | 56.3 Ah, NMC 523 3.65 V 205.49 Wh Manufacturer: Envision AESC | |

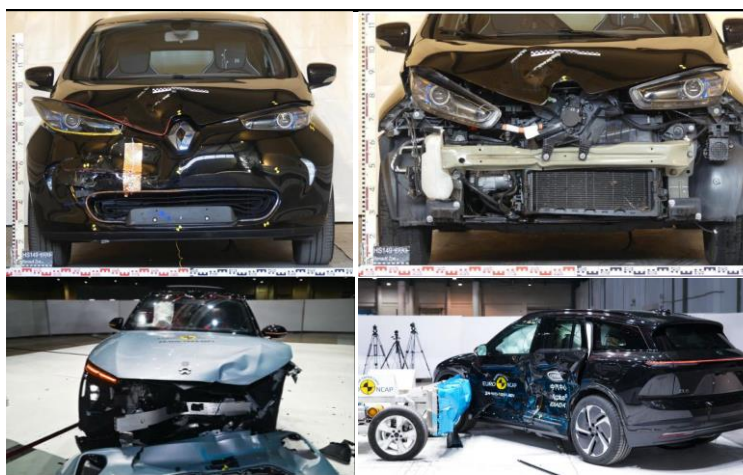
Figure 2. Images of various deformed electric vehicles in a crash test. Source: Renault Zoe (at the top) [44] and NIO EL6 (at the bottom) [45].

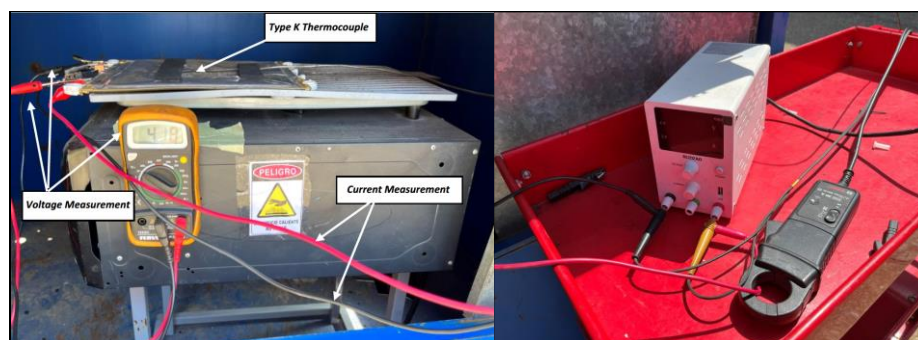
Figure 3. Images of the overcharge test set-up (left) and image of the charger used to supply 10 A (DC) (right).

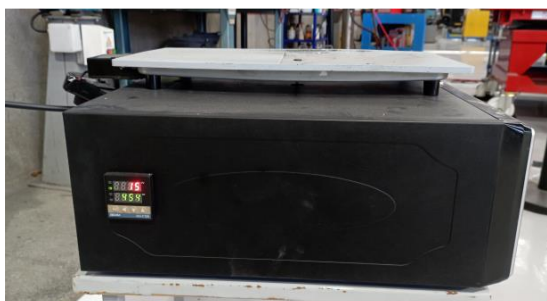
Figure 4. Images of the electric griddle instrumented with a PID-controlled thermostat, used for the heating tests.

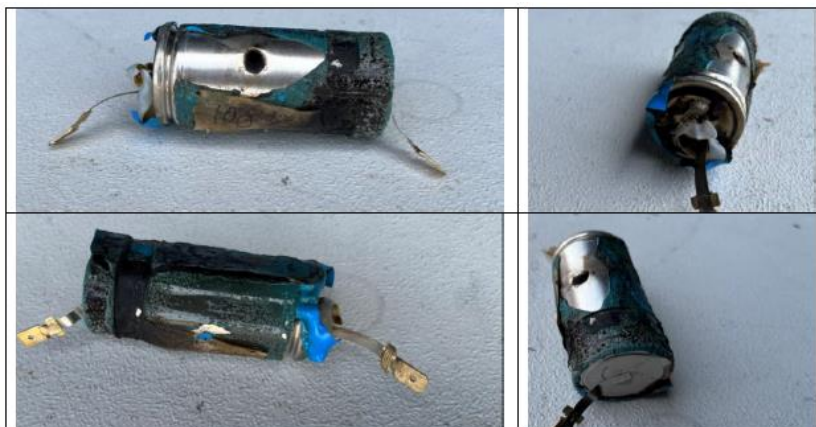
Figure 6. Images of the state of cell A after the test are shown, where the perforation it has undergone can be clearly seen.

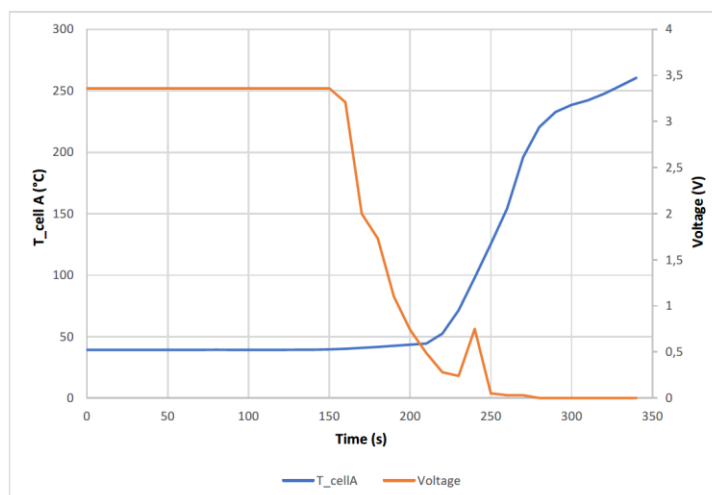
Figure 7. Temperature and voltage of cell A (SoC 100%) as a function of time, during the mechanical abuse test, in which it is subjected to a perforation in a direction perpendicular to the longitudinal axis of the cell until a short circuit.

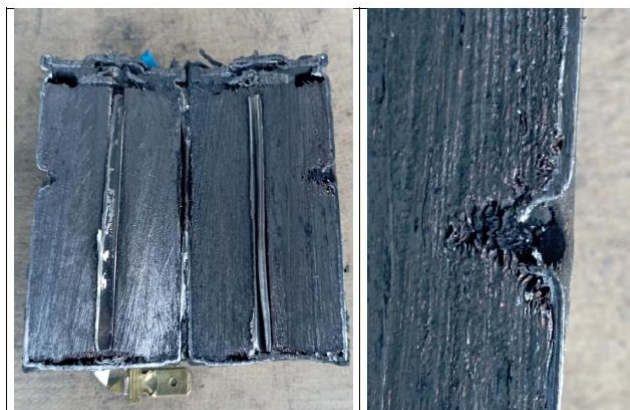
Figure 8. Image of damage to A cell tested for mechanical abuse by perforation in the direction perpendicular to the longitudinal axis of the cell.

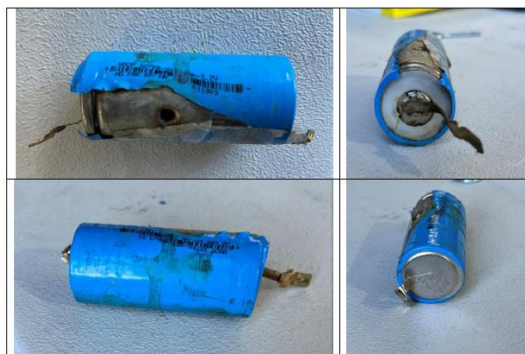
Figure 10. Images of the main events experienced by cell A (SoC 100%) during the mechanical abuse test (perforation in a direction perpendicular to the longitudinal axis of the cell).

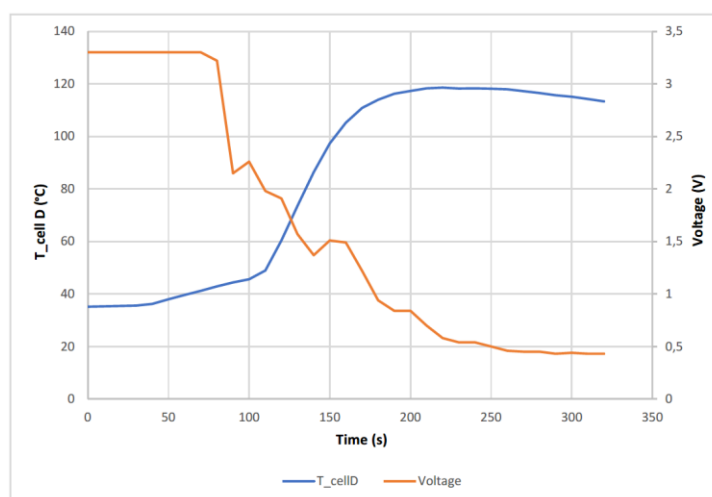
Figure 11. Temperature and voltage of cell D (SoC 50%) as a function of time, during the mechanical abuse test, in which it is subjected to a perforation in a direction perpendicular to the longitudinal axis of the cell until a short circuit.

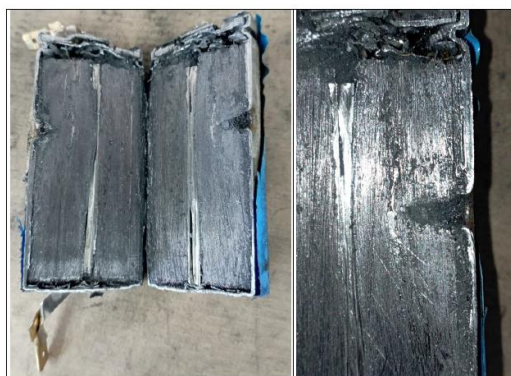
Figure 12. Image of damage to cell D (SoC 50%) tested for mechanical abuse by perforation in the direction perpendicular to the longitudinal axis of the cell.

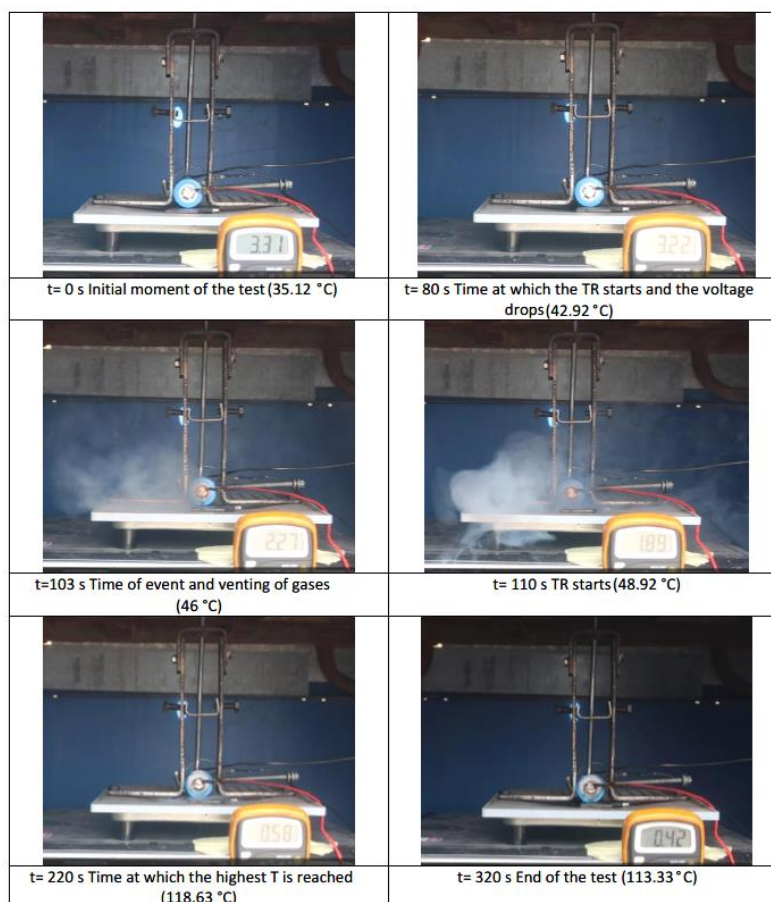
Figure 13. Images of the main events experienced by cell D (SoC 50%) during the mechanical abuse test (perforation in a direction perpendicular to the longitudinal axis of the cell).

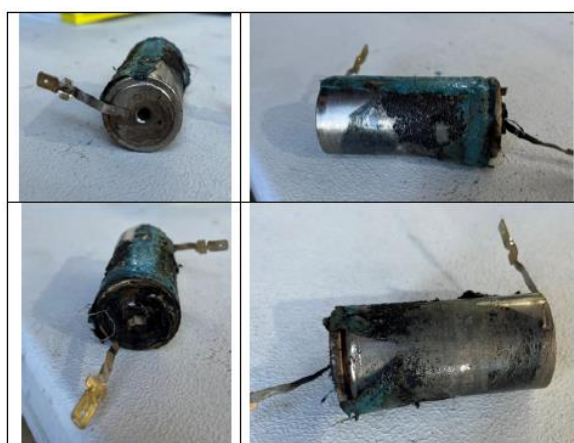
Figure 15. Images are shown of the state of cell C after the test, where the perforation it has undergone can be clearly seen.

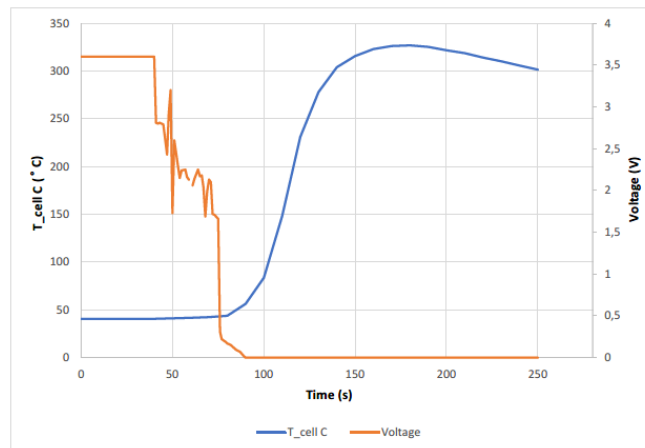
Figure 16. Temperature and voltage of cell C (SoC 0%) as a function of time, during the mechanical abuse test, in which it is subjected to a perforation in a direction of the longitudinal axis of the cell until a short circuit.

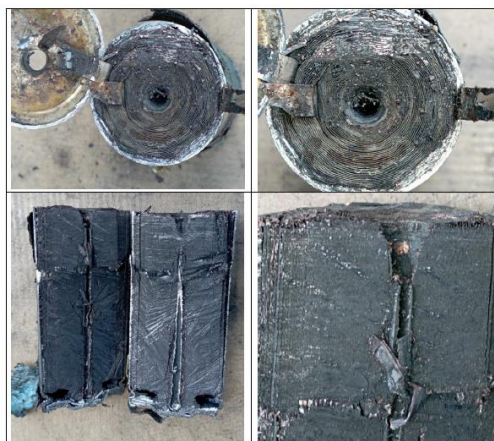
Figure 17. Image of the damage in cell C tested for mechanical abuse by perforation in the direction of the longitudinal axis of the cell.

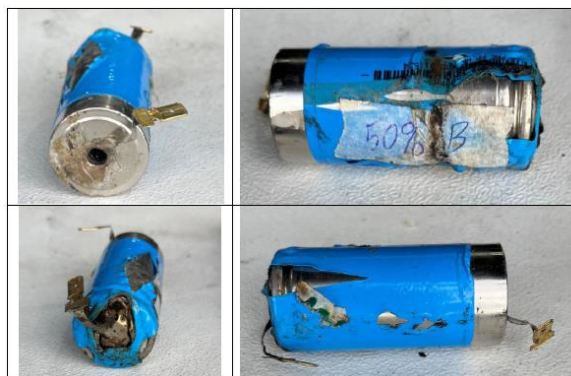
Figure 17. Image of the damage in cell B tested, where you can clearly see the perforation, it has undergone.

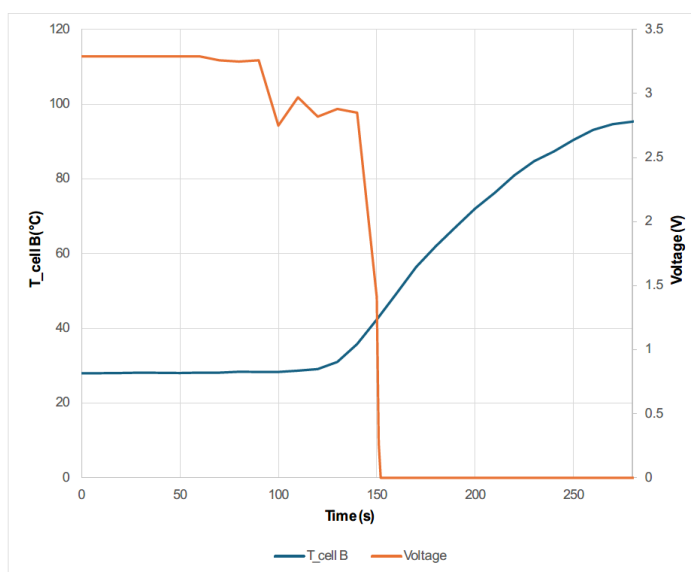
Figure 18. Temperature and voltage of cell B (SoC 50%) as a function of time, during the mechanical abuse test, in which it is subjected to a perforation in a direction of the longitudinal axis of the cell until a short circuit.

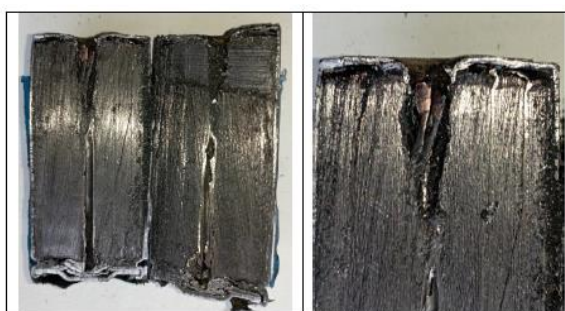
Figure 19. Image of the damage in cell B tested (SoC 50%) for mechanical abuse by perforation in the direction of the longitudinal axis of the cell.

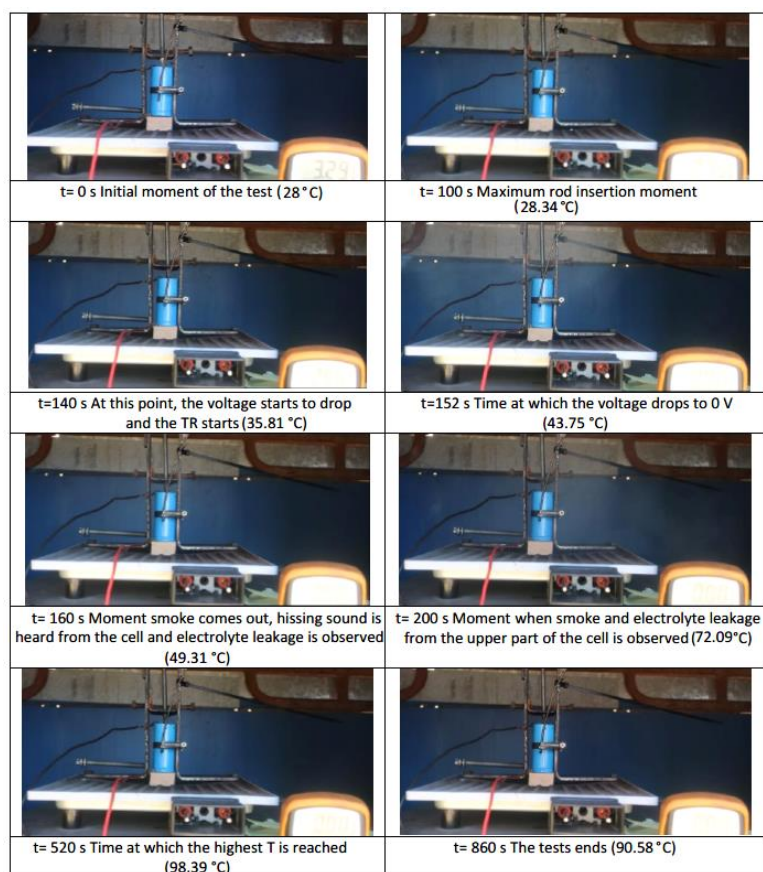
Figure 20. Images of the main events experienced by cell B (SoC 50%) during the mechanical abuse test (perforation in the direction of the longitudinal axis of the cell).

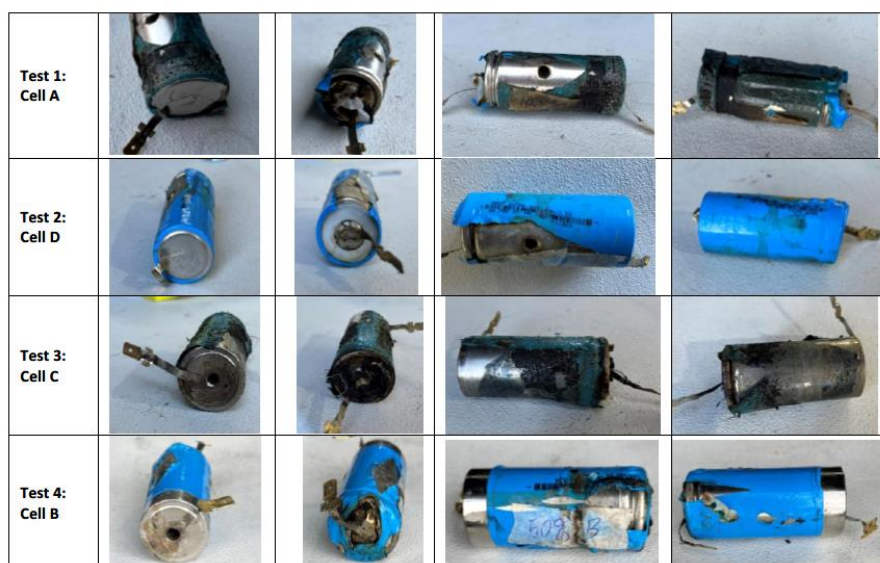
Figure 21. Qualitative comparison of the final state of the tested cells (analyzing their exterior).

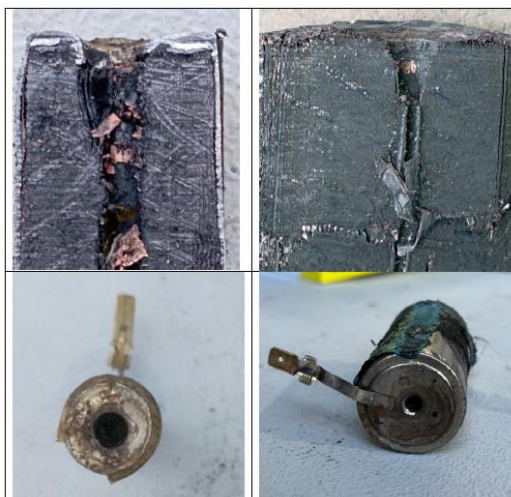
Figure 26. Qualitative comparison of the damage in the NMC cell (left) with the damage in the LFP cell (cell C) (right), tested by mechanical abuse by perforation in the direction of the longitudinal axis of the cell.

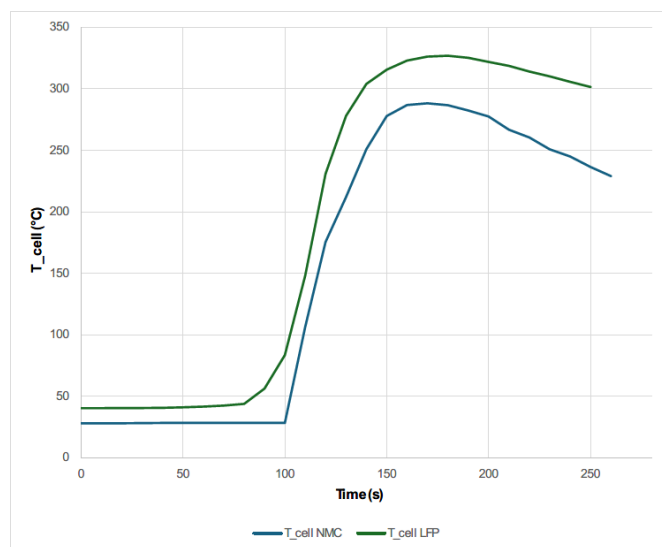
Figure 28. Temperature of NMC cell (SoC 100%) and cell C (LFP, SoC 100%) perforated in the direction of the longitudinal axis of the cell to the short-circuit.

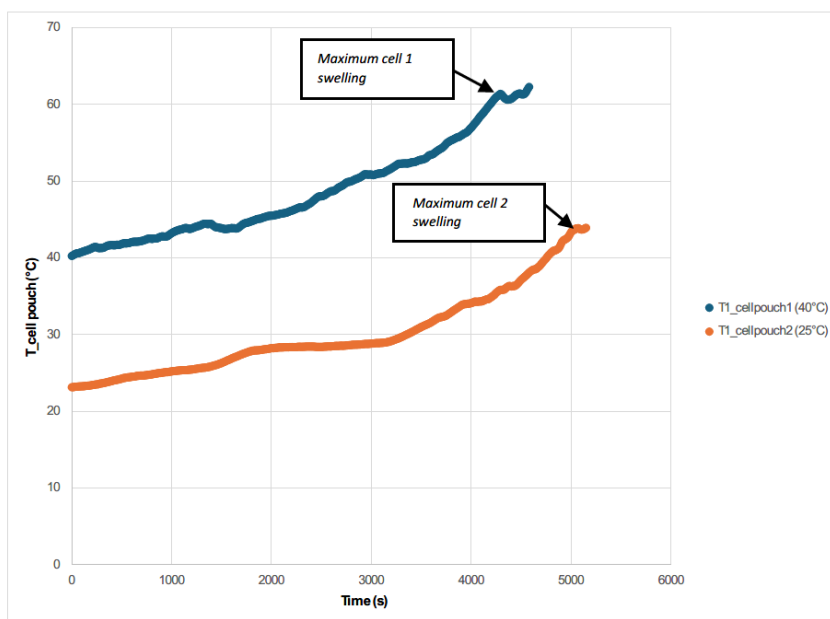
Figure 29. Temperature profile reached by the pouch cells subjected to the overcharge test, for ambient temperature of 40 °C and 25 °C.

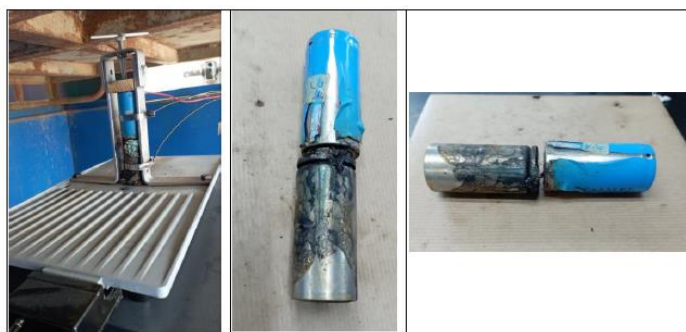
Figure 34. The first image shows the two cells with the tooling used to prevent them from moving during the test. The second and third images show the condition of the cells after test 1.

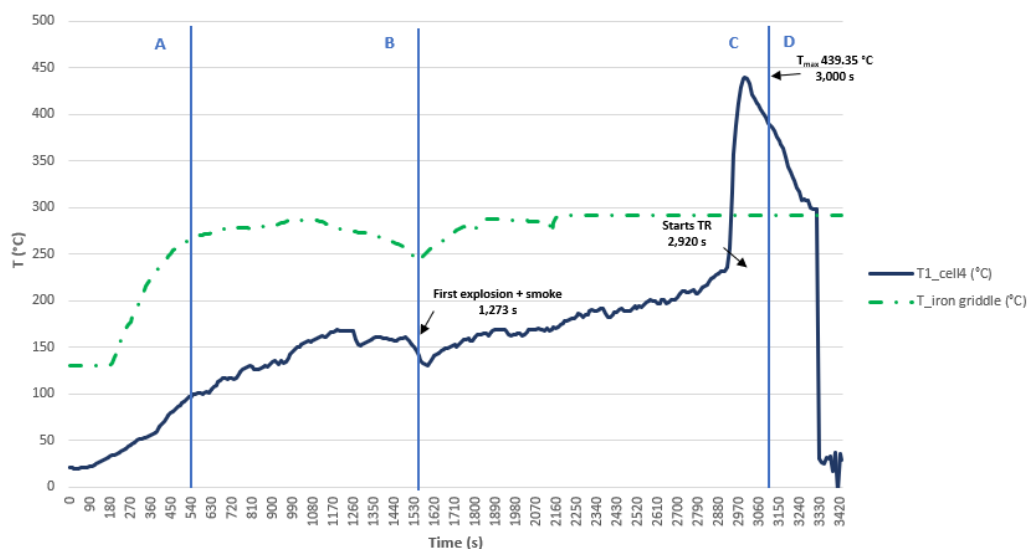
Figure 35. Cell 4 temperature (solid line) because of heating when placed on the electric griddle.

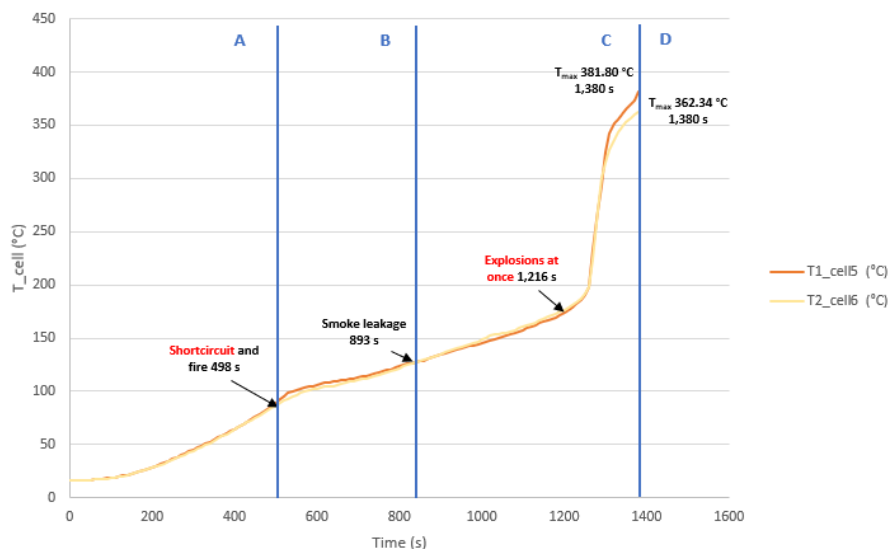
Figure 37. Temperature of cell 5 and cell 6 (solid lines) because of heating when placed on the electric griddle (Test 2).

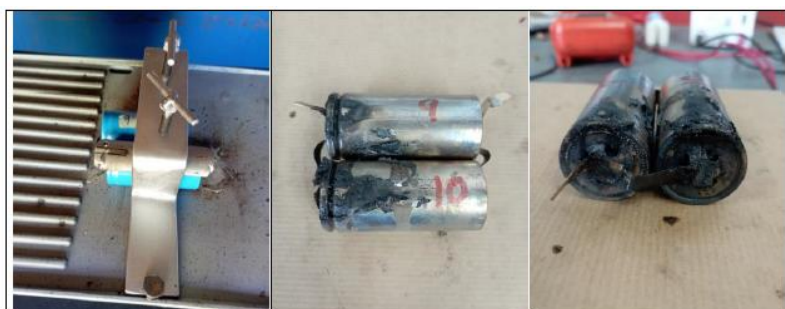
Figure 38. The first image shows the two cells before the test with the tooling used to prevent the cells from moving during the test. The second and third images show the condition of the cells after the test 3.

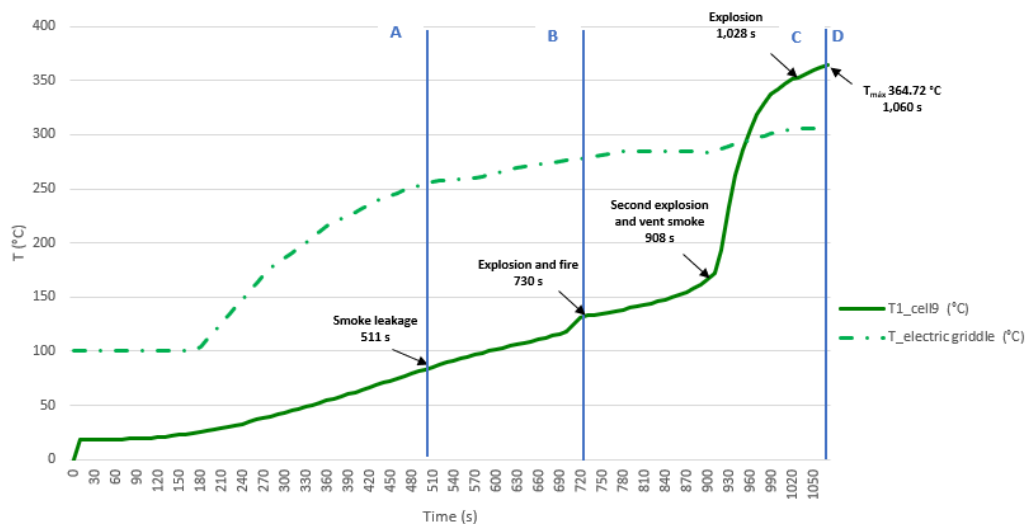
Figure 39. Temperature of cell 9 (solid line) because of heating when placed on the electric griddle (Test 3).

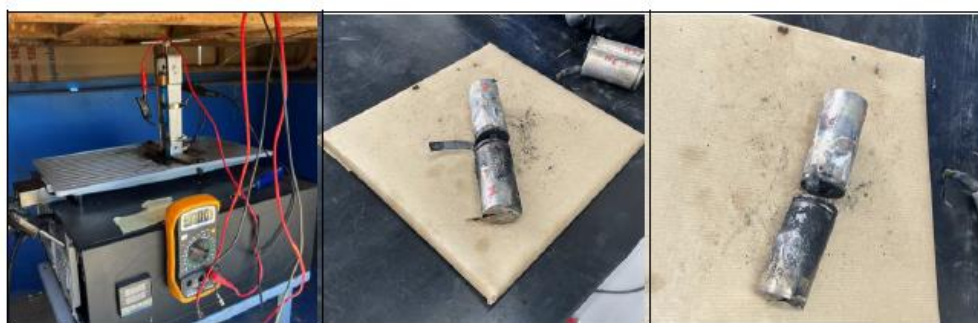
Figure 40. The first image shows the two cells on the electric griddle with the tooling used to prevent the cells from moving during the test. The second and third images show the condition of the cells after the test 4.

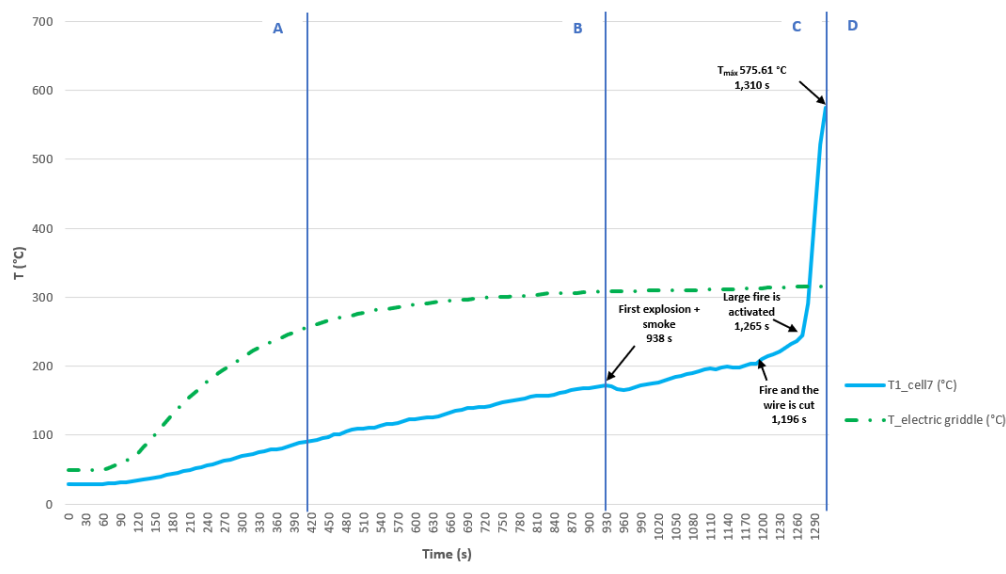
Figure 41. Temperature of cell 7 (solid line) because of heating when placed on the electric griddle (Test 4).

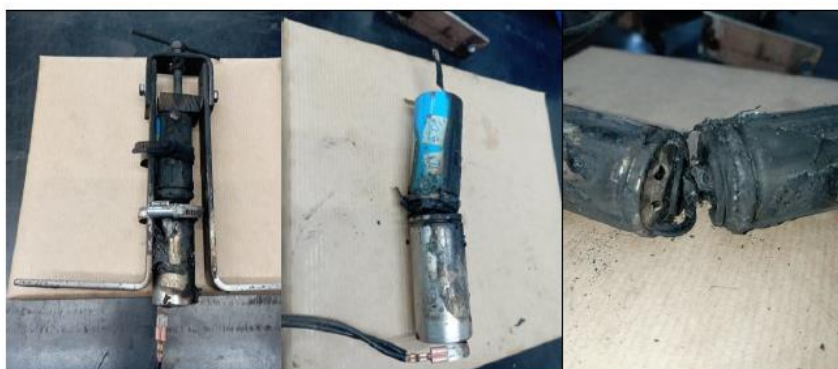
Figure 43. The first image shows the two cells with the tooling used to prevent the cells from moving during the test. The second and third images show the state of the cells after the test 5.

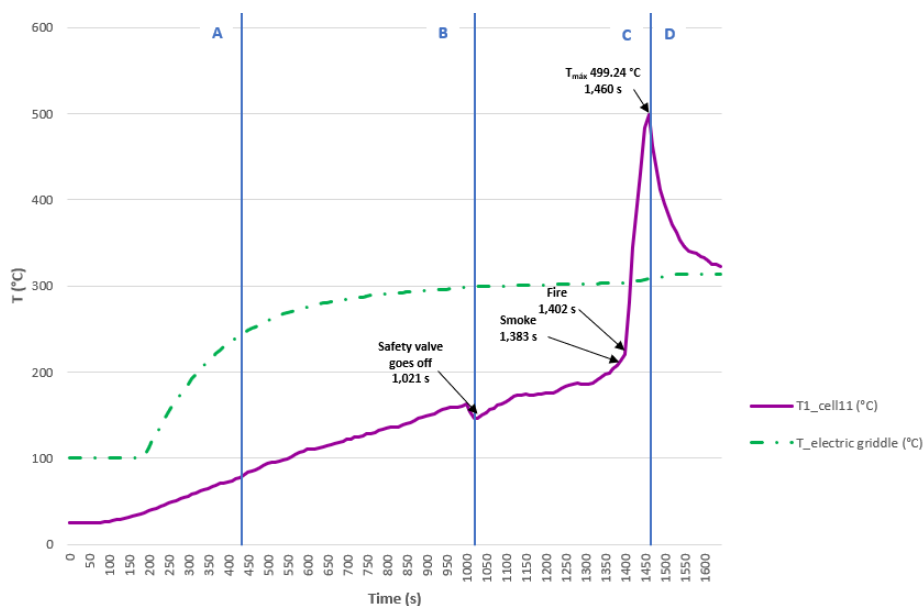
Figure 44. Temperature of cell 11 (solid line) because of heating when placed on the electric griddle (Test 5).

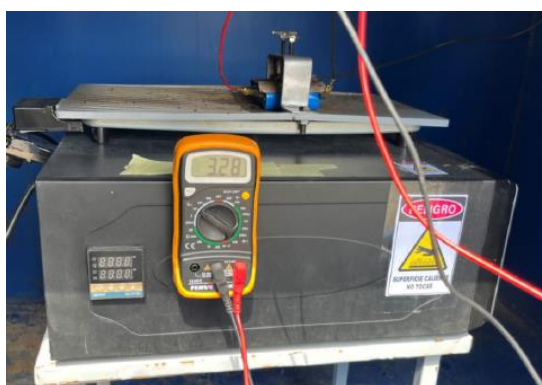
Figure 45. Image of the cells with an SoC of 50%, placed with a tool in a horizontal arrangement and connected in parallel on the electric griddle, before the starting the heating test.

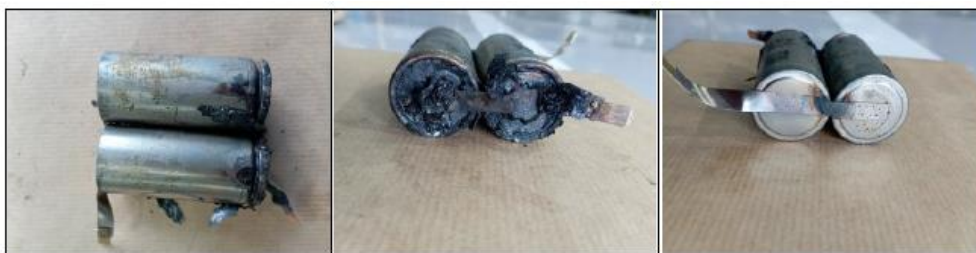
Figure 46. The first image shows the two cells seen from above, the second image shows the upper part of the cells (where the vent valve is located) and the third image shows the lower part of the cells.

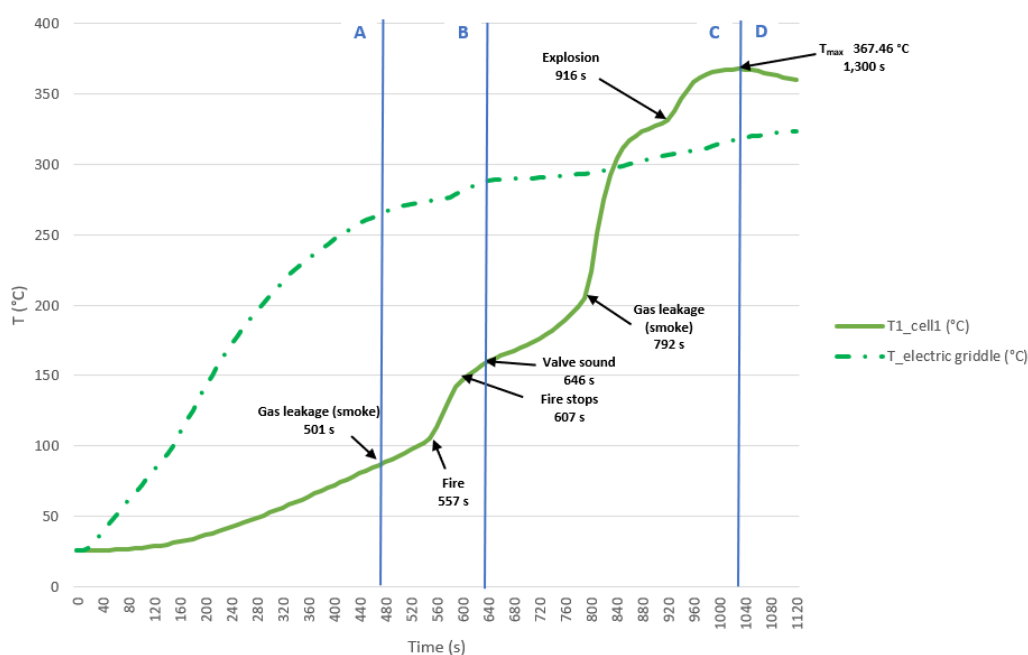
Figure 47. Temperature of cell 1 (solid line) because of heating when placed on the electric griddle (Test 6).

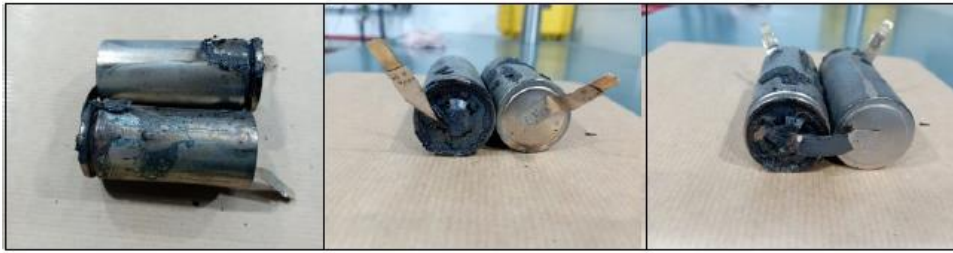
Figure 48. The first image shows the two cells seen from above, the second image shows the upper part of one of the cells (where the vent valve is located) and the third image shows the upper part of other of the cells.

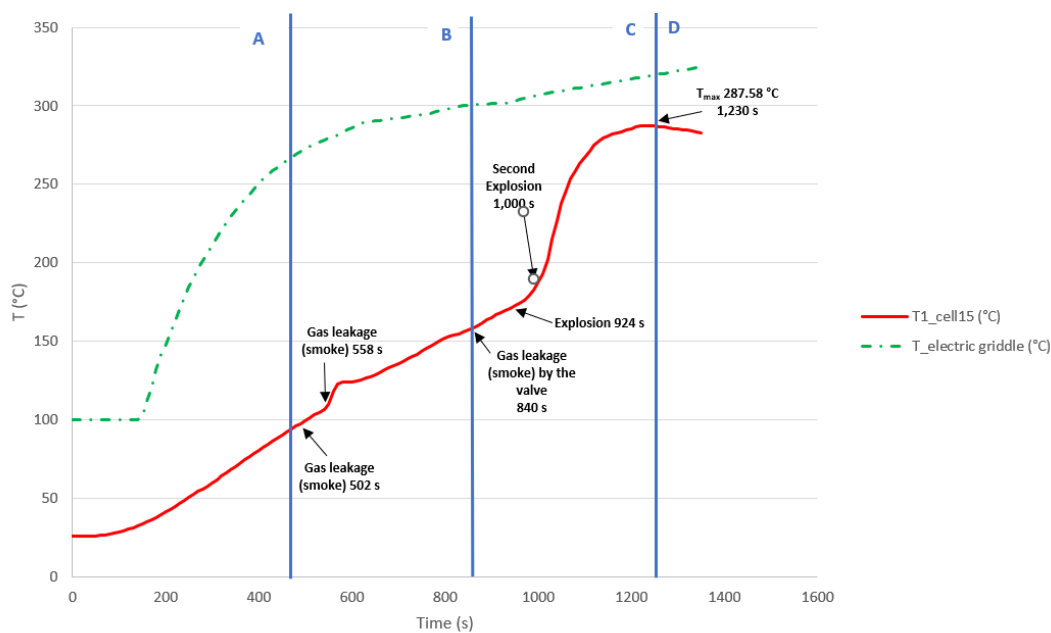
Figure 49. Temperature of cell 15 (solid line) because of heating when placed on the electric griddle (Test 7).

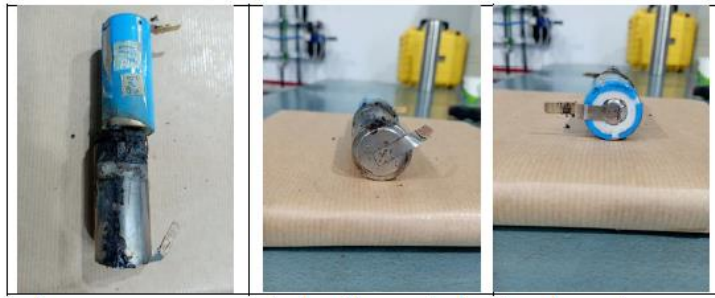
Figure 50. The first image shows the two cells seen from above, the second image shows the lower part of the cell 13 and the third image shows the upper part of other of the cell 17 (where the vent valve is located).

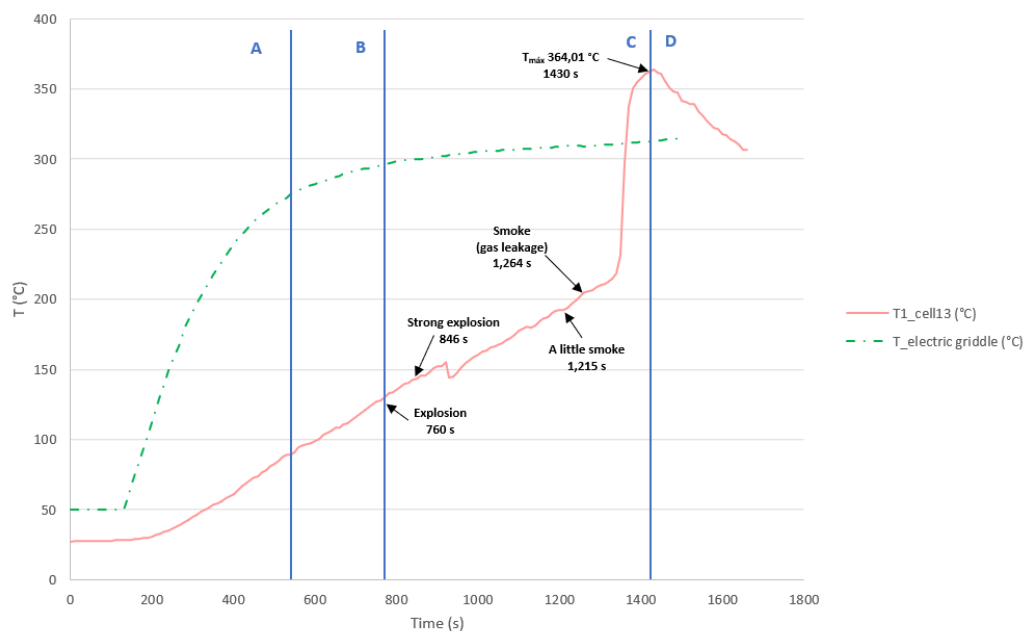
Figure 51. Temperature of cell 13 (solid line) because of heating when placed on the electric griddle (Test 8).

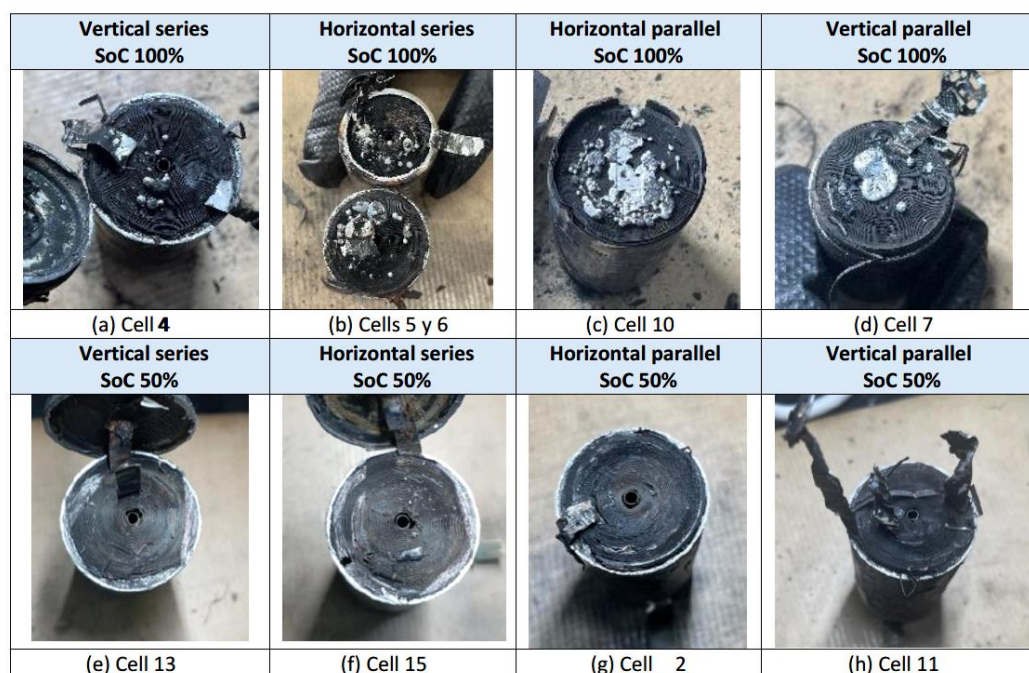
Figure 52. Final state of the cells after thermal abuse tests by heating, after removal of the top cover.

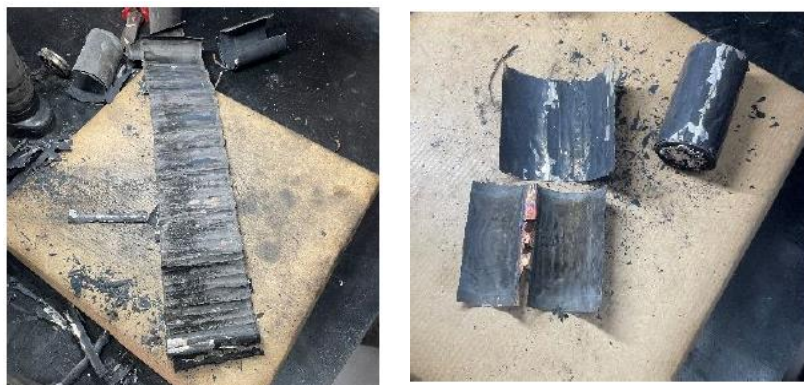
Figure 53. Final state of tested cell 7 (Test 4: vertical arrangement parallel connection SoC 100%) (left) and final estate of tested cell 10 (Test 3: horizontal arrangement parallel connection SoC 100%) (right).
