Residual Mechanical Properties of Sandstone After Fire

Ema Jankovičová, Jiří Pazderka and Radek Zigler *

Czech Technical University in Prague, Faculty of Civil Engineering, Department of Architectural Engineering, Thákurova 2077/7, Prague, 166 29, Czech Republic

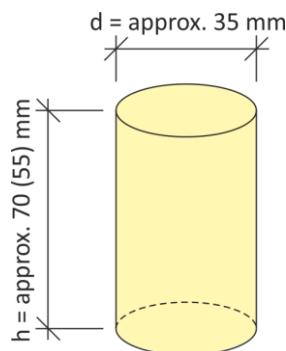
The experimental samples used in this study were cylindrical in shape, with dimensions of approximately \varnothing 35 mm and a height ranging from 55 mm to 70 mm (Figure 2). Following thermal treatment in an electric muffle oven, the samples were allowed to cool to room temperature before being subjected to uniaxial compressive strength (UCS) tests. This procedure was designed to evaluate changes in mechanical performance resulting from high-temperature exposure, while minimizing the effects of thermal shock.

Figure 2. Experimental samples dimensions.

The cylindrical sandstone specimens prepared for testing had a diameter of approximately 35 mm and heights ranging from 55 mm to 70 mm (Figures 3 and 4, Table 1). The height of the samples was limited by the size of the original stones from which the samples were prepared. Due to the variation in sample height, particularly for those around 55 mm, it was necessary to normalize the measured compressive strength values for accurate comparison. Several standard methods exist for this adjustment; in this study, the shape coefficient δ^{NP2} was applied. This coefficient was determined through linear interpolation based on Table 3.2 of the ČSN EN 772-1+A1 standard [21], and was calculated to be approximately 91 % of the measured compressive strength value. This adjustment ensured consistent and comparable results across all specimens regardless of height variation.

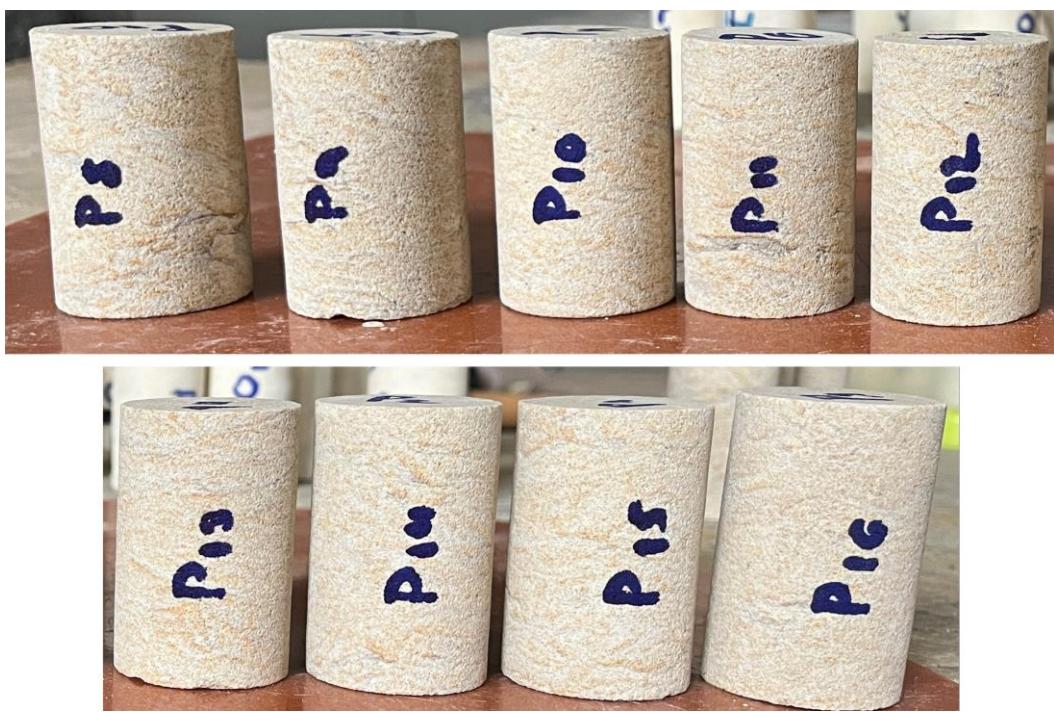
Figure 3. Experimental samples of sandstone with height $h = 55$ mm.

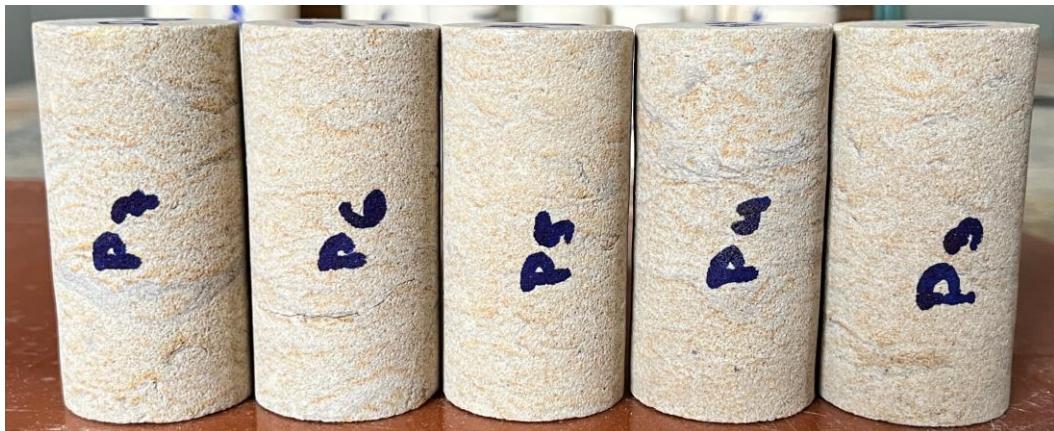
Figure 4. Experimental samples of sandstone with height $h = 70$ mm.

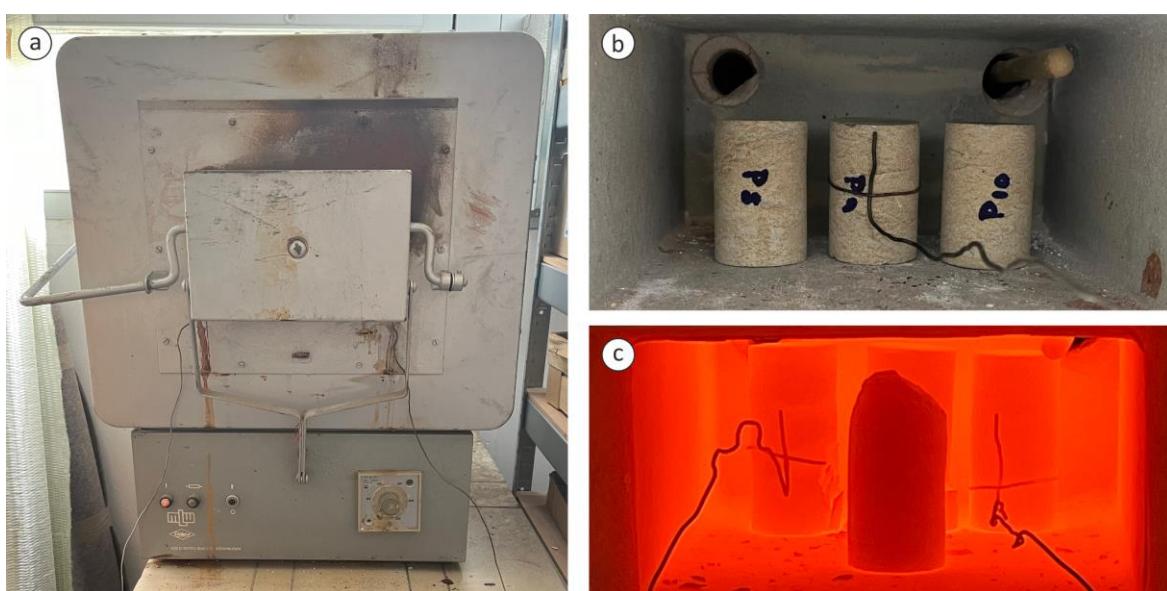
Sample heating was conducted using an electric muffle furnace (Figure 5). Four target temperatures were selected for the study: 180 °C, 460 °C, 620 °C, and 900 °C. The heating process comprised three stages: first, raising the temperature to the target value at a controlled rate of 16–18 °C/min (phase I); second, maintaining the target temperature for approximately one hour to ensure uniform heat distribution (phase II); and third, allowing the samples to cool naturally within the furnace to ambient room temperature (phase III, Figure 6). Throughout the process, the temperature was monitored using two thermocouples. For each temperature three samples were used, so at least a basic statistical evaluation could be possible. The total number of specimens was limited by the available raw stone material.

Figure 5. (a) Electric muffle furnace; (b) Samples before heating; (c) Samples during heating (temperature 920 °C).

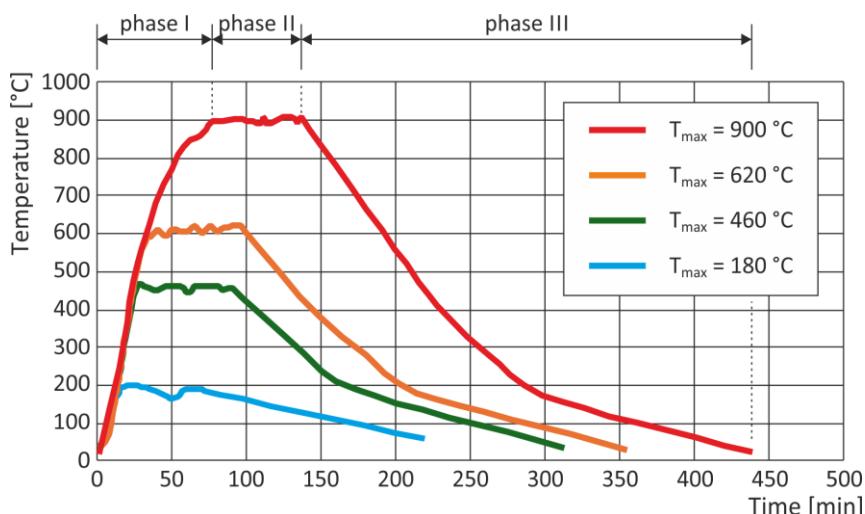
In real fire scenarios, the temperature increase is typically rapid. However, in large-scale structures, the significant mass of materials means that internal heating occurs more gradually compared to small laboratory samples exposed to simulated fire conditions. Therefore, the slower heating rates used in experimental testing are considered appropriate and should not significantly influence the final mechanical properties measured.

Figure 6. Heating and cooling curves.

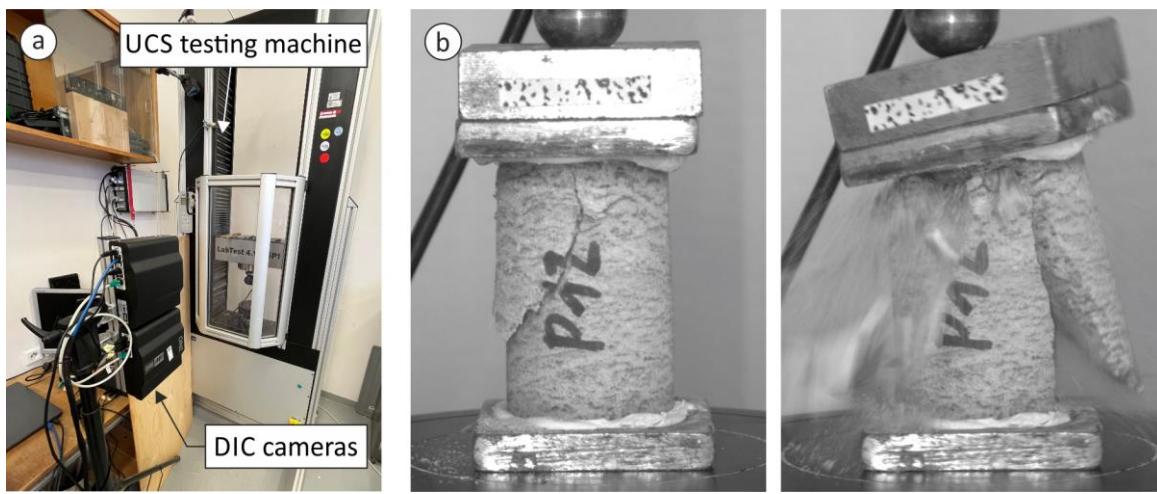
Once cooled to the room temperature, the samples were subjected to uniaxial compression testing using a LabTest 4.100.SP1 universal testing machine, capable of applying a maximum nominal load of 100 kN (Figure 7). The tests were conducted under displacement control with a constant loading rate of 0.25 mm/min.

Figure 7. (a) Experimental setup; (b) Test specimen failure under uniaxial compression.

During UCS testing, Digital Image Correlation (DIC) technology was employed to obtain detailed measurements of relative strain and displacements across the sample surfaces. The DIC system included an AOX-ONE camera, LED lighting to ensure consistent illumination, and specialized software for recording and analysing the acquired data.

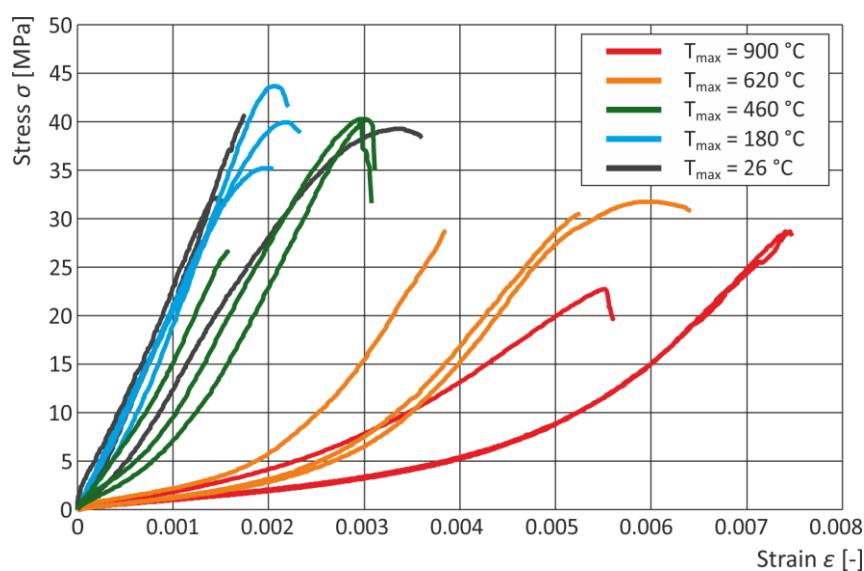
At the reference temperature, the sandstone samples exhibited a nearly linear stress-strain relationship (Figure 8), characterized by a steep initial slope and relatively low strain at peak stress. This indicates a high modulus of elasticity and compact internal structure. Samples heated to 180 °C and 460 °C followed a similar trend, showing minor variations in stiffness and strain, suggesting that low to moderate thermal exposure does not significantly disrupt the stone's internal cohesion.

In contrast, samples subjected to higher temperatures of 620 °C and 900 °C showed markedly different behaviour. The stress-strain curves for these specimens revealed a longer densification phase, where strain increased more rapidly during the initial stages of loading. This response implies an early onset of microcrack closure and particle rearrangement before the material reached peak stress.

Moreover, a significant reduction in the slope of the stress-strain curves for these high-temperature samples indicates a decrease in Young's modulus. This loss of stiffness suggests substantial damage to the internal microstructure, likely due to thermal expansion, mineral decomposition, and the formation of microcracks during heating and cooling cycles.

Figure 8. Stress-strain relationship of sandstone samples under uniaxial compression.

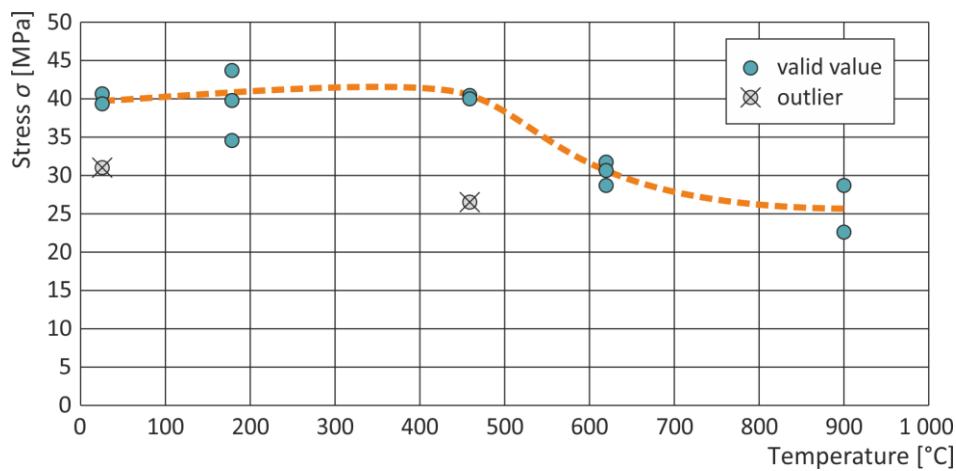
The compressive strength results (Figure 9) confirm this trend. While samples heated to 180 °C and 460 °C retained most of their strength (87 % to 109 % and approximately 100.4 % of reference values, respectively) and were comparable to the values of the reference samples, which had a maximum strength approximately 40 MPa (100 %, $\pm 1.75\%$), those exposed to 620 °C exhibited strengths ranging from 28.8 MPa to 31.8 MPa, which corresponds to 72 % to 79 % of the original strength. The degradation was more pronounced at 900 °C, where compressive strength ranged from 22.8 MPa to 28.7 MPa (57 % to 72 % of the original).

Figure 9. Relationship between ultimate stress and temperature.

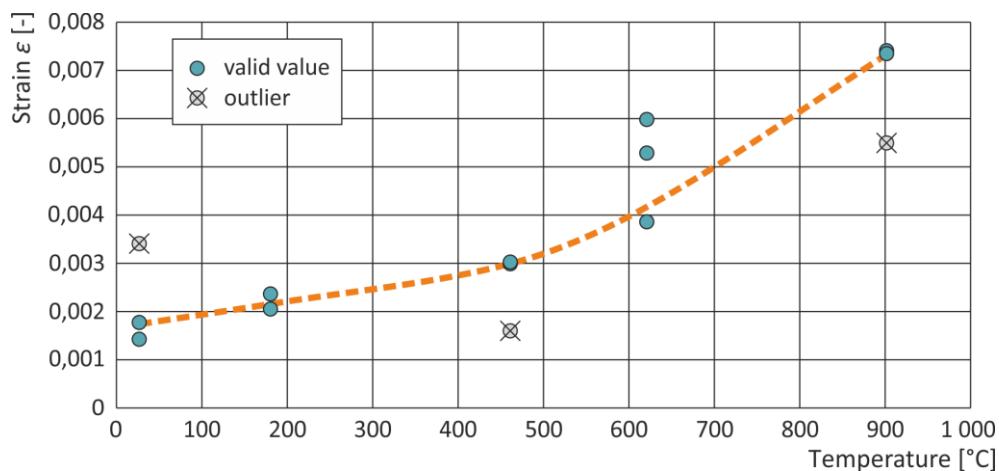
Figure 10 illustrates the axial strain data. As temperatures increased, so did the axial strain, particularly at 620 °C and 900 °C. At 620 °C, axial strain values were recorded at 0.00385 (244 %), 0.00527 (334 %), and 0.00598 (379 %). At 900 °C, values were 0.0074 (470 %), and 0.00745 (473 %). These represent dramatic increases when compared to the reference samples, as for unheated samples axial strain values ranged from 0.0014 (89 %) to 0.00175 (111 %), for samples at 180 °C ranged from 0.00204 to 0.00235 (129 % to 130 %), and those at 460 °C ranged from 0.00297 (188 %) to 0.00298 (189 %).

Figure 10. Relationship between ultimate strain and temperature.

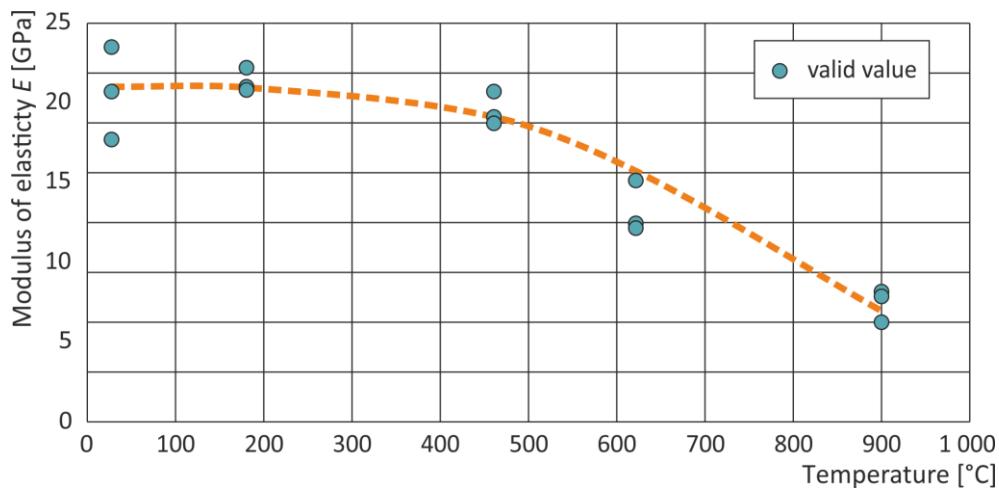
The values of Young's modulus of elasticity were defined as the slope of the straight line portion of the curve before the peak stress (the second half of the curve). Young's modulus (Figure 11) exhibited a similar temperature-dependent decline. Reference samples had moduli ranging from 17.6 GPa to 23.5 GPa (85 % to 114 %). Samples at 180 °C ranged from 20.7 GPa to 22.2 GPa (101 % to 108 %), while those at 460 °C ranged from 18.7 GPa to 20.7 GPa (91 % to 101 %). A significant reduction was observed at 620 °C (12.1 GPa to 15.1 GPa, or 59 % to 74 %), and further at 900 °C (6.2 GPa to 8.2 GPa, or 30 % to 40 %). The change in modulus of elasticity of individual samples is also reflected in the stress-strain curves of sandstone (Figure 8), where a significant change in the behaviour of samples due to temperature can be clearly observed.

Figure 11. Relationship between Young's modulus of elasticity and temperature.

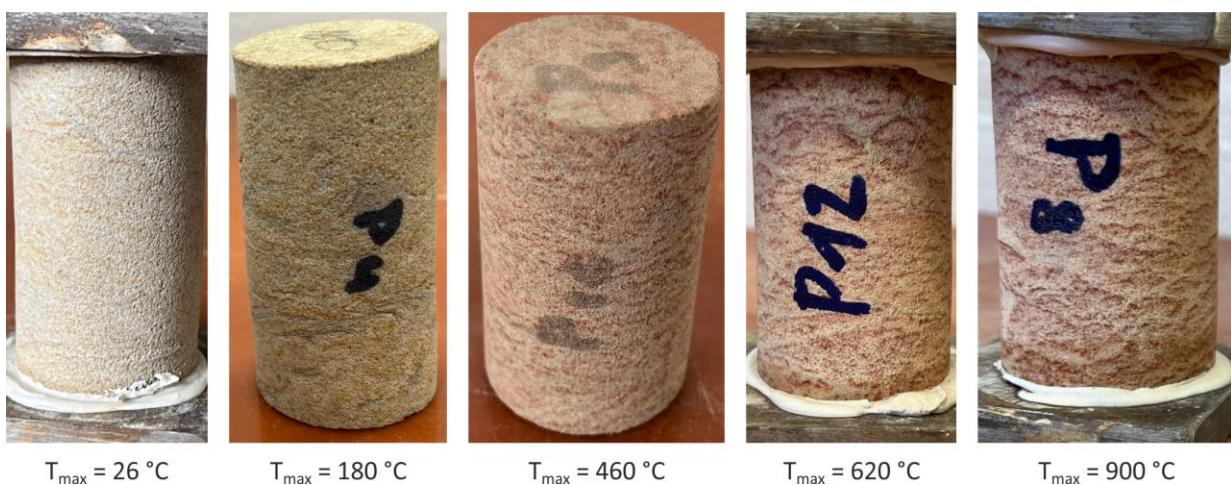
Colour change was also evident. Reference samples exhibited white to light grey and ochre layers. After heating to 460 °C, these shifted to a more vibrant orange-red. Further heating to 620 °C deepened the red hue, and samples at 900 °C showed no major additional changes, remaining dark red (Figure 12). These transformations likely result from the oxidation of iron-bearing minerals, which change colour under high temperatures.

Figure 12. Colour change of experimental samples.

Tian et al. [4] also reported visual alterations in rock colour with increasing temperature, particularly in shale, which changed from dark grey to light red and eventually to a reddish-brown hue as temperatures approached 1000 °C. This phenomenon is in line with the colour transitions observed in our Božanov sandstone samples, supporting the conclusion that iron oxidation plays a central role in the thermally induced discoloration process.
