Fatigue Resistance of C60 Steel by Thermochemical Oxidation Treatment

[Tudorache \(Nistor\) Iuliana](#)*, [Cornel Samoila](#)*, [Doru Ursutiu](#)

Posted Date: 17 April 2025

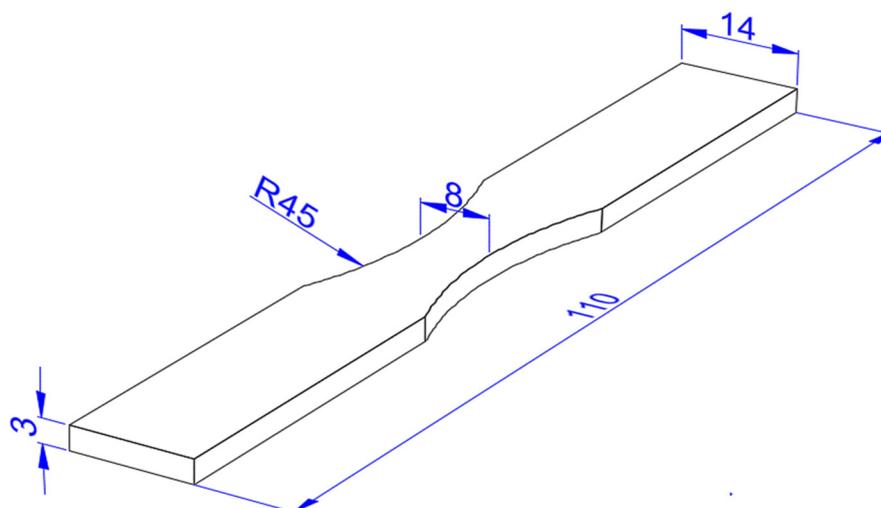
Figure 1. Shape and dimension of fatigue specimens [mm], under SR ISO 1099:2017.

The C60 material was purchased in hardened and tempered condition, with a ultimate tensile strength (UTS) of 1333 MPa, in the form of a platband with the dimensions of 110x14x3 mm (LxWxH) from Zelos Zerspanung in Bessenbach, Germany. The samples were processed according to SR ISO 1099:2017 "Fatigue testing. Axial load method" [25] (Figure 1).

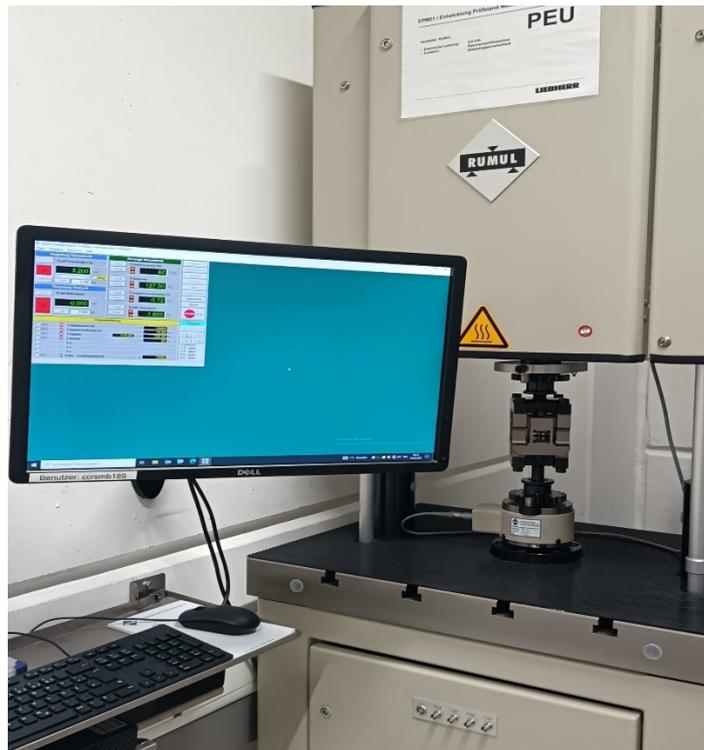
Figure 2. Fatigue-testing machine.

For fatigue testing 26 specimens were purchased for the study, of which 13 were tested as delivered and the remaining 13 were tested after thermochemical oxidation treatment. The samples were then subjected to fatigue tests at Fa. Liebherr Deggendorf, using a 100 Nm (20 kN) MIKROTRON four-point bending machine (4-Punkt-Biegevorrichtung), specifically designed for fatigue testing (Figure 2). The machine is capable of fatigue testing at a frequency up to 140 Hz. In these tests, the stress frequencies for all tests were 127 ± 10 Hz. The evaluation of tests in the present article conducted under voltage control is carried out exclusively within the domain of temporary fatigue resistance. In this case, the material has the ability to withstand repeated cyclic loading for a certain number of cycles before the appearance of a crack. This method differs from unlimited fatigue resistance, where the material can endure a very high number of cycles without suffering significant deterioration. For all tests conducted, a reduction in the testing frequency by 0.1 Hz has been established as the crack initiation criterion, while a reduction of 1.2 Hz has been set as the failure criterion, defining the critical threshold for assessing the system's behavior under stress conditions. The frequency decrease of 0.1 Hz, based on empirical experience, ensures a precise and reproducible methodology, facilitating a detailed analysis of variations in test parameters.

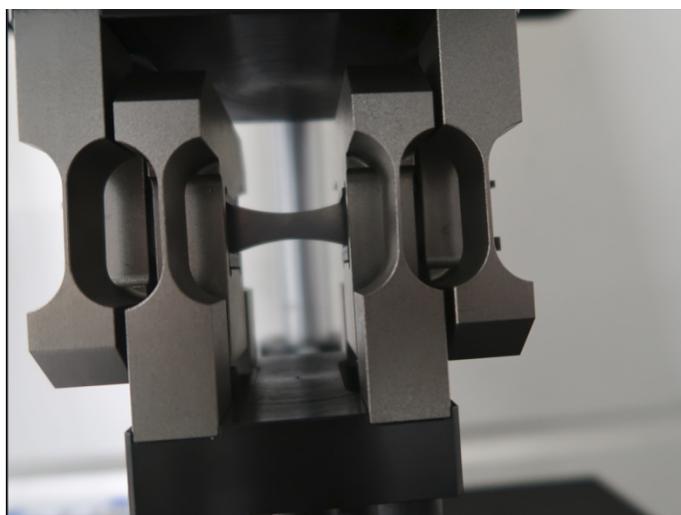
- In the four-point bending test, the sample is supported in pairs of two points. Counter nuts are used to eliminate gaps since the tests were performed in an alternating cycle.
- The gripping areas in the testing machine wedge grips are machined by milling to align the wedge grip and test sample with the direction of the loading force.
- Tightening of the testing machine wedge grip is carried out hydraulically, thus ensuring firm clamping and preventing slippage or dropping of the sample from the wedge grip when the force is reversed. Under these conditions, it can be stated that the specimen axis is correctly aligned with the direction of the loading force and that all gripping elements are properly tightened, eliminating gaps between the specimen's clamping components.

Figure 3. Sample wedge grip.

Figure 3 show the following:

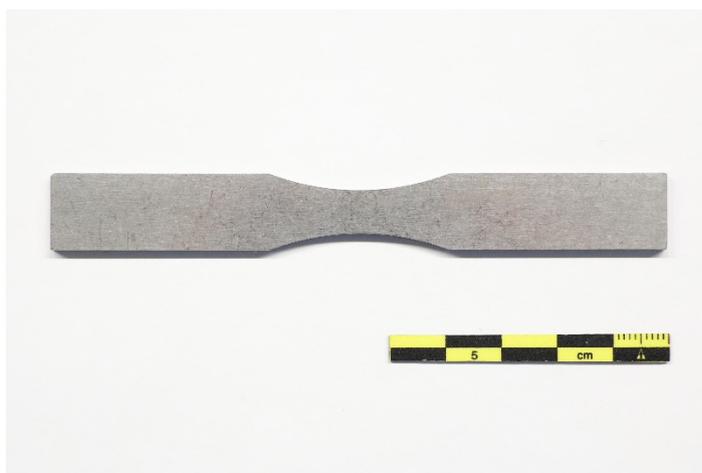
Figure 4. Sample in delivery condition.

A cross-sectional section was cut from the delivery state sample (Figure 4) using a QATM Brillant 220 machine equipped with a SiC cutting wheel at a low speed (0.05 mm/s) to avoid introducing stresses into the sample. The cut sample was then placed in the OPAL x-Press hot mounting machine from QATM. The samples underwent primary grinding to achieve a smooth surface, starting with coarse grit abrasive papers (P180) and progressing to fine grit (P1800). Finally, the samples were polished to obtain a very smooth and reflective surface using Mono diamond suspension.

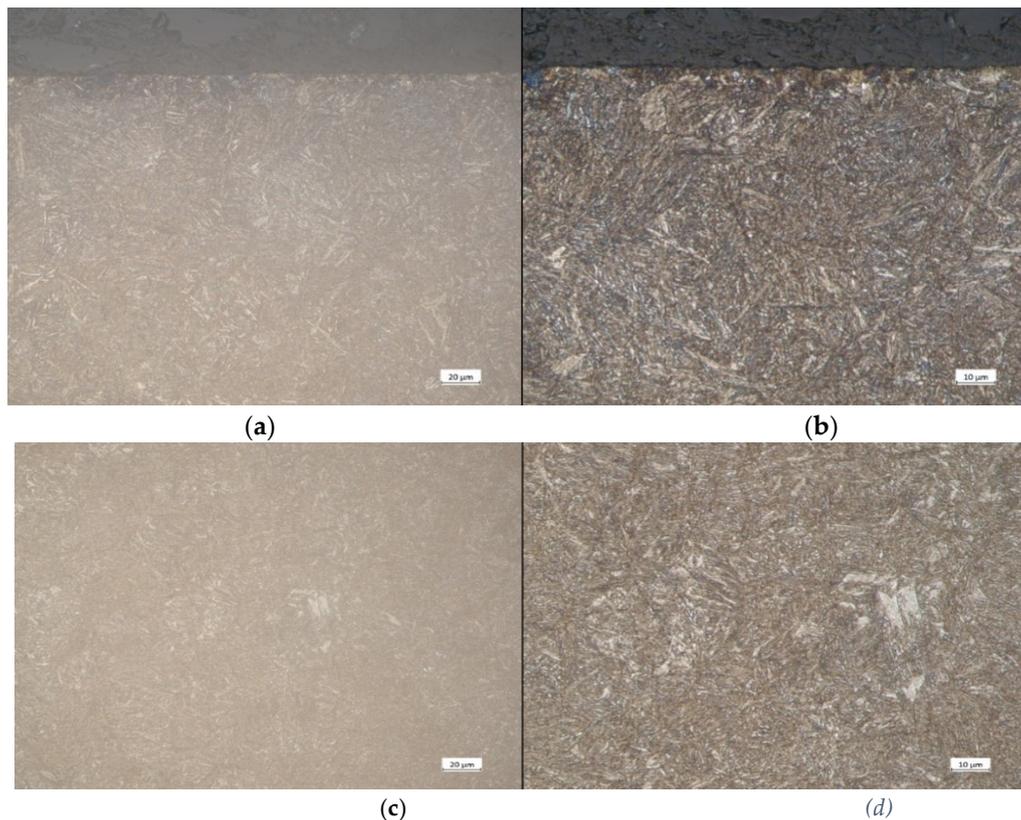
From the metallographic analysis of the material as delivered, a sorbitic structure consisting of a ferritic matrix and uniformly distributed iron carbides (cementite) is observed. No variations in the microstructure of the material were observed either at the surface of the part or in its core. Detailed metallographic analyses, performed both at the edge and in the core of the sample, showed a structure characteristic of hardened and tempered steel. Therefore, it can be concluded that the hardness of the C60 steel purchased hardened and tempered is consistent with the metallographic structure.

Figure 5. Microstructure of C60 steel as delivered – thermally treated by hardening and tempering a) microstructure at the edge of the part at a magnification of 500x - sorbite, b) microstructure at the edge of the part at a magnification of 1000x - sorbite, c) microstructure at the core of the part at a magnification of 500x and d) microstructure at the core of the part at a magnification of 1000x.

The process involved washing the sample with water, degreasing it with alcohol, drying and etching with a 3% Nital solution. Etching was stopped (when the surface became matte) by washing the sample under a water spray, spraying with ethanol and rapid drying with hot air. To verify that the thermal treatment applied was uniform over the entire section of the part, the sample was metallographically investigated both at the edge and the core. The samples thus prepared are shown in Figure 5.

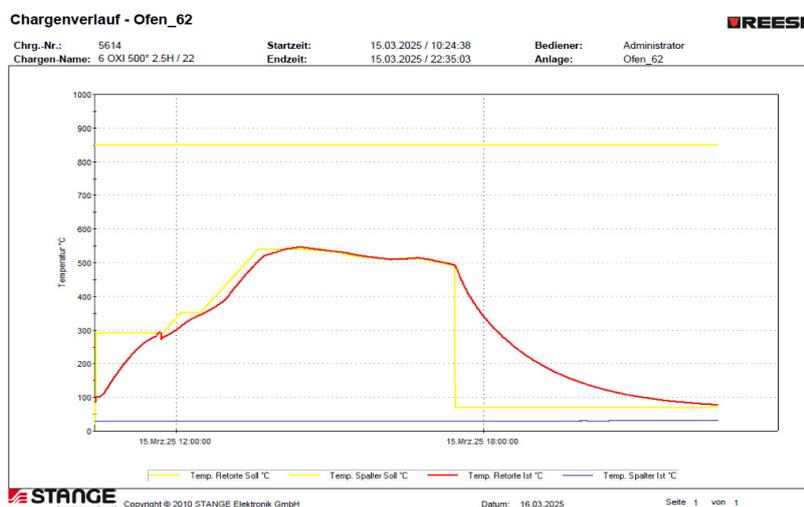
After thorough cleaning, the metal parts were placed in the furnace and arranged so that they did not overlap. The thermal oxidation of the steel was carried out at a constant temperature of 500°C for 2,5 hours in Fa. Härterei Reese Brackenheim (Figure 6). The parameters of the process are presented in table 4 und below.

Figure 6. Cyclogram of the oxidation process.

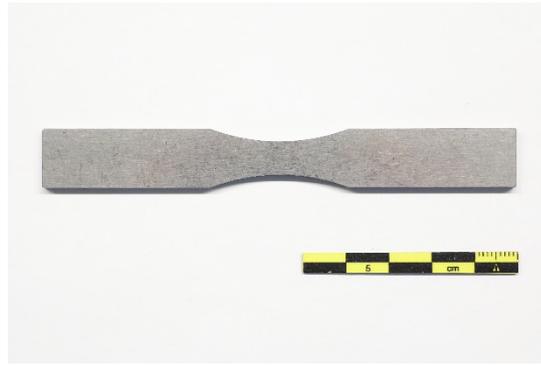
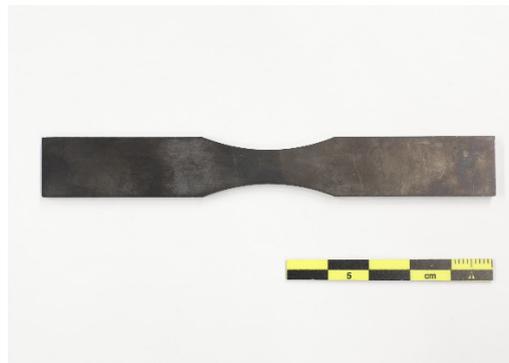
After thermochemical treatment, the samples exhibit a black tint over the entire surface, highlighting the uniformity and efficiency of the oxidation process (see Figure 7 and Figure 8)

Figure 7. Sample before oxidation.

Figure 8. Sample after oxidation.

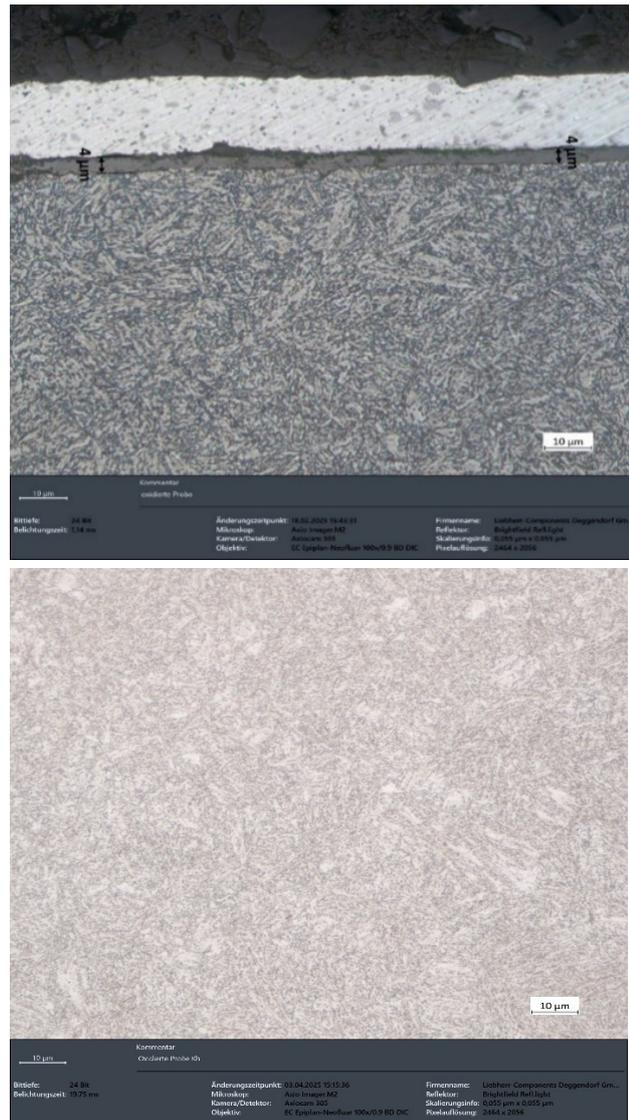
Figure 9a shows the microstructure of the sample thermochemically treated by oxidation, where the presence of an oxide layer of approximately $4\ \mu\text{m}$ on the surface of the part can be observed. In Figure 9b, in the core of the piece, due to maintaining the temperature at 500°C for about 2.5 hours followed by slow cooling, an intermediate bainitic structure can be observed [a mechanical mixture of supersaturated ferrite with carbon and carbides that have not reached the stage of cementite].

Figure 9. a) Surface microstructure of C60 steel subjected to thermochemical oxidation treatment. b) Surface microstructure of C60 steel subjected to thermochemical oxidation treatment.

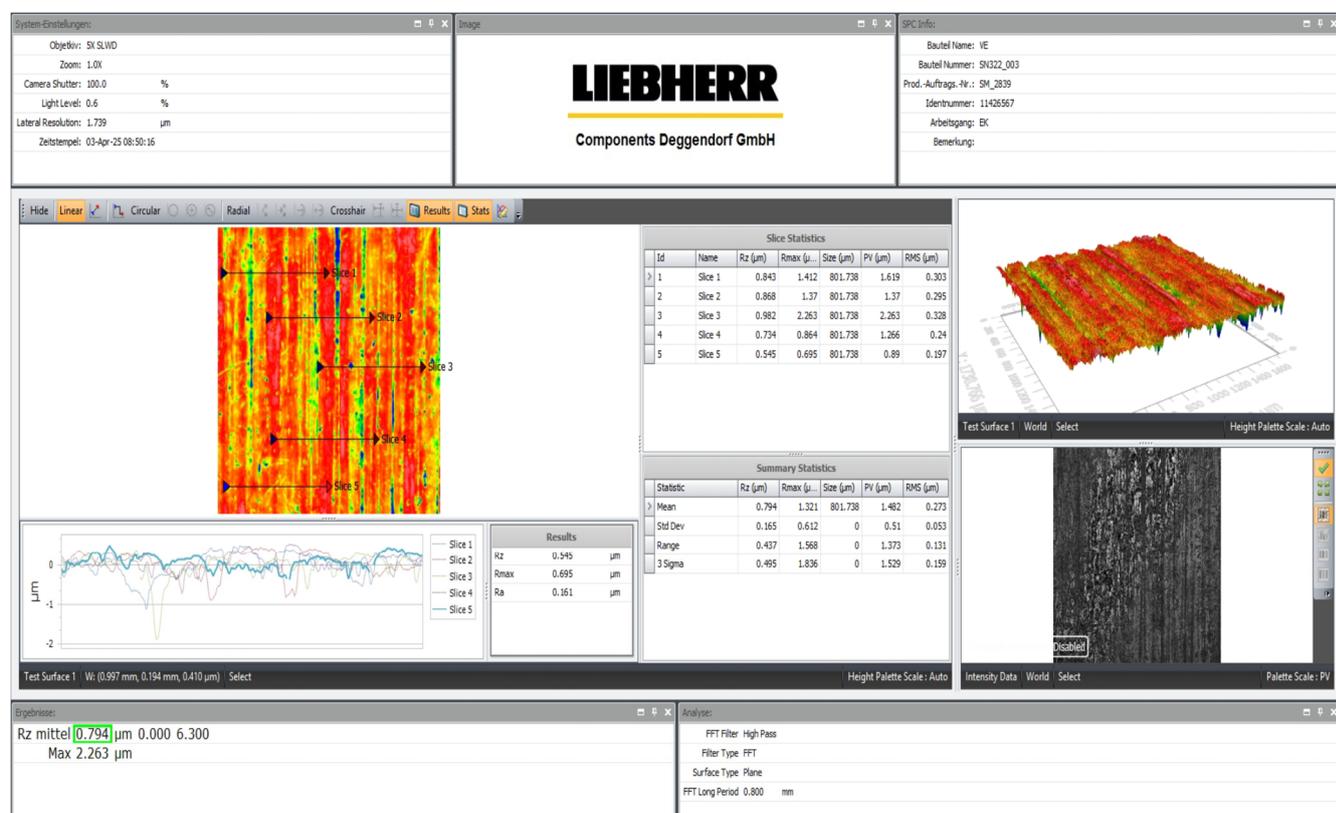
Figure 13. Surface Profilometry of improved Specimens: $R_z=0,794 \mu\text{m}$.

observed in the oxidized specimens is attributed to the formation of the oxide layer on the surface. Table 6 presents the results of roughness measurements for the improved specimens and the oxidized ones.

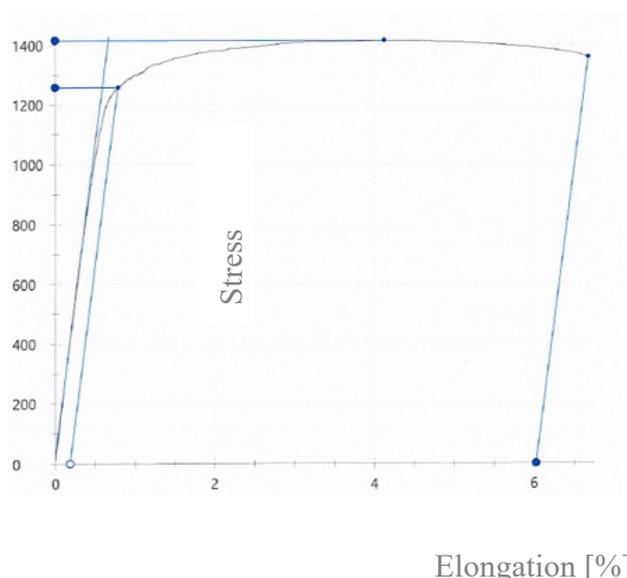
Figure 15. Load extension diagram for hardened and tempered C60 steel.

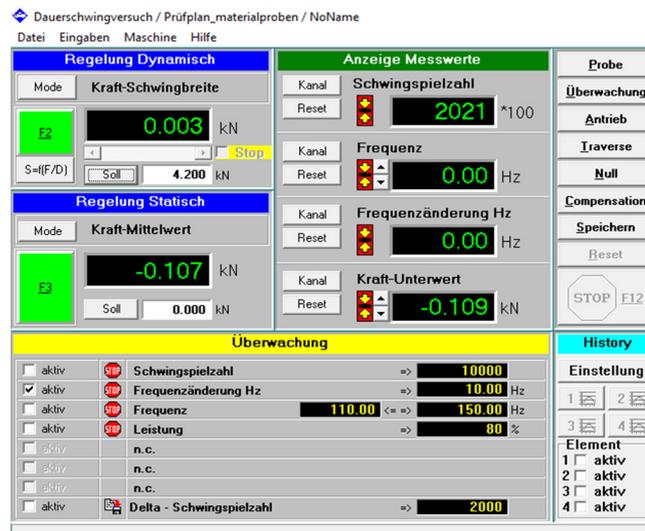
After adjusting the sample on the testing machine, the machine is set up by configuring the applied force, in this case, 4.2 kN. Figure 16

Figure 16. Setting the test machine parameters.

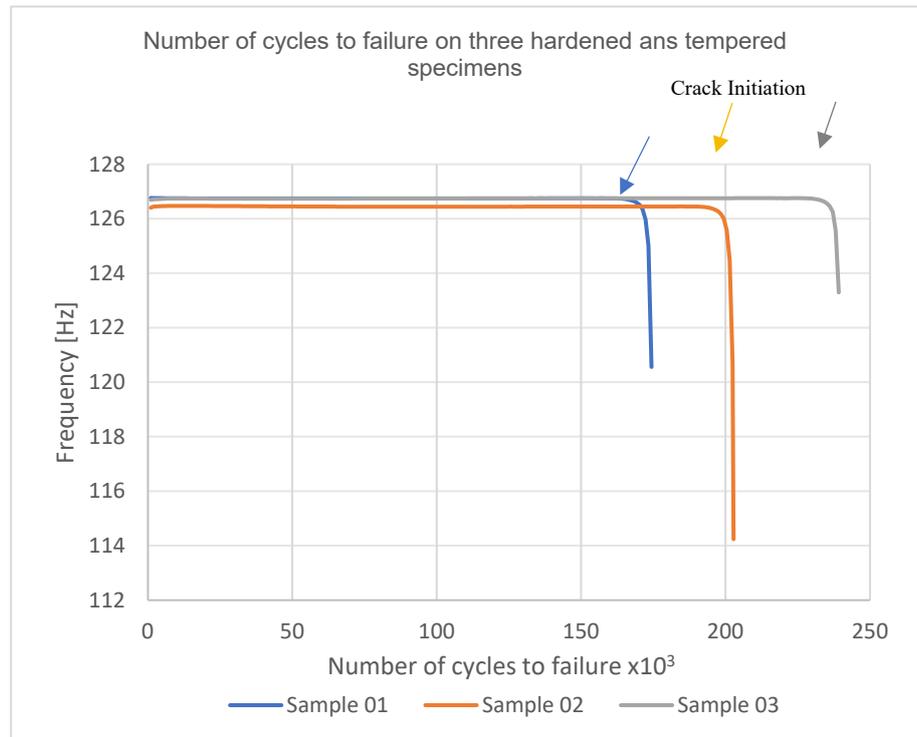
Table 9 shows the essential parameters, number of cycles to failure, and frequency changes for the three hardened and tempered reference samples. Figure 17 shows the failure diagram, highlighting the frequency variation and the maximum number of stress cycles, providing a schematic representation for a material that disintegrates.

The diagram gives a clear insight into the behaviour of the material under cyclic stresses, allowing its durability under fatigue conditions to be evaluated. The diagram shows that the

frequency remains constant up to a certain number of cycles at the beginning of the test, after which it starts to decrease. The decrease in frequency was identified at 163134 cycles for sample 01, 191177 cycles for sample 02 and 233013 cycles for sample 03

Figure 17. Failure diagram for hardened and tempered samples.

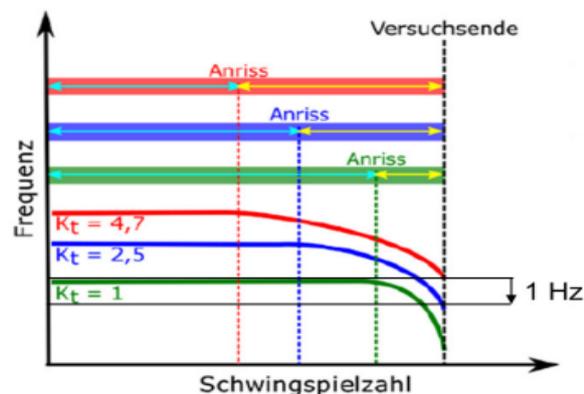
In the paper "Influence of Edge Processing of Aluminum Sheets on the Residual Formability and Strength Properties under Quasi-static and Oscillating Loads - Research Center Chair of Forming Technology and Foundry, Technical University of Munich," the evolution of the test frequency as a function of the number of cycles is schematically presented Figure 18 (Dittmann and Pätzold, 2018).

Figure 18. Schematic representation of the evolution of the test frequency as a function of the number of cycles (Dittmann and Pätzold, 2018).

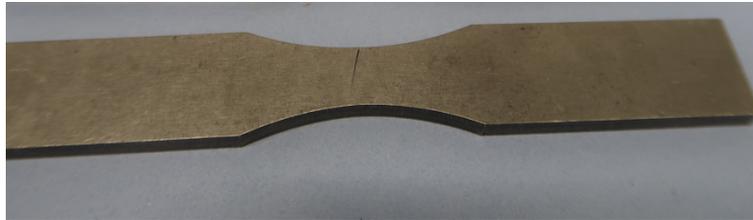
Figure 19 shows the hardened and tempered specimen tested to failure. It shows a visible crack without requiring CT inspection and the figure 20 a illustrates the frontal view of the specimen following a fatigue load of 202800 cycles and Figure 20 b illustrates upper surface of the specimen. The fatigue crack was initiated in the upper region of the radius, the sample display individual

Figure 19. Hardened and tempered sample after fatigue test.

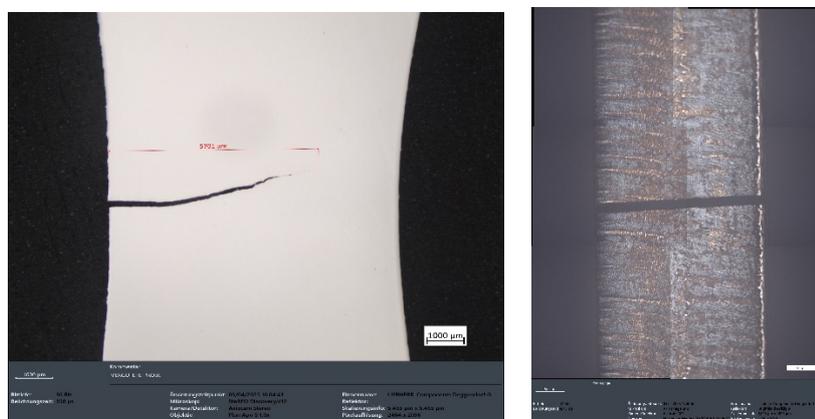
notches along the cut edges at regular intervals, which are clearly noticeable, originating from a machining defect. Its progression is notable for its linear trajectory, with minimal branching or deviation observed. The crack length on the frontal surface of the specimen, measured from its edge, is documented as 5701 μm , corresponding to approximately one-third of the specimen's total width.

Figure 20. a) The fatigue crack on the front side of specimen 02 after 202800 cycles [the crack length 5701 μm] und b) upper surface of the specimen.

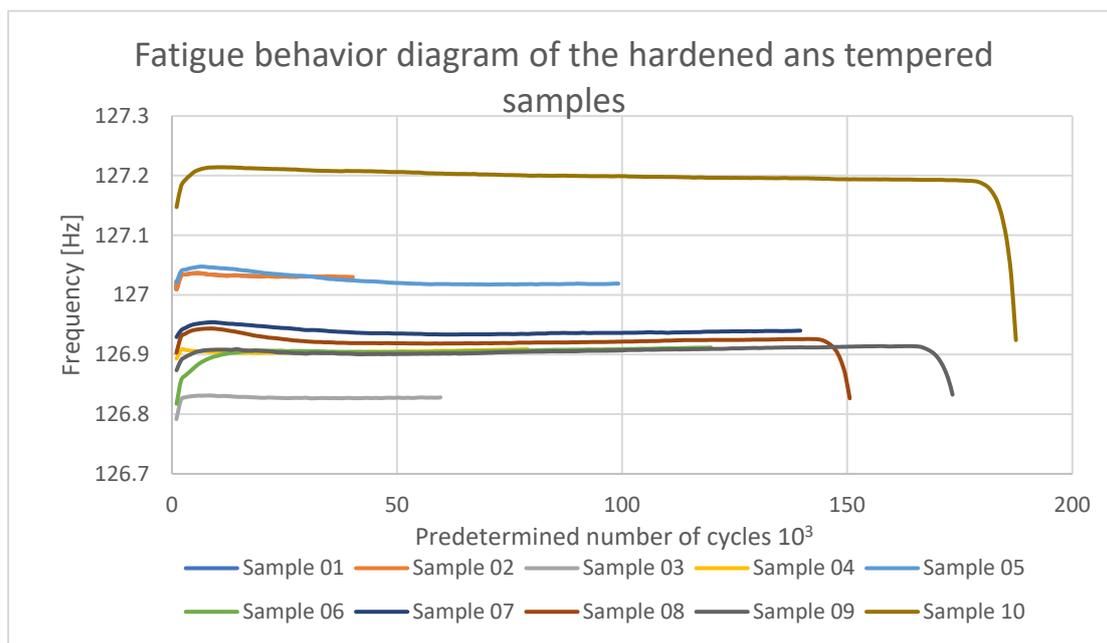
Table 10 shows the number of cycles set for each of the 10 additional specimens and the frequency changes that occurred during the experiment, and Figure 21 shows a graph superimposing the 10 fatigue behaviour curves of the hardened and tempered specimens subjected to a predetermined number of stress cycles. This graph illustrates the variability in the fatigue behaviour of the specimens and provides essential information for understanding how the material responds to cyclic stresses. During testing, it was observed that the frequency remained constant for specimens 1 through 7, exhibiting uniform behaviour with minimal variation between them. However, a decrease in frequency with 0,14 Hz was observed for samples 8, 9 and 10, indicating a significant behaviour change.

Figure 21. Fatigue behaviour diagram for the 10 hardened and tempered samples subjected to fatigue with a predetermined number of cycles.

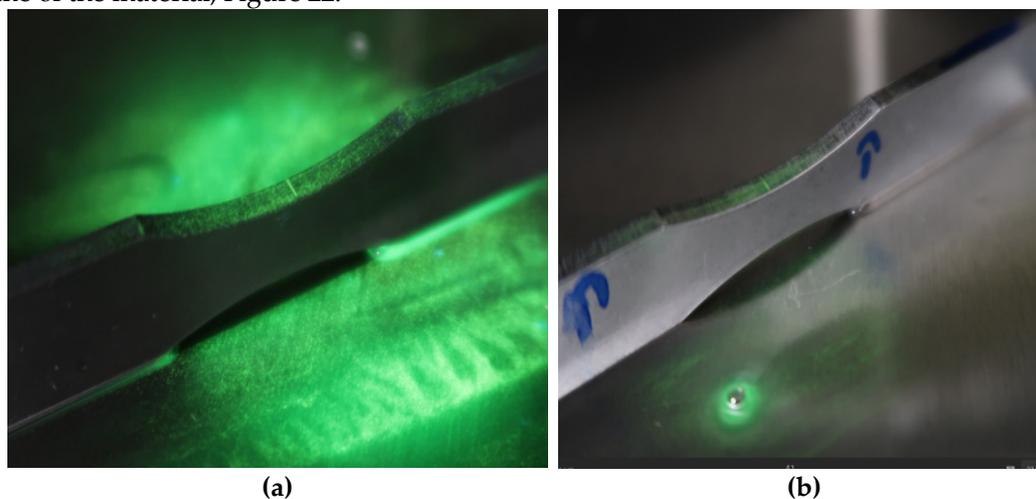
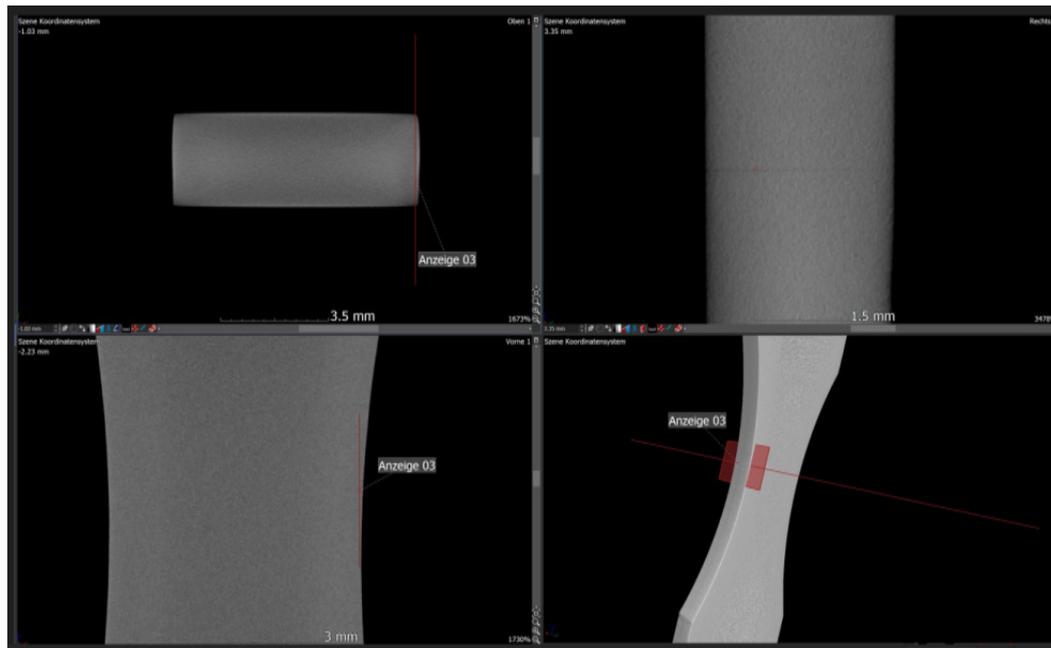
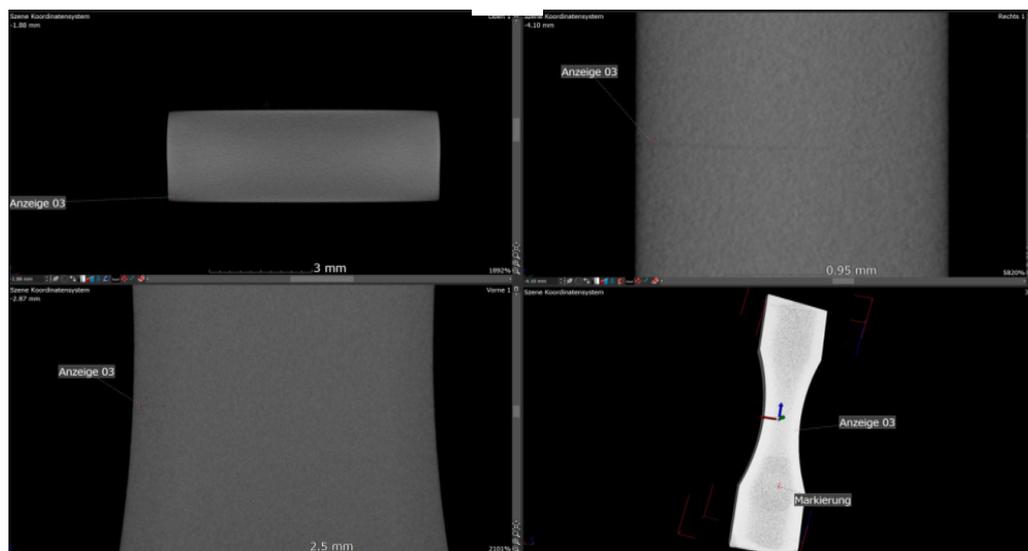
Samples 8 in which a decrease in frequency was observed were tested with liquid penetrant and tomographic inspection. The liquid penetrant analysis showed the presence of a microcrack on one of the sides. On the other hand, computed tomography (CT) allowed detailed detection of the internal microcracks, providing additional information about their size and exact localization in the entire volume of the material, Figure 22.

Figure 22. Non-destructive analysis applied to hardened and tempered C60 steel, after fatigue testing: a) and b) liquid penetrant inspection and c) and d) tomographic inspection.

From Figure 22, it can be observed that the sample initially presents a crack in the radius area, which subsequently extends to the frontal surface. This evolution of the crack highlights the critical points of the material and confirms the hypothesis that, with the decrease in frequency, a microcrack appears in the material.

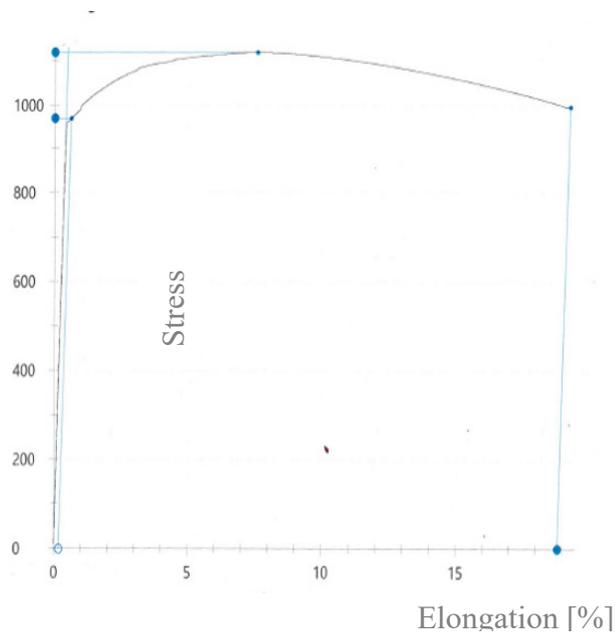
It can be observed that thermochemical oxidation treatment has a noticeable impact on the mechanical properties. The mechanical strength of the oxidized samples has significantly decreased compared to the improved delivery condition

**Figure 23.** Load extension diagram for oxidized C60 steel.

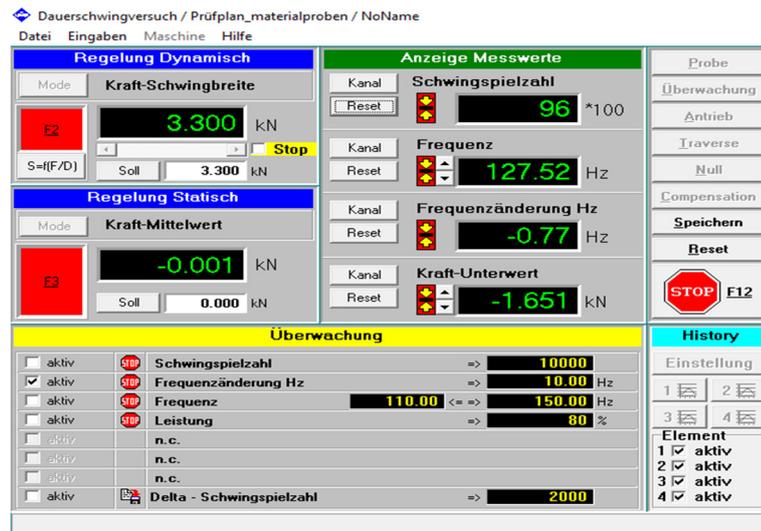
Therefore, the maximum allowable stress parameters introduced in the specimen and the force calculation applied to the samples were appropriately adjusted to reflect these changes. Thus, the force applied in this case was 3.3 kN. (Figure 24)

Figure 24. Setting the test machine parameters.

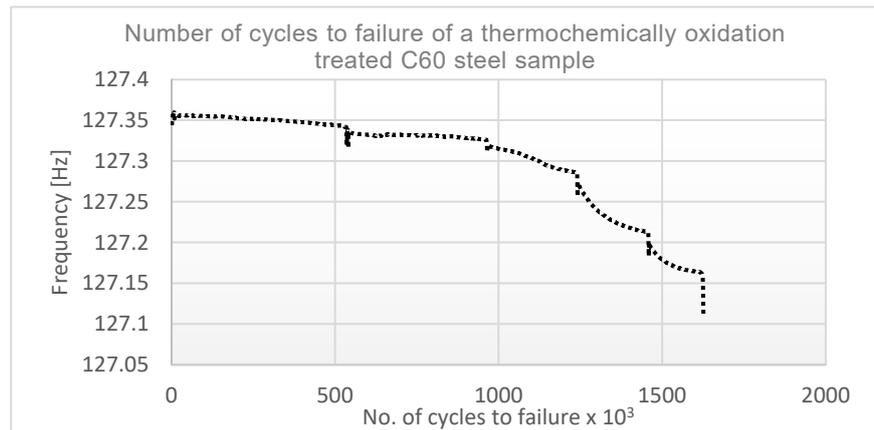
Figure 25 shows the failure diagram with the frequency variation and the maximum number of stress cycles. It can be observed that the frequency remains constant up to 540207 cycles, indicating that the material does not show significant damage, after which a slow decrease in frequency begins, signalling the appearance of the first microcracks in the material. These microcracks begin to affect the stiffness of the material. After 965144 cycles, the frequency continues to decrease, indicating a sharp and imminent deterioration of the material. At this stage, the microcracks have expanded significantly and have considerably affected the material structure. Eventually, the material completely failed at a total of 1630529 cycles, and the final frequency recorded a significantly low value.

Figure 25. Failure diagram for thermochemically oxidation-treated sample.

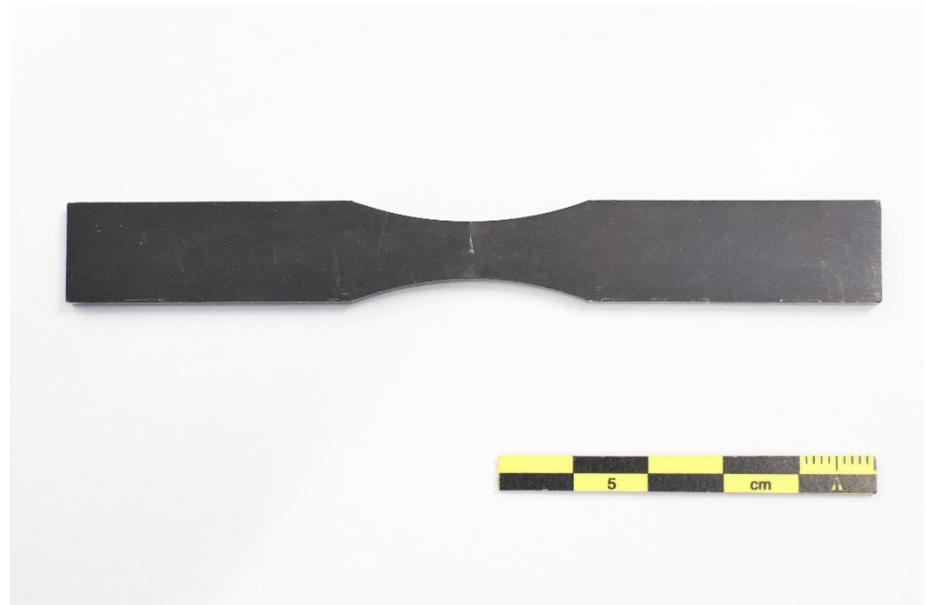
Figure 26 shows the oxidized sample tested to failure. Like the hardened and tempered sample, it shows a visible crack without requiring CT inspection the figure 27a illustrates the frontal view of the specimen following a fatigue load of 1630529 cycles and Figure 27 b illustrates upper surface of the specimen.

Figure 26. Oxidized sample after breaking test.

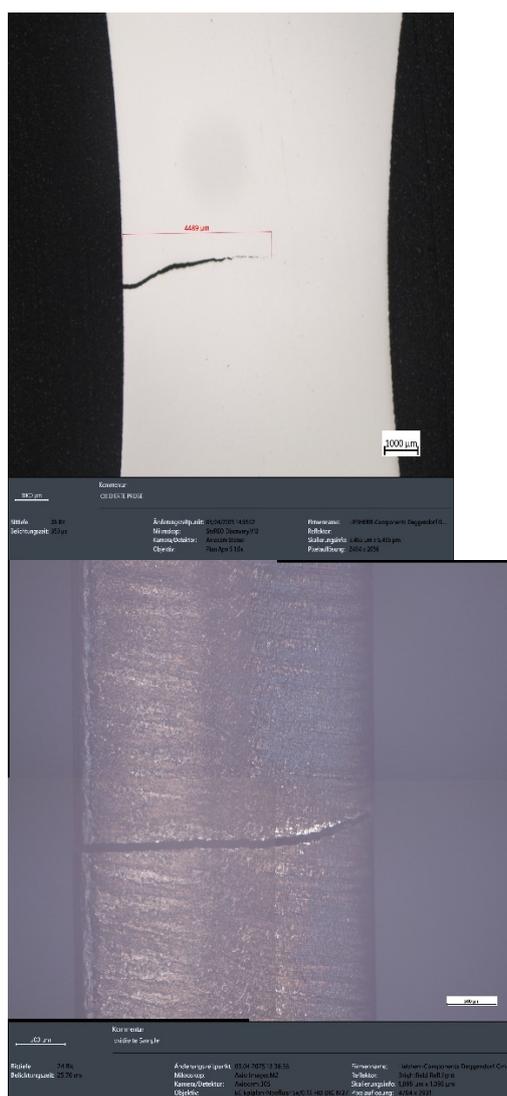
The fatigue crack was initiated in the upper region of the radius, originating from a machining defect. Its progression is notable for its linear trajectory, with minimal branching or deviation observed. The crack length on the frontal surface of the specimen, measured from its edge, is documented as 4489 μm , corresponding to approximately one-third of the specimen's total width

Figure 27. a) The fatigue crack on the front side of specimen 01 after 1630529 cycles und b) upper surface of the specimen: the crack length 4489 μm.

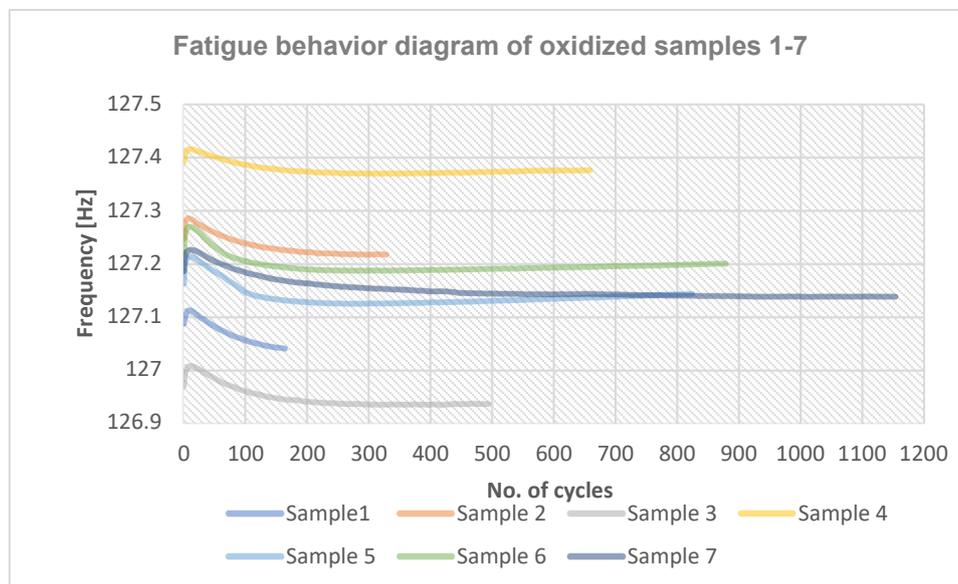
No frequency change was observed during the testing for samples 1 through 7. This indicates that the material exhibited no microcracking, thus demonstrating uniform strength and stable structural integrity under cyclic stresses.

Figure 28. Fatigue behaviour diagram of specimens 1-7 thermochemically treated by oxidation and subjected to fatigue with a predetermined number of cycles.

Table 13 shows the number of cycles set for each specimen of the 10 additional specimens and the frequency changes that occurred during the experiment, Figure 28 shows a diagram of the superposition of the 7 curves for the fatigue behaviour of the specimens thermochemically treated by oxidation and which showed no frequency changes, and Figure 29 shows samples 8, 9 and 10 for which a considerable decrease in frequency with 0,6 Hz was observed.

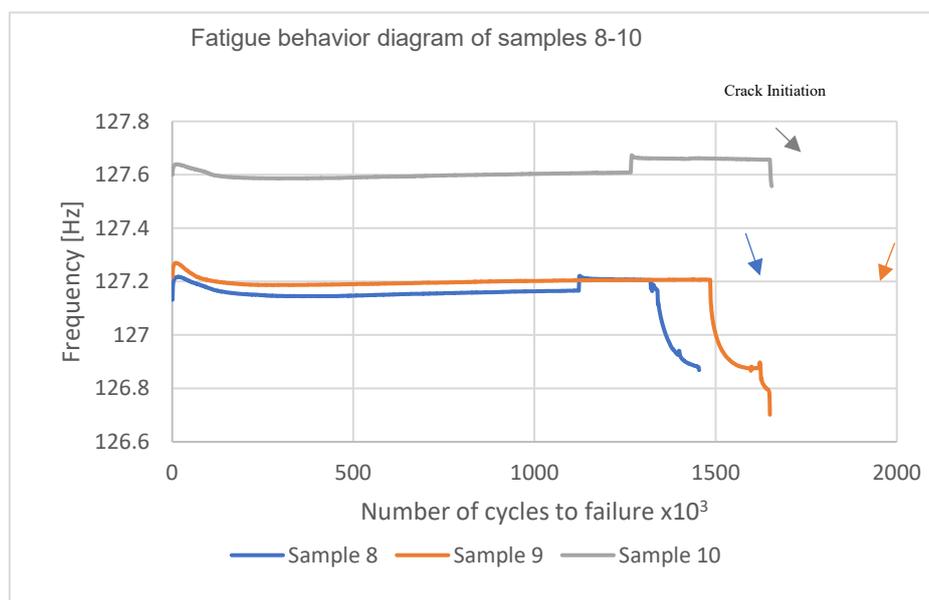
Figure 29. Fatigue behaviour diagram of specimens 8-10 thermochemically treated by oxidation and subjected to fatigue with a predetermined number of cycles.

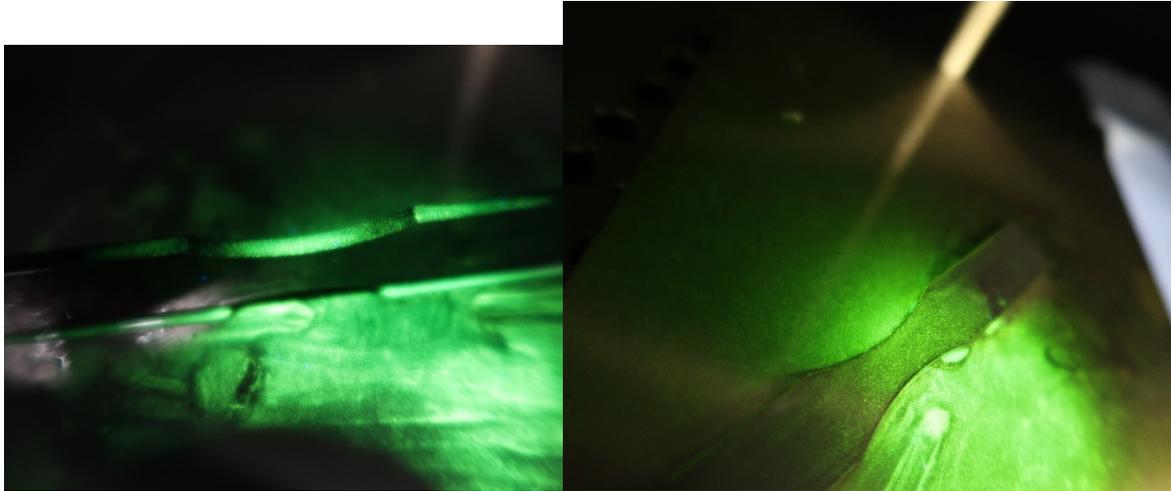
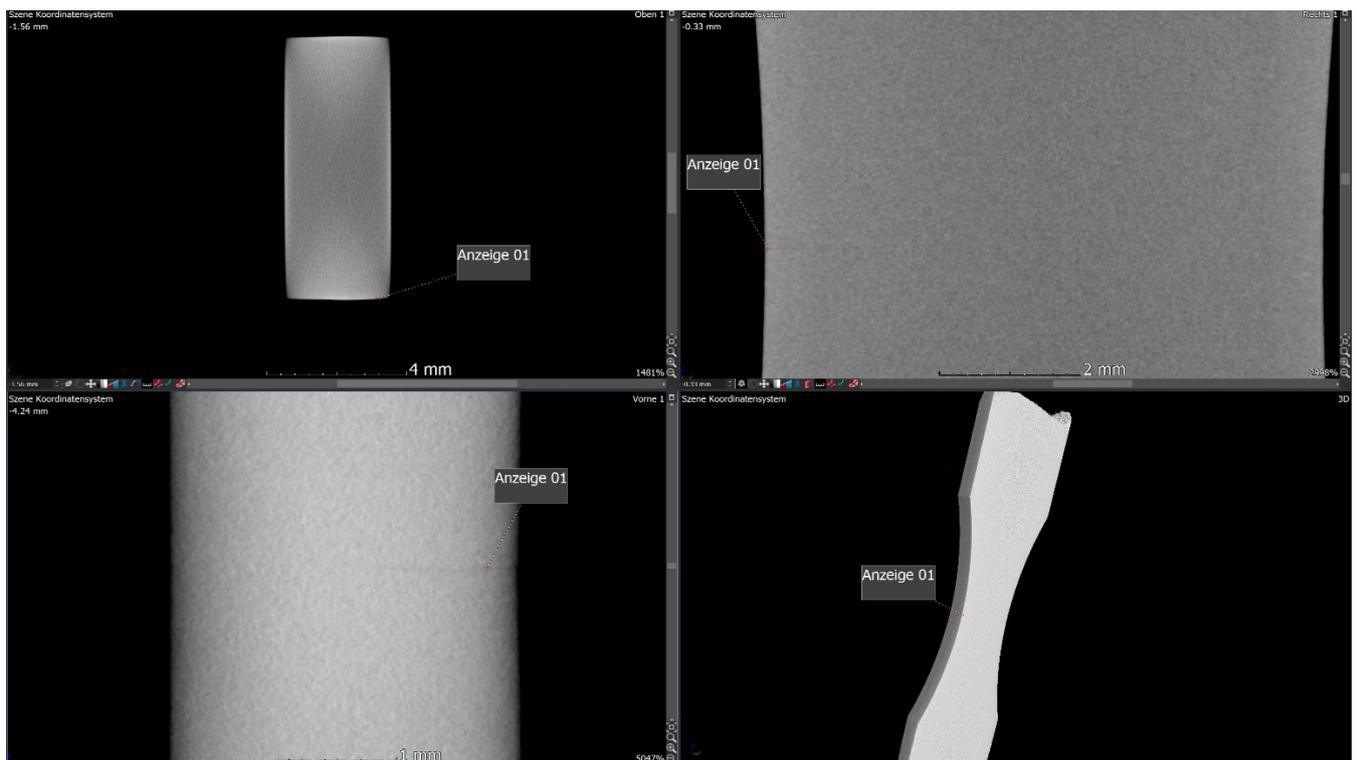
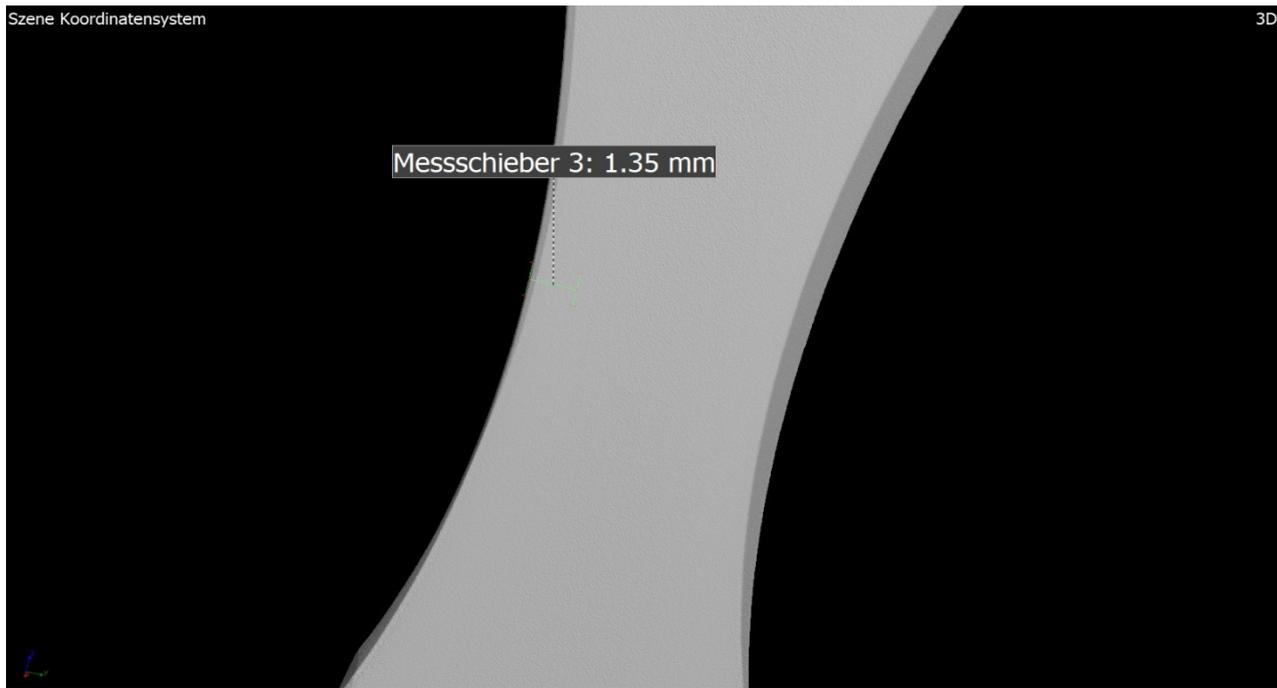
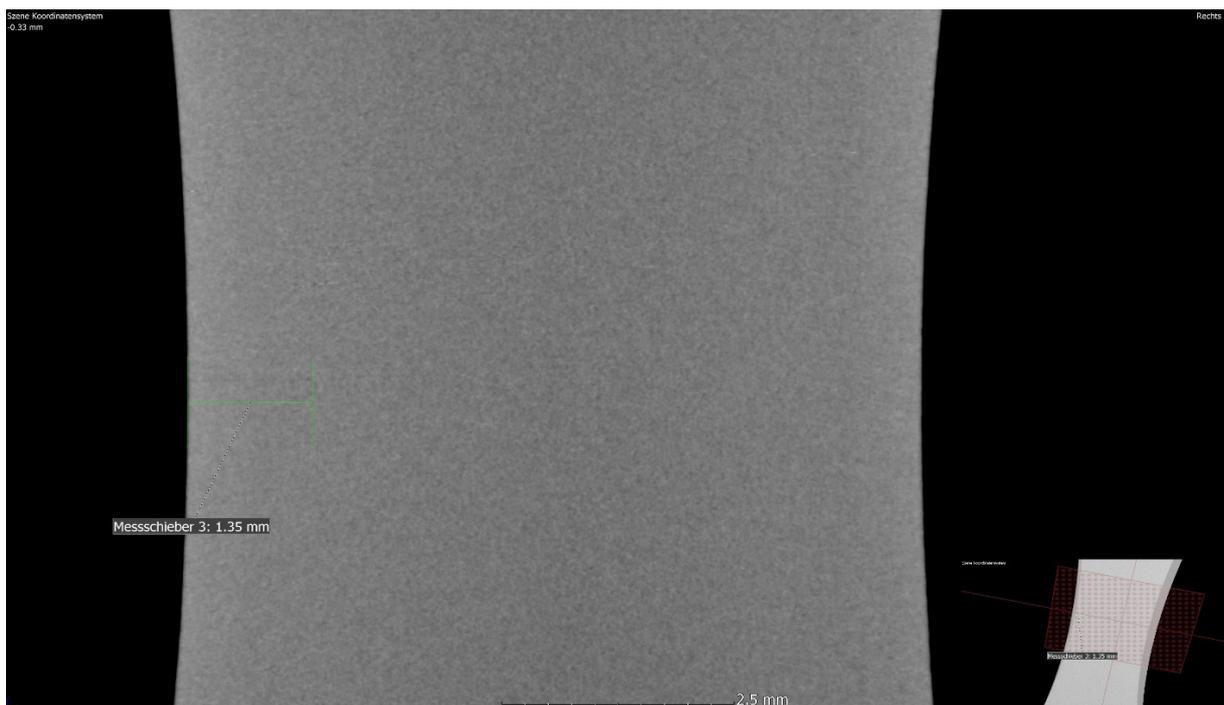
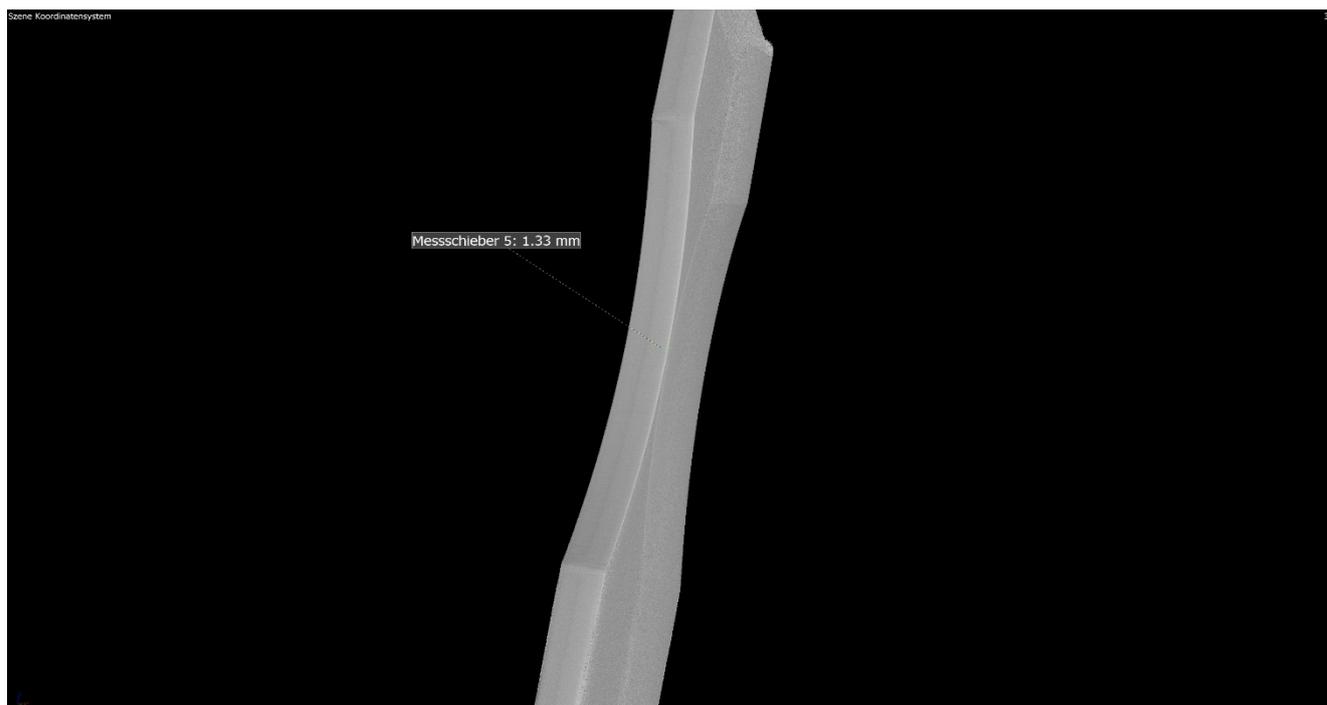
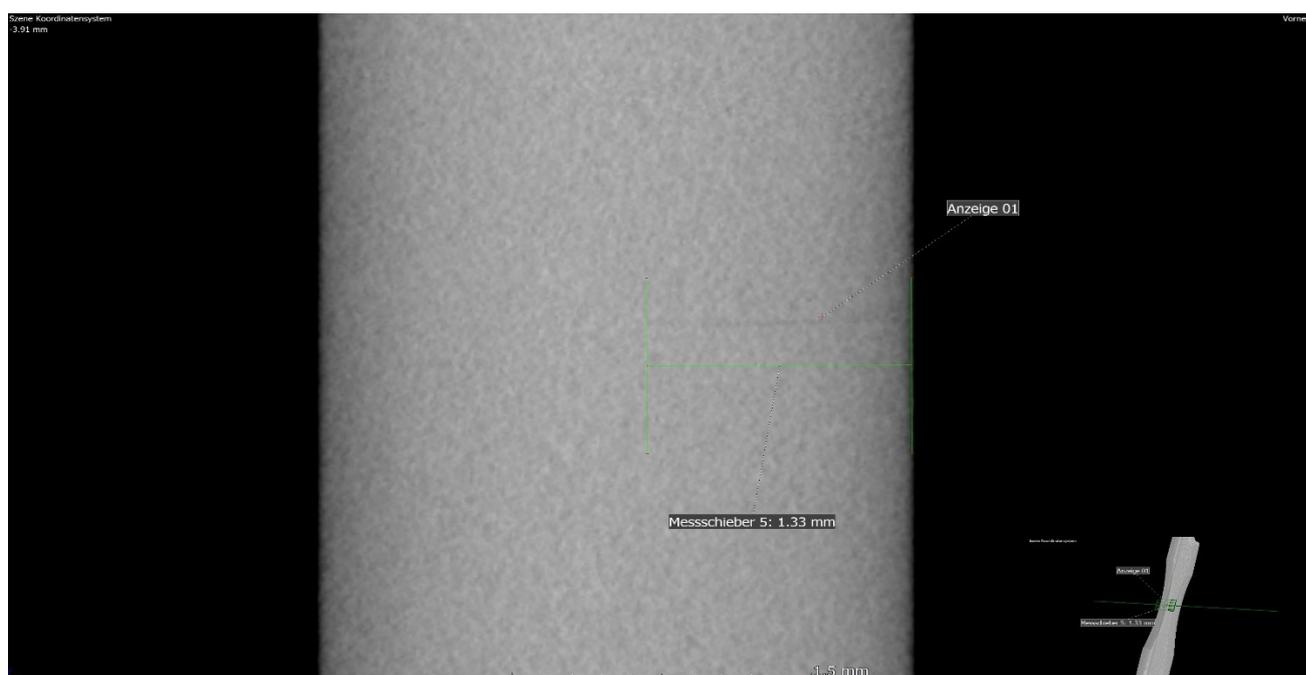
Samples 8 in which a decrease in frequency was observed were tested with liquid penetrant and tomographic inspection. The liquid penetrant analysis showed the presence of a microcrack on one of the sides. On the other hand, computed tomography (CT) allowed detailed detection of the internal microcracks, providing additional information about their size and exact localization in the entire volume of the material, Figure 30

Figure 30. Non-destructive analysis applied to oxidized Sample after fatigue testing: a) and b) liquid penetrant inspection and c) Overview of CT Examination d) Detail Volume Image-frontal surface of sample e) microcrack measurement in the frontal surface area, f) Detail Volume Image- radius area g) microcrack measurement in radius area.

The sample initially presents a crack in the radius area, which subsequently extends to the frontal surface. The crack size in the radius area is 1.33 mm, while on the frontal surface the crack measures 1.35 mm. This evolution of the crack indicates a propagation of the defect from the radius area to the frontal surface, thus highlighting the critical points of the material.
