Keywords: wood foundation; wood pillar; building failure; swampland

Early Signs of Swamp Building Collapse: Failure of Wood Pillar Foundation

Abstract: The construction of a house with a stage structure is the uniqueness of Banjarmasin's swampland. Particularly, foundations for swampy terrain necessitate special handling. Building material defects and the basic inability to modify the use and design of wood pillar foundations are the main causes of house building problems. The very limited capacity of a wooden pillar foundation makes house buildings collapse frequently. The aim of the study is to determine the weaknesses of the wooden pillar foundations by examining the indications of damage to the house structure. Field observation investigations, including housing and individual object observations, will be carried out at multiple construction sites in Banjarmasin (Indonesia) as part of this study. The way the data is presented is descriptive. A wooden pillar foundation, which is a frequently used foundation, has a limited load bearing capacity. Because that, there has been no related research that addresses the issue of how this foundation damage. The aim of the study is to de

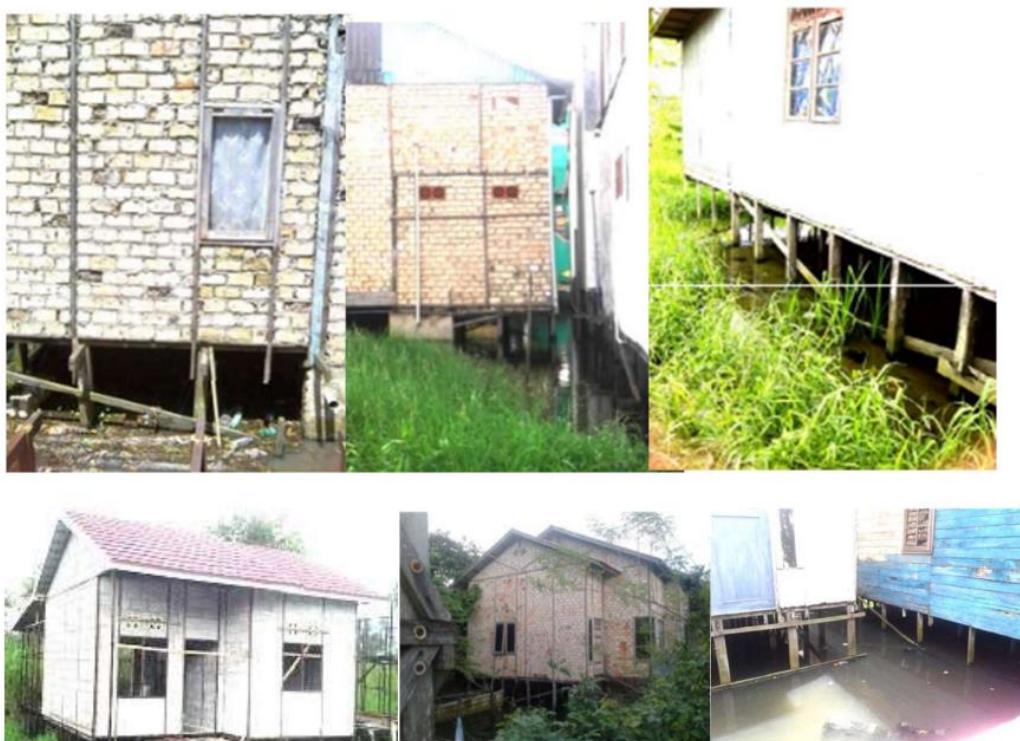
The problem of the wooden pillar houses is not free from the conditions of the wood pillar and the condition of the wet soil. The development of the semi-permanent building type (Figure 1) with the construction of bricks standing as the intercolumn filling of the wall pillars. Treated as permanent building finishing, diplester and acian, then painted. Then the wooden floor material is mounted on ceramic.

Figure 1. Wooden Pillar Home Development Issues.

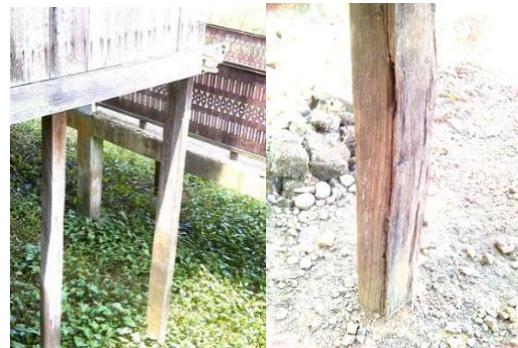
The source of the problem of building houses mostly comes from the wooden pillars. The strength of a wooden pillar is equivalent to the quality of the wood, so the damage to the material also affects the condition of the construction. The damage to the pillar may be due to the inability to carry the load on it, and it is also often due to soil and weather conditions (Figure 2).

Figure 2. Damage to Wooden Pillars.

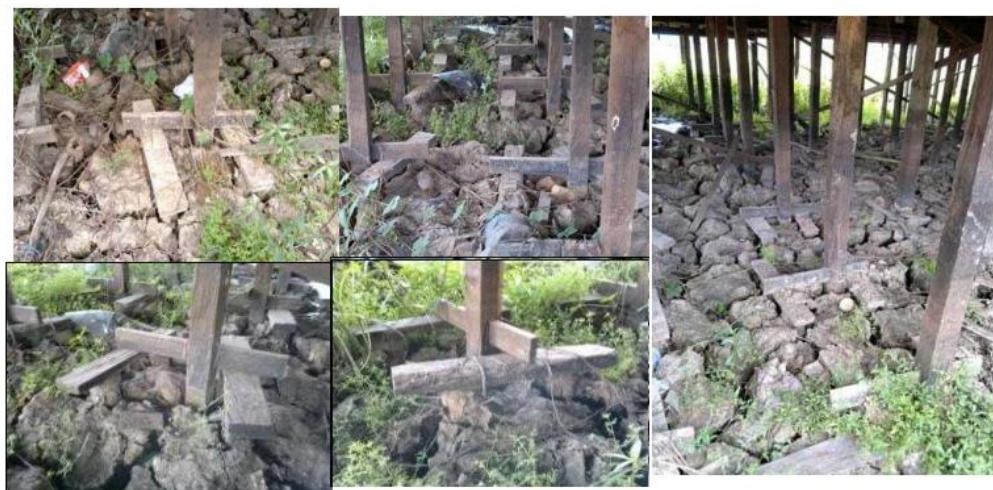
The wooden pillar is connected to the foundation part as an integrated part of a single unit. For the Banjarmasin area, use the support beam ('kalang') and the horizontal beam ('sunduk') seen in the Figures 3 and 4. After the hook, there's a hook element that's used to withstand the loads. In this element, there is usually a variation in the foundation and the presence of various other types of foundation.

Figure 3. 'Sunduk' Arrangement.

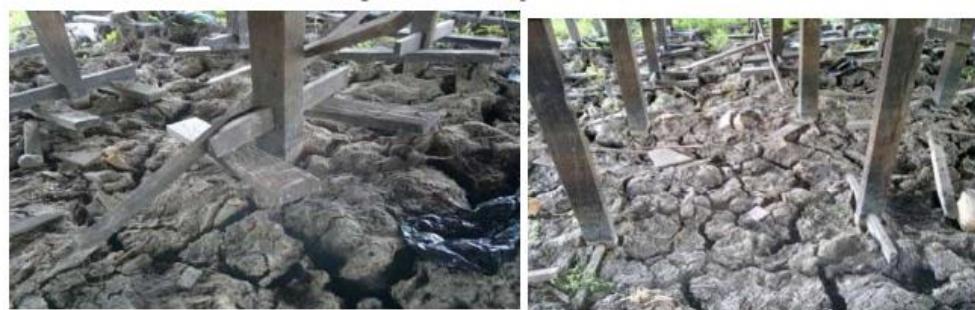
Figure 4. 'Sunduk' Condition.

Broken 'sunduk' from the picture, you can see the condition of the bottom of this wooden pillar. It appears that the mounting of the cuffs and braces when under the surface of the water becomes unclean by adjusting the position of the scissors. There is a field finding that there is a state of wood damage with the presence of a broken crown (Figure 5). This could be the cause of the falling floor in the house anyway. Because of the quality conditions of the cane, often the remaining pieces of wood,

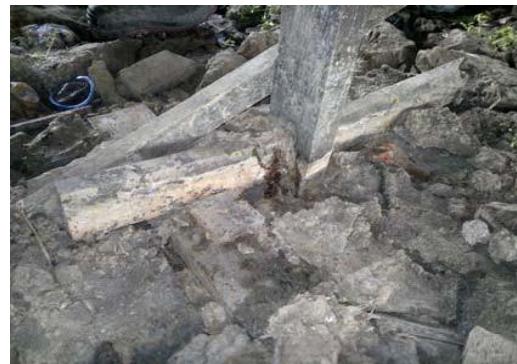
small and have a wooden eye, resulting in a broken cane. However, because the position of these building elements is below the surface of the water, this often leads to invisibility. Photo taken from the field survey with the conditions of the dry land area, so it can be clearly seen this situation.

Figure 5. Broken 'Sunduk'.

Improving 'sunduk' in wood foundations involves using durable materials, reinforcing the base, enhancing structural connections, and considering hybrid designs. By integrating modern construction techniques with traditional methods, it can create a stronger, more durable 'sunduk' that is resilient to moisture and environmental challenges. Regular maintenance and inspection are also essential to ensuring the structure's longevity. It is recommended to find a hybrid wood design with concrete material to improve wood foundation stability.

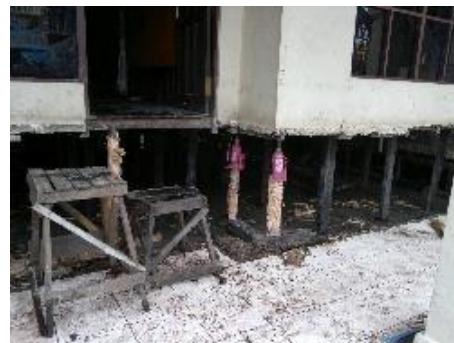
Other field finds include the activity of replacing wooden pillars with a way of crushing houses (Figure 6). It's done because the floor position of the house needs to be raised.

Figure 6. Scratching House Pillars.

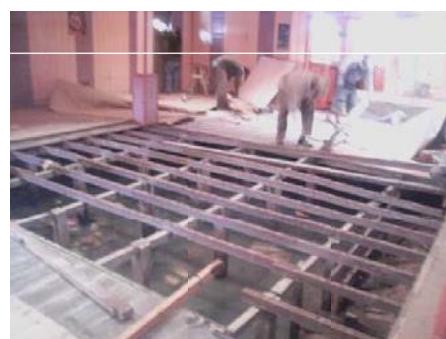
Damage to the wooden pillar element can cause falling and bending of the floor (Figure 7). The construction of the floor is visible with a 50cm floor beam, and continues to be lifted by rows of wooden columns. The characteristic of the fall of the foundation and the bending of the floor of the building is the presence of the ceramic floor covering that is broken and raised like in the Figure 8.

Figure 7. Falling And Folding Floor.

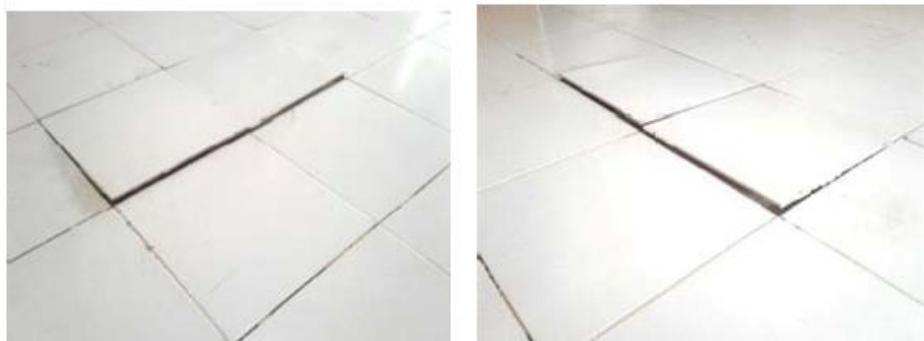
Figure 8. Ceramic Fractured on Floor.

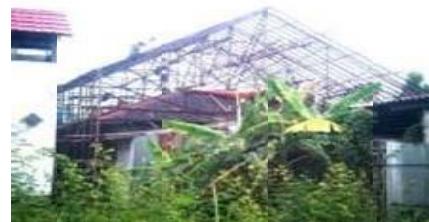
The most common thing about building houses with wooden frame structures is the repair or renovation of houses vertically (Figure 10). By demolishing the roof of the building and making it into a flat-scale house, the building burden increases. Even with the consideration of replacing the top material of the building with an even lighter material, this will increase the burden on the foundation.

Figure 10. Vertical Renovation.

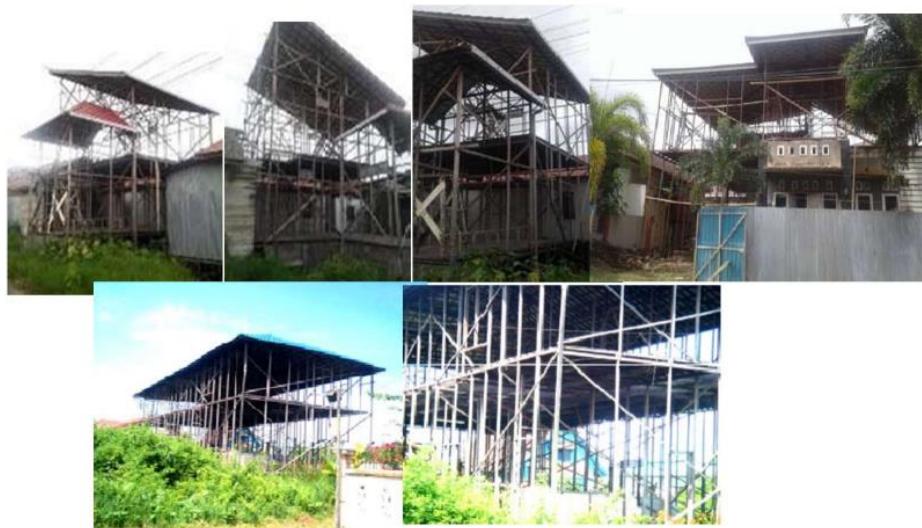
Besides, make the building of a house directly 2 (two) floors (Figure 11) and frequently done. But the foundations of the buildings used seemed to remain the same as the foundation conditions of the one-story buildings. Because the construction system and the material remained a row of wooden pillars on the bottom and a wooden frame on the building. Both of these cases actually require reinforcement of a wooden pillar to accept the added building burden.

Figure 11. 2 Story Wood House Building.

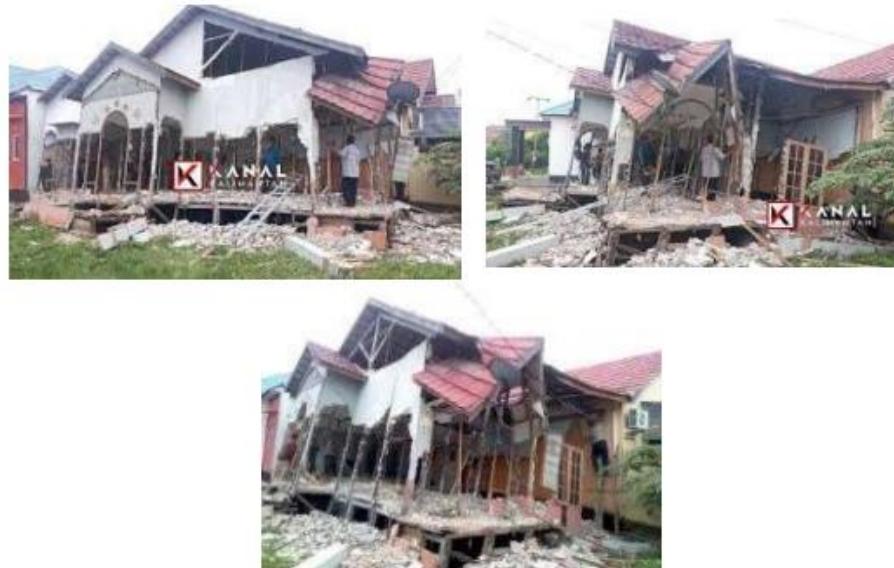
With more severe damage to the wooden pillars, there could have been some cases of house buildings that were not only bent but even collapsed (Figures 12 and 13). It is often said that this occurred because of the failure of the foundation of the house to follow its pillars. Errors in the selection of foundations, the lack of strength of the foundations and poles to carry the heavy building burden, or the depression and inexperience of the construction workers are often accused of being the cause. The wooden pillar is still involved.

Figure 12. Tilted House Building.

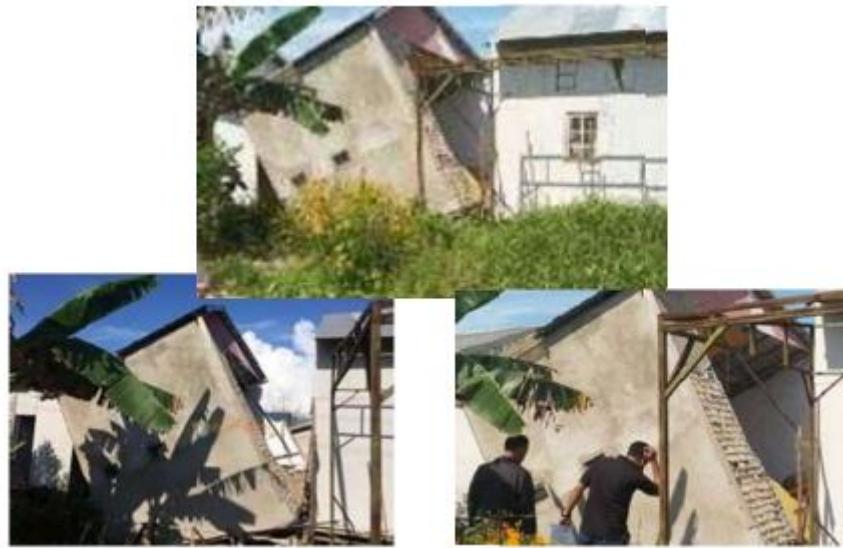
Figure 13. House Building's collapsed.
