# Structural Safety Assessment of an Existing Steel Bridge After 55 Years of Service

Mateusz Rajchel and Tomasz Siwowski \*

Rzeszow University of Technology, Al. Powstancow Warszawy 12, Rzeszow, Poland

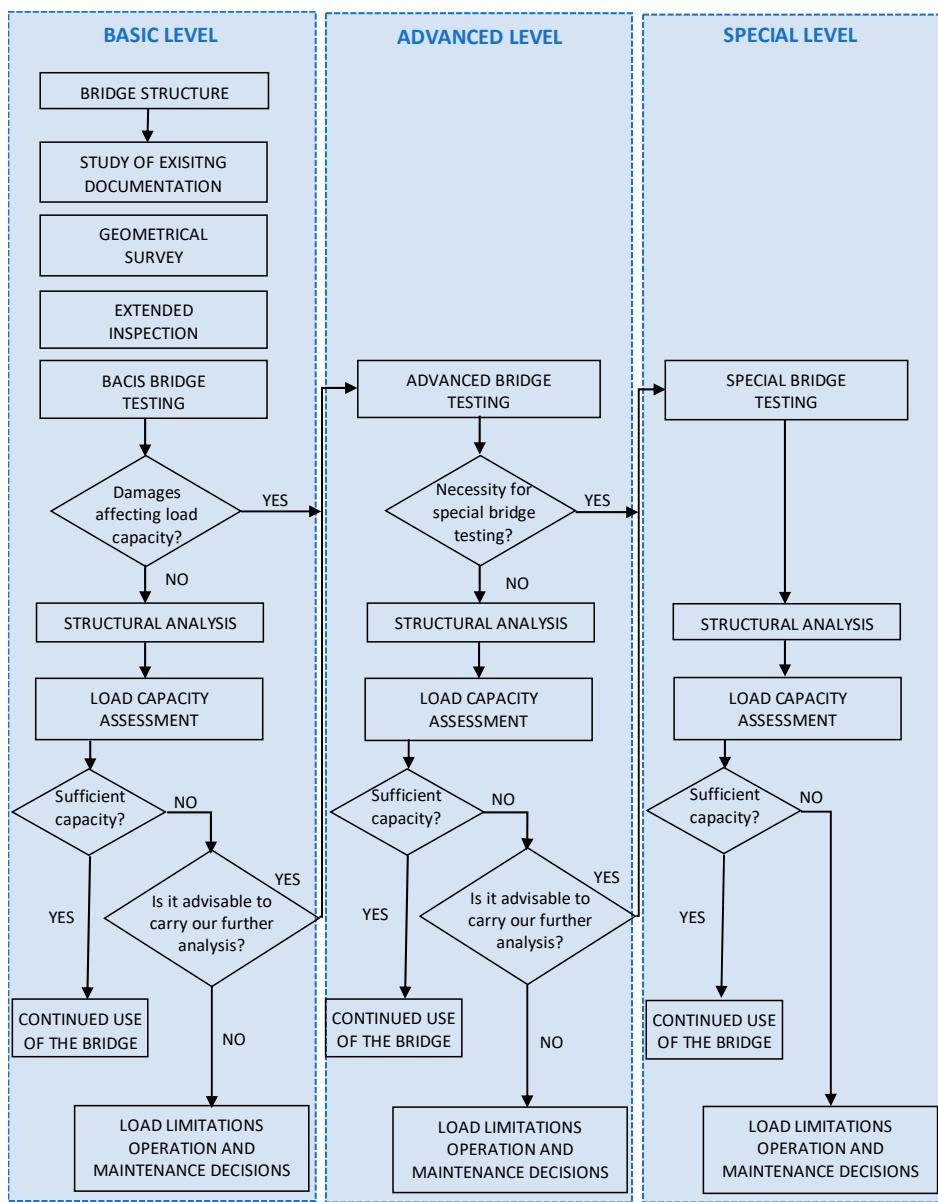
**Figure 1.** The framework for assessing the safety of an existing bridge according to the new Polish guidelines [47].

The assessment of the structural safety of the existing bridge should follow a stepwise framework with increasing levels of detail and accuracy (Figure 1). The first level involves analysing archival documents, inventorying the bridge's geometry (if necessary), conducting a condition survey (inspection), performing basic diagnostic tests, and executing simple computational analyses. Additional information, such as historical standards, construction strategies, and operation & maintenance experiences, is also essential. The assessment must consider the current condition of the bridge. Initial material properties can be derived from historical standards for different materials. Computational analysis involves re-evaluating the existing structure based on action forces and material parameters. At the second level, advanced diagnostic tests are required to identify detailed damage, among other things. Generally, updated characteristic values of materials are defined according to EN 1990, Appendix D [44], based on material testing. Structural safety and serviceability verifications are carried out using these updated characteristic material values and modified partial factors, in accordance with the primary design equations of prEN 1990-2 [43] within the partial factor framework. The advanced analysis (usually performed using the finite element method, FEM) considers the impact of identified failures on the bridge's structural safety. The third level involves specialised diagnostic tests of the bridge under proof or service loads to evaluate its performance. The outcomes of these tests are primarily used to update and validate the FEM model employed in the final assessment of structural safety. Throughout each assessment level, the structural safety is evaluated to determine if it is adequate for continued use or if further analysis is advisable. Based on this, the bridge authority can decide on additional maintenance actions (e.g., traffic or service load restrictions, repairs, strengthening). Any interventions should, where possible, be designed in accordance with standards (Eurocodes) for new structures.

Following the assessment framework (Figure 1), it was necessary to determine whether the observed failures of the steel structure had affected the safety of individual elements or the entire superstructure of the bridge. As is well known, cracks, plastic deformations, and severe corrosion are the leading causes of performance degradation in steel bridges. Cracks threaten the safety of the bridge and can even lead to collapse. In this case, most cracks in welded joints resulted from poor and faulty quality (many initial defects) and distortion caused by overloading or restraint issues.

Furthermore, steel bridges, especially those with orthotropic decks, are susceptible to fatigue cracking due to prolonged wheel loading and high cyclic stresses. The significance of the crack for the bridge's structural safety is of primary importance. If the crack is perpendicular to the tension direction induced by the service load, as shown in Figure 6, it may compromise the bridge's load-bearing capacity. Additionally, extensive plastic deformations in the cross-beams and local corrosion damage to the shells can substantially reduce the load-carrying ability. In summary, the damages observed in the steel superstructure, particularly their type and extent, may impact the structural safety of the bridge. Therefore, advancing to the second (more detailed) level of the assessment framework was necessary, as shown in Figure 1.

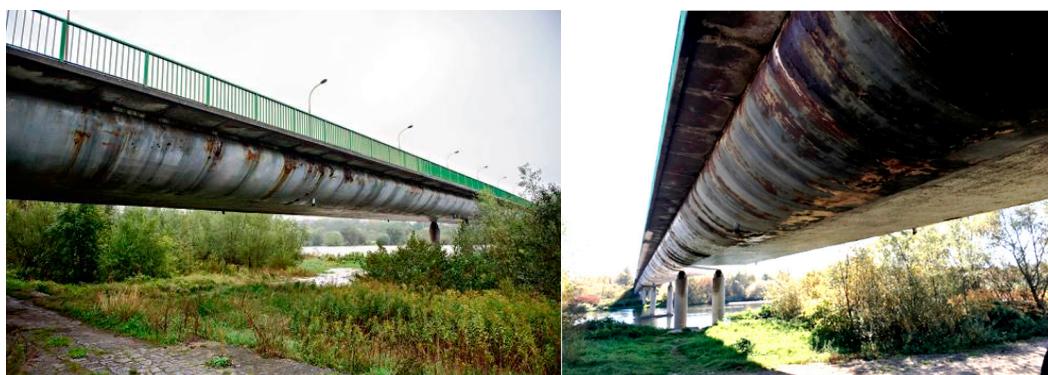
The bridge was constructed in 1970 and designed to withstand live loads according to the old Polish bridge standard from the early 1960s. It has a total length of 288,0 m and a static scheme of a five-span continuous beam with span lengths of 48,0 m, 60,0 m, 72,0 m, 60,0 m, and 48,0 m (Figure 2). The overall width is 11,20 m, comprising a roadway with two lanes (2 x 3,50 m) and two sidewalks (2 x 2,10 m). The spans of the bridge were constructed as a steel shell structure, with a depth of 2.0 m and a width of 9.0 m (Figure 3). The shell, shaped like a basket curve, is made of steel sheets stiffened with longitudinal trapezoidal ribs. The top steel sheet with ribs forms an orthotropic steel deck. The shell superstructure is internally stiffened with steel trusses: four longitudinal trusses (arranged as two pairs) and numerous transverse trusses spaced every 2,0 m (Figure 4). The first type of trusses features a standard triangulated system, acting both as longitudinal stiffeners for the shell and as the main load-bearing girders. The other, a Vierendel truss (or rigid frame), functions as a cross-beam. Both types are made from rolled or welded I-beams, with welded joints connecting all elements of the steel superstructure. Reinforced concrete prefabricated slabs are attached atop the steel sheets on both sides to form the bridge sidewalks.

**Figure 2.** The general view of the bridge.

The condition survey showed that the steel shell, some longitudinal ribs, and parts of the trusses were superficially corroded (Figures 2 and 4), mainly near equipment elements such as expansion joints, drainage inlets, and where the lighting lantern is attached to the structure, as well as at points where the prefabricated concrete slabs connect to the orthotropic bridge deck. Measurements of the thickness of these steel sheets and components indicated significant corrosion losses, reaching up to 3.0 mm in critical areas. The inspection also identified numerous (more than 100) severe plastic local deformations of the elements forming the trussed cross-beams (Figure 5). These deformations reduce both the load-bearing capacity of the cross-beams and the overall stiffness of the spans. Their high number, plastic deformation, and localisation mainly in the support zones of the spans may point to overloading as the primary cause of their occurrence.

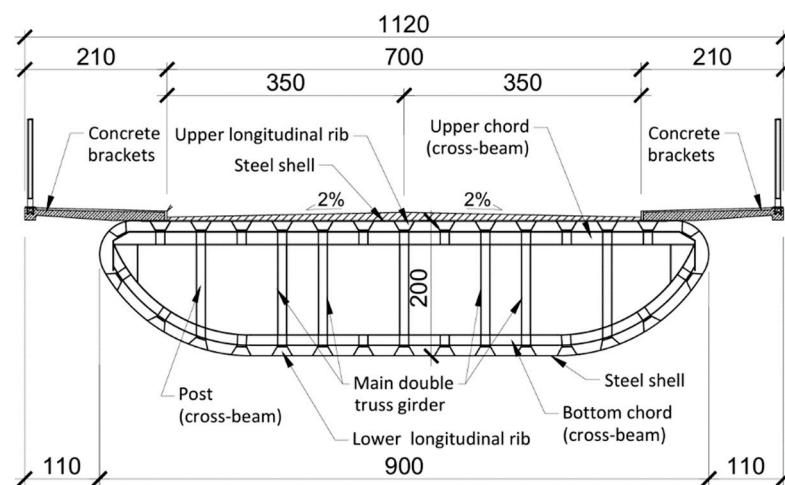
**Figure 3.** Cross-section of the steel shell superstructure.

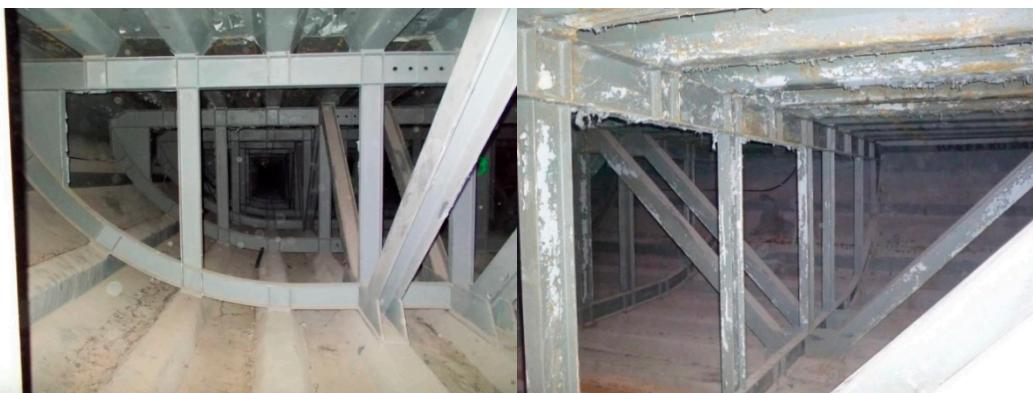
**Figure 4.** Interior of the steel superstructure showing longitudinal and transverse stiffening trusses, with shell sheets reinforced by longitudinal trapezoidal ribs.

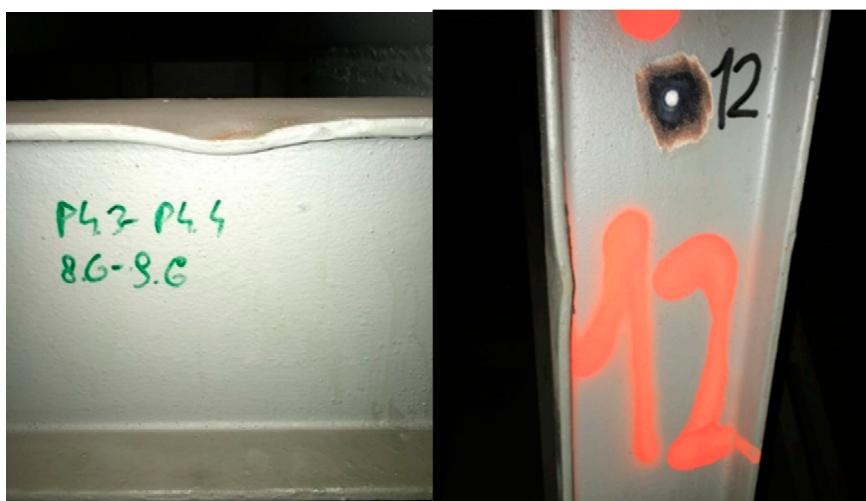
**Figure 5.** Local plastic deformations of the upper chord (left) and post (right) of the cross-beams.

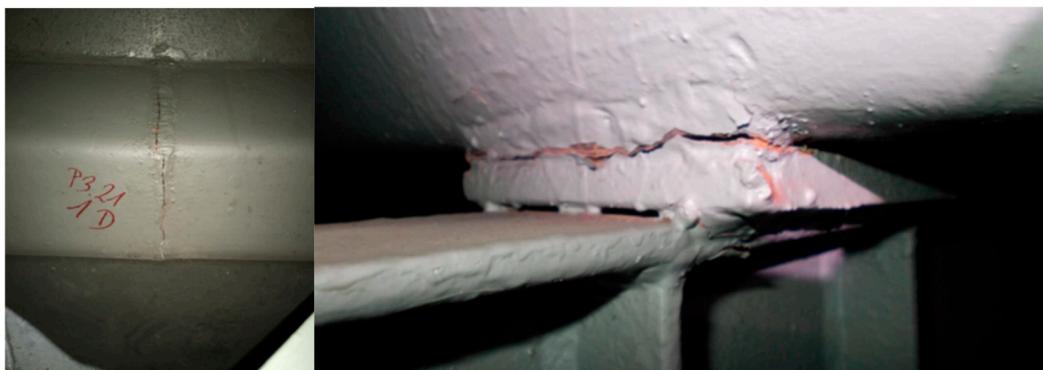
The most serious damage to the steel structure, identified during the condition survey of the bridge, was cracks in the welds (Figure 6). At this assessment level, most superstructure welds were examined using a combination of visual inspection and penetrant tests. The inspection revealed the poor condition of the butt welds of the shell's longitudinal stiffening ribs. More than 40 cracks were discovered in the butt joints of the trapezoidal ribs, particularly located in the orthotropic deck at the support zones of the spans. These cracks disrupt the continuity of the longitudinal ribs, alter their static scheme and local internal force distribution, and negatively impact other structural elements, ultimately leading to their deterioration. For example, they caused cracks in adjacent fillet welds connecting the deck ribs to the upper chords of the cross-beams. More than 100 cracks (!) were found in these locations. The cracks varied in development, from hairline cracks that initiated weld destruction to complete joint break.

**Figure 6.** Typical weld cracks in the butt joints of longitudinal ribs (left) and an example of a crack in the fillet weld connecting the longitudinal rib to the upper chord of the cross-beam (right).

In most cases, the cracking of these joints was progressive, occurring 10 years after the initial repair of the welds, which revealed a permanent structural defect in this type of connection. Finally, several cracks were discovered in the welded joints between the upper cords of the main truss girders and cross-beams, particularly in the zones where the spans are supported. The primary cause of most cracks in welded joints is their poor quality, along with overloading and fatigue in some instances.

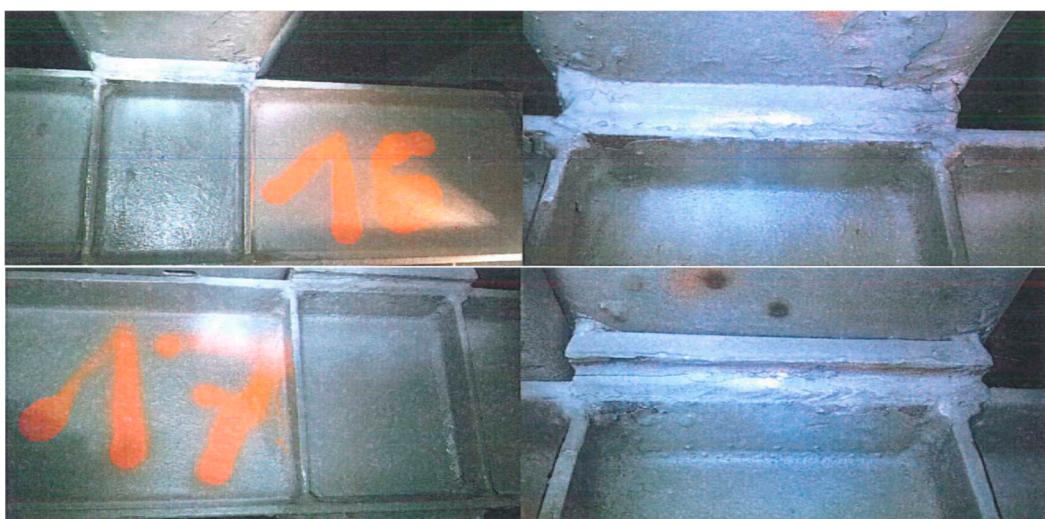
Magnetic particle tests on selected welds were performed using a magnetic jet flaw detector AC42 K+D Flux Technic type, following standards EN ISO 9934-1:2017-02 [54] and EN ISO 17638:2017-01 [55]. The purpose was to detect surface and subsurface discontinuities in the fillet welds connecting the longitudinal ribs of the deck to the upper chords of the transverse cross-beams. The examination covered 22 welds, which showed no cracks based on visual inspection. The surface and subsurface of the joints were inspected over an approximately 20 mm area. On all tested welds, several inadmissible indications (i.e., flaws with  $l > 2$  mm and/or  $d > 1$  mm) were found on the surface, indicating very low weld quality (Figure 7).

**Figure 7.** Surface discontinuities of the fillet welds connecting the longitudinal ribs of the deck with the upper chords of transverse cross-beams.

The observed discontinuities in the fillet-welded joints connecting the orthotropic deck and the cross-beams may lead to a lack of composite action between these elements, as assumed in the original design. Consequently, it was also investigated whether these discontinuities had a significant impact on the overall stiffness of the superstructure. The potential change in stiffness was evaluated by measuring the permanent deflection at the midpoint of the longest span ( $L = 72.0$  m) using precision levelling. The average measured permanent deflection was 105 mm ( $L/686$ ), which is considered substantial after 55 years of bridge operation, especially since the superstructure was initially built with reverse deflection. This indicates that the flaws found in the welded joints of the steel structure considerably reduce the overall stiffness of the spans.

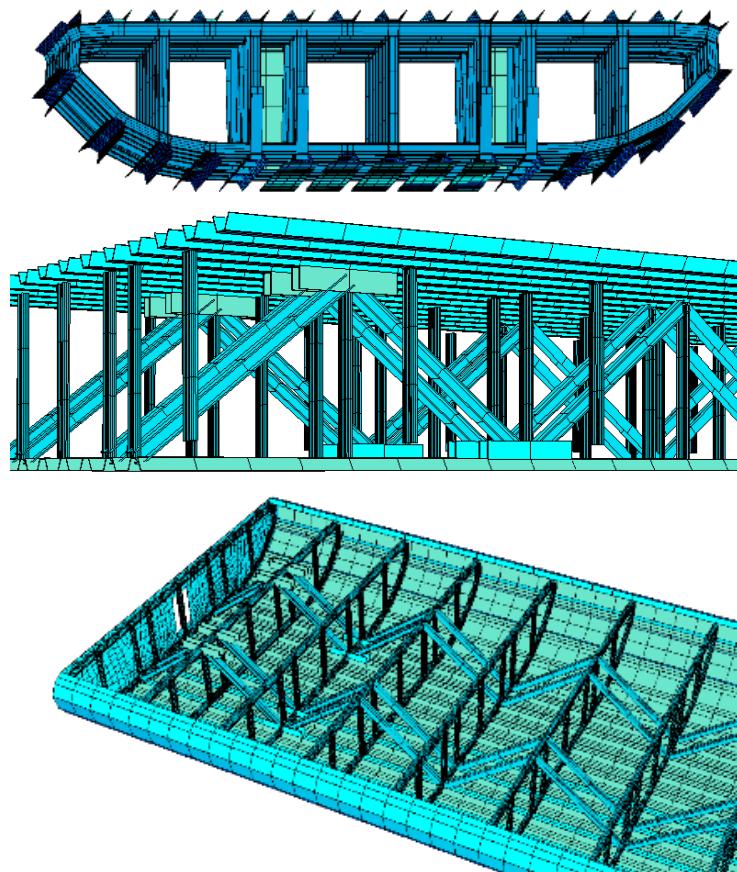
Shell (quad) and beam finite elements were used to model the superstructure. Depending on the structure's geometry, the appropriate type of finite elements and meshing method were selected to generate the mesh. The general meshing technique was applied to ensure all nodes in contact areas were converged. An ordered reticulation method was employed. The shell elements discretised the superstructure shell with a maximum size of  $300 \times 500$  mm. Mesh refinement with an element size of  $150 \times 500$  mm was used for the longitudinal trapezoidal ribs. Various shell sheet thicknesses and different types and sizes of ribs and truss sections were considered. The actual thicknesses of individual elements, which vary across the cross-section of the bridge span and along its length, were incorporated into the model. The results of the condition survey and advanced bridge testing were incorporated into the model, including corrosion losses of deteriorated elements and cracks in the fillet welds between the longitudinal ribs of the deck and the upper chord of the cross-beams. The latter failures were simulated by omitting the axial stiffness in the (x) and (y) directions, along with the corresponding bending stiffnesses. The material properties of the finite elements were assumed to be derived from and updated based on analysis of design specifications and construction records, corroborated by the condition survey and material testing results. The visualisation of the numerical model of the steel superstructure is shown in Figure 8.

**Figure 8.** Numerical model of the superstructure.

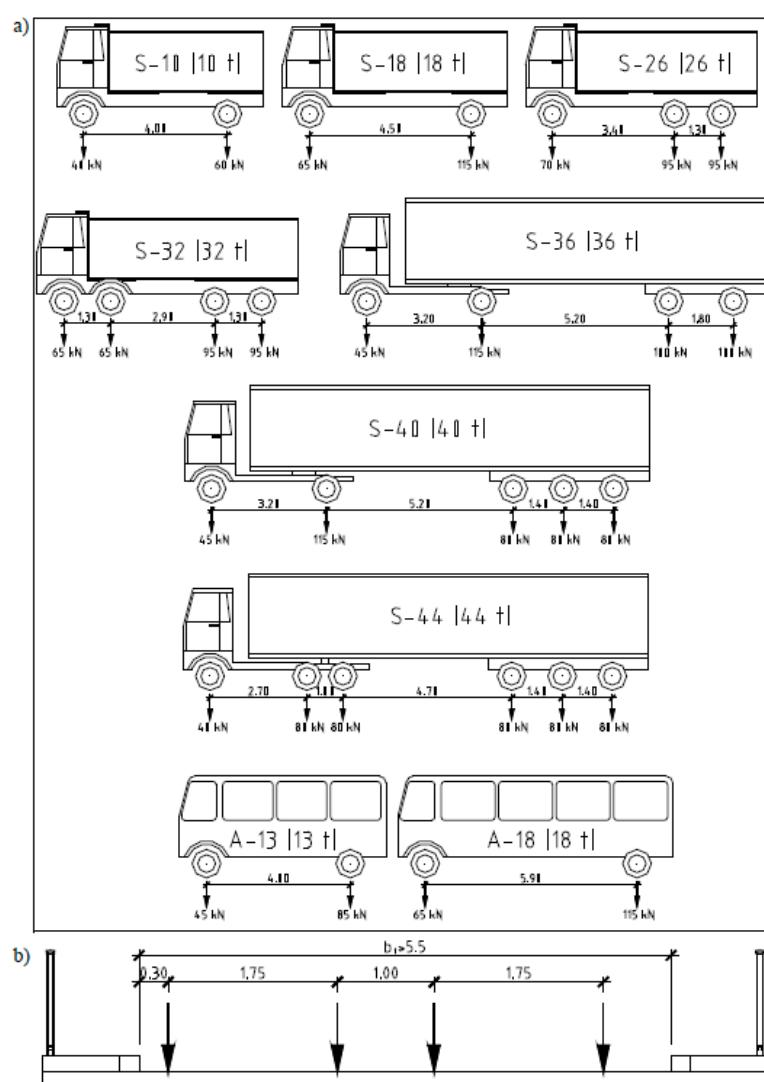
models used to evaluate the bridge's load-bearing capacity were adopted in accordance with the requirements of the Polish road administration [9]. The vehicle schemes, loads, and markings, as adopted as actual traffic loads in the structural analysis, are shown in Figure 9.

**Figure 9.** Models of traffic vehicles for assessing the structural safety of existing bridges, as per [9].

The single vehicles, as shown in Figure 9, were used in the numerical analysis as a surface load of a single wheel, considering a wheel load area of  $0.30 \times 0.40$  m. An example of the load position of the traffic vehicle, marked as 2×S10, is shown in Figure 10.

The following traffic vehicles, according to Figure 9, were set to move along the length of the bridge spans, assuming two possible combinations:

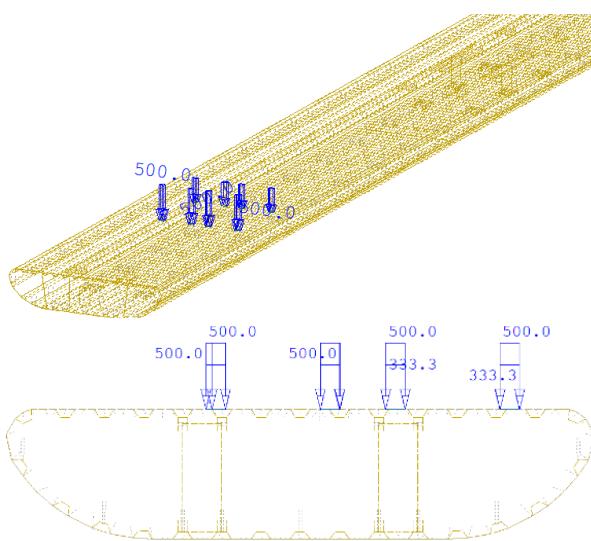
**Figure 10.** Wheel load of the 2×S-10 single traffic vehicle [ $\text{kN/m}^2$ ].

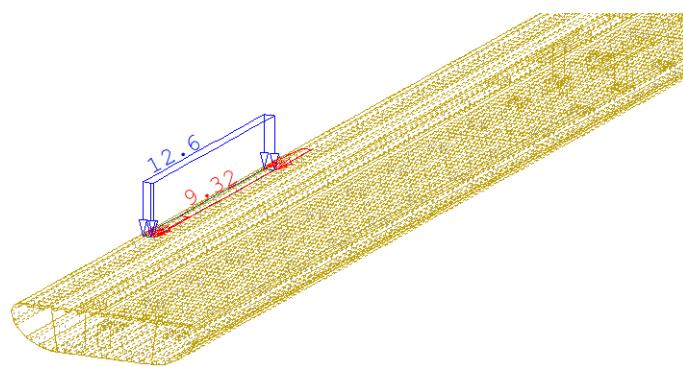
**Figure 11.** Pedestrian load on sidewalks.

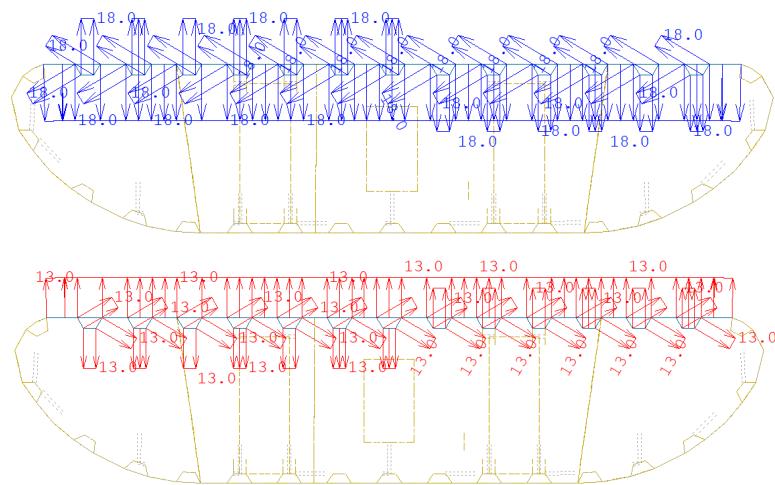
**Figure 12.** Temperature actions: heating (top) and cooling (bottom).

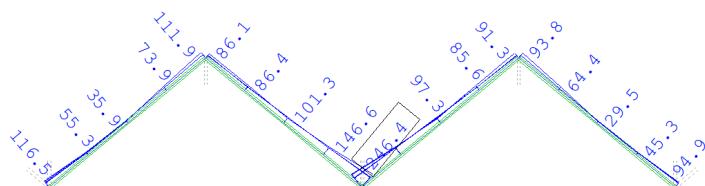
**Figure 13.** Maximum H-M-H stresses for the diagonals of the longitudinal stiffening truss (under 2 x S-10 vehicle load).

The assessment of the steel superstructure revealed that the structure lacks a sufficient safety margin regarding the ultimate limit state (ULS), even when subjected to the weight of a traffic vehicle of the lowest class, 2 x S-10 (a vehicle with a total weight of 10 tonnes). The main steel elements responsible for the superstructure's insufficient safety are as follows:

- Longitudinal truss diagonals – the assessment value of the resistance ( $R_a$ ) is exceeded by up to 5 %; number of deficient elements – 4;
- upper chord of cross-beams - the assessment value of the resistance ( $R_a$ ) is exceeded by up to 550 % (!!!); number of deficient elements – 20;
- lower chord of cross-beams - the assessment value of the resistance ( $R_a$ ) is exceeded by up to 620% (!!!); number of deficient elements – 20;
- cross-beam posts - the assessment value of the resistance ( $R_a$ ) is exceeded by up to 505% (!!!); the number of deficient elements is 120.

Considering the poor technical condition of the steel superstructure (corrosion, numerous cracks in welds, and local deformations) and the results of the structural safety assessment, which essentially disqualified the continued use of the steel structure for the bridge's operation, the fatigue life analysis (typically conducted in such cases, see [57]) and the special bridge testing were deemed unnecessary. Because of the very low structural safety of the superstructure (even under self-weight and permanent load) revealed during the assessment, the bridge authority decided not to impose any traffic restrictions (such as vehicle load or speed limits, or operational constraints). Instead, they ordered the immediate closure of the bridge until a decision was made on whether to repair/strengthen or replace the superstructure. However, repairing or strengthening the steel structure would involve extensive work and high direct costs. Furthermore, the life cycle cost analysis comparing repair versus replacement convinced the road authority to replace the superstructure

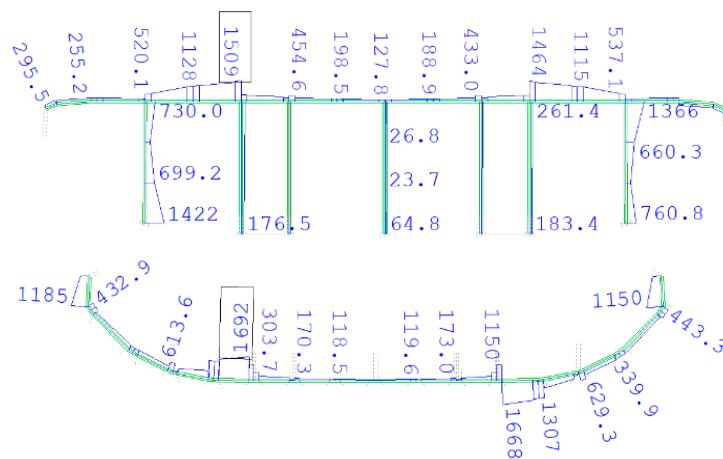
**Figure 14.** Maximum H-M-H stresses for the cross-beam elements (under 2 x S-10 vehicle load).

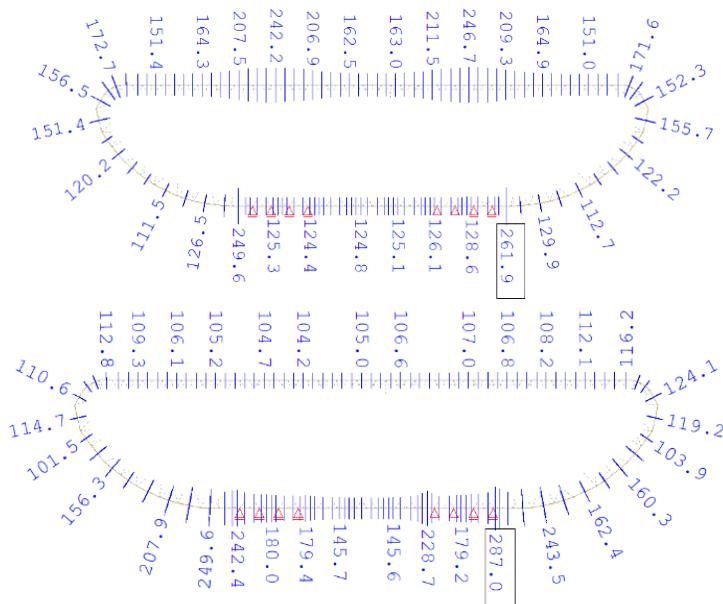
**Figure 15.** Maximum H-M-H stresses for the shell sheets at the P-3 support section of the span (under 2 x S-10 vehicle load).

The shell sheets of the superstructure, its longitudinal stiffening ribs, and its upper part, the orthotropic deck, have sufficient safety regarding ULS; however, only for the lowest class 2 x S-10 traffic vehicle. Additionally, the analysis showed that the resistance values of some of the elements mentioned above were exceeded under self-weight and permanent load (by up to 200%). A comparison between analysis results and the condition survey indicated the same elements, where local plastic deformations were observed (Figure 5). The structural analysis revealed that more than 180 superstructure elements are insufficiently safe to carry the actual minimum traffic loads with the safety level required by the new national guidelines [47] and the European standard prEN 1990-2 [43].
