# Analysis of Aviation Risks Due to Adverse Weather Conditions. Case Study: Pucallpa Accident 08/23/2005

doi: 10.20944/preprints202405.1638.v1

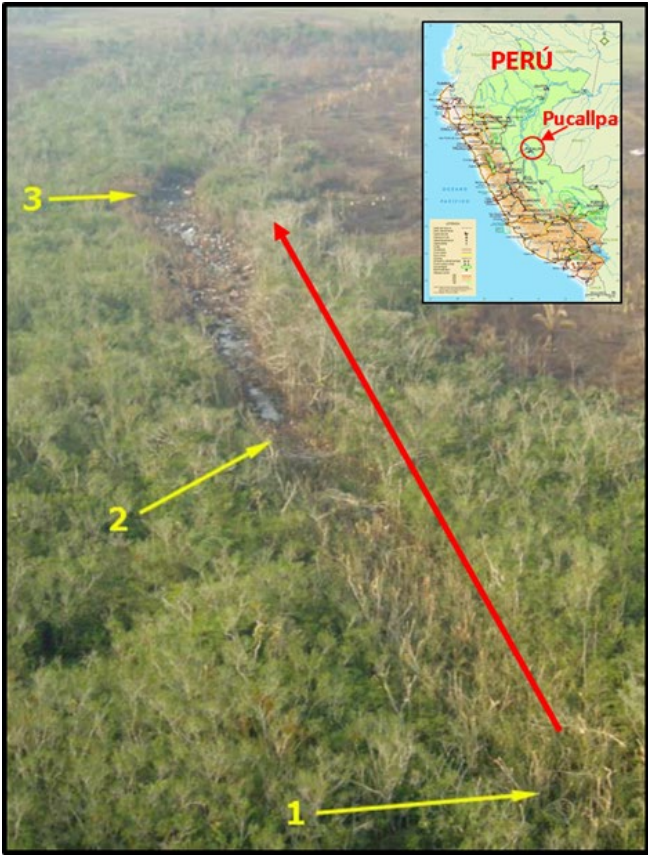
The aircraft crashed into trees in a swampy area, leaving a trail that is depicted in Figure 2. Figure 3 shows part of the fuselage of the aircraft, the final location can be identified at position 2 in Figure 2. Investigations did not detect any evidence of mechanical malfunctions, system failures prior to crash, or other malfunctions that could have caused the accident.

**Figure 2.** Aircraft impact location - A.A.H.H. La Florida - Pucallpa [6]. The impact path is highlighted in red, while the beginning of contact with the trees is indicated with a yellow indicator (1) and the point of impact of the front part of the fuselage with another yellow indicator (2). The final position of the wreckage of the aircraft and the location of the fire are indicated by a third yellow indicator (3).

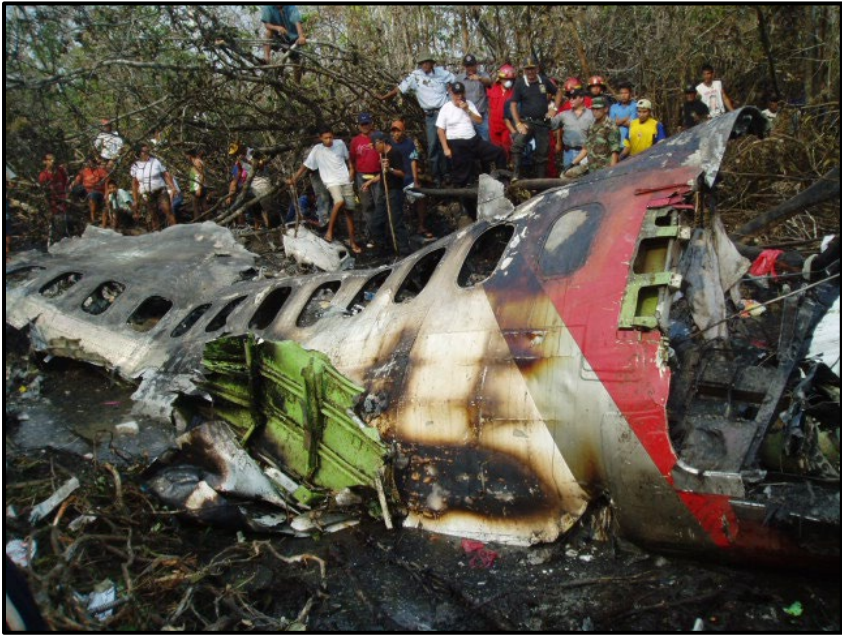
**Figure 3.** Fuselage of the aircraft TANS Peru - August 23, 2005.

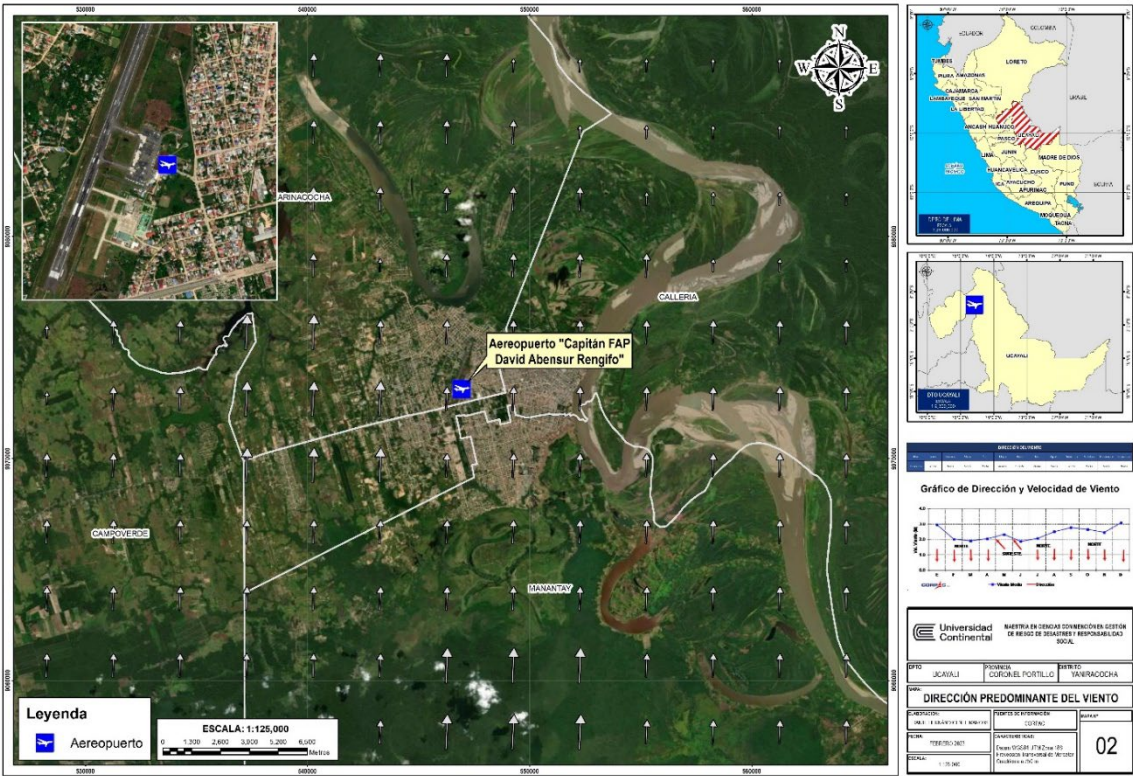
Figure 7. Risk map by wind direction.

Based on the previously analyzed information, three maps have been created that illustrate the main risks associated with the main meteorological variables that can affect aircraft during the flight phases at Pucallpa airport. These maps provide valuable insights into the potential risks to aviation in the area.
