# The impact of the lubricant dose on the reduction of wear of QRO90 steel dies used in the forging process of the valve forging made of high-nickel steel

Łukasz Dworzak<sup>1,\*</sup>, Marek Hawryluk<sup>1</sup>, Marta Janik<sup>2</sup>

1 Wroclaw University of Science and Technology, Department of Metal Forming, Welding and Metrology, Lukasiewicza Street 5, 50-370 Wroclaw, Poland;  
2 Mahle Poland, Mahle 6, 63-700 Krotoszyn, Poland, marta.janik@mahle.com,

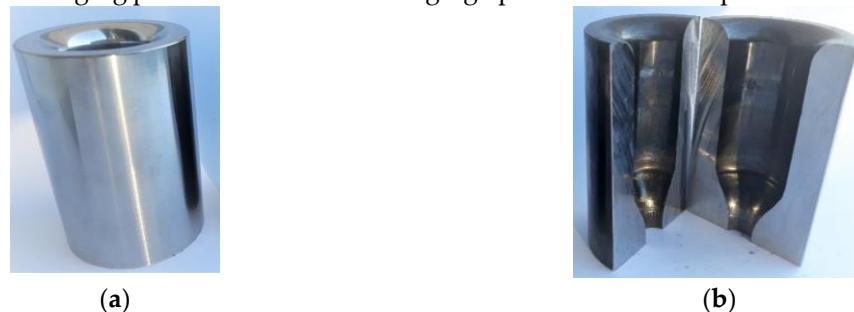
**Figure 1.** Selected dies used in the first operation (preliminary forging) of forging process of valve forgings:  
(a) new tool; (b) removed from production with visible wear

A detailed analysis was the chosen die used in the first operation (Fig. 1). Such a die is used in the industrial manufacturing process of the valve forging of high-nickel high-temperature creep resisting steel (NCF 3015). The analyzed type of forging is an important element of a motor engine and due to the strict requirements for the automotive industry, it needs special supervision during the production process. The whole forging process consist of two forging operations on crank press with 0.7 MN [34,35].

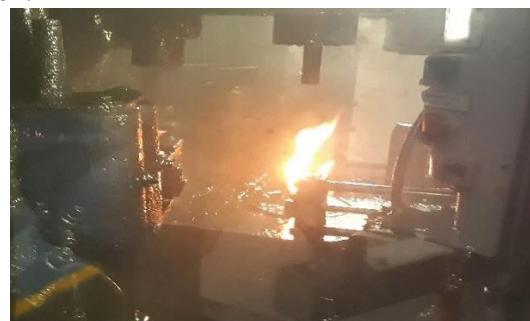
**Fig. 2.** Photo of a press chamber in an industrial forging process with visible lubricant residues and a flame due to oil burnout after contact with a hot forging in the die

To evaluate the results, it was assumed that the more lubricant remaining inside the tool cavity during laboratory tests, the better. It was so, because in the industrial process rapid "seizing" of the working part of the tool cavity was observed, caused by an insufficient lubricant dose. Industrial process analysis results have shown that a significant portion of lubricant that should fall into the tool cavity is bounced off or sticks to the die walls or the lubricating nipple, rather than enters inside to improve lubrication. Furthermore, after the entire production cycle, huge amounts of lubricant residues were observed in the working space of the press, which would indicate that a large part of lubricant is sprayed out of the tools and wasted due to incorrect settings in the industrial process. Further, due to the conditions prevailing in the industrial process, i.e. high temperature of the charge material and the working temperature of the tools, it was decided that after each test in laboratory conditions, complete cleaning of the system on the test stand would be tantamount to complete burnout of the remaining lubricant in the industrial process. This situation is confirmed by the appearance of a flame each time after lubricant is fed into the die in the industrial process (Fig. 2).

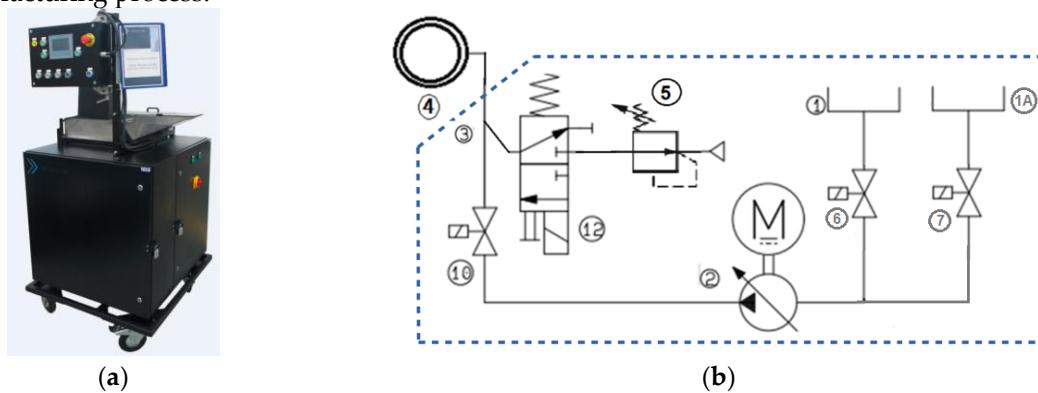
**Figure 3.** View: (a) the lubricating and cooling station, called "Shako"; (b) lubricant dosing system diagram,

1 – lubricant tank, 1A – cleaning agent tank, 2 – force pump, 3 – tee, 4 – head with nozzles, 5 – pressure regulator, 6 – cut-off valve of the liquid lubricant tank, 7 – cut-off valve of the cleaning liquid tank, 10 – cut-off, metering valve, 12 – air valve of air exerting pressure on the liquid

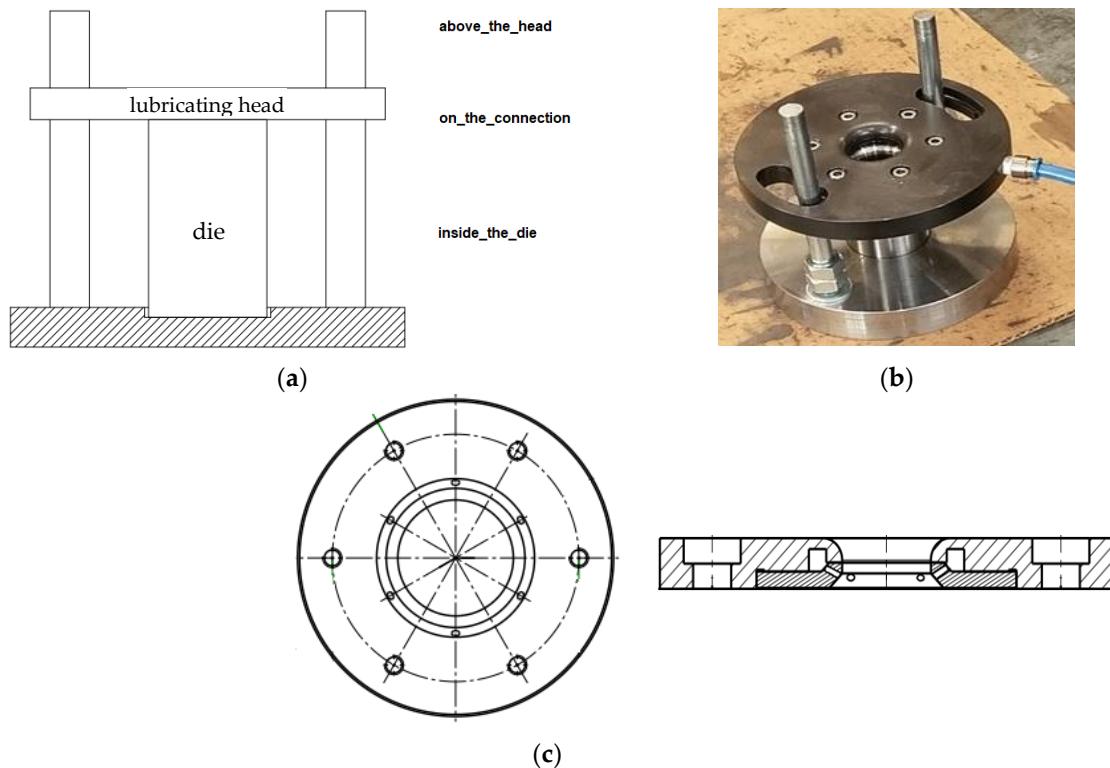
**Figure 4.** Test stand diagram: (a) schematic diagram; (b) test stand; (c) lubricating head diagram

Therefore, based on the analyses and preliminary tests in the industrial process, it was found that the lubricant, apart from its influx into the die cavity, often accumulated between the upper die surface of the lower surface of the lubricating head or completely escaped over the entire tool set, and based on this the concept of the test stand was developed, which was to reflect the conditions of the industrial process (Fig. 4).

The amount of lubricant in each of the 3 zones was assessed by measuring the weight remaining on a tared paper towel sheet. For this purpose, a balance with an accuracy of 0.001 gram was used. Due to the small amounts of lubricant supplied, each test (with the particular pressure and time parameters) was repeated 5 times and based on this the average values were determined. After each test, each surface of the laboratory stand was thoroughly cleaned. In laboratory and industrial tests, the same lubricating head shown in Fig. 4c was used. This head is characterized by six nozzles through which lubricant was pushed out. The nozzles in the form of holes are placed at an angle, thanks to which lubricant is supplied inside the die, they minimize the amount remaining on the connection of the lubricating head and the die.

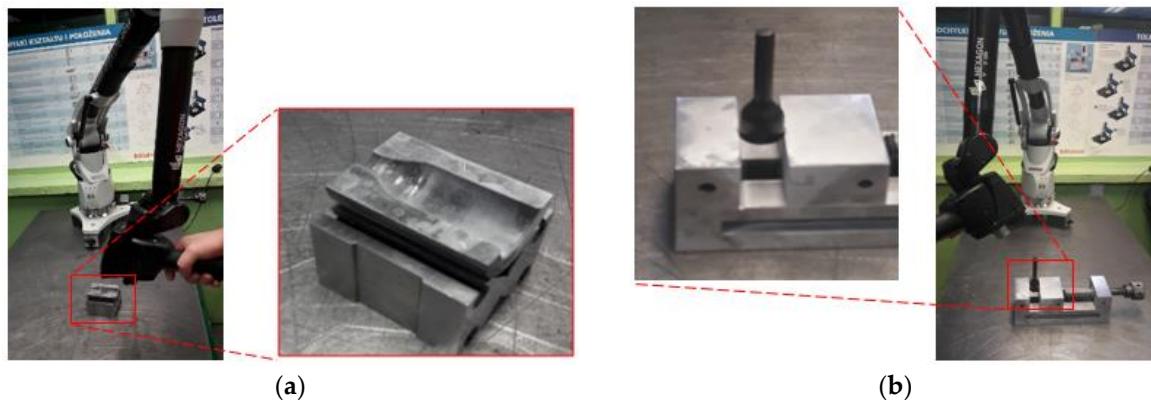
**Figure 5.** Station with measuring arm ROMER AbsoluteArm 7520si, integrated with a laser scanner RS3, used for the 3d measurements: (a) die measurement; (b) forging measurement

For the tests, a measuring arm ROMER Absolute ARM 7520si integrated with a scanner RS3 was used, as well as the Polyworks software and the Real Time Quality Meshing scanning technology. For the purposes of the tests, a laboratory measurement stands were constructed, shown in Fig. 5. The device is assigned for measurements with the use of the laser scanner RS3 integrated with the arm, which provide the possibility of collecting up to 460 000 points / s for 4600 points on the line with the linear frequency of 100 Hz. The accuracy of the integrated scanning system SI according to the standard B89.4.22 equals 0.053 mm.

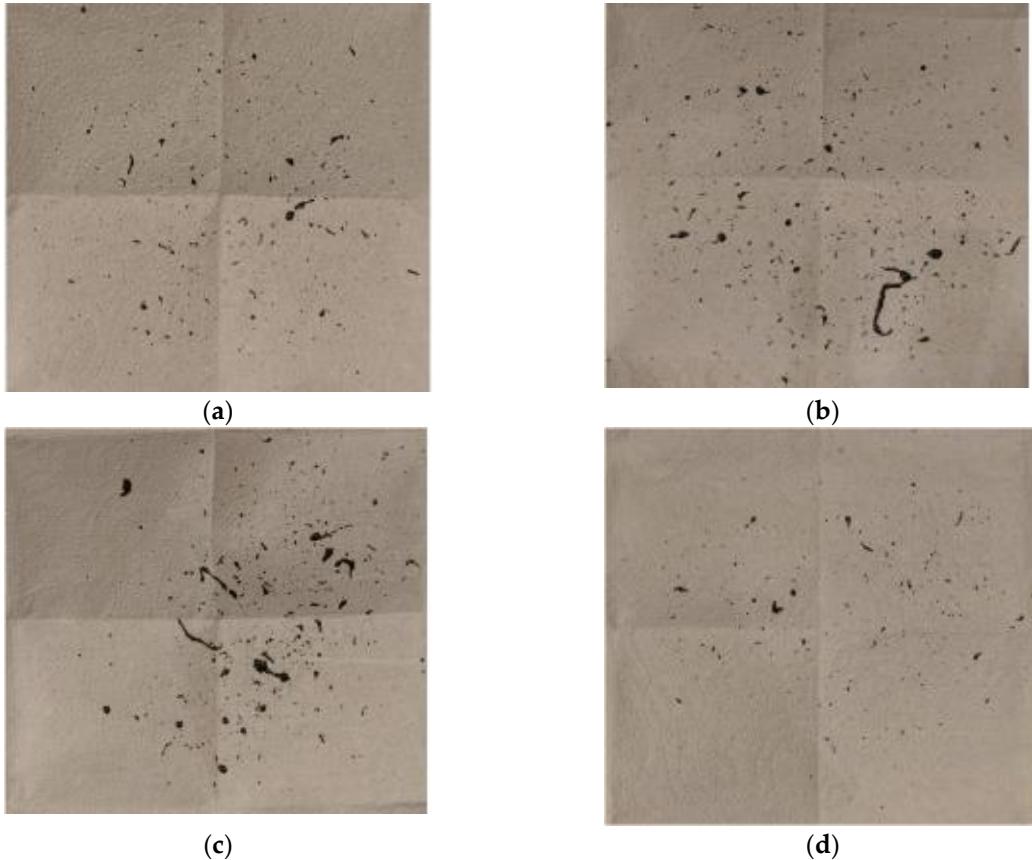
**Figure 6.** Sample photos of towels above the head for particular test parameters: (a) variant 1; (b) variant 3; (c) variant 2; (d) variant 4

Laboratory tests included the following parameters of air pressure acting on the lubricant and the valve opening time presented in Table 2. Figure 6 shows examples of photos of paper towels above the head.

For variants 1 and 4, the amounts of lubricant bounced off the die were much smaller than for variants 2 and 3. The probable cause of the situation for variants 2 and 3 is the fact that not only lubricant is bounced off when entering the die, but also the agent that is dosed to the upper die part, which, combined with low dynamics (variant 2) and short time (variant 3), results in lubricant being bounced off the lubricant already fed into the die.

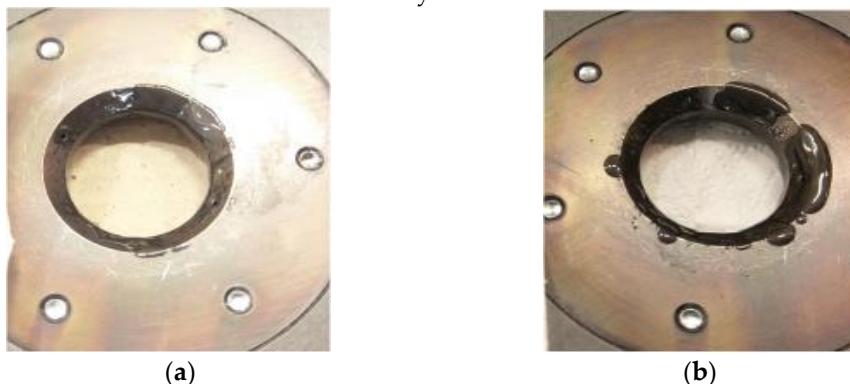
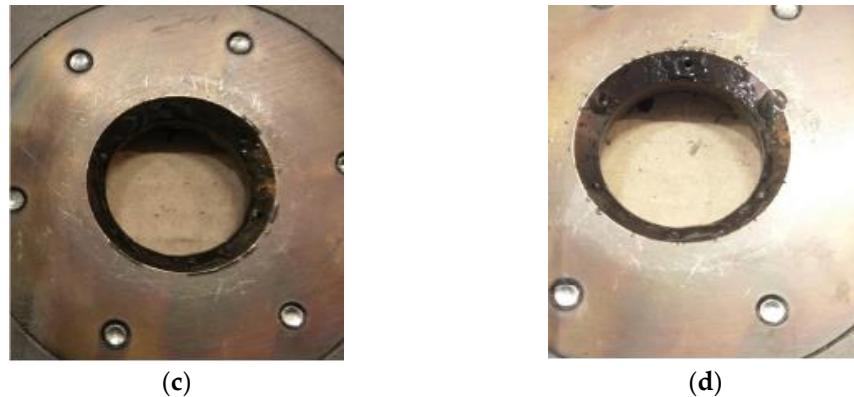
**Figure 7.** Lubricant remaining on the die for particular test parameters: (a) variant 1; (b) variant 3; (c) variant 2; (d) variant 4

Figure 7 shows pictures of the lubricating nipple with lubricant left over during the tests. Variants 1, 2 and 4 are very similar compared as opposed to variant 3. In the 3 variant, the accumulation of lubricant on the face of the nozzle head is clearly visible.

This situation may be caused by liquid lubricant being pushed out from the nozzles in the initial phase in the form of a growing drop, which, after exiting the nozzle, “explodes” only to be subsequently delivered in the form of a continuous stream of liquid lubricant. Due to the short valve opening time (0.5s in the 3 variant versus 0.7s in the 4 variant), the lubricant deposited on the head as a result of the “explosion” is not taken towards the die due to the relationship between the viscosity and the further dose of lubricant, which takes place in variant 4. The situation of “explosion” of drops is less noticeable in the 1 and 2 cases, where the dynamics of lubricant being pushed out is lower due to lower pressure. Figure 8 shows the inside of the die with the lubricant applied. The 4 variants were characterized by the lubricant fed the deepest into the constriction area of the die.

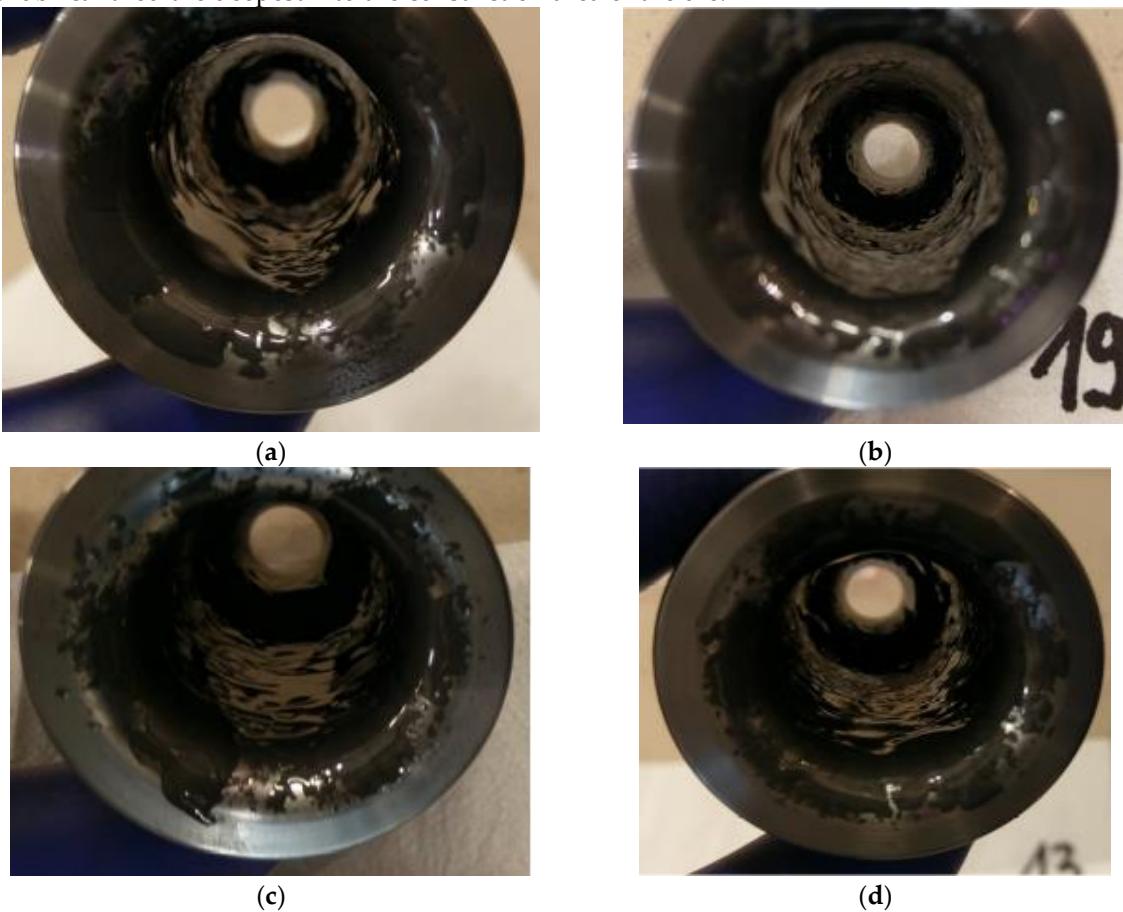
**Figure 8.** Lubricant fed inside the die for particular test parameters: (a) variant 1; (b) variant 3; (c) variant 2; (d) variant 4

In the case of variants 1 and 2, the amounts of lubricant fed into the die were slightly smaller, but the vast majority of it was applied to the cylindrical part of the die above the constriction. In the case of 3, lubricant was mostly located on the cylindrical part, though much closer to the constriction as in the case of 1 and 2. Table 3 summarizes the results presented as mean values of 5 repeat tests for a particular variant.

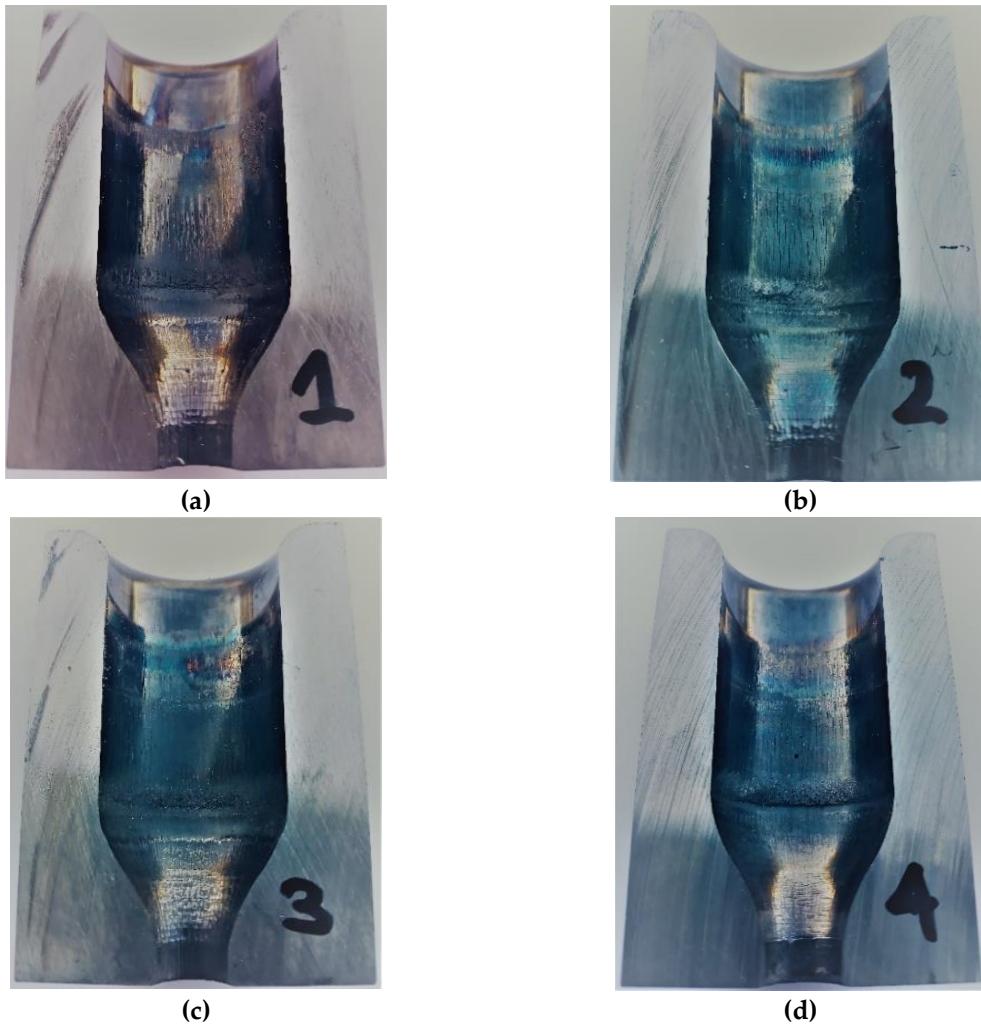
**Figure 9.** Macro photos of cut dies: (a) variant 1; (b) variant 2; (c) variant 3; (d) variant 4

For the same settings of the lubricating and cooling system, verification tests were carried out in industrial conditions. Fig. 9 shows macro photos of the dies cut in half after making 500 forgings for various settings of the lubrication system. A comparative analysis of the obtained results shows that all dies were worn in a similar way. There are several wear zones in each of them. On the cylindrical side surface of the die cavity, a clear trace of the perimeter (edge after cutting) of the high-nickel steel preform, where the punch started upsetting the material, can be observed from the top. Slightly below, another circumferential mark can be seen on the cylindrical portion of the impressions, which is where the forging leg is pressed out after upsetting. Further, there are longitudinal scratches in the direction of the punch movement and the flow of material for all the impressions. Some of the scratches are open, especially in the event of tools where lubricant is fed at a lower pressure (Fig. 9a and 9b). For tools with higher lubricant supply pressure (Fig. 9c and 9d), this area is smoother, although for all tools slight longitudinal plastic deformations can be observed. Another characteristic zone is the transition area from cylinder to cone; for all the tools, peripheral impressions are visible, which are the result of the lower bases of the incoming preforms being bounced off. In this area, there is a clear abrasive wear of the tool material, which can be seen even better in the tool scanning results. You can also see cracks slightly above this area, larger for tools with lower lubrication pressure, which may be due to insufficient lubricant film in this area.

The last characteristic zone is the area of cross-sectional area reduction, where the leg of the forging is created by concurrent extrusion. In this area, especially for tools with reduced lubrication pressure, characteristic thermo-mechanical crazing can be seen, which indicates the presence of high temperature during a long-time contact of the forging, extruded at high pressures, with the tool surface. The appearance of crazing may be indicative of a lack of lubricant in this area, which, in addition to lubrication, should insulate the cooler material of the tool from the hot forging. The least worn-out tool is the die, which worked with lubricant fed at a higher pressure and a longer exposure time, because it can be seen that in each of the areas it is worn the least, and in the latter it is difficult to notice traces of a thermo-mechanical fatigue crazing, which indicates the best tribological conditions resulting from the most intensive lubrication. Fig. 10 shows examples of scanning results of dies used in the first operation of preliminary roughing die forging of the valve forging after 500 forgings were made under different tribological conditions (4 different lubrication system settings). Before scanning, the tools were cleaned of lubricant residues and scale. Then they scanned and their digital images were converted into a cloud of points, turned into triangle meshes and referenced to the nominal CAD model. The conducted analyses confirmed the tests carried out at an earlier stage (based on macro photos) and allowed for obtaining additional information on the size of geometry changes.

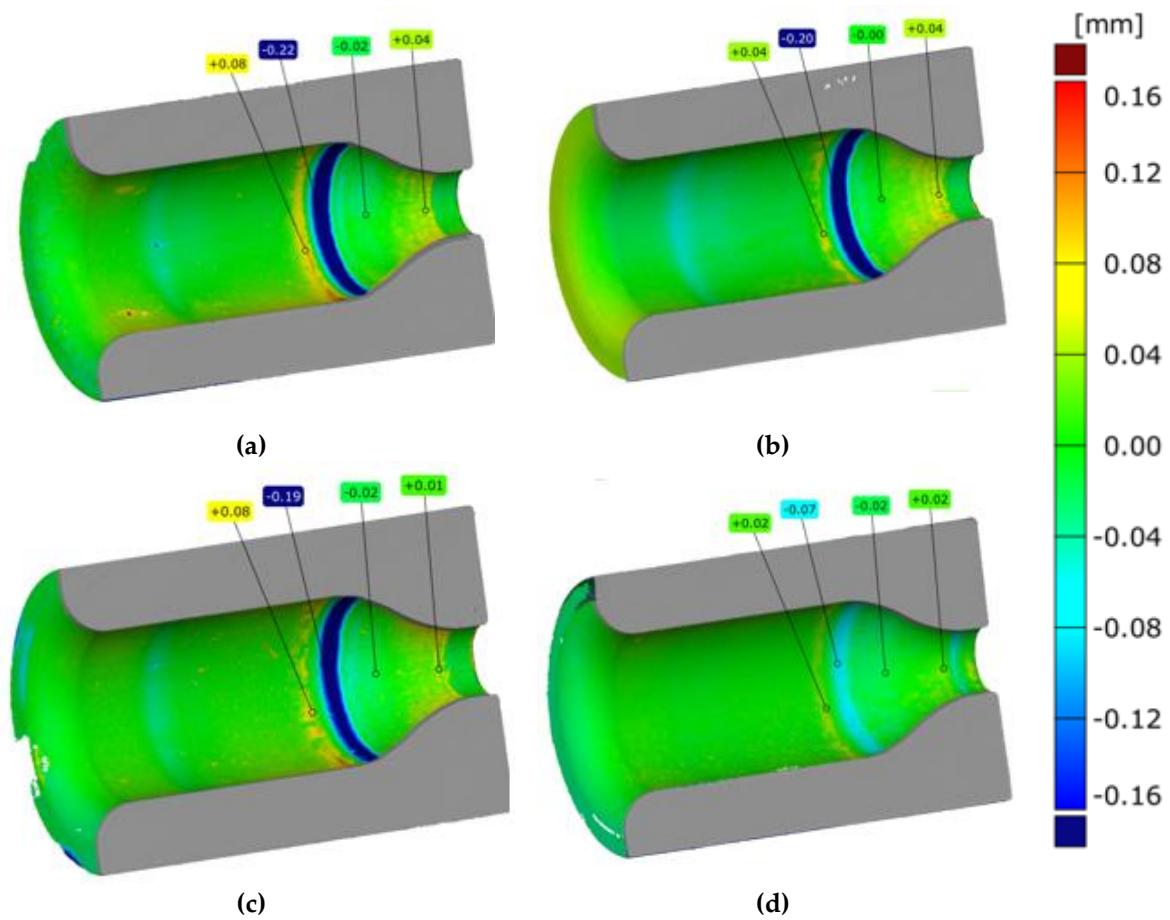
**Figure 10.** Results of 3D scanning of dies cut in half: (a) variant 1; (b) variant 2; (c) variant 3; (d) variant 4

The comparative analysis of the results obtained (Fig. 10) emphasizes that all the dies were worn in a similar manner and several wear zones can be noticed in each of them. The perimeter preform trace (of edge after cutting) of the high-nickel steel material (Fig. 9) on the cylindrical side surface of the die cavity visible in earlier tests, where the punch started the upsetting of the material, is visible in the

presented results (Fig. 10) in the form of a light blue ring where the material loss is between -0.04 mm and -0.06 mm and in the case of the 4 variant cavity, the ring is not noticeable because the material loss is below -0.04 mm. In the next two areas, i.e. in the cylindrical impression, where, after upsetting, the leg of the forging is extruded, and in the area below the place where longitudinal scratches in the direction of the punch movement and material flow are visible in Fig. 9, the material loss is below -0.04 mm and it is visible for the scale adopted in Fig. 10 in the form of a green area with a light blue tint. Another characteristic zone visible in Fig. 9 is the area of the transition from cylinder to cone, which in Fig. 10 is visible in the form of a ring indicative of wear at the level of -0.07 mm for the 4 variant to even -0.22 mm for the 1 variant. The ring is formed in the place where the preform comes into contact with the tool for the first time, and its blue color is indicative of the amount of material loss. Further, a second characteristic yellow ring is formed in front of this ring, indicative of cracks (visible in Fig. 9). in this area. For tools with a lower lubrication pressure the values are at the level of 0.08 mm, in the case of the 3 variant they are at the level of 0.04, and the lowest for the 4 variant where the value is at the level of 0.02 mm. The last characteristic zone is the area of reduction of the cross-sectional area, where the leg of the forging is created by concurrent extrusion and the material loss is very small, ranging from 0 to -0.02 mm. In the last part of the smallest diameter grooves appear, which cause material growth of 0.02 to 0.04 mm.

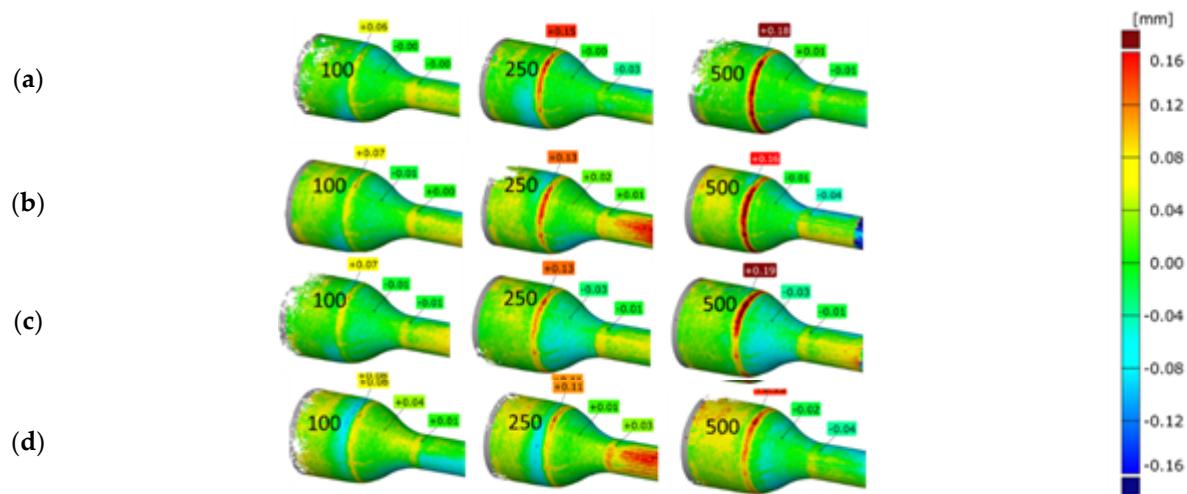
**Figure 11.** 3D scanning results of the next k 100, 250 and 500 pieces of forgings: (a) variant 1; (b) variant 2; (c) variant 3; (d) variant 4

Moreover, forgings were periodically sampled from the process to determine the intensity of geometry changes over time. Figure 11 presents selected color deviation maps of the 3D scanning results of periodically sampled forgings. These results make it possible to analyze the intensity of changes in the geometry occurring over time.

The analysis conducted shows that in the case of the variant 4 tool (Fig. 11d) for the lubrication variant of 4 bars and 0.7s opening time, these changes occur the slowest. This effect is visible in the form of the least visible red rings appearing on 250 forgings. For 500 forgings, this ring then develops unevenly around the circumference and obtains a value from 0.7 to 0.15 mm, which is indicative of material loss on the tool in the range of -0.07 to -0.15 mm.

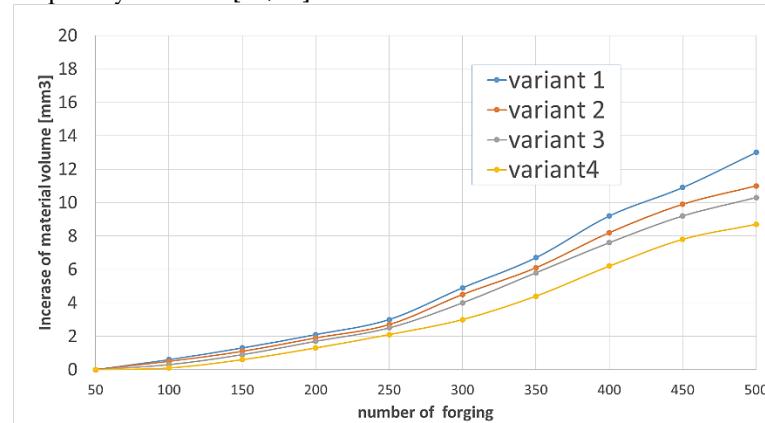
**Figure 12.** Scanning results of the cut dies for different pressure settings and solenoid valve openings

In order to better visualize the volumetric changes in the subsequent forgings for each variant, the Polyworks software was used to build a graph of the volume changes of the forgings for the entire deformation area identical to the worn area of the die cavity (Fig. 12), according to the 3d scanning revers method-developed by authors [31,34].

Analyzing the gradual (as the number of forgings increased) increase in the volume of material on the forgings indicates the progressing wear (material loss) of each tool. Although these changes are small, as they only reach a few  $\text{mm}^3$  at the final stage of the service life, which is 500 forgings, an upward trend can be observed for each of the lubrication variants. The smallest increase in forging volumes, indicative of die wear, can be observed for tool representing variant 4.

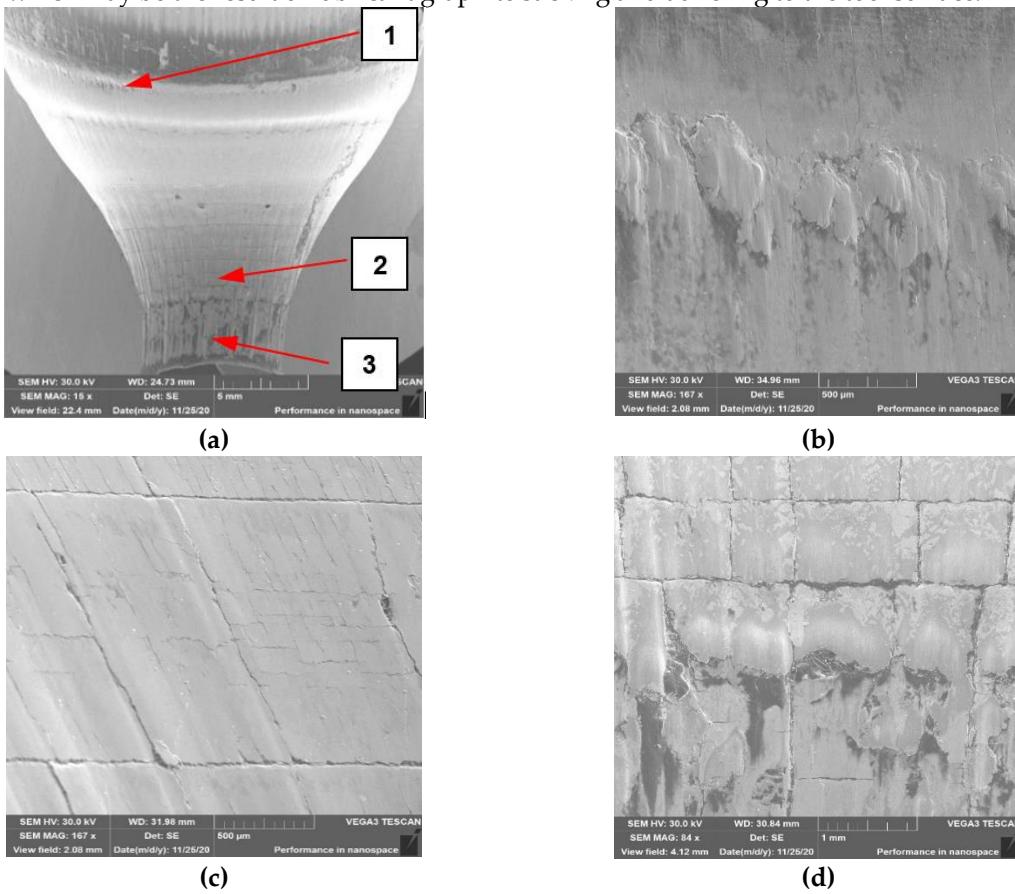
**Figure 13.** SEM analysis for tool 1: (a) cavity; (b) area in zone 1; (c) area in zone 2; (d) area in zone 3

To carry out the SEM analysis, due to the fact that the main part forming the forging, which is also the most worn out, each of the dies was cut from the bottom (the smallest diameter being the area forming the forging leg) up to a height of 30 mm. Fig. 13 shows the results of SEM surface topography analysis for each of the 4 dies. Additionally, the photos b to d (beside and below) show the enlarged characteristic tool areas. The analysis of the surface topography for the tool No. 1 (Fig. 13) shows that in area 1 – of the lower base of the preform bouncing off causes intensive abrasion of the tool material (Fig. 13a). In this area, the

scanning results showed material loss in the normal direction, and just above it (dark area) showed material growth, which may be the result of lubricant graphite sticking and adhering to the tool surface.

Loss of material in zone 1 may be the result of repeated impact of the preform with sharp edges in the lower base and tearing out (Fig. 13b) along with plastic deformation of small fragments of the tool material. A more thorough organoleptic analysis showed a clear step in this area, which is indicative of the occurrence of plastic deformation. In zone 2, the primary thermo-mechanical crazing and the beginnings of the formation of the secondary crazing are visible (Fig. 13c). In zone 3, thermo-mechanical crazing that is rubbed and torn in the direction of the material flow can also be observed. There is clearly a lack of sufficient amount of lubricant in zones 2 and 3, as evidenced by the formation of crazing and material abrasion. The detachable small hard particles of the material from zone 2 may cause the formation of longitudinal scratches on forgings, which can be seen particularly well in Fig. 13d and has been confirmed by tests using 3d scanning. The topography analysis for die no. 2 (Fig. 14) showed the presence of similar phenomena in the selected three zones.

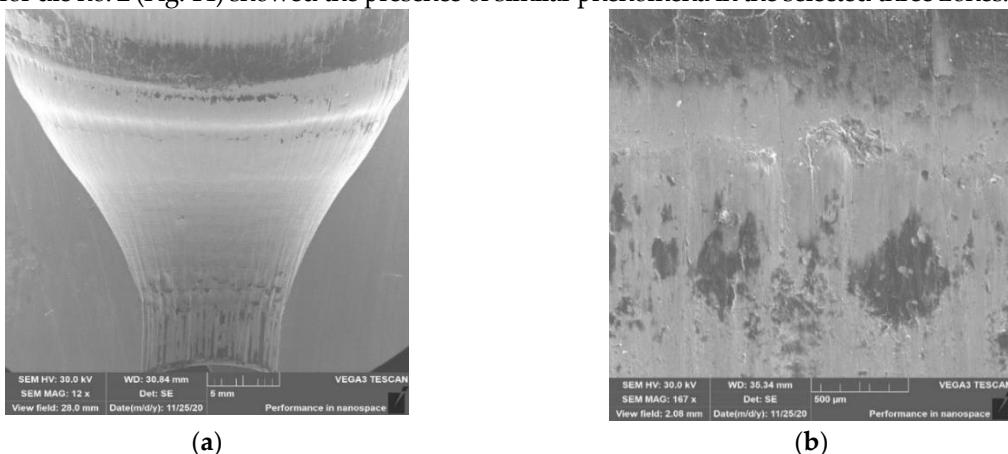
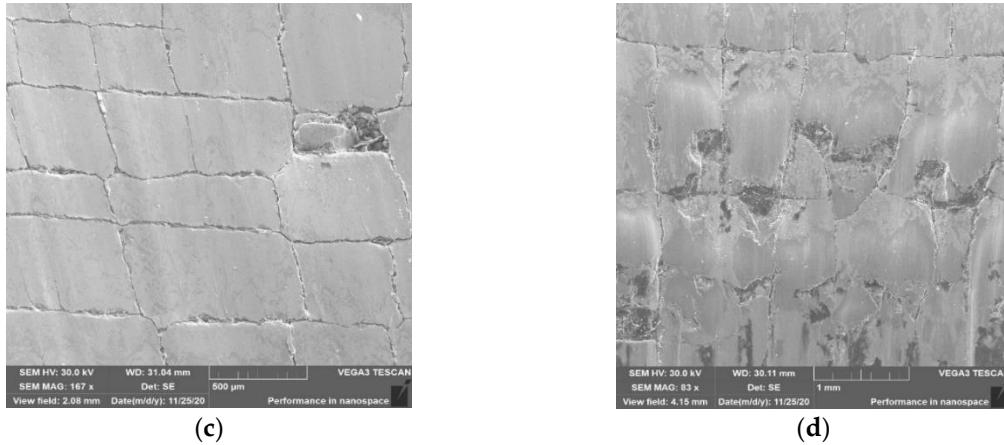
**Figure 14.** SEM analysis for tool 2: (a) cavity; (b) area in zone 1; (c) area in zone 2; (d) area in zone 3

The thermo-mechanical crazing in zones 2 and 3 (Fig. 14c) is slightly less visible, which may be indicative of slightly better tribological conditions in this case. In zone 3, we can see alternate tearing out of “square” parts of the crazing as material sticking progresses (Fig. 14d). Lubricant remnants can also be observed in some of the torn areas.

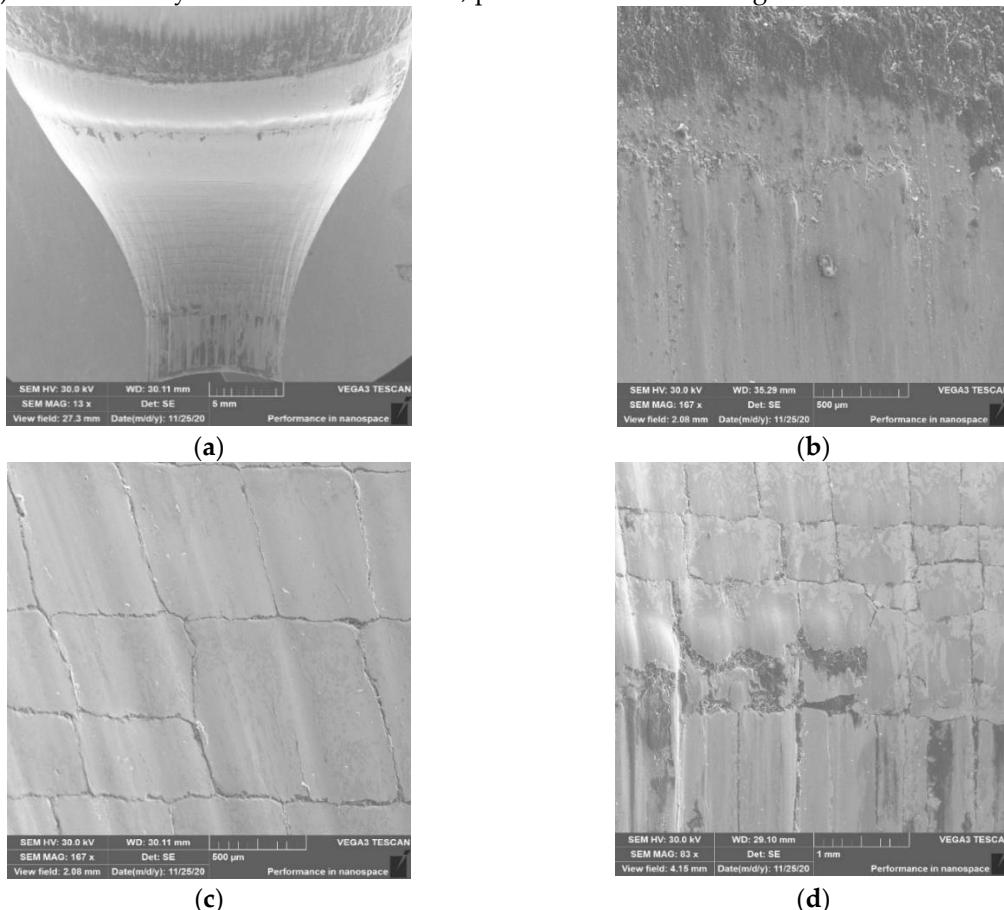
**Figure 15.** SEM analysis for tool 3: (a) cavity; (b) area in zone 1; (c) area in zone 2; (d) area in zone 3

The analysis of the SEM results for the 3rd tool (Fig. 15a) is almost identical to that observed for the 2nd die. It can be seen that the topography appears to be slightly softer for tool 2, which may be due to narrowly better lubrication conditions. This is also evidenced by slightly larger thermo-mechanical crazing in zone 2 (Fig. 15c) and a narrowly smaller number of tears, places of material sticking and lubricant residues.

The greater amount of lubricant in this case may result in better thermal protection of the tool against the hot forging and a certain shift in time of the destructive mechanisms causing thermal and thermo-mechanical fatigue on the surface of the tool cavity.

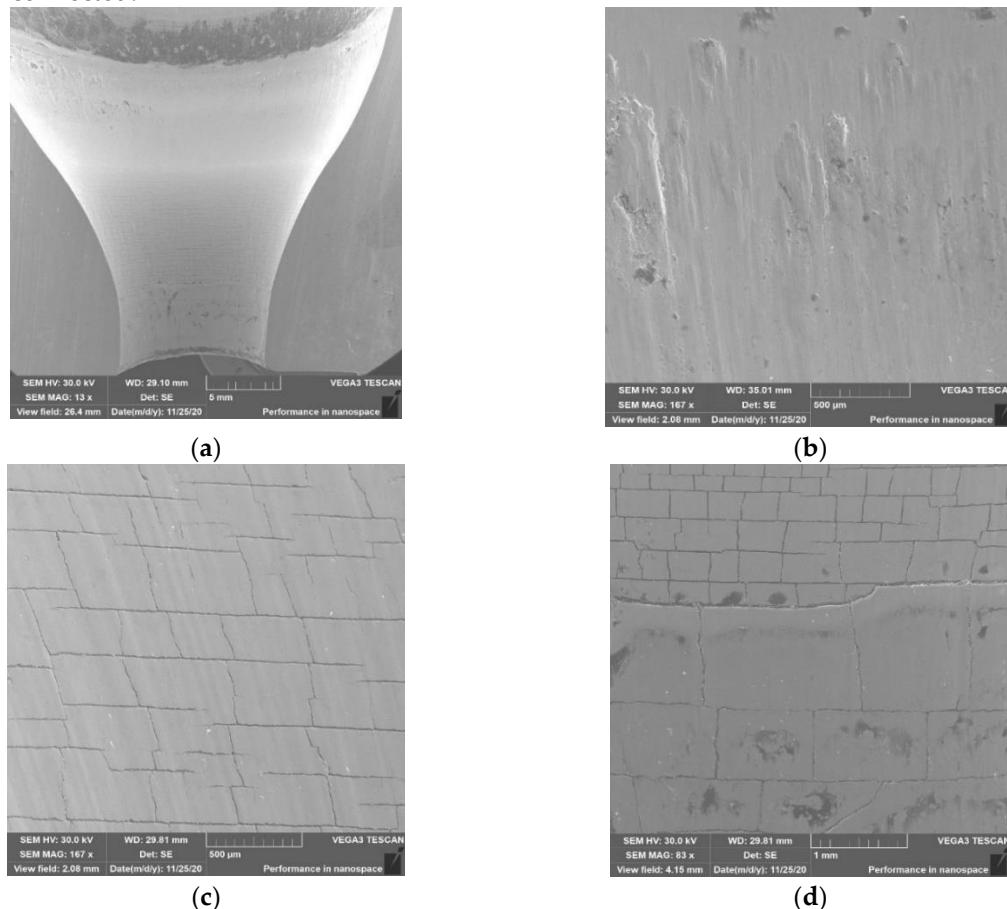
**Figure 16.** SEM analysis for tool 4: (a) cavity; (b) area in zone 1; (c) area in zone 2; (d) area in zone 3

In the case of the last tool no. 4 (Fig. 16), it can be observed that it is the least worn in all analyzed zones compared to the other three dies. In area 1, there is no visible change in the geometry due to plastic deformation, which may be the result of the most advantageous lubrication and on the one hand, better flow of the forging material, and on the other hand, protection of the lubricant against hitting the base of the preform and from contact and overheating of this area with the hot charge material. Areas 2 and 3 show characteristic thermo-mechanical crazing, but it is free of chipping and sticking, especially in area 2 (Fig. 16c). It can also be seen that the crazing is not yet fully formed, as some of the lines are not fully connected.

However, in the case of area 3, it can be observed that at the top the thermo-mechanical crazing is smaller than below. It is difficult to explain this situation and find its cause. Nevertheless, when analyzing the wear for tool 4, it can be concluded that the most favorable tribological conditions prevailed in the forging process, which were caused by an increased presence of a lubricant. Moreover, the higher pressure and longer lubricant supply time made it reach the lower parts of the die cavity and provided better lubrication, which translated into reduced wear and the formation of forgings without longitudinal scratches on the stem.

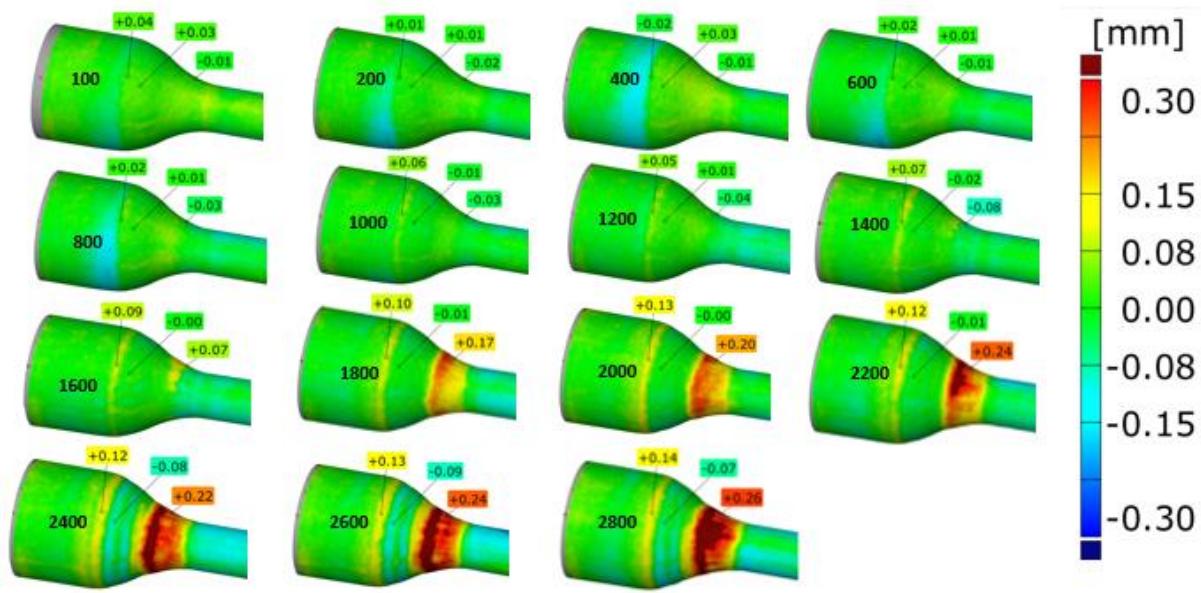
**Figure 17.** Comparison of the scans of forgings in the form of a change in the shape of the selected area in respect of the 100th forging, from 500 to 2800 items.

To confirm the completed laboratory tests, and subsequent tests in the industrial conditions of short production runs, a decision was made to perform industrial forging of a much longer run, until tool's complete deterioration. The settings of the lubricating and cooling system were adopted as for tool 4, i.e. 4 bars and 0.7 s of lubricant exposure time. The production process standard settings are most often 4 bars with the exposure time of 0.5s. Fig. 17 show the results of 3D scanning of forgings (every 100th

item) in the form of a color map of deviations describing the changes in the shape of the selected surface in respect of the scan of the 100th forging, which were obtained according to the measurement technique presented above.

The results suggest that, with the increasing number of forgings, a progressing wear of the tool is observed. According to the idea of the 3D method, a geometric growth of the material on the forging can be seen, which is mostly localized in the area of the stem (the most deformed part of the forging) in the form of long longitudinal groove-like scratches (Fig. 17). In turn, slightly above this zone (on the profile), we can observe a growth of material on the forging together with the increasing number of forgings, pointing to a loss of material on the tool and as well as it is possible to determine the history of wear-performance of the die. A more complex macro-analysis as well as the use of FEM (high values of normal pressures and a long contact time were observed) made it possible to establish that, initially, this area was dominated by plastic deformation, which in time transformed into thermo -mechanical fatigue and abrasive wear. Base on the above results Fig. 18 shows the results of 3D scanning of the analyzed die after 2830 forgings together with the marked zones, in which we can distinguish between the dominant destruction mechanisms, which will be identified and confirmed by further research.

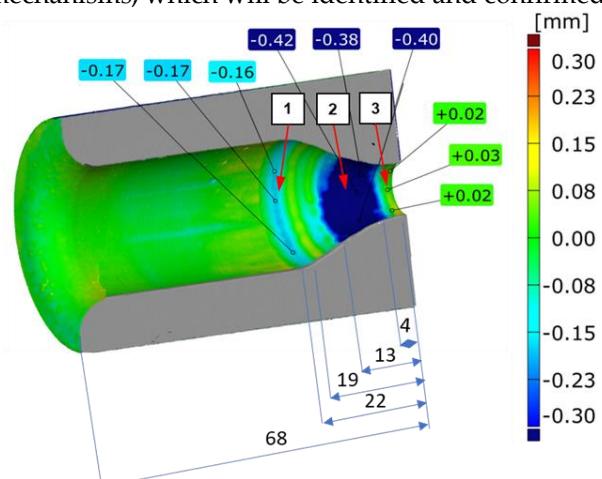
**Figure 18.** View of a scan results of the die after 2830 forgings with the characteristic zones (1-3)

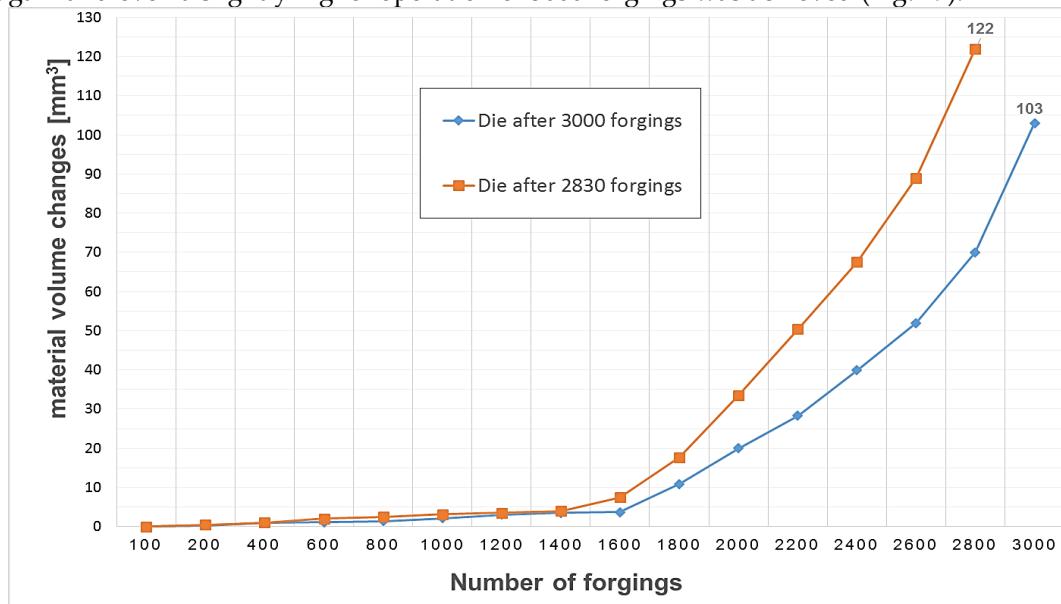
Figure 19. Volume changes – loss of material for the selected tools calculated from forgings

Additionally, in order to determine the changes and their intensity during the entire operation of the selected tools, an analysis of the volumetric changes of the material was carried out, using cyclically collected forgings from the process. It should be noted that the tests for the same settings were repeated once again and even a slightly higher operation of 3000 forgings was achieved (Fig. 19).

When analyzing the graph, it can be noticed that exploitation process is characterized by an increase in the material on the forging, which, based on the reverse scanning method developed by the authors, means that in dies cavities there is a loss / wear of material. This phenomenon is more intensified and the material loss process increases significantly after the production of 1600 forging, until a loss of 122 mm<sup>3</sup> is obtained for die after 2830 forgings and up to about 103 mm<sup>3</sup> for tool after 3000 pieces.
