Effective Parameters on the Wear Behavior of High-Pressure Grinding Rolls and Development of the Process for Iron Ore

Keywords: High Pressure Grinding Rolls (HPGR); Iron Ore; Concentrate; Wear Behavior; Process Development

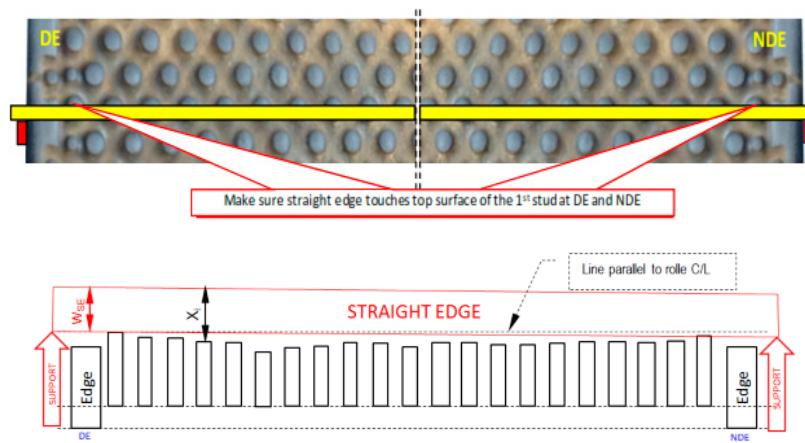
For assessment of wear behavior of the HPGR rolls (Fixed and movable) which consists studs and tire surface, the straight edge measuring tools was used as shown in Figure 1. The following equipment for the measurement were used: Vernier caliper with one bracket shortened, Depth gauge and straight edge tool, two magnetic brackets, sharp tool for autogenous protection layer removal and permanent market.

Figure 1. Position of the straight edge on the tire surface.

For stud length measurement, the following procedure was performed: the magnetic brackets at both end of the tire at reference edge protection elements were set, then the straight edge in the forks of the magnetic brackets was set and sure it was in the line with selected row of studs. Straight edge bottom surface of studs touched the top surface of studs at both ends of the tire. Once the straight edge was set up, the distances (X_i) was measured from the top of the straight edge to the surface of each stud which is representative for the wear of the roller from NDE tire side. Stud wear was assessed on minimum two rows of studs for each tire. Measurements of the wear rate of the masters were made at 6500, 7500, 8500, and 9500 operating hours. At the same time, sampling of the feed entering the HPGR was carried out to prepare the sample for performing the required laboratory tests.

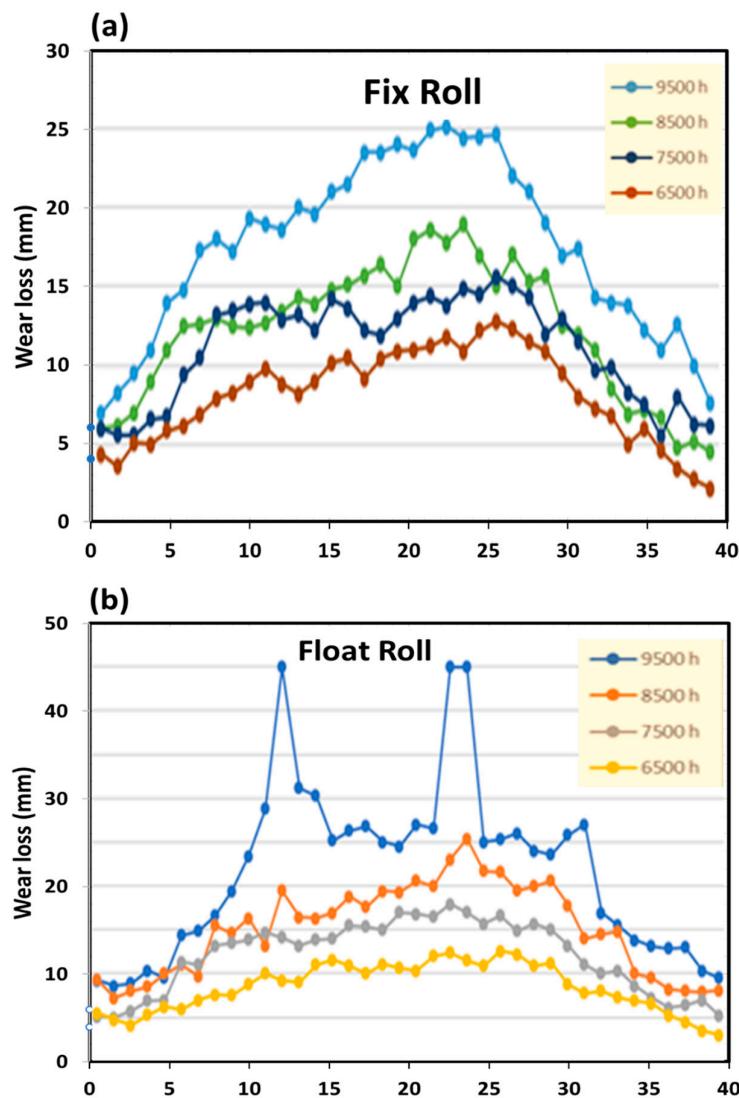
Based on the proposed methodology, the wear rate of the roll surfaces was measured. Figure 1 illustrates the wear distribution on the surfaces of the fixed and floating rolls. The wear rate is higher at the center of the rolls compared to the edges, and the wear on the floating roll is significantly greater than that on the fixed roll. The results indicate an increasing trend in the wear rate of the floating roll. After 8,500 hours of operation, the wear rate exhibited an upward trend in both rolls. The fracture and replacement of studs are also evident in both the floating and fixed roll curves.

The conducted analyses indicate that the wear and corrosion of the studs range from 5 to 13.6 mm at the edges of the roll and from 11 to 30 mm at the center of the roll in the measured section. The minimum remaining depth for installing a replacement stud at 9,500 hours of operation is 15 mm at the center of the roll (Figure 2). It is worth noting that each stud has a diameter of 16 mm and a height of 45 mm, of which 5 mm protrudes above the tire surface, while the remaining 40 mm is embedded inside the tire (Figure 3).

Figure 2. Wear curve of (a) roll-fix studs and (a) float roll HPGR120MI01 at operating hours 6500, 7500, 8500, 9500.

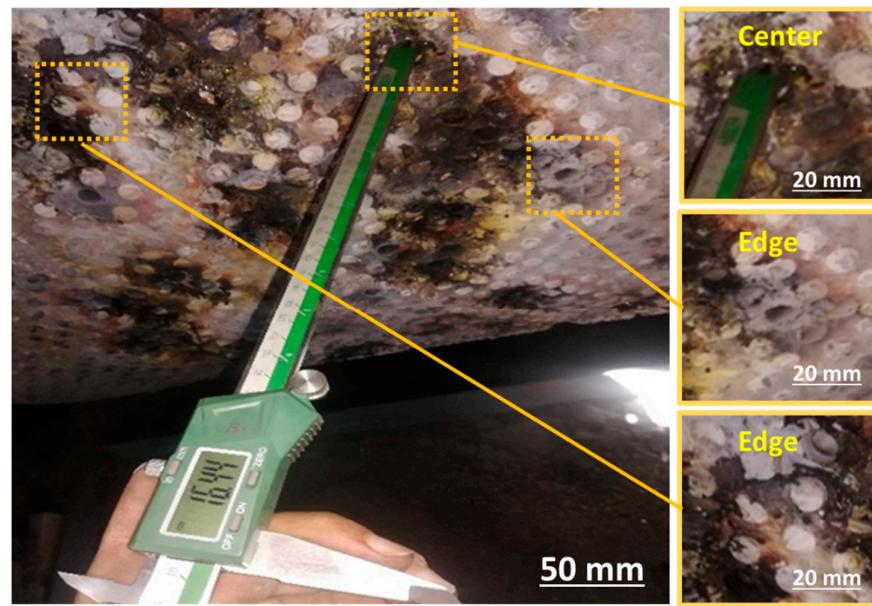
Figure 3. Tire shell thickness at the center and edge of the roll for stud placement.

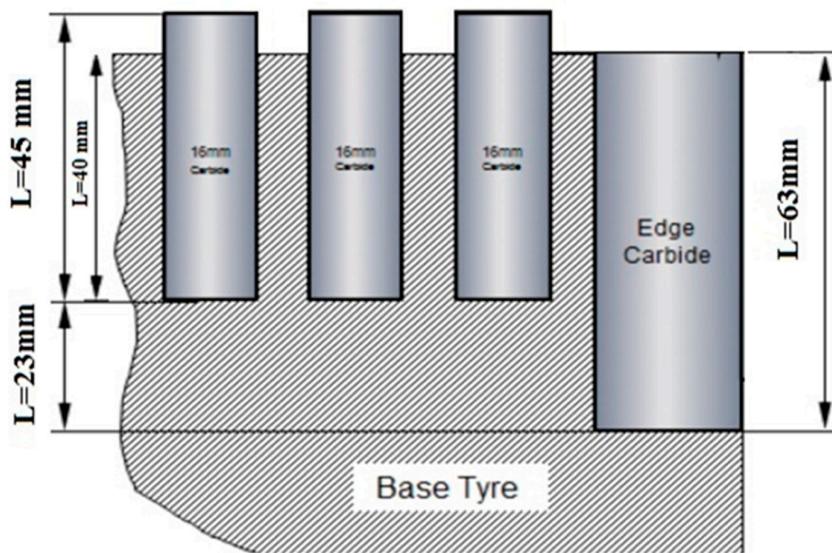
Figure 4. Arrangement and dimensions of studs and Edge-Blocks inside the tire.

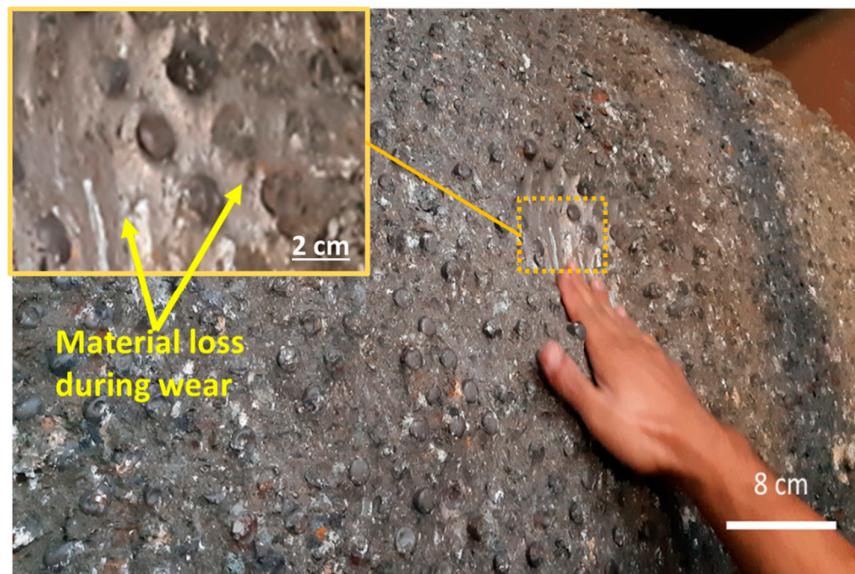
Given the surface deterioration of the roll in certain sections of the tire after crushing 4,800,000 tons of iron ore lumps (Figure 5), along with the assessment of roll surface wear over specified time intervals, the monitoring of other measurable parameters affecting roll wear was carried out. These parameters include the physical and chemical properties of the feed material and the machine settings, as detailed below.

Figure 5. Initiation of roll surface wear due to stud loss (operating at 6000 hours).

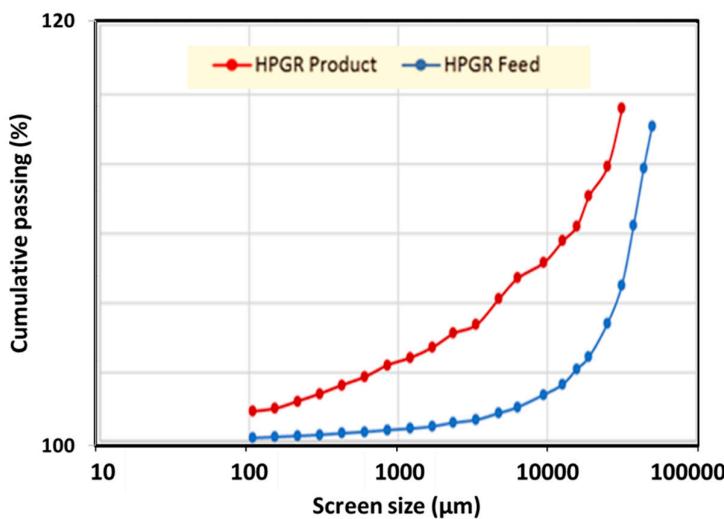
- As shown in Figure 5, the actual feed material entering the HPGR has a particle size distribution of $D_{80} = 45$ mm and $D_{100} = 70$ mm.

- 10% of the feed material has a particle size between 50 and 70 mm, while only 45% is below 30 mm.

- 80% of the HPGR product has a particle size of less than 25 mm ($D_{80} = 25$ mm), while 20% is larger than 25 mm.

- The results indicate an increase in the feed particle size, leading to a rise in the HPGR product size from 8 mm to 25 mm and an increase in the circulating load from 40% to 50%. The increase in circulating load directly impacts the reduction of fresh feed throughput and alters the particle size distribution of the HPGR feed.

Figure 6. Feed and Product Particle size distribution.

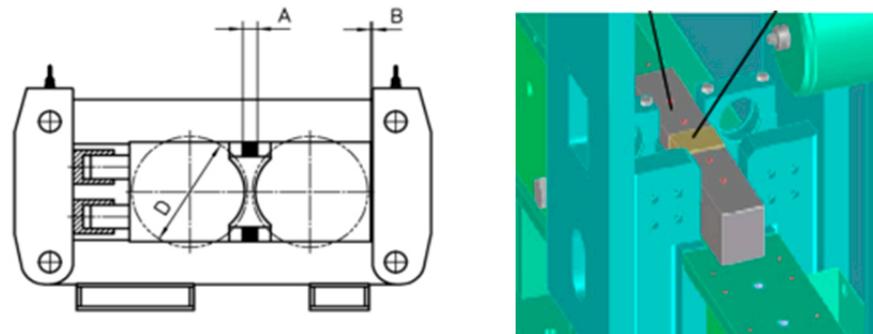
To adjust the gap, an initial pressurization was applied to bring the floating roll as close as possible to the fixed roll. The gap measurement was then conducted using a paste test, and the Type 2 shim plates were removed to set the zero gap (Figure 7).

Figure 7. Placement of gap adjustment shims (Shim A) at the top and bottom sections. Placement of type A shim plates for zero-gap adjustment.

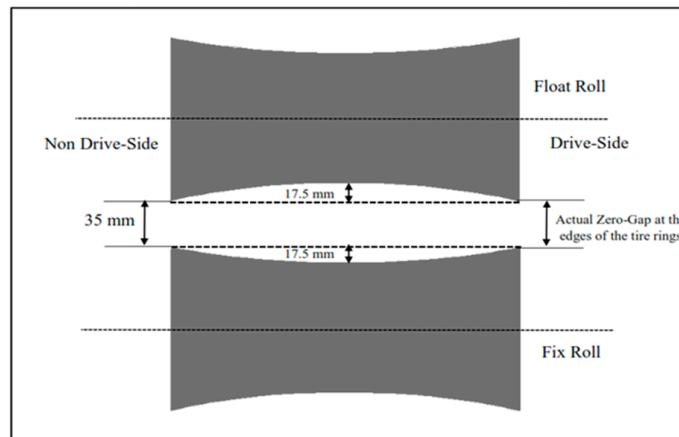
Investigations revealed that the gap was not adjusted during operation despite roll wear and changes in feed size distribution. As a result, the zero-gap increased from 35 mm to 70 mm (Figure 8) without any adjustment to the shim plates. In other words, the zero gap exceeded the required working gap of 55 mm.

Additionally, when the rolls experienced severe wear, and the required product size was not achieved, the operations team, unaware of the extent of wear (due to uncalibrated distance sensors), reduced the hydraulic pressure behind the rolls to 145 bar in an attempt to achieve the required 55 mm working gap. However, this action resulted in:

- Increased product size
- Higher circulating load
- Reduced displacement of the floating roll
- Shortened lifespan of the floating roll

Figure 8. Zero-gap measurement (equipment operating at 9500 hours).

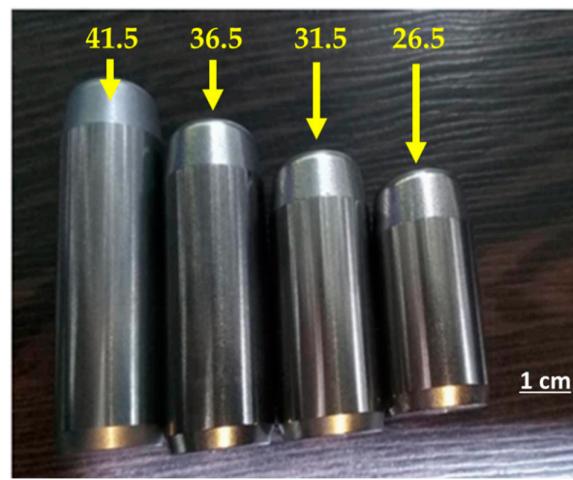
Stud fractures occur due to the entry of iron pieces and foreign materials larger than the zero gap into the gap between the rolls. Additionally, some studs have completely detached due to excessive tire wear, making the tire more vulnerable to damage. In the event of stud breakage or detachment, a healthy stud must be replaced immediately to prevent the failure of adjacent studs. The height of replacement studs is not always constant (Figure 9). As the tire shell thickness decreases, shorter studs are selected to prevent excessive height differences, which could lead to increased wear or fracture (Figure 10). Investigations indicate that there has been no systematic inspection program for monitoring the tire surface and studs, resulting in significantly extended replacement intervals.

Figure 9. Sizes of replaceable studs: 26.5, 31.5, 36.5, 41.5.

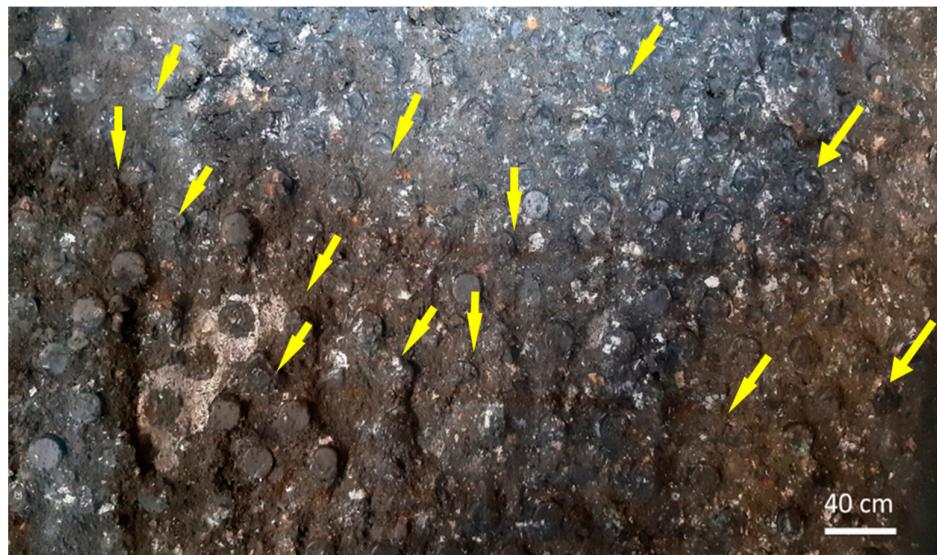
Figure 10. Failure to replace broken studs and continuation of the crushing operation.

Failure to replace broken studs promptly (every 175 hours) has led to the loss of multiple adjacent studs and, ultimately, the deterioration of the tire surface. Considering the wear rate, 26.5 mm studs—the smallest available size—were used as replacements at the center of the rolls. This resulted in a maximum protrusion of 11.5 mm beyond the tire surface, causing the newly installed studs to fracture once the comminution process resumed (Figure 9). This issue applies to all excessively worn studs.

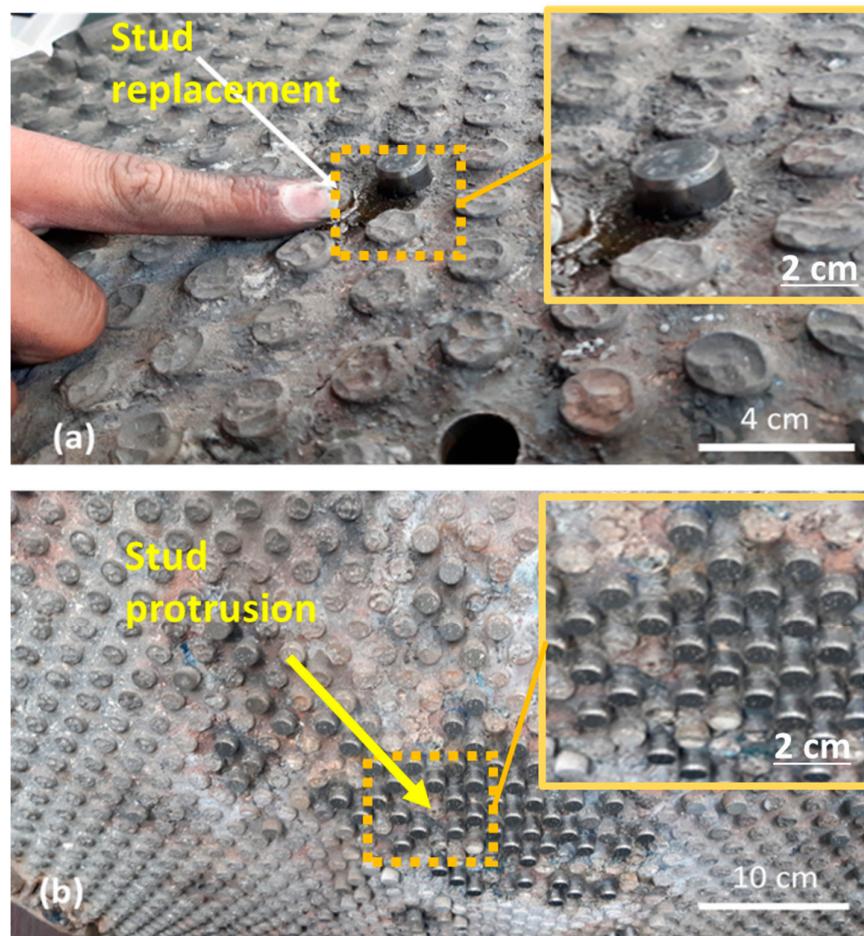
Figure 11. (a) View of simultaneous replacement of multiple studs (b) Stud protrusion from the tire surface.

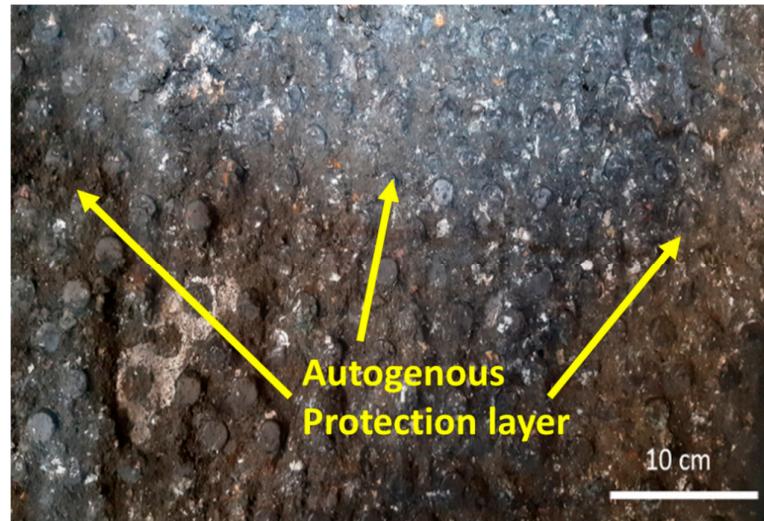
This way the roll surface is coated and protected from the direct wear of the mineral rock (Figure 12). The autogenous surface generally prevents larger rocks from directly impinging on the roll surface, and provides a shield from the abrasive movement of material parallel to the roll surface. For generating a competent autogenous wear surface, the feed of a High Pressure Grinding Roll should preferably contain some moisture. The amount of moisture in the feed entering HPGR should be less than 5 percent. Under operating conditions, the moisture content of the feed entering the HPGR120MI01 is 3-4%, and a protective layer is formed well on the surface of the roll.

Figure 12. Formation of APL for tire surface protection.

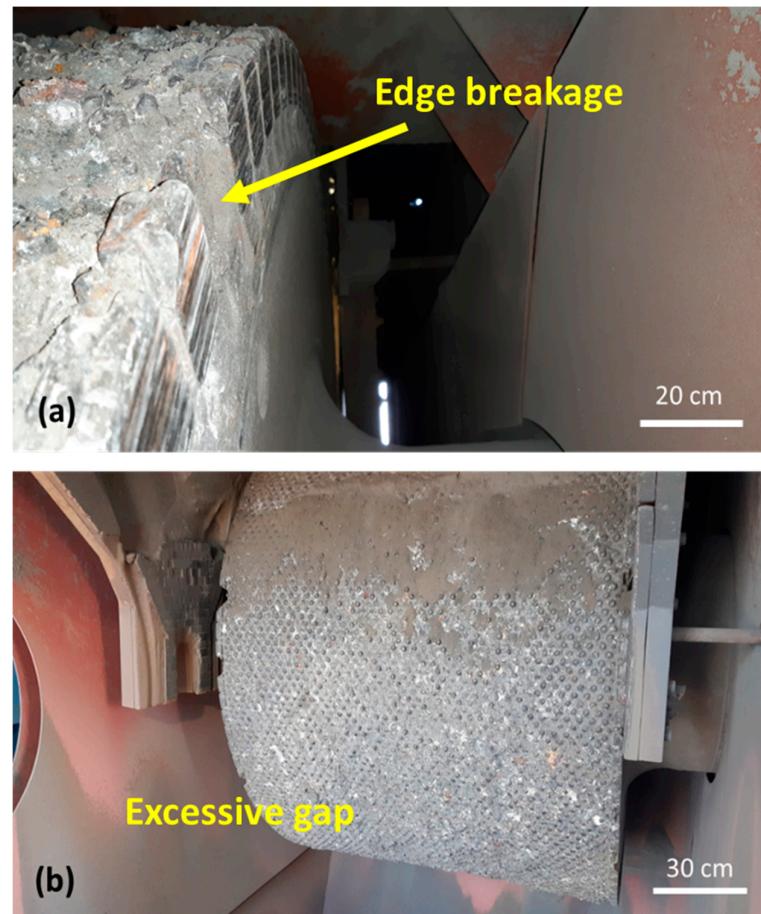
This is a further contribution to lower the cost of wear. Figure 13 shows the check plate not adjusting and causing wear on the roll and breaking the edge block.

Figure 13. (a) Improper check plate adjustment leading to edge block breakage and check plate surface damage. (b) Excessive gap between the check plate and the tire.

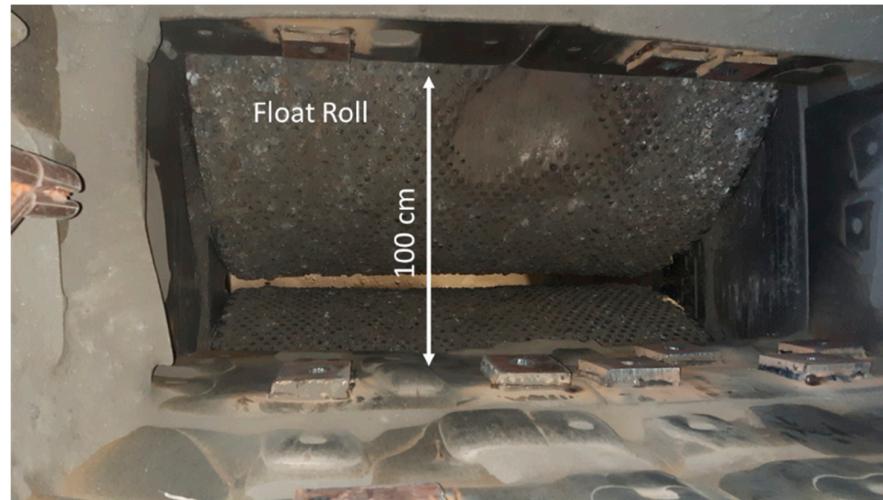
Figure 14 illustrates that in HPGR120MI01, the spacing between the rolls was 100 cm, whereas it should have been adjusted to a maximum of 20 cm. Failure to comply with this requirement by the operator has directly contributed to increased wear on the roll flutes, breakage of the studs, and a reduction in the service life of the tires.

Figure 14. Misalignment of the gravity feeder, causing material spillage onto the flute roll.

- Misalignment of the gravity feeder has resulted in direct feed impact on the roll flute surface, causing excessive wear on the roll flute compared to the fixed roll, ultimately leading to tire failure.

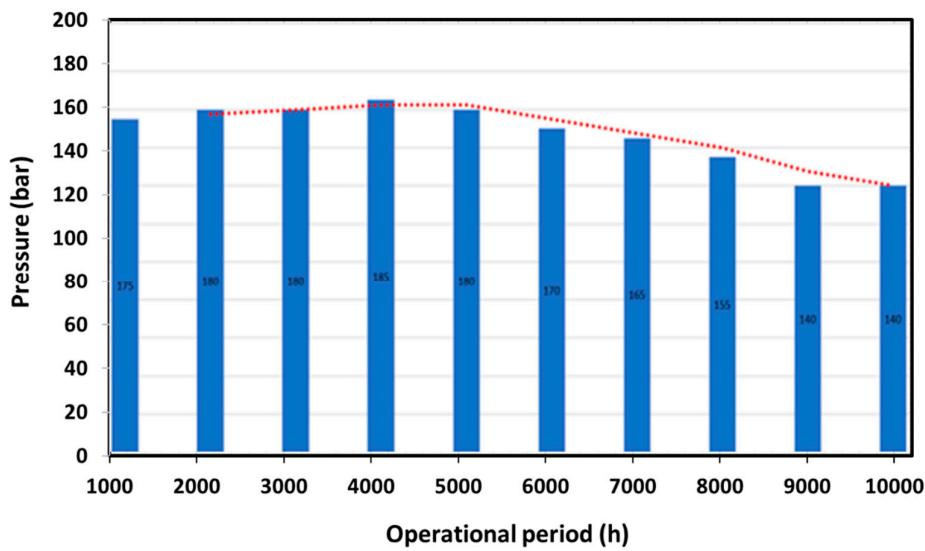
According to operational records, at the beginning of the commissioning phase, the system pressure was set between 180–185 bar to achieve the desired product particle size. Over time, as roll wear increased, operators reduced the pressure. Between 8,000 to 10,000 operating hours, the average working pressure used was around 145 bar (Figure 15).

It is noteworthy that increasing the pressure from 185 to 200 bar did not result in any significant reduction in product particle size, indicating that higher pressures beyond a certain threshold do not necessarily improve product fineness.

Figure 15. Trend chart of roll pressure variations during the operational period.

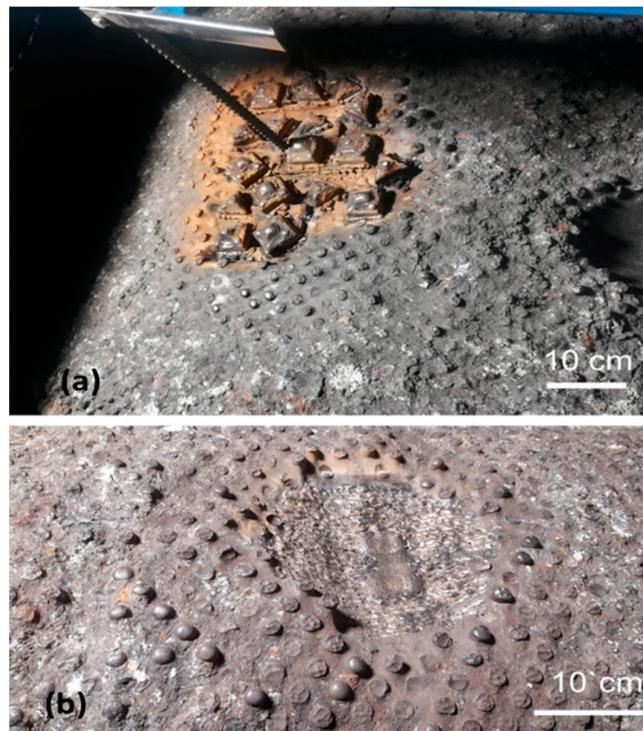
Due to increased wear on the tire surface, higher vibration levels in the equipment, and frequent stoppages caused by non-compliance with the aforementioned operational parameters, welding and refilling the tire surface was implemented as a temporary corrective measure by the operator. This process continued until the roll replacement at 10-256 operating hours.

Figure 16. (a) Filling and welding of the tire surface; (b) Wear and loss of the welded section.

However, this action did not improve the performance of the HPGR and ultimately resulted in additional time and cost expenditures. Furthermore, the welded areas experienced severe wear and quickly reverted to their original worn condition within a short operational period, rendering the repair ineffective.
