# Based on historical seismic damage data to rapidly assessment the vulnerability of structures in rural village

**Abstract:** This study investigated and classified typical structures in rural village and analyzed the vulnerability of various typical types of structures. Based on the statistics of earthquake damages with magnitudes above 5 from 1996 to 2013 in China, the damage matrixes of different types of structures in rural village are obtained. And The vulnerability index and the vulnerability equation of structure are crucial to assess the earthquake losses of typical structures under different magnitudes earthquakes. According to the seismic loss of different types of structures under different earthquake magnitudes, there are possible to improve the seismic resilience of the buildings in rural village. Moreover, the regional vulnerability is analyzed by  $\beta$  probability distribution function, and the comprehensive seismic performance index of different types of agricultural buildings in the region is obtained. The main research is to predict the loss of different types of structures under different earthquake magnitudes in the future, and to provide technical support

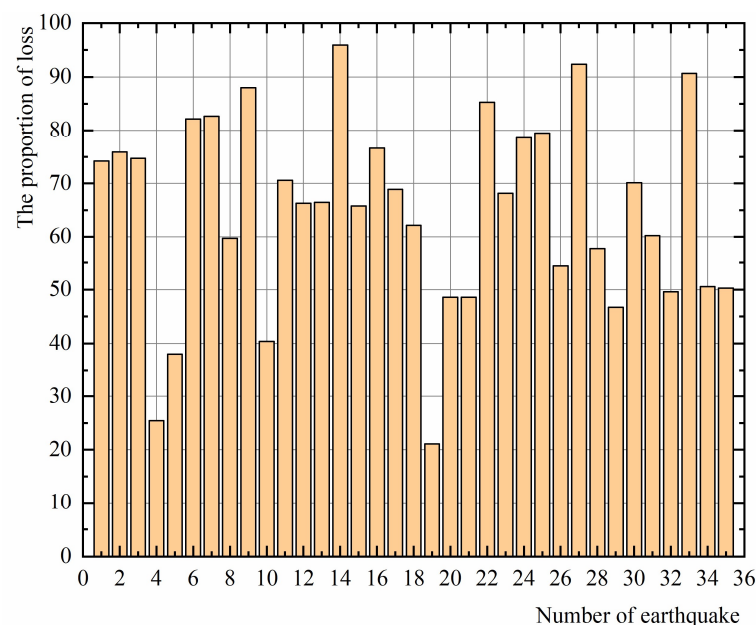
**Figure 1.** Proportion of loss of rural structures in earthquakes with magnitude 5 or higher in China from 2000 to 2012.

The main reason lead direct economic losses are large number of buildings collapsed in the earthquake. Statistics show that the damage and loss to structures in rural village under Mw 7 earthquakes accounted for more than 60% - 96.7% of the total direct economic loss (see Fig 1). The seismic damage of residential buildings in different areas is quite different. The geographical environment in the western region is relatively poor, and the economic level is relatively backward. The degree of seismic damage is relatively heavy. The central and eastern regions of China are densely populated, and the economy is relatively developed. The renewal period of structures in rural village is short. The quality of buildings is high, and the degree of earthquake damage is relatively light. Traditional adobe structure, Brick-concrete structure, Wooden structure and Stone structure, Brick-wood structure are prone to collapse or severe damage under earthquakes. By comparison, the seismic performance of brick-concrete structure is better. Earthquake secondary disasters are severe, especially due to the nature of the epicenter and the special terrain. Sand liquefaction, landslides, landslides, mudslides and other phenomena are common occurrence, which magnifies the earthquake effect. The impact of small and medium-sized earthquakes below Mw 5 on rural residential buildings cannot be ignored, and even some Mw3 and Mw4 earthquakes have caused of millions USD in economic losses and casualties. The losses of private buildings caused by small and medium earthquakes are equal to the total disaster losses.

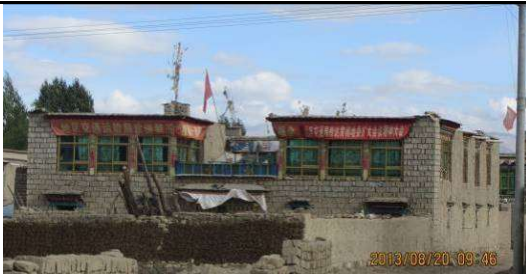
1. Adobe structures (see Fig 2) generally do not have foundation treatment. The wall is built with adobe or rammed soil. Generally, adobe blocks, which use cohesive soil, are often mixed with wheat straw as tie bars during the production process. In the process of building the wall use dry soil for level, the adobe blocks are laid vertical or horizontal for the wall. Meanwhile, the structures have smaller doors and windows. Roofs are used wood, which built by two methods that are hard frame supporting and wooden roof truss. The support loads of adobe structure are vertical wooden pillars and soil wall, which is the main structural form of structures in China before 1950s. With the rapid development of the economy, the proportion of adobe structures in economically developed areas is very low. It is mainly distributed in economically backward rural areas in the west and northeast China.

Figure 2. adobe structure

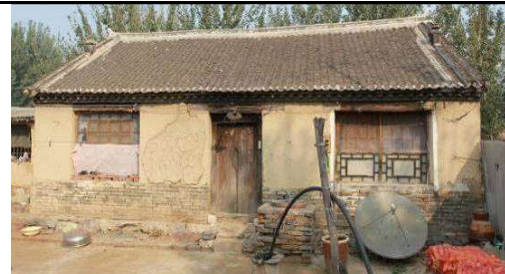
2. Brick-adobe structures (see Fig 3) is the lower brick upper adobe or the outer brick inner adobe. Some of the gables are made of adobe and other walls are built with bricks. In general, the roof weight is borne by the brick-adobe wall. There are two types of roofs for brick-adobe mixed structures: one is for hard frame supporting and the other is for wooden roof trusses. Brick-adobe structure is a type of transitional structure between adobe structure and brick-wood structure. It is a result of the economic development, and the safety and reliability of rural buildings has been paid attention, but this kind of structure use two type of materials with different mechanical properties, including the connection of the two materials. However, the connection between the two materials is not reliable. From the perspective of seismic damage, the seismic capacity of the brick-adobe structure is even lower than that of the soil structure.

Figure 3. Brick-adobe structure

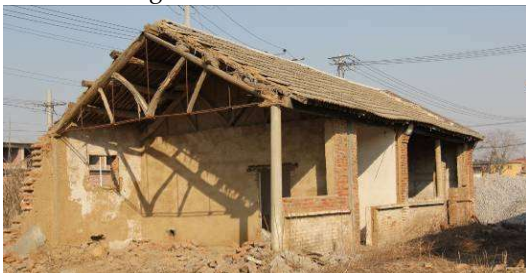
3. The horizontal and vertical load-bearing members of wood frame structures (see Fig 4) are wooden members. Wooden columns are used as vertical supports. Bricks, wooden boards or adobes bricks are used as retaining walls. The roofs are in the form of wooden roof trusses. This structure has four types of roofs: flat roof wooden structures. (This kind of roof truss is thick with thin columns, wooden columns are built into the retaining wall, and there is no connection between the wooden columns and the wall. There is no concealed joint between the wooden columns and the beam. There are no other diagonal braces or connections. Measures, this structural form is widely distributed throughout the country, mainly in northern regions and western regions with less rain); Slope roof wooden frame (the main beam in this type of roof truss is relatively thick, with beams of different heights on the melon pillars, sandals are placed on each melon pillar, and sandalwood is laid on the sandalwood); triangular wooden pillar wooden roof trusses (wood pillars are used vertically Load-bearing, triangular wooden roof trusses are placed in each room, wooden

posts are connected to the roof mortise and tenon, sandalwood is placed at the nodes of the two isosceles of the triangular roof truss, and rafters are laid on the wooden rafters. This structure is mainly distributed in the east area; piercing wooden frames (each frame is supported by 3-5 wooden columns in the vertical direction, the top and middle of the wooden columns are connected by piercings, and the short columns in the upper part of the frame are also connected by piercings and wooden members. It is relatively rich, and generally consists of tenon-joint, dovetail connection, butt joint, etc. This type of structure is mainly distributed in southwest China.

Figure 4. Wooden frame structure

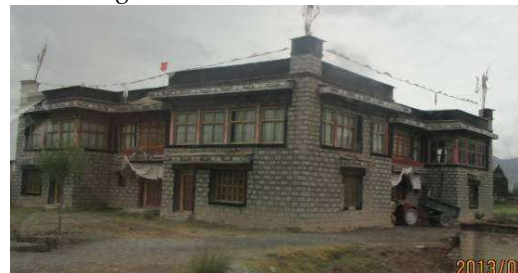
4. Stone structures (see Fig 5) is vertically supported by stone walls. The stones were often built with silty clay or cement mortar. This type of structure is restricted by stones and is mainly distributed in mountainous areas such as the western and southeast coasts of China.

Figure 5. Stone structure

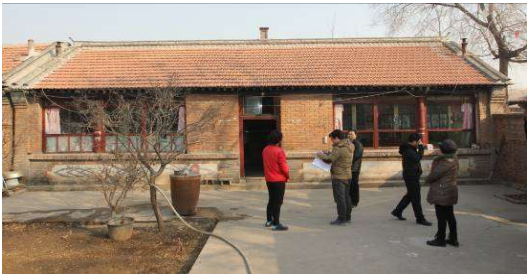
5. Brick-wood structures (see Fig 6) are currently the most common structural form used in rural village of China. The main supporting structure of a brick-wood structure is masonry structure or wooden truss structure [12-18]. The roofs of brick and wood structure are wooden roofs, which have four types such as double-slope roofs, single-slope roofs, and flat roofs. Most of them are in the form of hard frame supporting. The brick walls of the structures are mainly used as vertical load-bearing members. Masonry materials generally include mud, slag mortar, cement mortar. The wall varies significantly from north to south. The temperature in the northeast is relatively low. In order to keep warm, the thickness of the wall is 49cm. The thickness of walls is 37 cm mainly distributed in the central and western regions of China.

Figure 6. Brick-wood structure

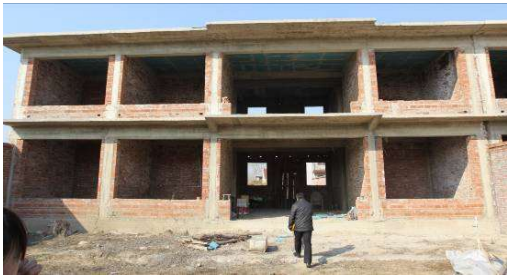
6. Brick-concrete structure (see Fig 7) is the most commonly used structural form in rural villages of China in recently years. Vertical brick walls are used to load-bearing walls. The brick walls are built with cement mortar. The form of roof has precast slab or reinforced concrete cast-in-place. Due to the unreliable connection between the prefabricated slabs and the prefabricated slabs and the wall, the seismic capacity of the two brick-concrete structures is quite different.

Figure 7. Brick-concrete structure
