# Casual-Nuevo Alausí landslide (Ecuador, March 2023). A Case Study on the Influence of the Anthropogenic Factors

**Abstract:** Landslides in Ecuador are one of the most common fatalities in natural hazards, such as the one on March 26, 2023. A large-scale landslide occurred in Alausí, Chimborazo province, causing 65 fatalities and ten disappear people, significant infrastructural damage, and the destruction of six neighborhoods. The study presents a detailed case analysis of the anthropogenic factors that could contribute to the instability of the affected area. Field investigations and a review of historical, geological, and social information were the basis for analyzing the complex interactions between natural and human-induced conditions. Key anthropogenic contributors identified include unplanned urban expansion, improper drainage systems, deforestation, road construction without adequate geotechnical support, and changes in land use, particularly agricultural irrigation and wastewater disposal. These factors increased the area's susceptibility to slope failure combined with intense rainfall and seismic activity, which could be the cause of the rupture process. The study als

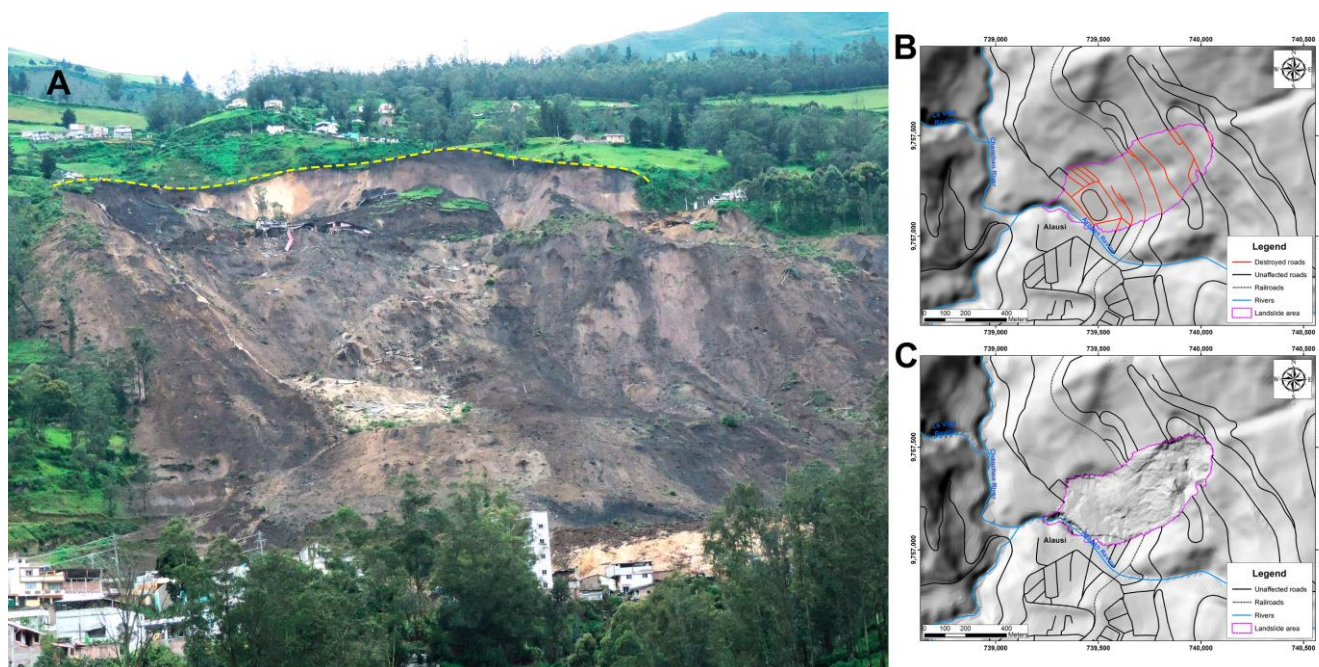
**Figure 1.** (A) A panoramic view from the West of the 2023 Alausí landslide, one of Ecuador's largest and mortiferous landslides in the last years (yellow dashed line marks the landslide crown). (B) Digital elevation model (DEM) of the area before the landslide event (2019). (C) DEM showing the changes in elevation at the affected area in 2023 (modified DEM from free data at the Ecuadorian Militar Geographic Institute geoportal [9]).

The Alausí landslide (Chimborazo province, Ecuador) was triggered on March 26, 2023 (21:13 local time, Sunday), after a slow precursor process that was initiated in December 2022 (Figure 1 A) [6,7]. It can be considered a major catastrophic event that devastated over 24 hectares (cut and fill) and caused significant loss of life and infrastructure damage. It had a big size [8] with ~236 m wide, ~300 m length, and 18 m deep in average, which mobilized more than 1.3 million m<sup>3</sup> (volume obtained from the difference in digital elevation models shown in Figure 1 B and Figure 2 C). The interplay between natural and anthropogenic factors is the article's aim as a previous interpretation of the process. Also, it can be said that this landslide (as a big disaster event) highlights the need to understand human responsibilities in the triggering of landslides and to find which ones have been the probable causes of the initiation of the mass movement. Alausí canton (located in the Chimborazo province and near the same name famous volcano) has a long history of landslides and seismic events, so that kind of hazard is well-known by the population, for example, in the nearest village of Chunchi [5].

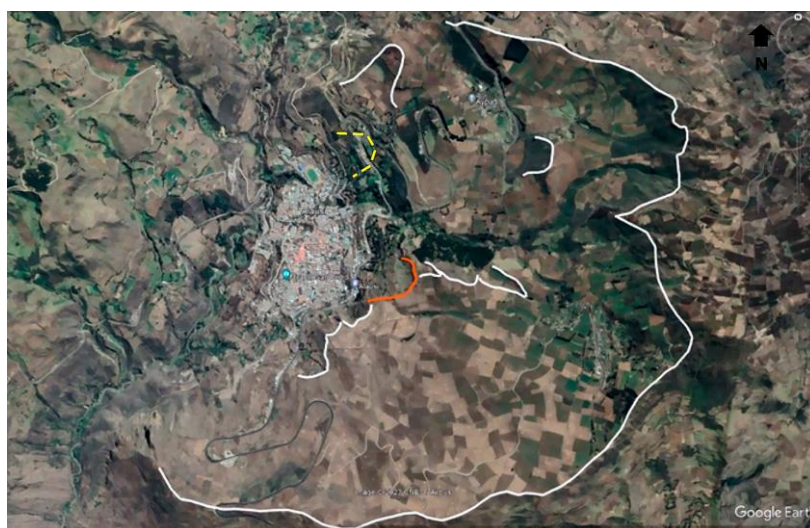
**Figure 3.** Aerial view of the Alausí landslide area (village at the center of the picture and the crown in dashed yellow line) showing several scarps (white lines) related to possible ancient mass movements, including the Cerro Gampala landslide scarp (in red line). Modified from Google Earth [17].

The landslide and its surroundings (direct and indirect influenced) are positioned west of the Pachamama plateau, between it and the Alausí River. This area forms a general slope with variable gradients, featuring horseshoe-shaped escarpments in the upper part (Figure 3).

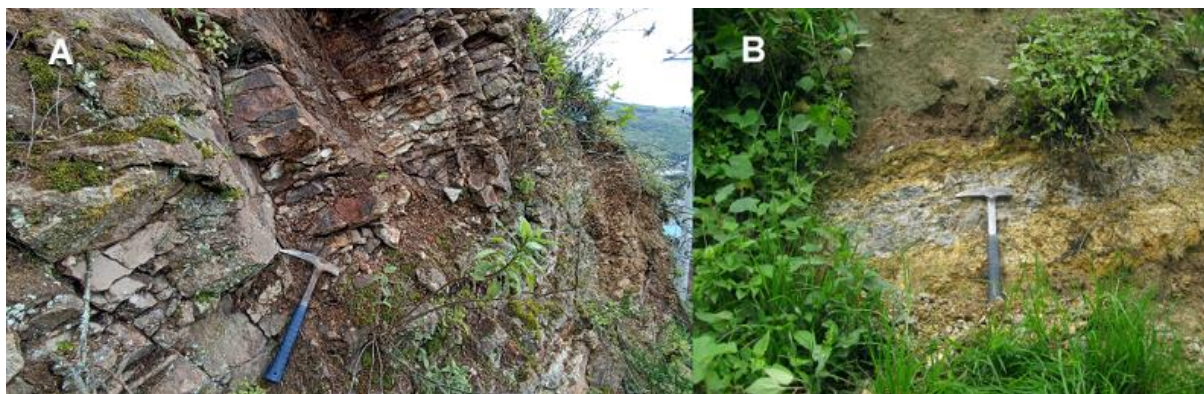
**Figure 4.** Altered and weathered rock outcrop located to the Northwest of the Alausí Coliseum. A predominant white coloration in the rocks (possibly hydrothermal alteration) and a high grade of fractures and discontinuities can be observed (A). Outcrop of four extremely weathered rocks of reddish-brown color (lower layer), creamy-yellowish layer (layer coinciding with blue hammer handle), light gray layer, and yellowish layer, overlain by consolidated superficial clastic deposit (B).

The subvolcanic rocks comprise rhyolites, exposed on the main scarp and over the E-35 Road, South of the Casual-Nuevo Alausí landslide crown. These rocks exhibit intense hydrothermal alteration, including silicification, kaolinization, and pyritization. X-ray diffraction analysis performed at FIGEMPA Faculty [7] determined that the rock contains mostly kaolinite and, to a lesser extent, cristobalite. These rocks possibly constitute the Southern extension of the rhyolitic body reported by Dunkley and Gaibor [16] further North of Alausí. Altered and weathered rocks of whitish and reddish yellow color are exposed in a small outcrop Northwest of the coliseum (UTM, WGS 84: 739,410N, 9,757,428E), which are highly jointed and whose main families have a N70E/20NW and N20E/40SE orientation (Figure 4 A).

The studied area has a complex geology in the basement and soil. Fractured rocks with high permeability [22] where hydrothermal alteration was evidenced in that investigation (see Figure 4), which weakens the rock strength and makes it easy to mobilize and develop excavation processes by people [23,24]. Additionally, the low permeability of the Cangahua formation soils joint to the high-grade slopes forces the constructors to fill or deviate the stream channels.

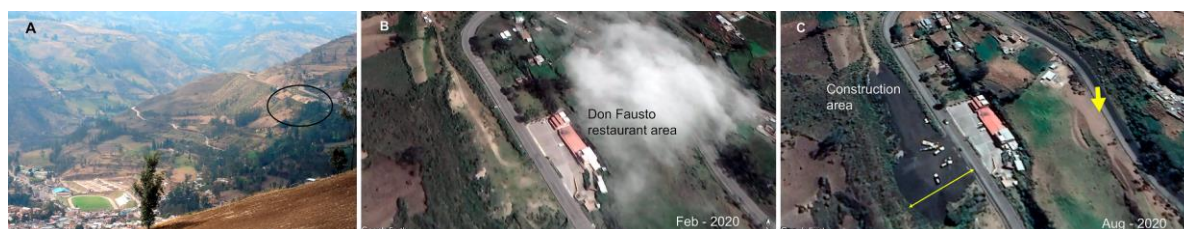
**Figure 7.** (A) A view of the location of the anthropic landfill between the Casual and Nuevo Alausí neighborhoods (black circle). That anthropogenic deposit was located in the head of the area of the landslide (the Don Fausto Restaurant is to the right of the circle). (B) On February 4<sup>th</sup> 2020, it can be noticed that no anthropic landfill was there, as shown in the picture [17]. (C) On August 29<sup>th</sup>, 2020, it can be seen in the image that a black landfill was deposited in the area (red arrow) where some earth machinery was working [17]. The

yellow arrow shows where cut-and-fill material was deposited from the E-35 Road construction and the double arrow line shows a 55 m length size.

- November 2th and 3th, 2022.** After a technical inspection of the Shushilcón-La Elegancia area (Southeast of Alausí village), the authors did not identify any abnormal behavior on the E-35 Roadway in the area where it will be the head of the landslide (the Don Fausto Restaurant area). Moreover, the presence of a material deposit of anthropic origin was identified in front of the mentioned restaurant and close to the E-35 Road (Figure 7 A and C). Regarding this fill, it was found that it was for the project construction of the Land Transportation Terminal [28]. The project, located in front of the Don Fausto restaurant, was proposed as a bus stop and tourist viewpoint. It was determined that the structure did not exist in February 2020 (Figure 7 B, analyzing Google Earth Pro images), and it appears that the construction started before August 29, 2020 (Figure 7 C). The structure had an area of approximately 3,250 m<sup>2</sup> and 4,800 m<sup>2</sup> at its base with a 6 to 10 m high. The aforementioned anthropic body had an approximate volume between 47000 and 79000 m<sup>3</sup> (78000 to 130,000 tons in weight considering about 1.65 g/cm<sup>3</sup> material density). Additionally, the presence of another older fill as a flat platform can be identified at the head of the area (East of the restaurant), which can be related to cut-and-fill material from the construction of the E-35 Road (see yellow arrow in Figure 7 C).

- **New urbanization pressure and potentially developed areas.** The last anthropic factor analyzed, which can be considered a compilation of the previous, was the pressure of urbanization building without the rules of the established municipality planning. Some examples were the bus terminal construction (see Figures 7 A, B, and C), the football field and

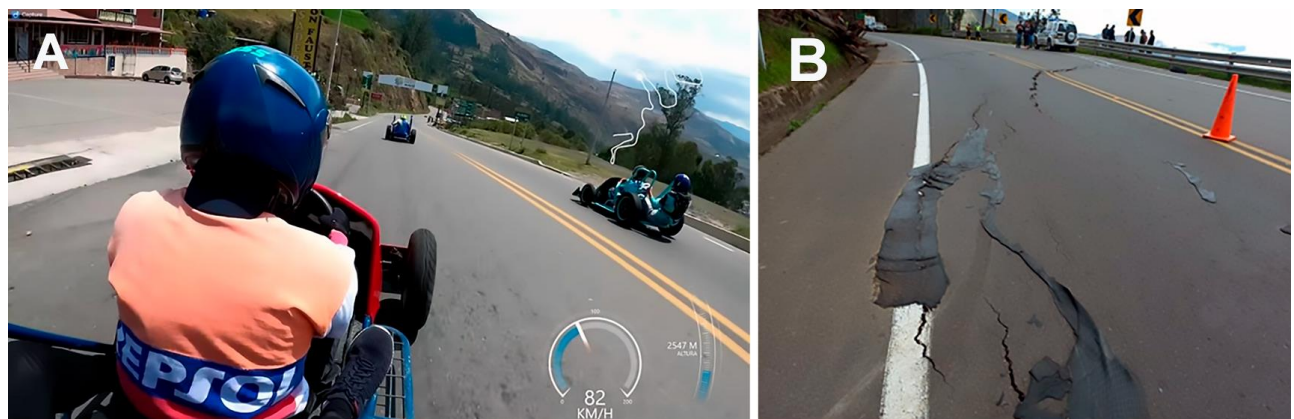
**Figure 8.** (A) A picture obtained from video footage shows the condition of the pavement on E-35 Road. The race cannot be performed if the road were cracked (4:25 minute frame from a camera over a no-motor car in front of the Don Fausto restaurant, modified from a video posted by César Zumba [29]). (B) Some cracks were developed at the same location as the A-picture on February 8, 2023 (modified from [32]).

- November 12, 2022.** Extracted from the frames of an amateur video [29], the recording of the route over one vehicle (playing a wooden car competition) could identify that there was no evidence of damage in the E-35 Roadway in the area of the head of the landslide (Figure 8 A).

- **February 2023.** On the 8th, a local online news report [32] showed the effects of the increase of cracks and settlement in the E-35 Road (Figure 8 B), and on the 19th, the Yellow Alert was established by the Government over 247 Ha zone [33]. That includes the Aypud and Casual communities (no urban areas) and La Esperanza, Control Norte, Nueva Alausí, Pircapamba, and Bua (urban neighborhoods). The exceptional pluviometry over the area was that some minor landslides affected the steep slope of the E-35 Road, 100 m down the abovementioned restaurant, and up to 10 m high slope runs through the road (Figure 9A).

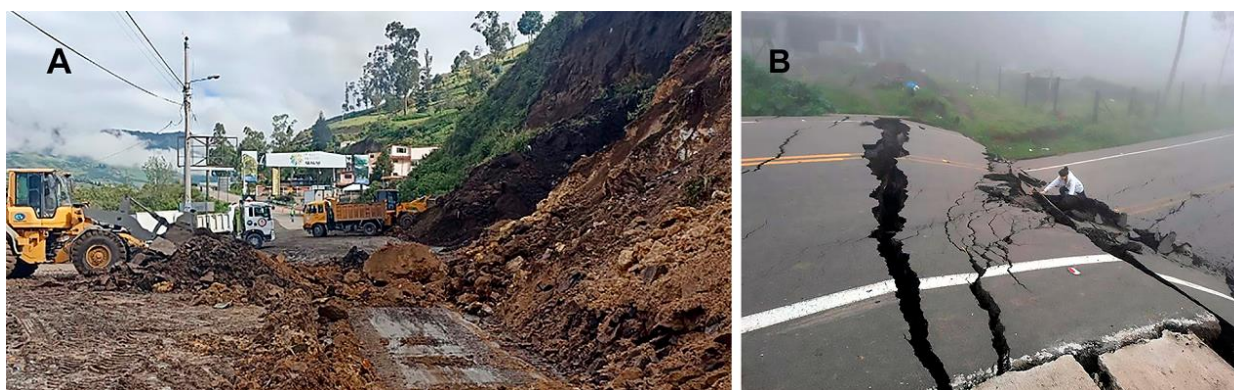
**Figure 9.** (A) Government machinery works to clean and open the E-35 Road, south of the Don Fausto restaurant, in the casual sector, February 19, 2023 [30]. (B) Impressive open cracks and vertical displacement (over four meters) 50 m North of the Don Fausto restaurant. The picture was granted by S. Berrones, a geologist, who took it on 26th Mars 2023 in the morning, a few hours before the event happened.

- **Mars 23 to 26 (in the morning) 2023.** The local news and neighbors report apertures up to 60 cm, depths over 1.8 m, and 2.0 m high to the cracks (Figure 9 B). Some people heard bass sounds and cracking noises ([34] and Mss. Berrones geologist personal communication). At 21:13 h, Mars 26th, the landslide happened.

In March 18, 2023 (eight days before the landslide event) an earthquake 6.64  $M_w$  (63.1 km depth) was happened in the Puná Island (Guayas province, 130 km faraway from Alausí) and was reported a macro seismic intensity of IV (which corresponds to 0.014g to 0.039g acceleration on the ground). This earthquake, named as Balao event, have activated minor displacements and a small landslide close to the E-35 Road with a Southwest direction and the ruptures in the landslide increasing in size (see Figure 9 B), but it was not triggered the landslide at that moment [31].

The triggering factor has been noted as the oversaturation of the ground, according to the PNUD report [58], and indicated in others [6,31], which was a product of the high rainfall recorded in the area for several months before (see Table 1). However, both in the field visits of this research group, as well as in the verbal communications of the inhabitants of the area (it has been indicated that the affected people came out dusty, and the presence of dust on the roofs of nearby houses has been determined) the fallen material presents low to medium humidity percentage, but its saturation has not been observed. That agrees with the permeability values obtained in the tests carried out in the area [7,22]. In consequence, the water accumulation in soils and rocks is not a determining factor when considering the trigger of the rupture. Also, it is necessary to consider that the rupture process lasted about 4 months (it began to become evident in December 2022) and the Balao earthquake accelerated the process (see Figure 9 B) [6].
