# Differential Settlement in Historic Masonry Towers: The Case of the Murcia Cathedral Bell Tower

Keywords: Murcia Cathedral Tower; historic masonry structures; differential settlement; soil–structure interaction; geotechnical analysis; non-destructive testing; heritage conservation; structural stability; Spanish Renaissance architecture; Baroque engineering

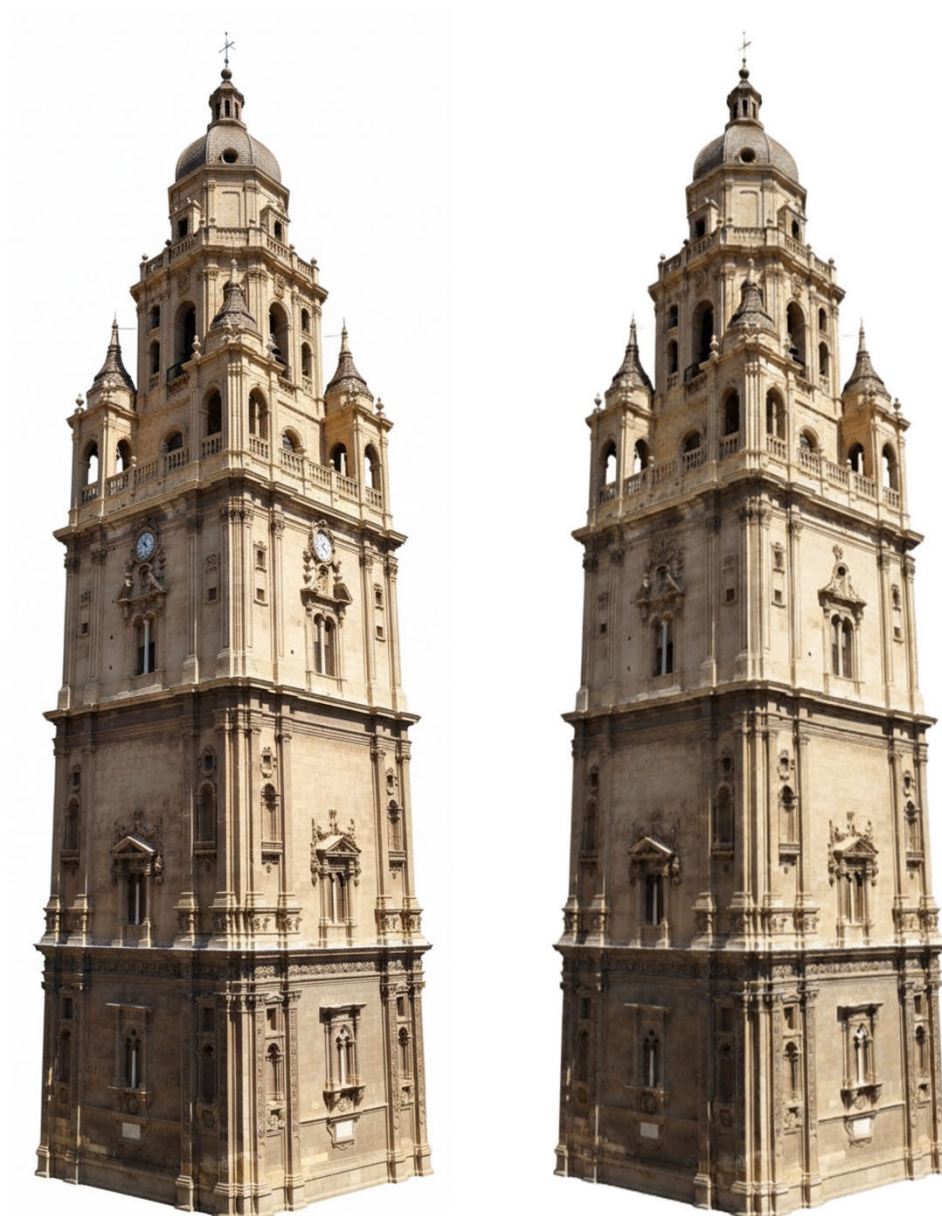
**Figure 2.** Three-dimensional representation of the tower of Murcia Cathedral: on the left, two adjacent sides with mild perspective distortion; on the right, the opposite sides digitally corrected (author's graphic).

The left-hand image shows two adjacent façades with a slight perspective distortion, while on the right the opposite sides have been digitally corrected. The slight real inclination of the tower toward the west, in the direction of *Plaza del Cardenal Belluga*, is also evident (Figure 2).

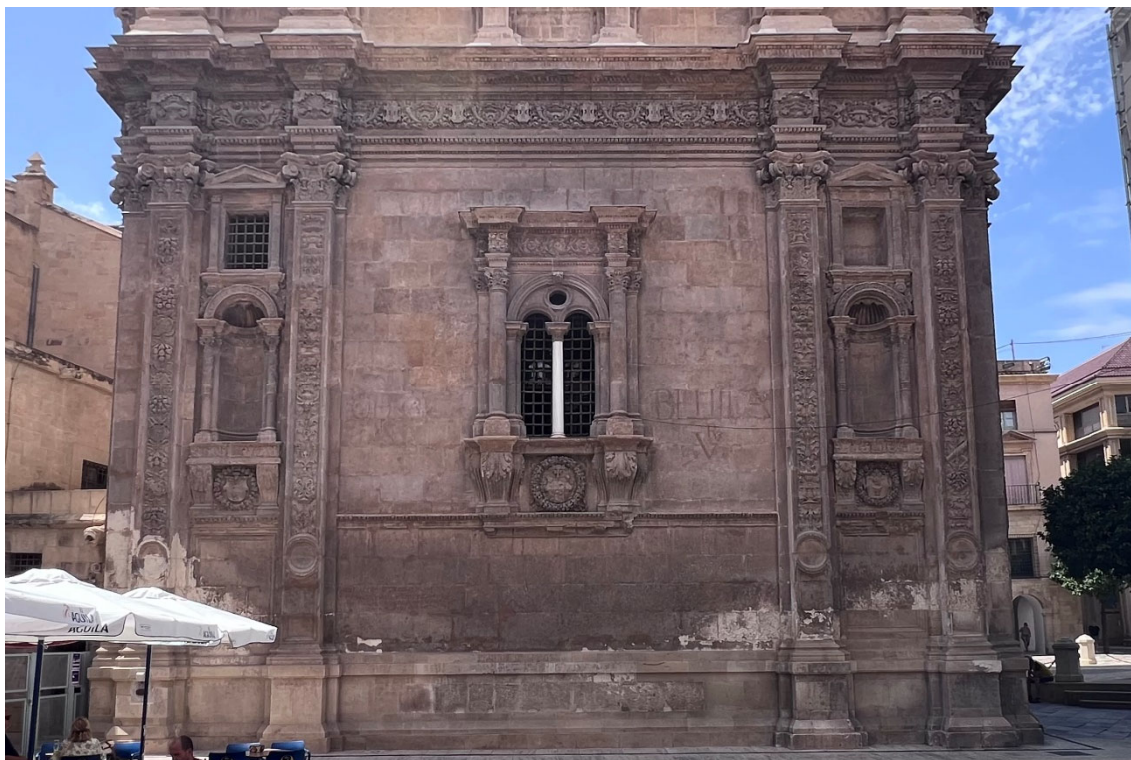
**Figure 3.** First tier of the bell tower of Murcia Cathedral, east façade (photograph by the author).

From the exterior (Figure 3), this first tier presents a square plan and a structure characteristic of the Spanish Renaissance. The *sotabanco*—a rebated plinth acting as a foundation—remained concealed until the later urban reforms of the *Plaza de las Cadenas*. This element, approximately 2.5 *palmas* high and 3 *palmas* wide, integrates seamlessly into the tower's base, securing its solidity. The Corinthian pilasters adorning the exterior, recessed and ringed, take inspiration from Lombard architecture and are decorated with garlands, grotesques, musical instruments, vases, shields, and fruit motifs, all recurrent elements of Tuscan Renaissance ornamentation.

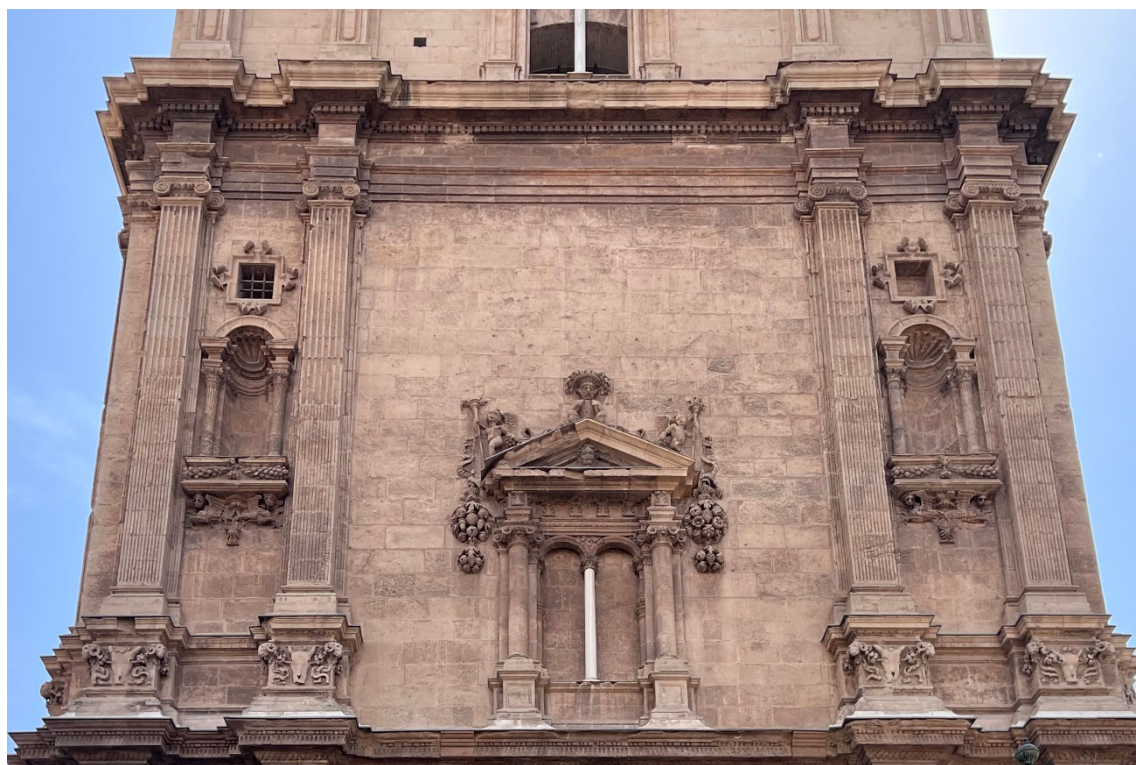
The second tier of the tower began construction in the 1540s under the direction of Jerónimo Quijano. This master builder respected the structural layout conceived by the Florentino brothers for the first body, though he introduced greater decorative richness. On the exterior, the Ionic pilasters exhibit a more refined design, with capitals featuring retracted volutes and collarinos, reflecting artistic currents arriving from Florence (Figure 4). Quijano also made certain adjustments, such as omitting capitals at the corners, since the proposed design did not allow for their proper placement.

The frieze, probably reconstructed in later centuries, departs from Quijano's characteristic ornamental taste, suggesting that it is not part of the original design. The windows, while similar to those of the first tier, are distinguished by Plateresque candelabra motifs on the jambs and triangular pediments above, establishing a dialogue between Spanish Renaissance refinement and local craftsmanship.

**Figure 4.** Second tier of the bell tower of Murcia Cathedral, north façade (photograph by the author).

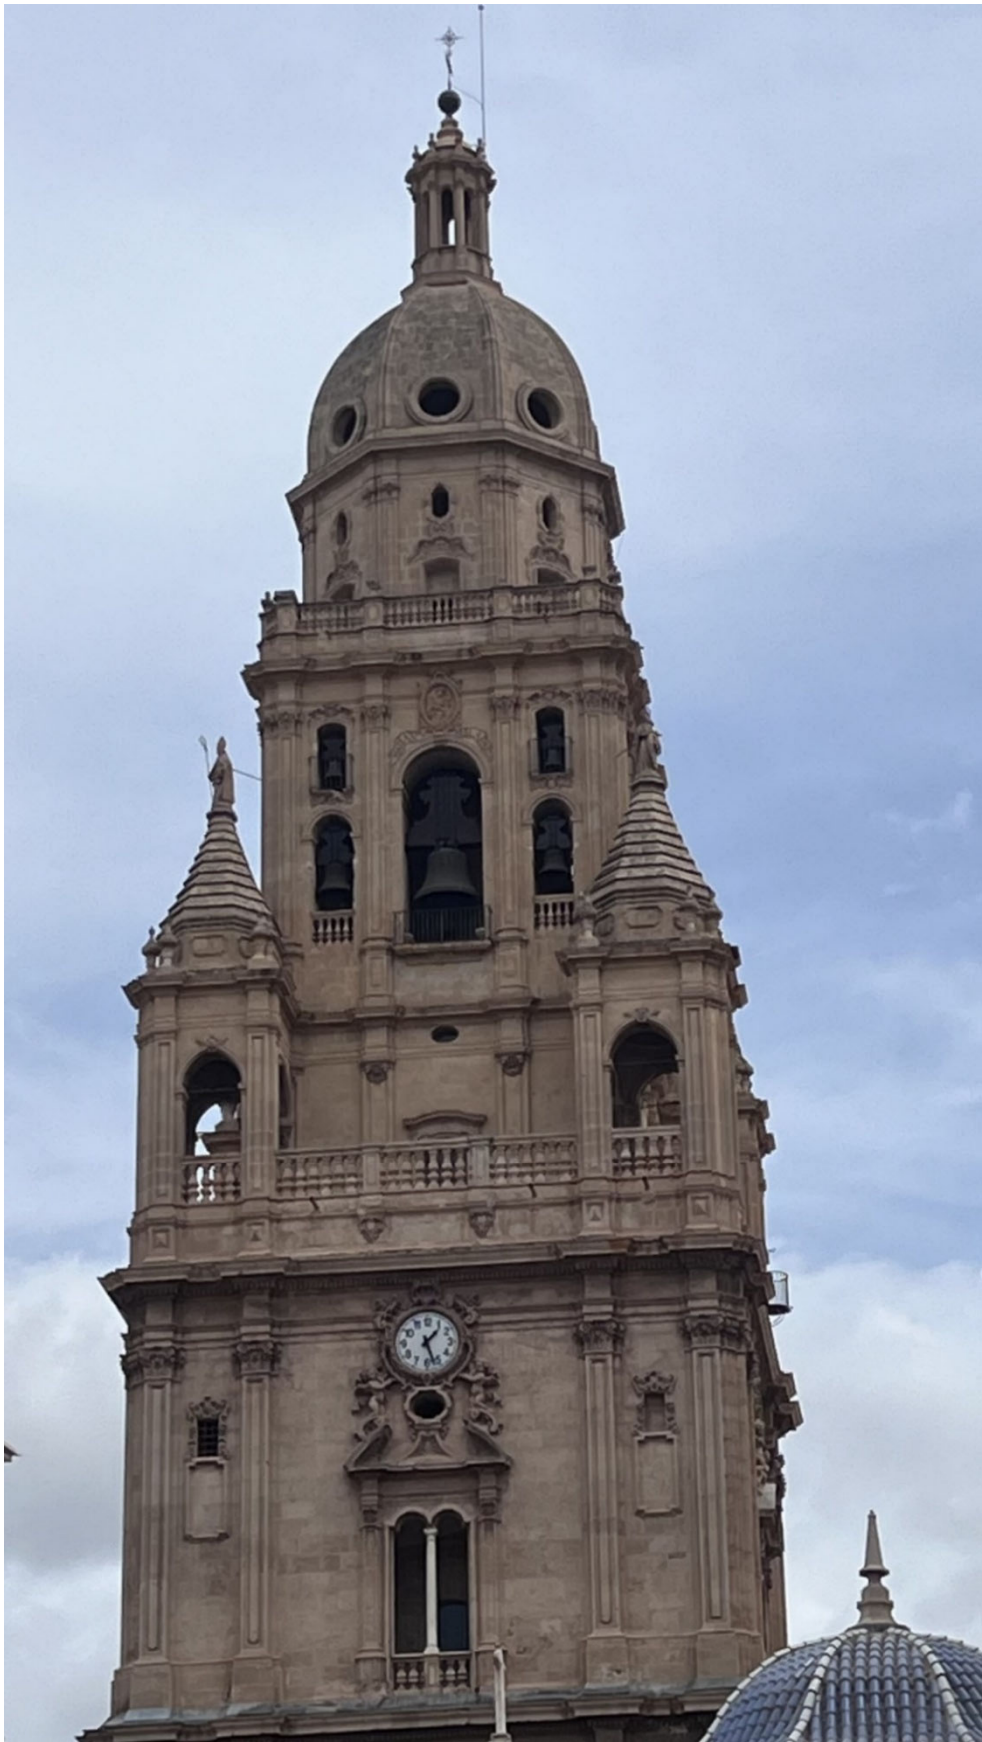
**Figure 5.** Third tier, conjuratorios, and bell chamber of the Cathedral Tower, west façade (photograph by the author).

From the outside, the third tier is distinguished by its Baroque interpretation, which contrasts with the Renaissance restraint of the lower levels (Figure 5). This tier introduces a reinterpretation of the Corinthian order, clearly visible in the attached pilasters, whose fluting and volutes exhibit a more dynamic and ornamented design. The corners, in particular, are reinforced by paired pilasters, enhancing the perception of robustness and monumentality throughout the composition.

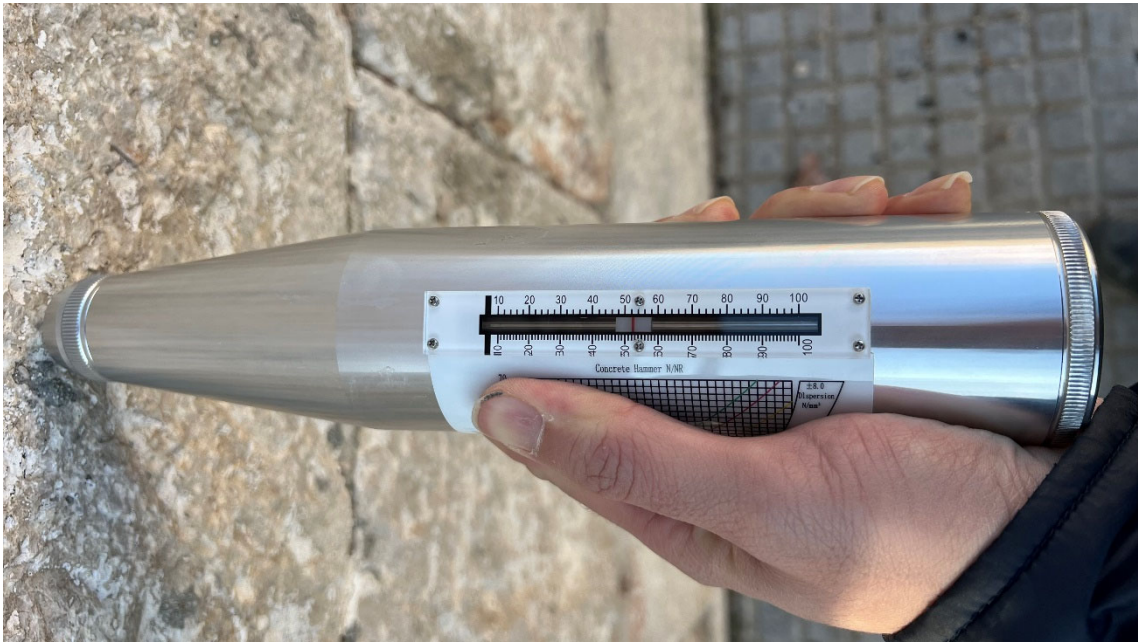
**Figure 6.** Measurement of the compressive strength of the Cathedral Tower’s limestone using a Schmidt hammer, taken from the first ashlars on the west façade (photograph by the author).

No destructive testing has ever been conducted to determine the compressive strength of the tower's limestone or other construction materials [12]. Attempts were made [13], but the ethical imperative of preserving the monument's integrity prevailed over the desire for direct measurement. Consequently, the present study relied on non-destructive testing, specifically rebound hammer (Schmidt hammer) measurements, to estimate the compressive stress magnitudes (Figure 6).

The procedure, while not perfectly precise, was deemed reliable, as the expected statistical dispersion rendered further complexity unnecessary. Only if the material had shown signs of operating near its mechanical limits—which was not the case—would more sophisticated techniques have been required. This study continues a series of previous sclerometric analyses performed on the same limestone [12,14]. As in earlier campaigns, the results indicate that the weathered limestone exhibits strengths roughly five times lower than the unaltered rock (Figure 7). However, these alterations affect only superficial layers, averaging less than 1 cm in depth [12,15], and thus do not compromise the overall mechanical integrity of the masonry.

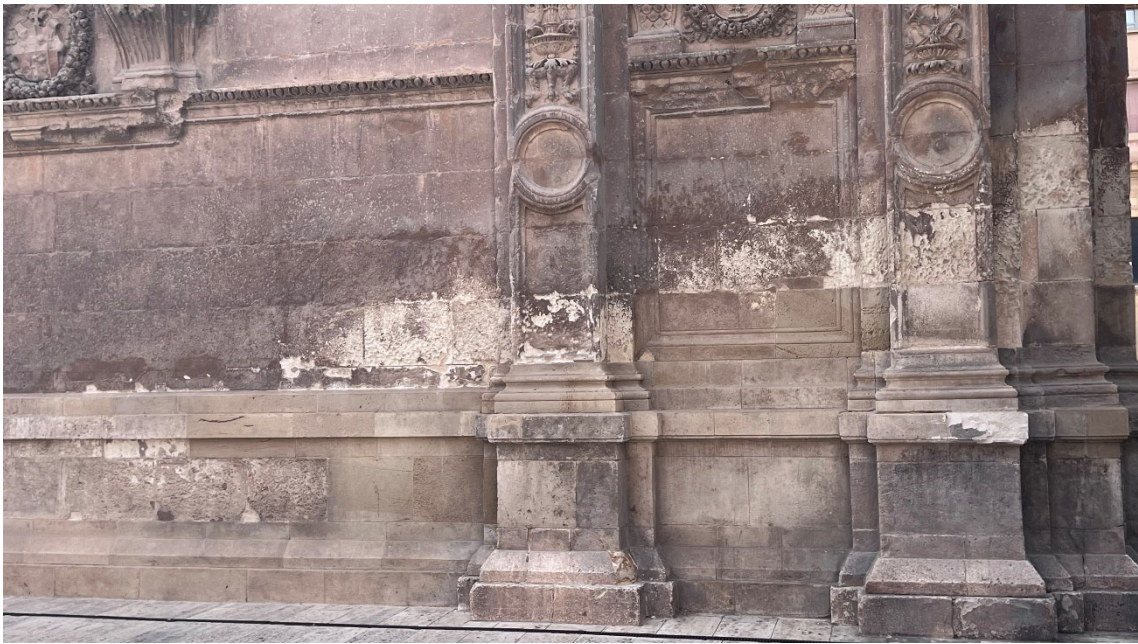
**Figure 7.** Sound and deteriorated limestone at the base of the tower, east façade (photograph by the author).

The tower has demonstrated stability during major earthquakes, including the 1755 Lisbon event, whose effects reached Murcia [18,19], the 1829 Torre Vieja earthquake [20], and the 2011 Lorca earthquake [21]. Occasional transient stress increases, possibly up to threefold, may explain the presence of minor vertical cracks observed on the lower north corners (Figure 7), though these remain localised and non-structural.

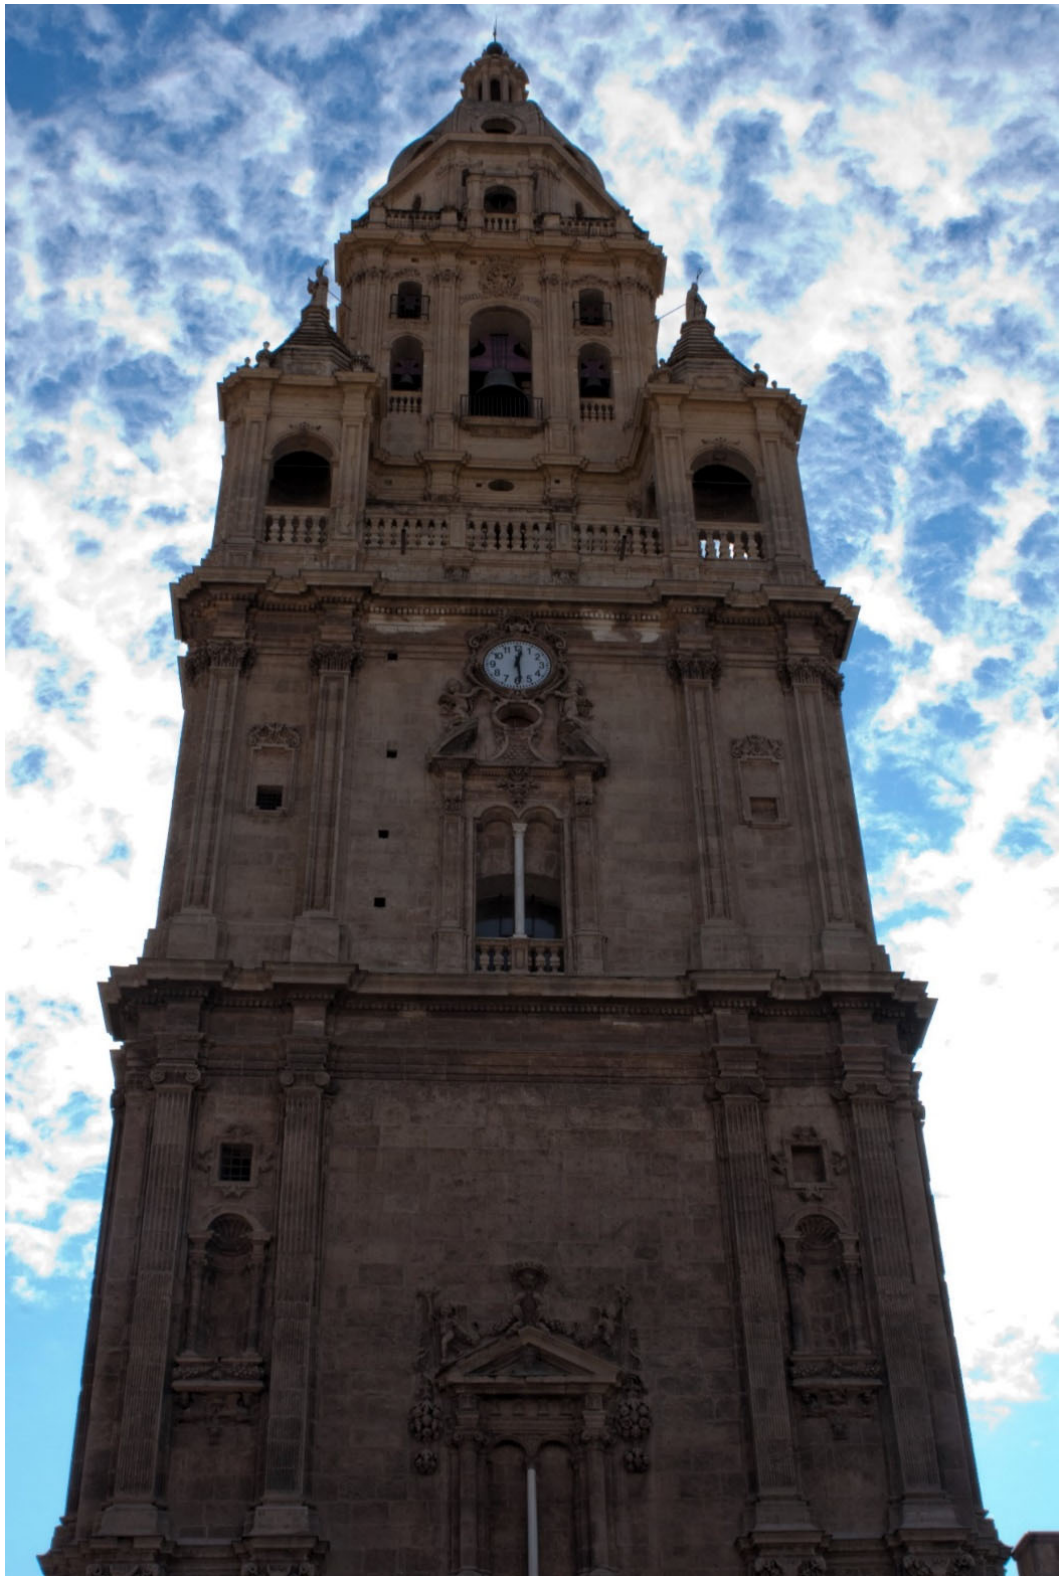
**Figure 8.** Northern elevation of the tower showing the second and third tiers, conjuratorios, and bell chamber. The successive deviations from verticality and compensations applied during construction are visible (photograph by the author).

These compensations are visible today from the north façade or the southwest corner (Figures 8 and 9), where the loss of vertical alignment and the successive corrections made during construction can clearly be observed in the slightly curved profile of the tower's elevation.

a considerable magnitude that explains the maximum relative settlement observed at the northwest corner (Figure 8).

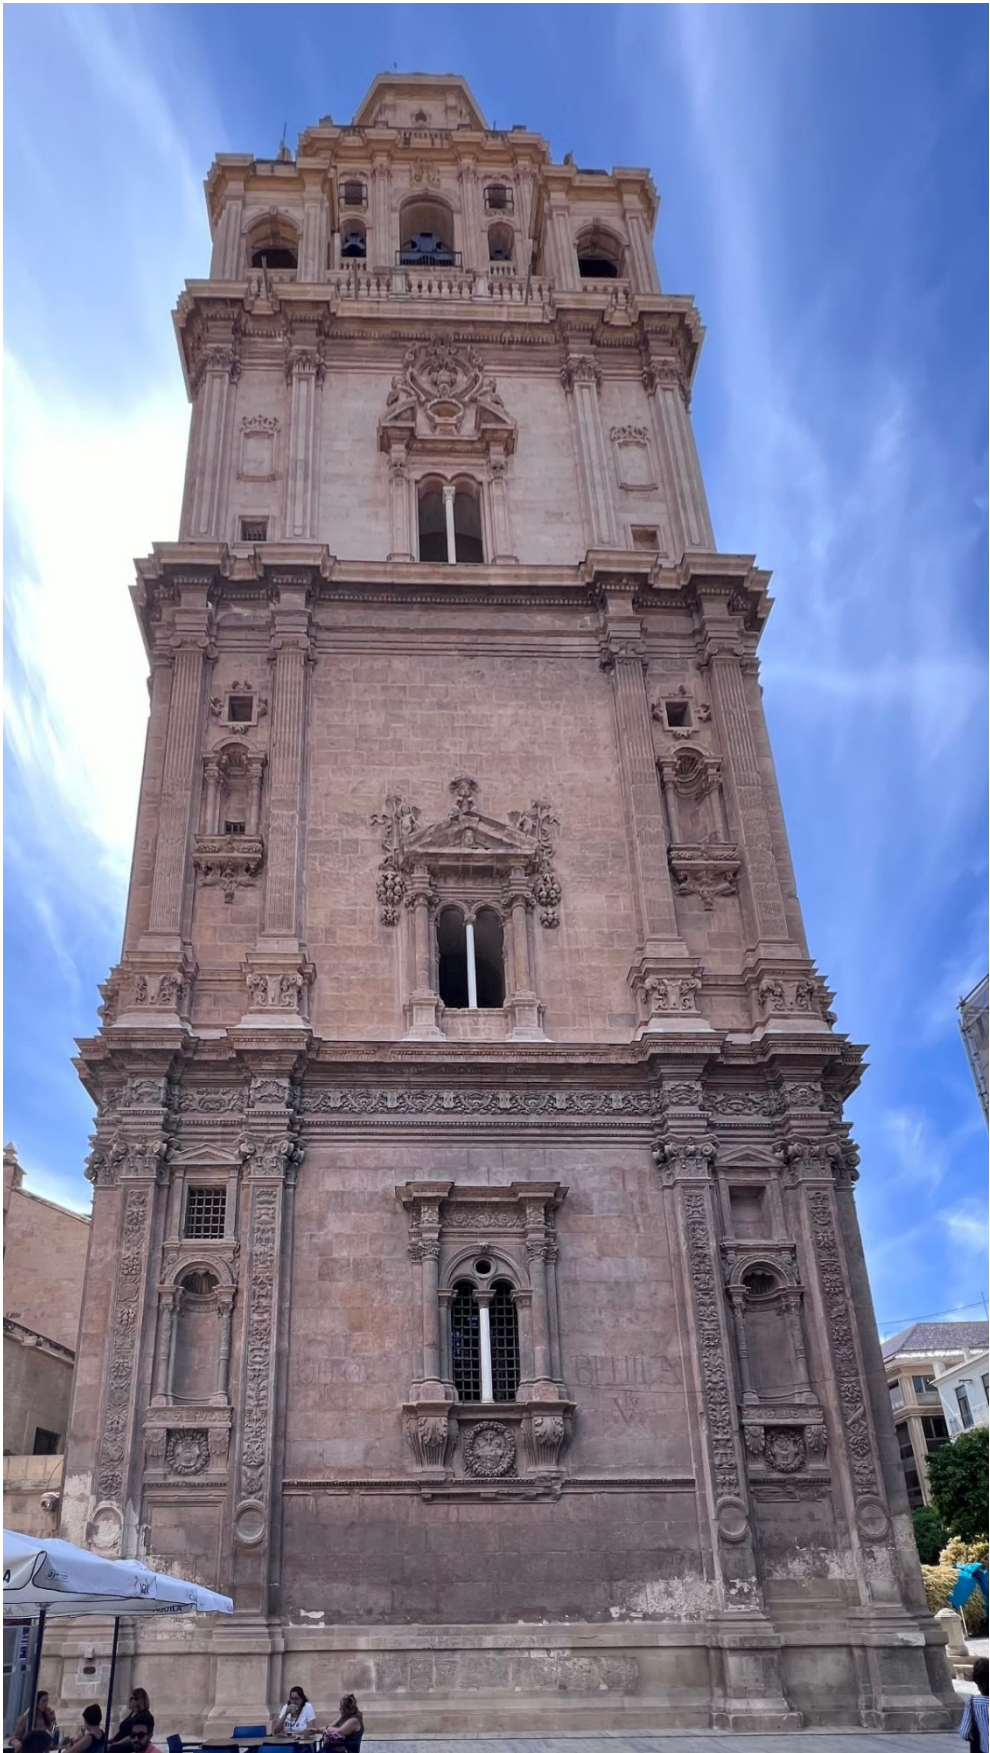
**Figure 9.** Eastern elevation of the tower, showing the same deviations and corrective alignments introduced as construction advanced (photograph by the author).

Since its foundation in 1519, the tower has experienced relative differential settlements, the northeast corner (Figure 9, right) currently standing 56 cm lower than the northwest—distinct from the uniform settlement of the footing.
