Article

Impact of Volcanic Ash on Road and Airfield Surface Skid Resistance

Daniel M Blake^{1,*} Thomas M Wilson¹ Jim W Cole¹ Natalia I Deligne² Jan M Lindsay³

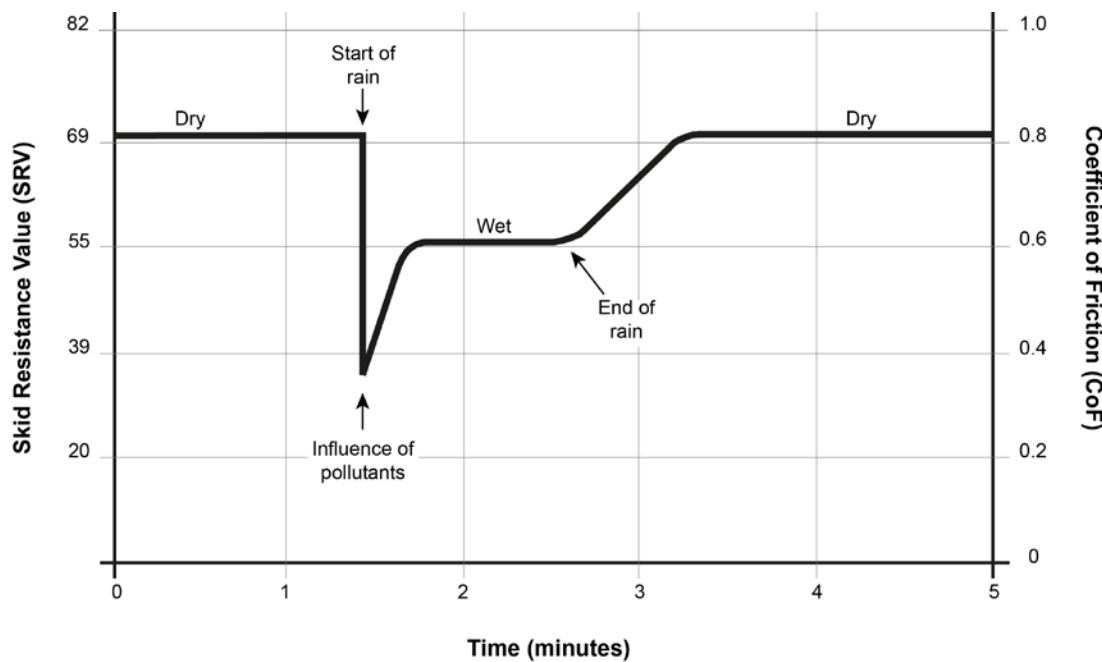
Figure 1. Variation in CoF during a rain event [after 16,49-51].

Rain, snow and ice are common hazards that compromise the quality of road surfaces [46-48] by interfering with surface macrotexture and microtexture. In 2003, Bennis and De Wit quantified how surface friction varies with time during a short rain shower following a reasonable period of no rain (Figure 1) [49]. The measured skid resistance significantly reduces immediately after rainfall and then recovers to a more typical wet skid resistance. However, the effect of individual contaminants, such as vehicle residues and atmospheric dust, on surface friction is poorly understood [16].

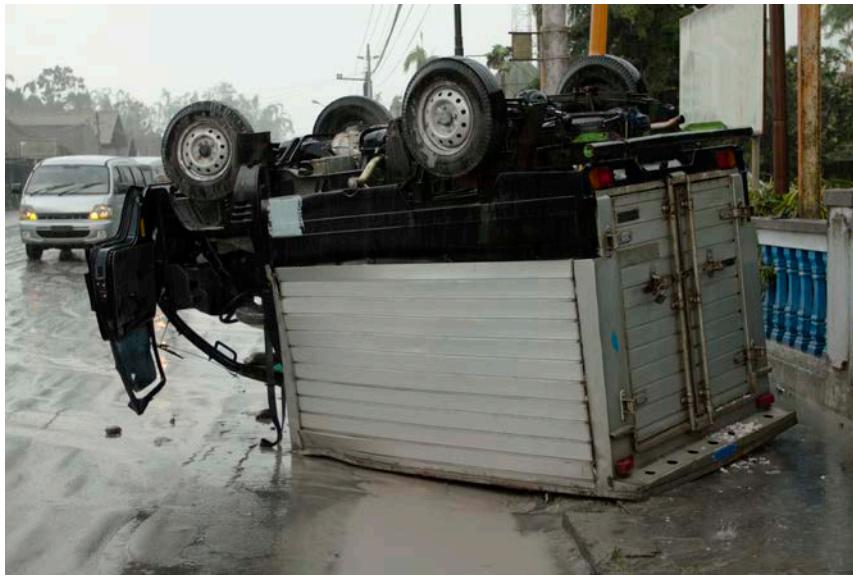
Figure 2. Vehicle accident attributed to reduced skid resistance after ashfall from Merapi volcano, Indonesia, 2010 [68].

Merapi, Indonesia	2010	<i>not specified</i>	Slippery roads caused accidents (Figure 2) and increased journey times [30]
Pacaya, Guatemala	2010	20-30	Slippery roads with coarse ash [9]
Puyehue-Cordón Caulle, Chile	2011	>100	2WDs experienced traction problems (wet conditions) [31]
Shinmoedake, Japan	2011	<i>not specified</i>	Ladders very slippery [32]
Kelud, Indonesia	2014	1-100	Roads slippery with increased accident rate [33]
Sinabung, Indonesia	2014	80-100	Road travel impracticable in wet muddy ash [34]

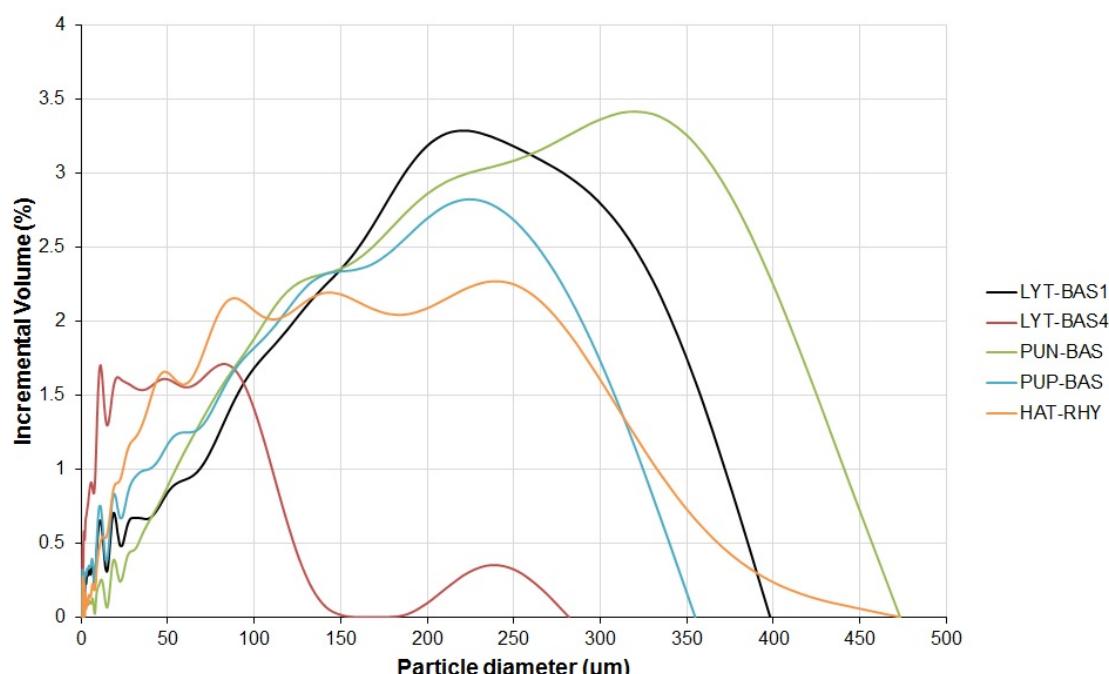
Figure 3. Mean particle size distribution analysed using a Micromeritics Saturn DigiSizer II Laser-Sizer (3x runs per sample). Note that the maximum particle sizes for the four samples that were sieved to 1000 μm are in fact <500 μm , likely due to the pulverisation process. Some particles for the LYT-BAS4 sample (sieved to 106 μm) exceed 106 μm due to the often-tabular nature of volcanic ash particles and their ability to pass through the sieve mesh when vertically orientated.

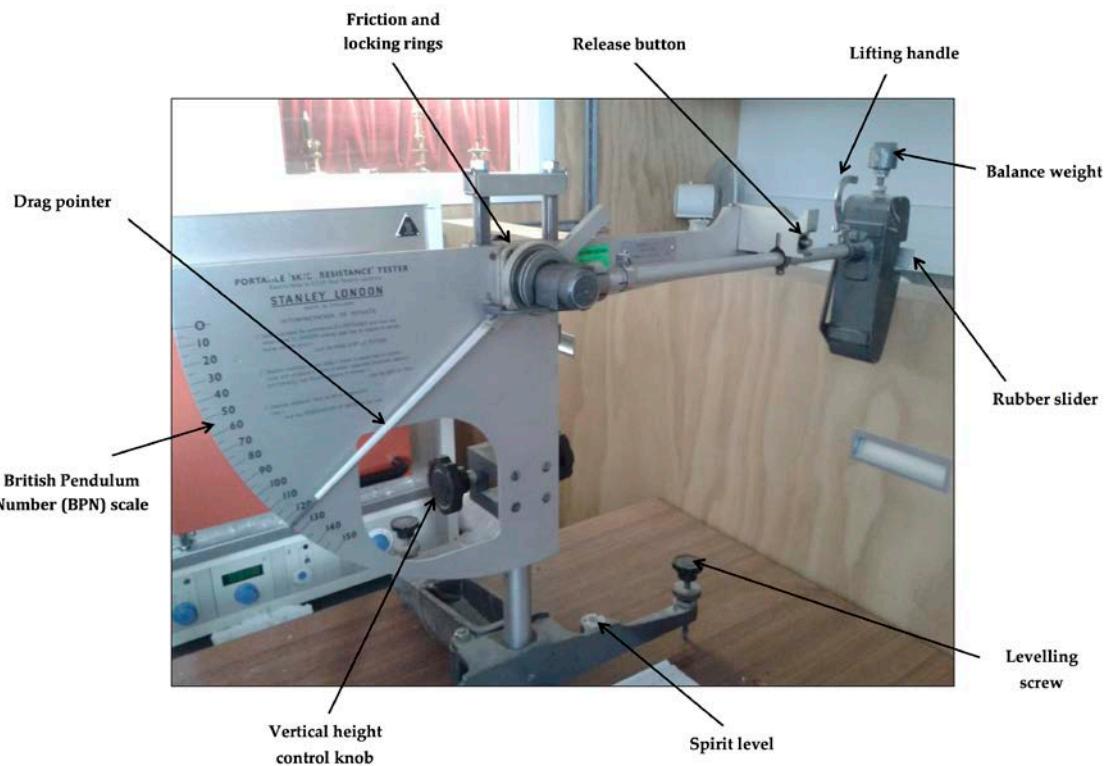
Figure 4. British Pendulum Tester (BPT) used for surface friction testing.

The test procedure for the BPT (Figure 4) is standardised in the ASTM E303 (2013) method [76]. It is a dynamic pendulum impact type test, based on the energy loss occurring when a rubber slider edge is propelled across the test surface. The method is intended to correlate with the performance of a vehicle with patterned tyres braking with locked wheels on a wet road at 50 km h^{-1} [45]. Since the BPT is designed to test the skid resistance of extensive surfaces in-situ, care was taken to ensure that the instrument was stable and slabs were aligned before conducting our testing in the laboratory environment. Both 3.00" rubber mounted TRL (55) sliders (used for road testing) and 3.00" CEN sliders (used for airfield testing), purchased from Cooper Technology UK, were used in our study.

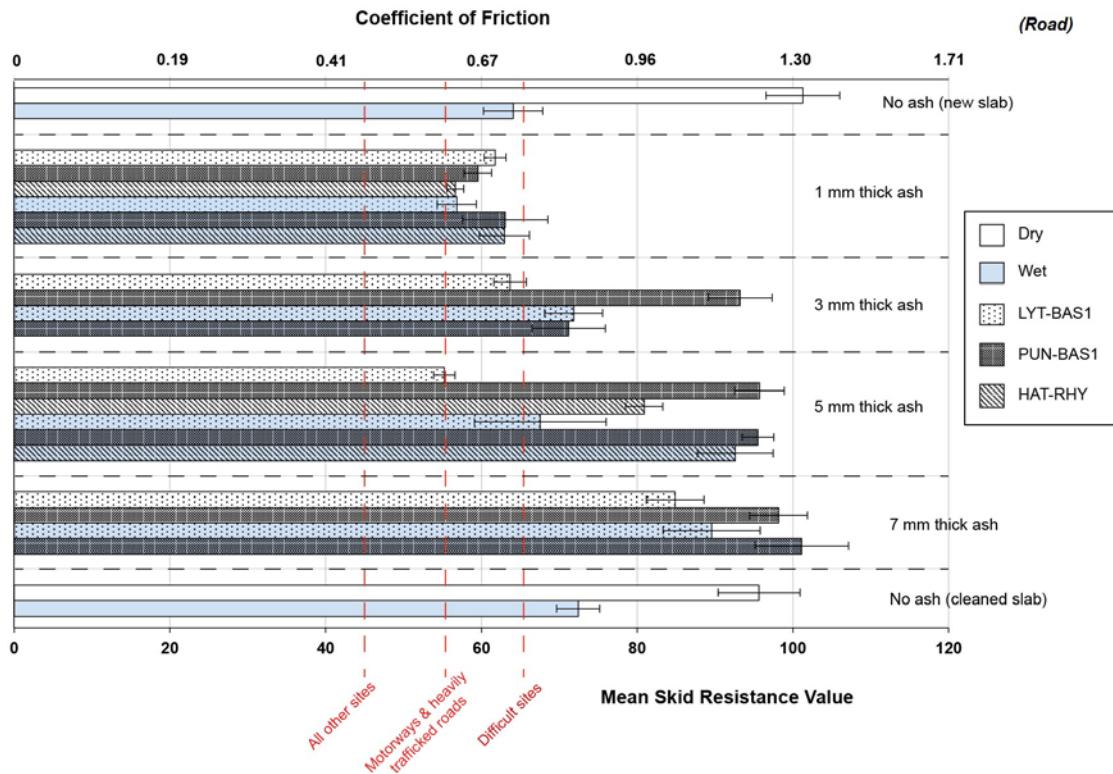
Figure 5. Mean SRVs and CoFs for the non-contaminated SMA and SMA covered in the three ash types sieved to 1000 μm . Wet and dry samples at 1, 3, 5 and 7 mm thicknesses are shown although limitations in the quantity of rhyolite (HAT-RHY) meant that testing was only conducted at 1 and 5 mm thickness for this ash type. The error bars represent the standard deviation for each data set. Also displayed (as red dashed lines) are the minimum recommended SRVs for different road network sites (Table 2).

When ash was replenished between each swing, the skid resistance remained relatively constant with time, permitting calculation of a mean SRV for each condition. The mean SRVs and corresponding CoFs for the non-contaminated SMA (new and cleaned) and for the SMA covered by three samples sieved to 1000 μm are shown in Figure 5. Similarly, the SRVs and CoFs for the airfield concrete, both clean and covered by two samples sieved to 1000 μm are shown in Figure 6. The Pupuke volcano sample (PUP-BAS1) was found to have very similar values to the Punatekahi (PUN-BAS1) sample. This was expected as they are both scoriaceous basalt. Due to limitations in available ash and time constraints, full testing was only conducted with one of the scoriaceous samples on the SMA and airfield concrete.

Anecdotal observations during historical eruptions suggest that skid resistance on roads is reduced following dry unconsolidated ash accumulation. This is consistent with our results, which also reveal that reduced SRVs are particularly pronounced under dry conditions for a 1 mm thick ash layer on asphalt (Figure 5). Mean SRVs for all 1 mm thick ash types fall below the minimum recommended SRV for difficult sites (an SRV of 65). Wet 1 mm ash-covered surfaces are not necessarily more slippery than dry 1 mm ash-covered surfaces and the wet surfaces covered in 1 mm thick ash are only slightly more slippery than the wet asphalt without ash contamination.

For the 3 and 5 mm thick ash-covered asphalt surfaces, we observe different trends. The LYT-BAS1 sample has similar SRVs to the 1 mm thick ash layer and the mean SRV for 5 mm is near the recommended minimum SRV for motorways (SRV 55). Samples PUN-BAS1 and HAT-RHY however, have greater SRVs than those for 1 mm of ash, suggesting that these ash types are perhaps less slippery when thicker, especially sample PUN-BAS1. The wetted PUN-BAS1 and HAT-RHY >1 mm samples have increasing SRVs as thickness increases. SRV values exceed those for bare wet asphalt surfaces and are similar to those for dry bare asphalt surfaces when ash is >5 mm thick. The vesicular nature of these two samples may play a role in increasing SRVs with the individual particles perhaps able to effectively interlock with one another and with the asphalt aggregate beneath. The pumiceous HAT-RHY sample is more friable than the PUN-BAS1 sample, which may explain the slight difference in SRVs between the two. We note that the pendulum arm may be

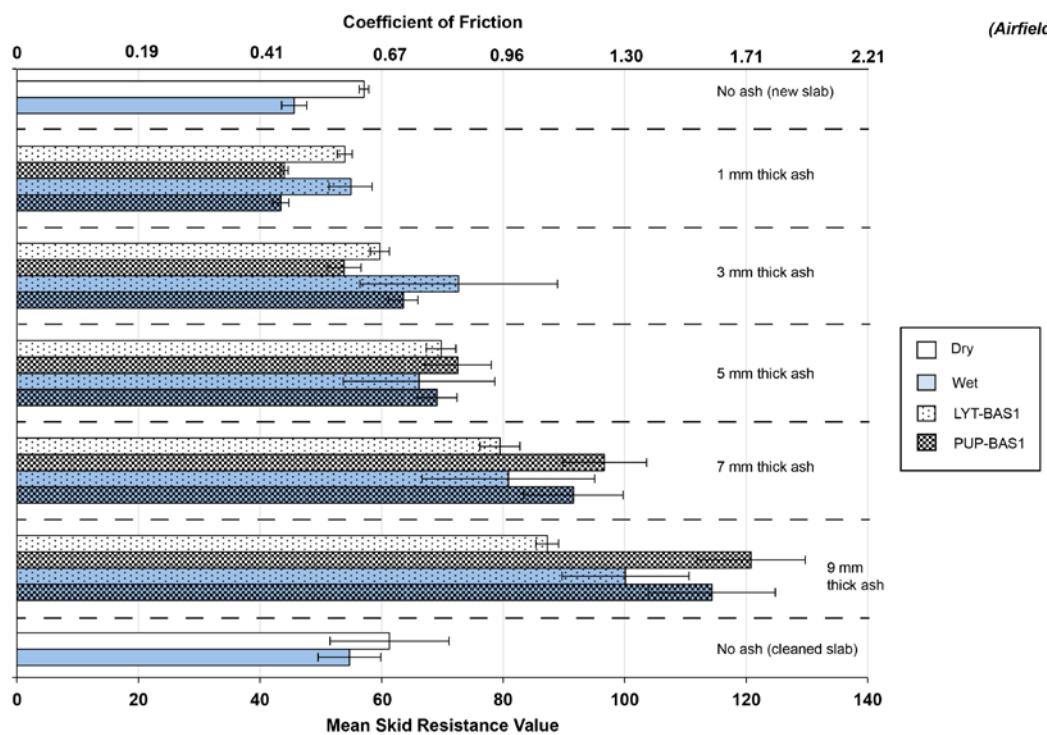
Figure 6. Mean SRVs and COFs for the non-contaminated airfield concrete and airfield concrete covered in the two ash types sieved to 1000 μm . Wet and dry samples at 1, 3, 5, 7 and 9 mm thicknesses are shown. The error bars represent the standard deviation for each data set.

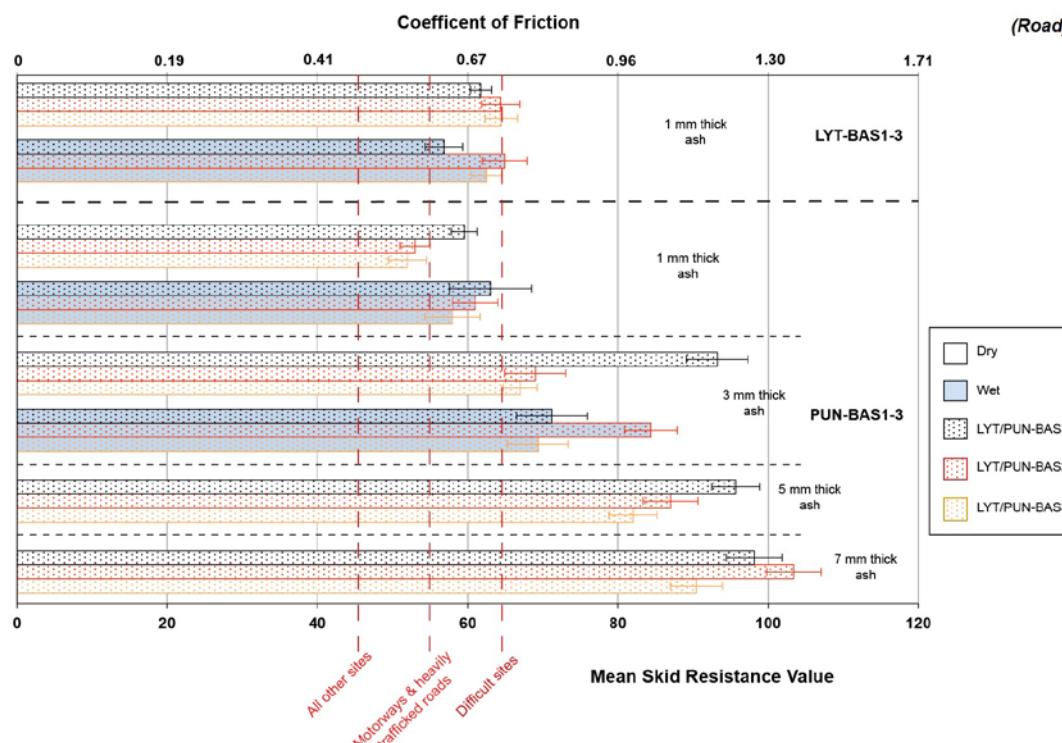
Figure 7. Mean SRVs and CoFs for the road asphalt covered in non-dosed and dosed LYT-BAS and PUN-BAS ash sieved to 1000 μm . Both samples dosed in RCL and WICL fluid under dry and wet conditions are displayed. Due to limitations in dosing fluids and possible interference caused by the crystalline characteristics of the LYT-BAS samples, most testing was undertaken using the PUN-BAS samples. Large quantities of freshly dosed ash samples were required for each thick ash test under wet conditions, hence only dry conditions were analysed for the 5 and 7 mm thick testing rounds. Also displayed (as red dashed lines) are the minimum recommended SRVs for different road network sites (Table 2).

There are no clear differences in SRVs observed between non-dosed and dosed LYT-BAS ash at 1 mm thick (Figure 7). However, the highly crystalline properties of this ash type may reduce the impact that dosing has on SRVs. SRVs for the dosed scoriaceous PUN-BAS ash used on road asphalt (Figure 7) and dosed scoriaceous PUP-BAS ash used on airfield concrete (Figure 8) are generally less than those which are not dosed. For all ash thicknesses, the PUN-BAS3 sample (i.e. that dosed in WICL fluid) produce lower SRVs than the PUN-BAS2 sample (i.e. that dosed in RCL fluid), suggesting that the skid resistance of non-crystalline ash-covered road surfaces decreases if the soluble component of the ash increases. This corresponds with findings for other road contaminants [50], demonstrating a friction drop at the transition between no rain and rain due to the high-viscosity mix of rain water and road debris. As such, only WICL fluid was used to dose the PUP-BAS sample (used for airfield concrete) to assess results representative of a 'likely worse-case' SRV scenario.

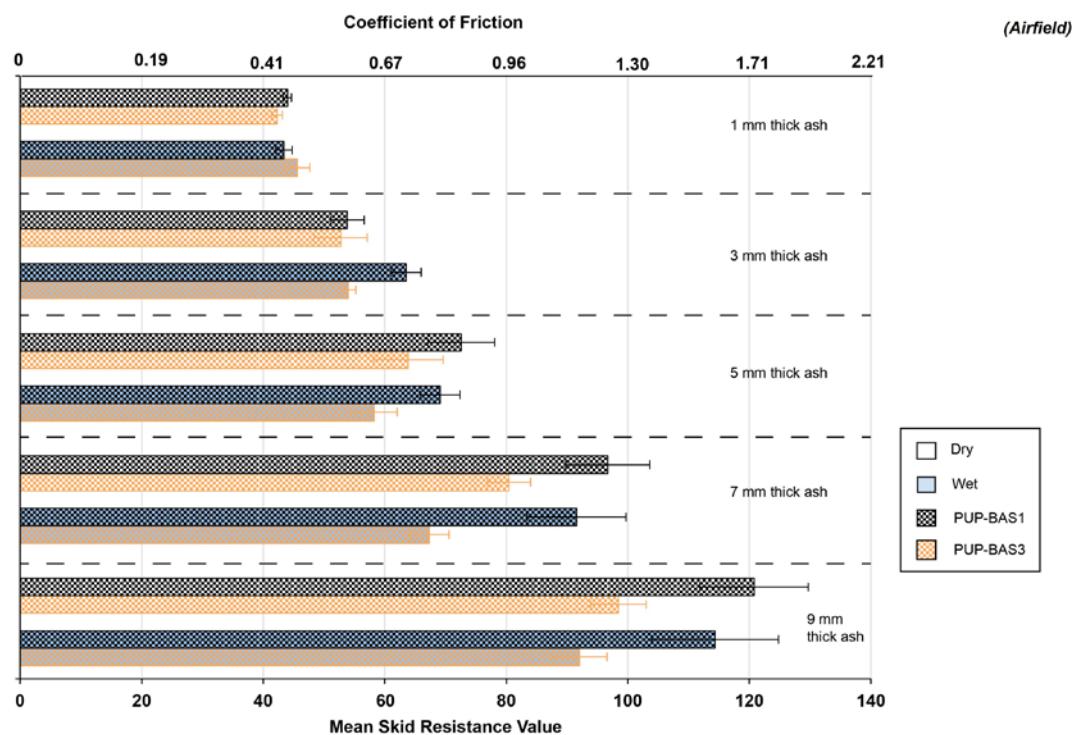
Figure 8. Mean SRVs and CoFs for the airfield concrete covered in non-dosed and dosed PUP-BAS ash sieved to 1000 μm . The samples dosed in WICL fluid under both dry and wet conditions are displayed.

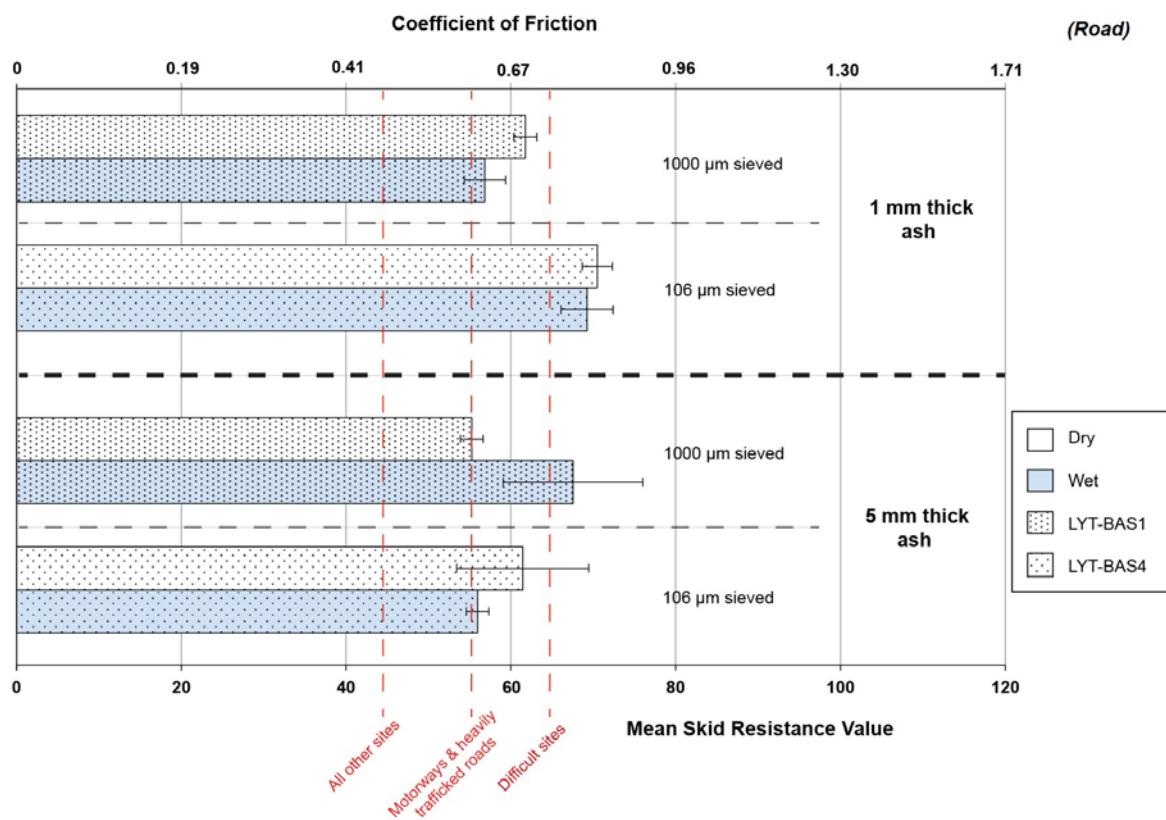
Figure 9. Mean SRVs and CoFs for the asphalt covered in coarse-grained (i.e. LYT-BAS1, 1000 μm sieved) and fine-grained (i.e. LYT-BAS4, 106 μm sieved) samples at 1 mm and 5 mm ash thickness under both dry and wet conditions. Also displayed (as red dashed lines) are the minimum recommended SRVs for different road network sites (Table 2).

The mean SRVs for fine-grained basaltic ash (LYT-BAS4) are slightly higher than those for the coarse-grained ash of the same type (LYT-BAS1) when at 1 mm thickness on roads, with mean values for both wet and dry samples above the minimum recommended SRVs for difficult sites (Figure 9). This concurs with field observations made by the Kagoshima City Office staff following frequent volcanic ash deposition on roads from the multiple eruptions of Sakurajima volcano, Japan (since 1955). Reports suggest that the finer ash from the recent eruptions at the Showa crater resulted in less slippery roads than the generally coarser-grained ash produced during past eruptions from the Minami-daki summit area [83]. We hypothesise that this is due to the finer particles being more easily mobilised and displaced at the tyre-asphalt interface, allowing

improved contact between the tyre and asphalt. However, no clear correlations exist between the fine- and coarse-grained ash when at 5 mm thick, perhaps due to both types covering the asphalt surface when the tyre makes contact.

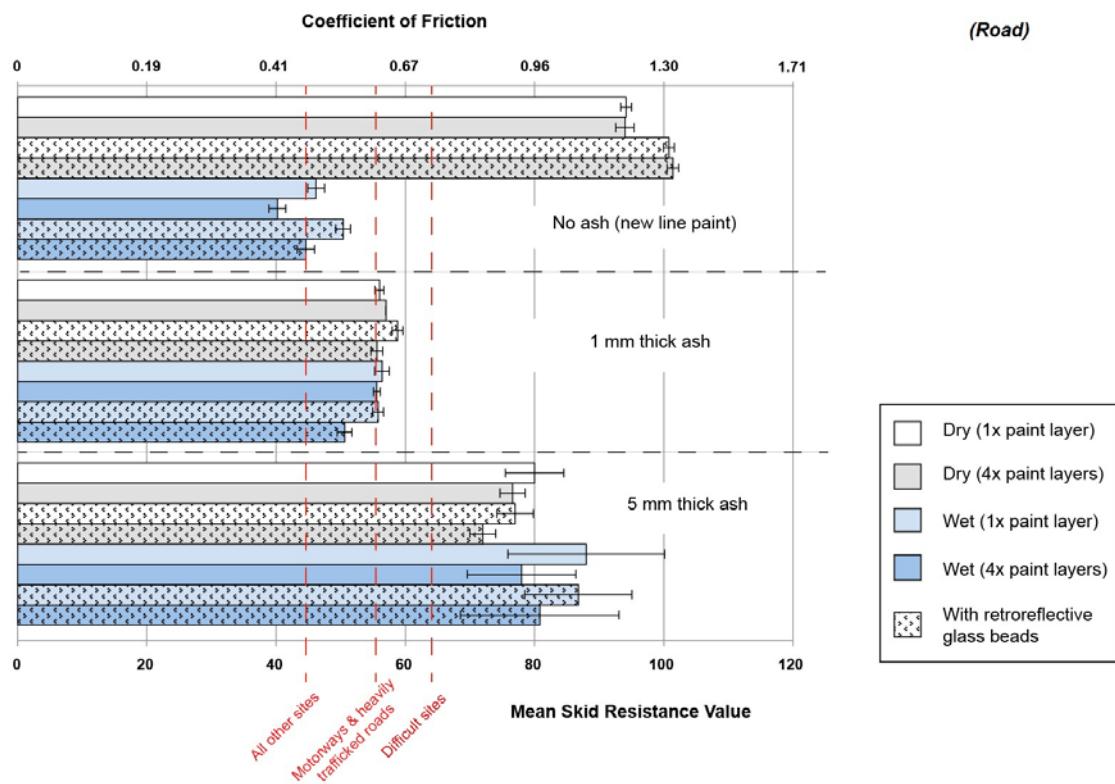
Figure 10. Mean SRVs and CoFs for the road asphalt with line-painted surfaces. Conditions of no ash, 1 mm thick ash, and 5 mm thick ash (using the LYT-BAS1 ash type) were analysed under both wet and dry conditions. Also displayed (as red dashed lines) are the minimum recommended SRVs for different road network sites (Table 2).

SRVs can be reduced substantially as a result of road markings, although the addition of retroreflective glass beads can increase values to more acceptable levels [76]. This is demonstrated in our findings for wet conditions, in which BPT analysis is typically conducted, with mean SRVs on line-painted asphalt surfaces with no beads and no ash the lowest of all our results. SRVs for these wet surfaces range from 40 to 46, and lie below the minimum recommended skid resistance for 'all other sites' when 4x coats of line paint have been applied (Figure 10). The addition of glass beads does increase SRVs (by around 5), although values are still relatively low. SRVs for 'clean' and dry line-painted asphalt surfaces are very high, but as with non-painted surfaces, the addition of a 1 mm ash layer decreases SRVs substantially. Conversely, the SRVs for wet asphalt concrete increase with a 1 mm ash layer to similar levels as for dry conditions. With the thicker (5 mm) ash layer on top of line-painted surfaces, SRVs increase further by around 20 (Figure 10).

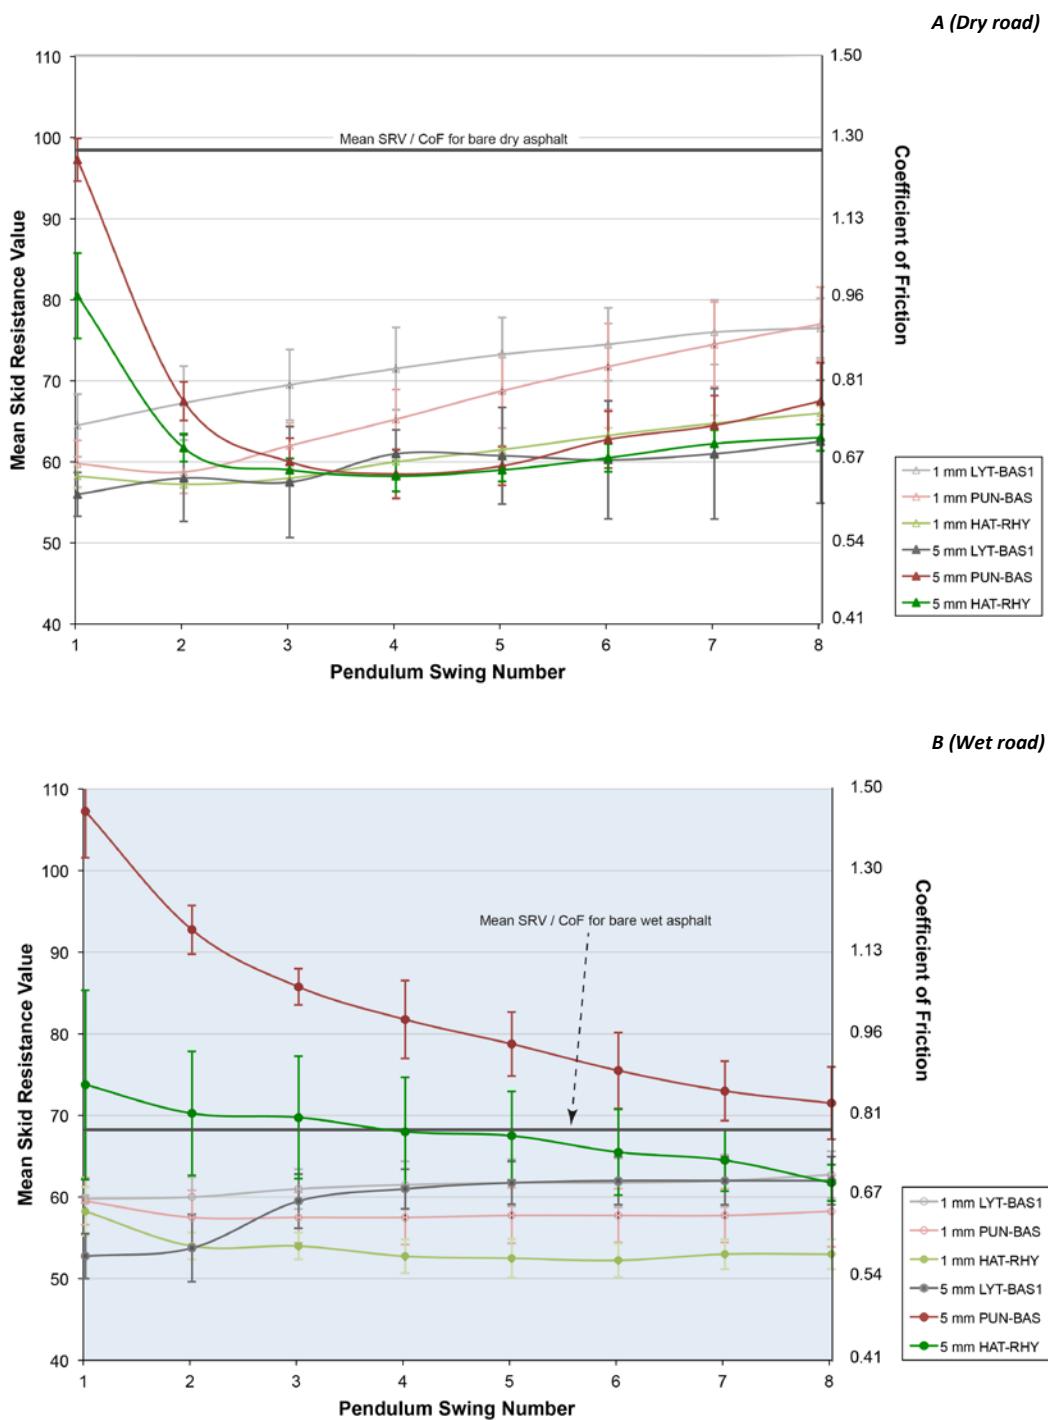
Figure 11. SRVs and corresponding CoFs on asphalt covered by ash sieved to 1000 μm , under (a) dry and (b) wet conditions. Also shown are the mean SRVs for bare asphalt, taken from section 3.1. Error bars display the standard deviations for each pendulum swing number for the different sample types. Note that the first 2-3 swings over 5 mm deposits should be interpreted with caution due to possible impacts on SRVs caused by the initial contact between the pendulum slider and surface.

SRV results obtained for the samples sieved to 1000 μm (at 1mm and 5 mm ash thickness) and deposited on road asphalt are shown in Figure 11. Note that tests of other thicknesses (3, 7 and 9 mm) were also conducted but these have been omitted from the figure for clarity.

Despite the large standard deviations, the 5 mm thick PUN-BAS1 and HAT-RHY samples initially produced high SRVs. However, the SRVs recorded for the first 2-3 swings of the pendulum

over 5 mm thick ash should be interpreted with caution. This is due to possible interference of the thicker deposit when the pendulum slider first impacts the surface; similar circumstances may occur in the field when initial vehicles are driven into thicker ash deposits. When wet however, the SRVs are higher than the mean recorded on the bare asphalt surface, particularly for the PUN-BAS1 sample, suggesting that thicker layers of vesiculated (and especially harder) volcanic ash are perhaps initially less slippery than thin layers of ash of those ash types. Observations during our experimentation revealed that the wet 5 mm thick vesiculated deposits (PUN-BAS1 and HAT-RHY) consolidated, thus resisting major ash displacement more than for dry ash (Figure 12), even following several swings of the pendulum arm. The consolidated deposits were very firm to touch and, although further work is required to test this, it is suggested that light vehicles would be able to drive over the surface without sinking substantially.

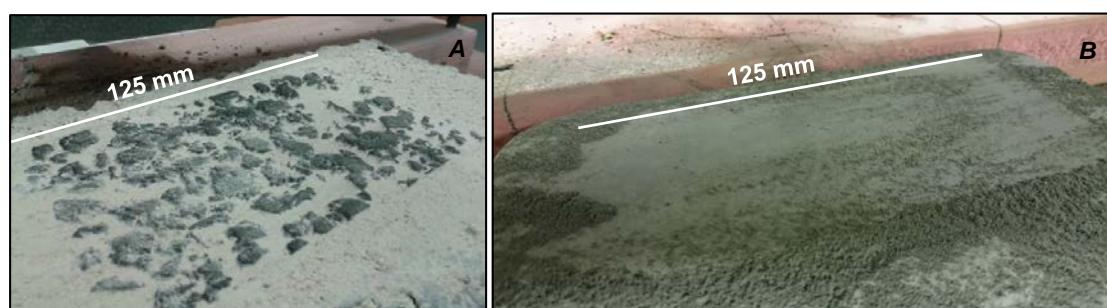
Figure 12. Dry ash displacement from the BPT slider-surface interface after 8x swings of the pendulum arm for (a) SMA, and (b) airfield concrete. Dry ash was displaced from the surface more readily than wet ash. Note that white lines indicate length of slider contact path (i.e. 125 mm).

Very similar patterns in skid resistance were observed for the airfield concrete surfaces where ash was not replenished between swings. The main difference was that the initially high SRVs for the scoriaceous sample (PUP-BAS) decreased more quickly with pendulum swings, most likely due to the ash being more easily displaced from the smoother concrete surface than for asphalt.

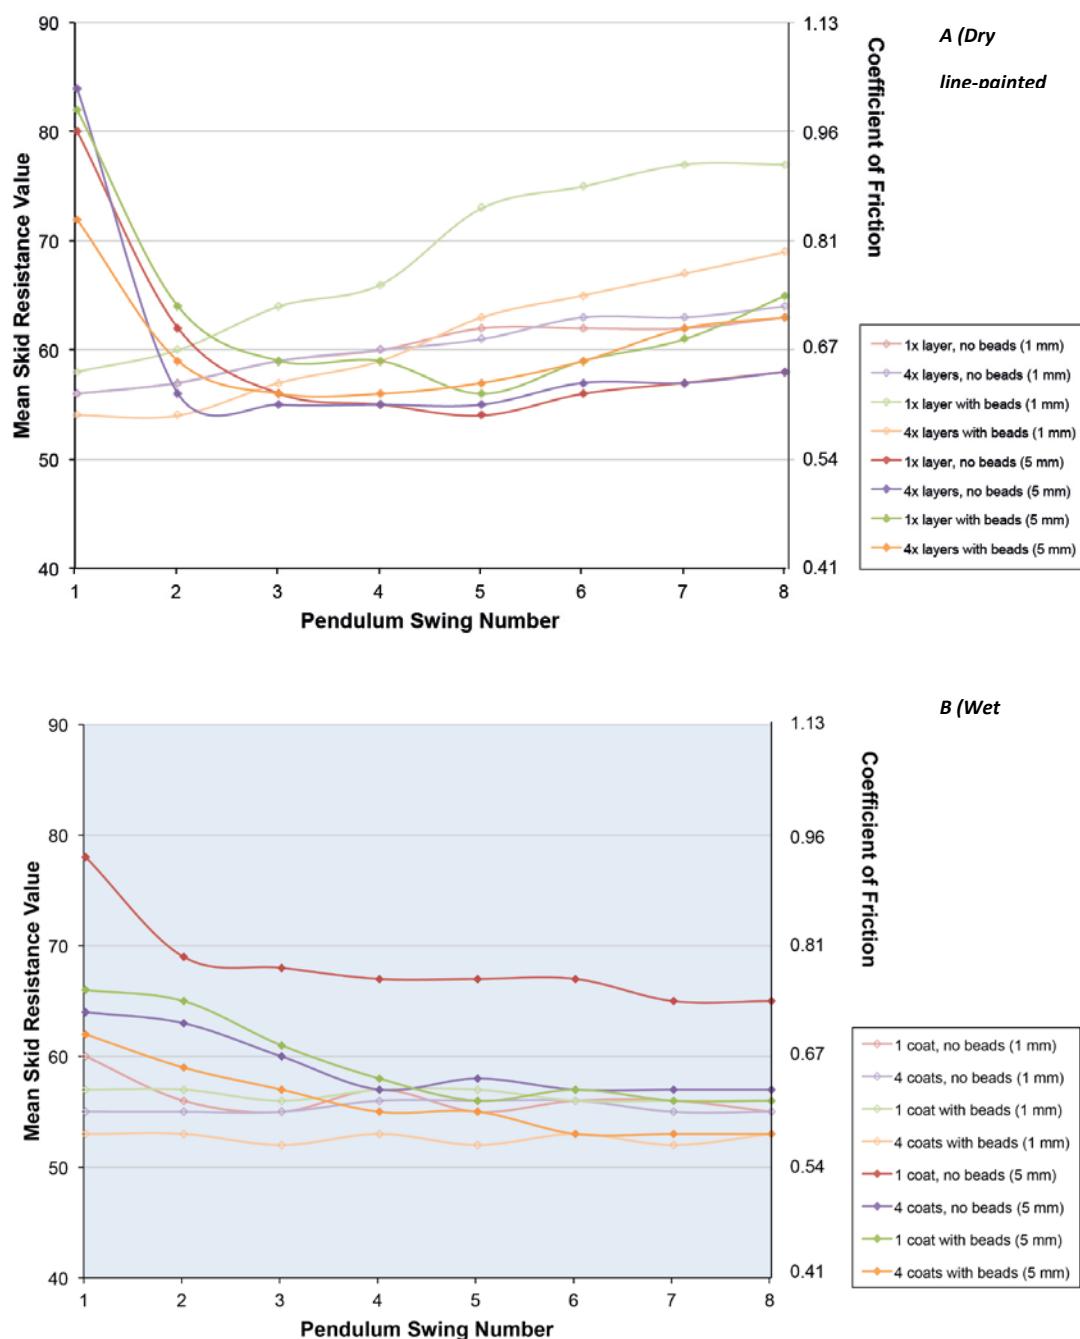
Figure 13. SRVs and corresponding CoFs for line-painted asphalt surfaces covered in 1 mm or 5 mm thick LYT-BAS1, under (a) dry, and (b) wet conditions. Only one test was conducted on each surface type due to the availability of line-painted slabs. Therefore, no standard deviations were calculated and the results should be treated with some caution. Note that the initial 2-3 swings over the 5 mm deposits should be treated with particular caution.

Line-painted asphalt surfaces covered in ash (Figure 13) produce relatively low SRVs. Although the first 2-3 swings involving 5 mm thick ash are not considered, it is evident that wet painted surfaces are generally slightly more slippery than painted dry surfaces. The trend of quick SRV recovery (as seen in section 3.2.1) is also evident under dry line-painted conditions, when compared to wet conditions which remain slippery for longer. Under dry conditions, the addition of retroreflective glass in the line-paint appears to aid the recovery of skid resistance over time (as shown by the rising green and orange lines for the latter swings in Figure 13a). However, this trend is not evident for wet conditions.

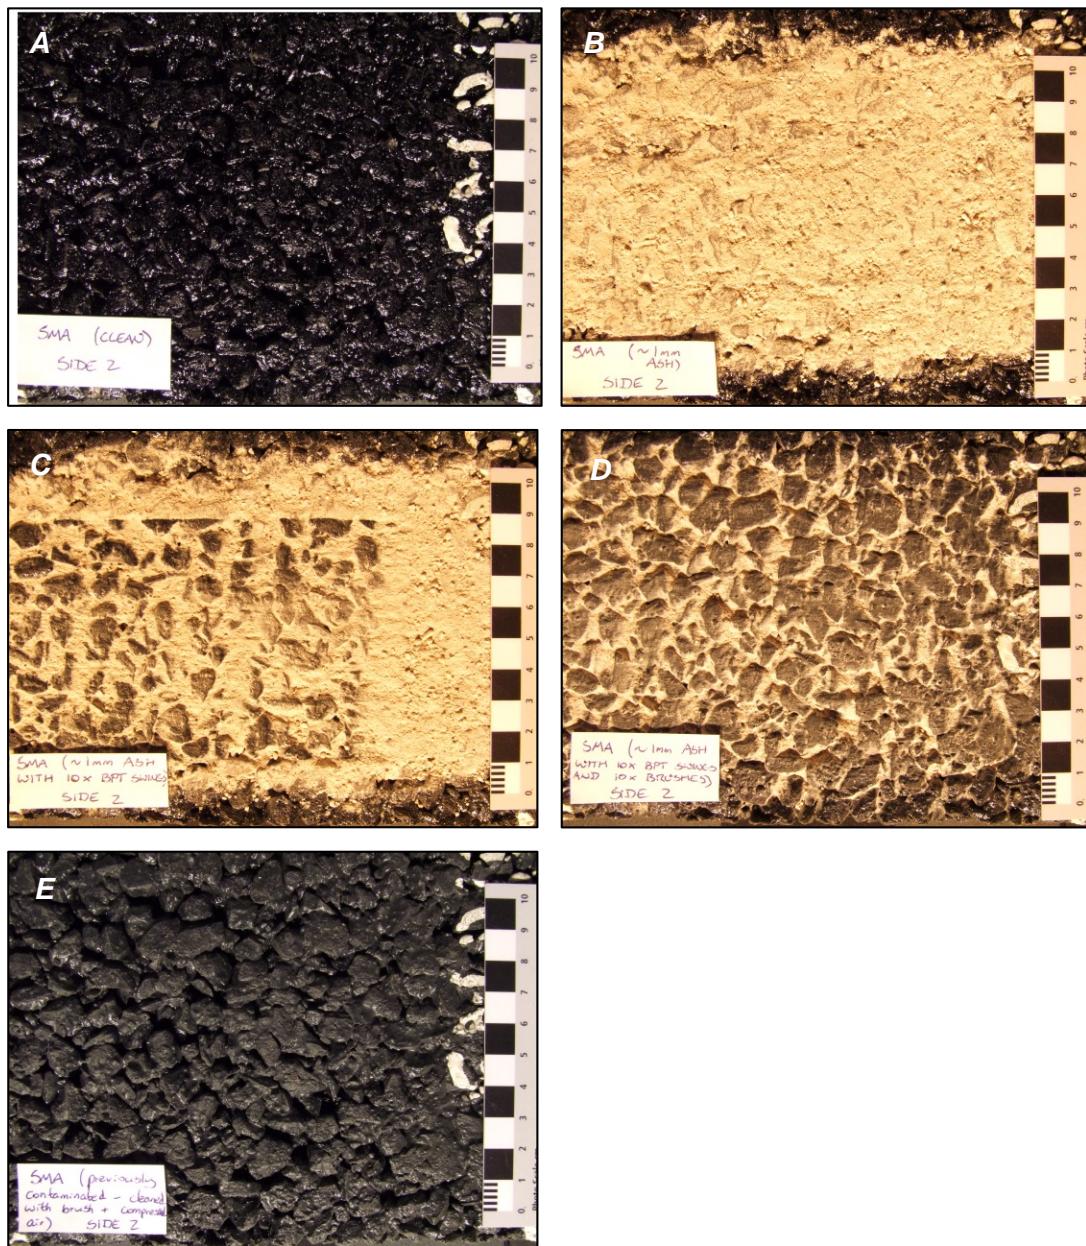
Figure 14. Macrotecture image sequence for asphalt. (a) Clean new slab, (b) covered with 1 mm rhyolitic ash (100% surface coverage), (c) after 10x BPT swings (81% surface ash coverage), (d) after cleaning with 10x brush strokes (40% surface ash coverage), (e) after cleaning with compressed air (<1% surface ash coverage). The macrotecture of the surface is visibly affected in images b-d with much ash remaining between the asphalt's aggregate pore spaces, even after 10x BPT swings and cleaning using a brush.

The results for the new slab and pre-contaminated slab after cleaning with compressed air suggest that there is little difference in macrotexture depth after cleaning using this method. However, cleaning using only brush strokes shows a mean macrotexture depth reduction of 0.38 mm, 28% less depth than the original new surface. This suggests that cleaning of dry road surfaces using only brushes may not be entirely effective and that alternative methods should be considered where possible. To confirm this, after brushing and 10x swings of the BPT, some HAT-RHY ash remains - as shown in the digital photography macrotexture image sequence (Figure 14) and semi-quantitative analysis of these images using *Ilastik* and *Adobe Photoshop* gives results of surface coverage (Table 6).

Cleaning using high-pressure water spraying and brushing was more effective than brushing alone at removing ash (<1% surface ash coverage afterwards). However, this approach requires large quantities of water and the microscope imagery revealed that some small particles of ash remain on the surface, which would perhaps still reduce skid resistance somewhat. Field observations from Kagoshima, Japan, where high quantities of only low-pressure water are used to clean road surfaces indicates that some ash remains on the road surfaces even immediately after

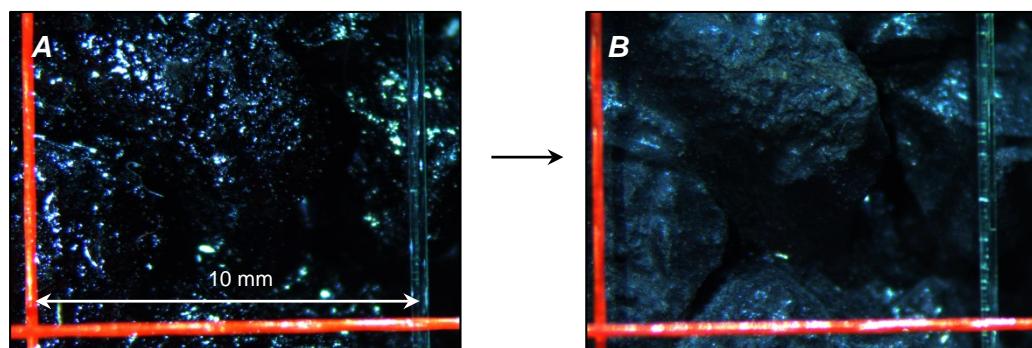
Figure 15. Microscope images on the same segment of asphalt, (a) on the new slab and (b) after contamination with volcanic ash and cleaning with compressed air. Much of the shiny film visible on the surface of the new asphalt has been removed. Note that the length of the white lines is 10 mm and that lighting conditions and microscope settings were consistent for both images.

In normal conditions, the skid resistance of bare asphalt surfaces changes over time. Typically, during the first two years following construction it increases as the surface is worn by traffic and rough aggregate surfaces become exposed, and then decreases over time as the aggregates become more polished [41]. The initial trend of increasing skid resistance was confirmed during our testing of the bare wet asphalt and concrete slabs before and after contamination with ash (but following cleaning), particularly so for the asphalt (Figure 5). We suggest that the abrasive properties of volcanic ash accelerates these processes, especially for our testing as all ash particles were $<500\text{ }\mu\text{m}$ in diameter (see section 1.2.4). Following testing, the SRV of bare wet asphalt had increased by around 5. The microscopy imagery showed that the lustrous film on the new asphalt slabs had been removed during BPT experimentation (Figure 15).

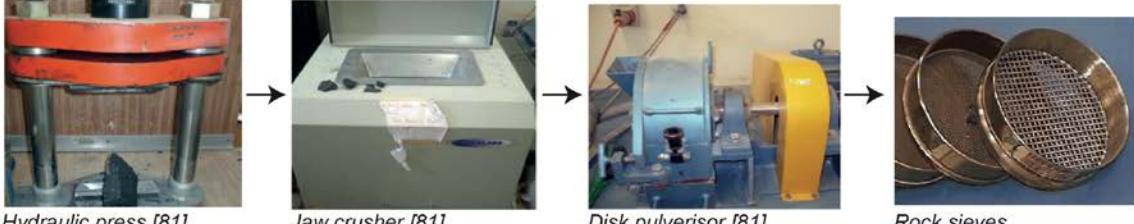
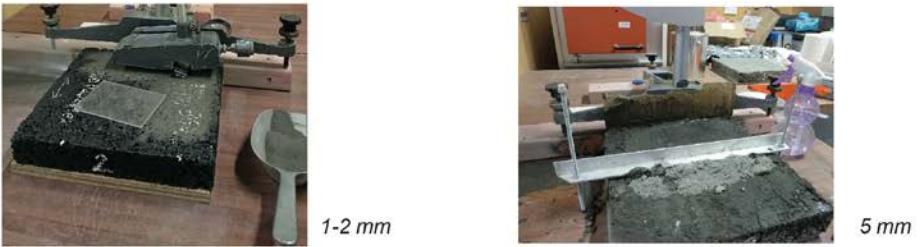
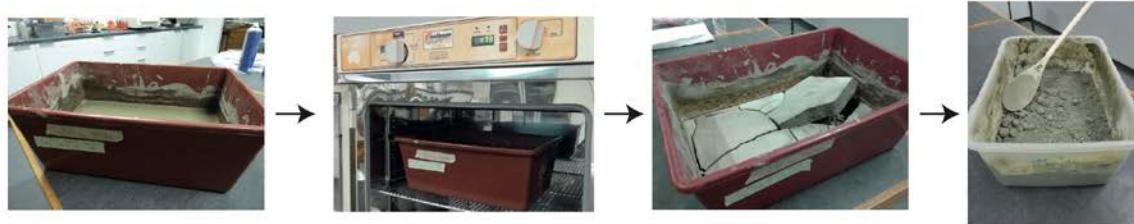
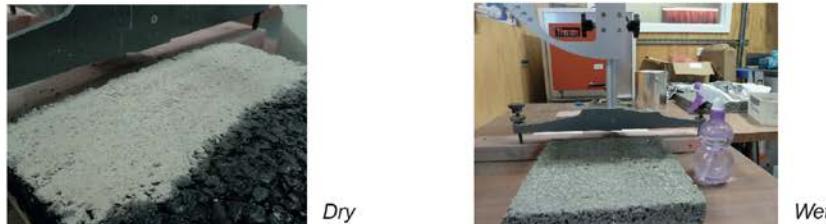
Figure A2. Ash characteristics analysed during experimentation and illustrations to show production of each characteristic.

Characteristic	Variables	Method Summary
Ash type	Hard basalt, scoriaceous basalt, pumiceous rhyolite	Different volcano source locations in New Zealand
Ash grain size	<1000 µm, <106 µm	Rock splitting, crushing and pulverisation (as required), then sieving

<p>Hydraulic press [81] Jaw crusher [81] Disk pulverisor [81] Rock sieves</p>
Ash thickness	1-2 mm, 5 mm	Manual sprinkling (1-2 mm), Metal spacer across ash surface (5 mm)

<p>1-2 mm 5 mm</p>
Soluble components	Non-dosed, dosed with Ruapehu Crater Lake fluid, dosed with White Island Crater Lake fluid	Established laboratory dosing technique (see section 2.1.1)

Wetness	Wetted to saturation, dry (no added moisture)	Hand-held water sprayer (water at room temperature)

The ash characteristics analysed during experimentation and production techniques are summarised in Figure A2. For the surfaces covered in ash, we use two test methods to replicate different ash settling conditions in combination with vehicle movement effects:

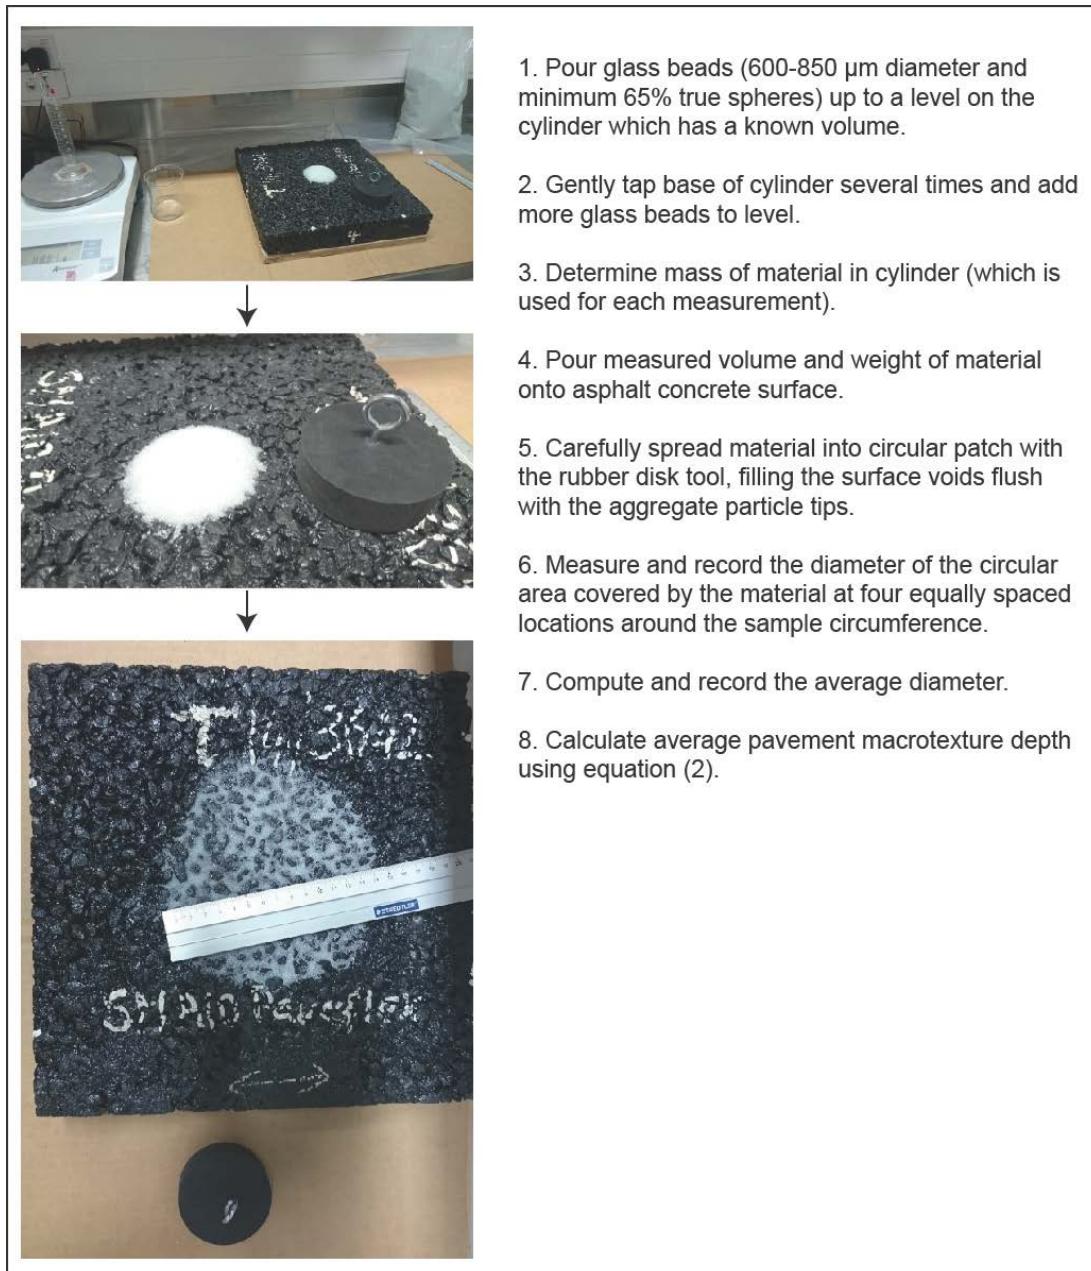
Figure A3. Summary of sand patch volumetric technique used to calculate the average pavement macrotexture depth (adapted from [82])

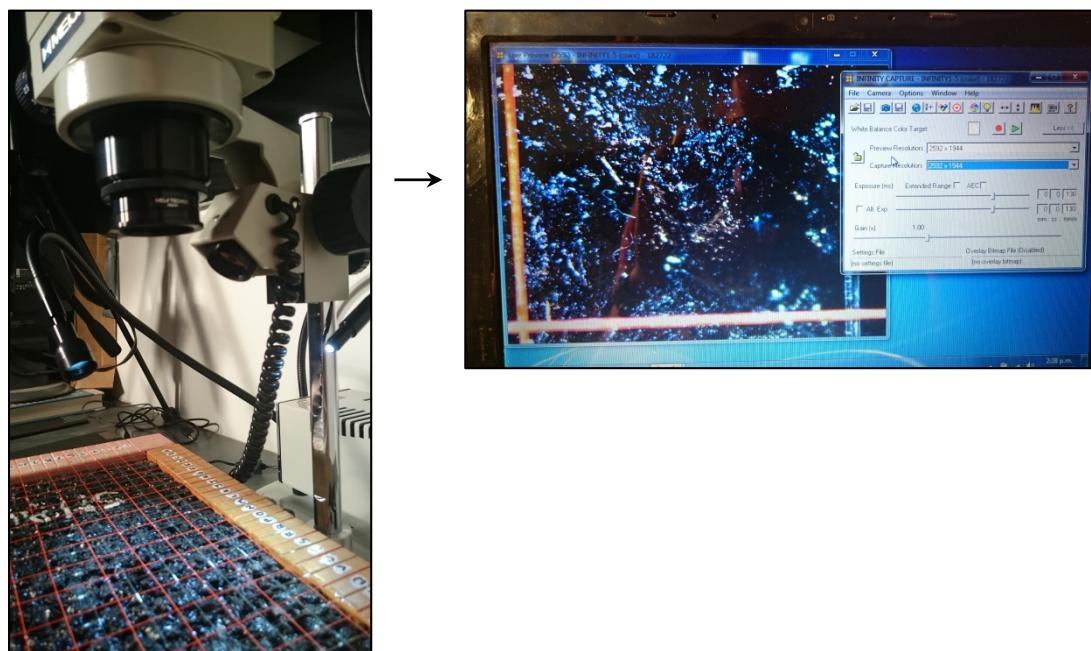
Figure A4. Image capture using stereo-microscope to analyse asphalt at a microtextural scale. Note that the grid squares (a) are spaced at 10 mm intervals.
