# Improvement Measures for Bridge Inspection Efficiency Using Spatial Information Technology

**Keywords:** bridge maintenance and inspection; UAVs; machine vision

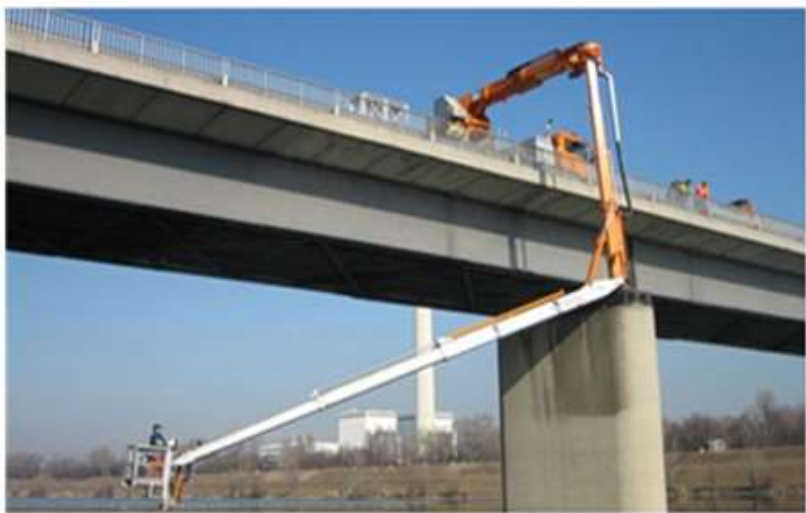
Figure 1. Close inspection using bridge inspection vehicle

As of 2016, there were 30,983 existing bridges in Korea. Among these, 10,358 bridges (considered on Types 1 and 2) are known to be registered in the Facility Management System of the Korea Infrastructure Safety and Technology Corporation. These bridges are subjected to inspections under two categories—safety inspection and precise safety diagnosis—in accordance with the Special Act on the Safety Control of Installations and relevant guidelines (Detailed name: Guidelines on Safety Inspection and Precise Safety Diagnosis, Ministry of Land, Infrastructure and Transport) on infrastructure safety management. The primary purpose of the safety inspection is to check the current status of infrastructure facilities using simple tools and carry out a condition assessment. The safety inspection comprises three sub-inspections: regular inspection, close inspection, and emergency inspection. Close inspection consists of early and regular inspections, whereas emergency inspection consists of damage and special inspections. A regular inspection involves an investigation of the general external condition of the accessible areas of the bridge. Naked eyes and assistive tools such as telescopes and mirrors are used, and the inspection is conducted at least once every 6 months. In principle, an early inspection shall be conducted by a qualified senior engineer who can perform close and emergency inspections, and the initial close inspection of new or modified infrastructure facilities shall be conducted within 6 months after the completion of construction or from the date of granting approval for use (including temporary use). A regular close inspection involves an accurate assessment of the current status of infrastructure facilities, an assessment of changes from the initial or previously recorded status, and a confirmation of whether infrastructure facilities satisfy the requirements for use. In addition, a closer naked-eye inspection, simple measuring instruments, and bridge inspection vehicles are used if needed. A regular close inspection is conducted at least once every 2 years. Figure 1 shows a photograph of an inspection using an inspection vehicle when conducting a close inspection.

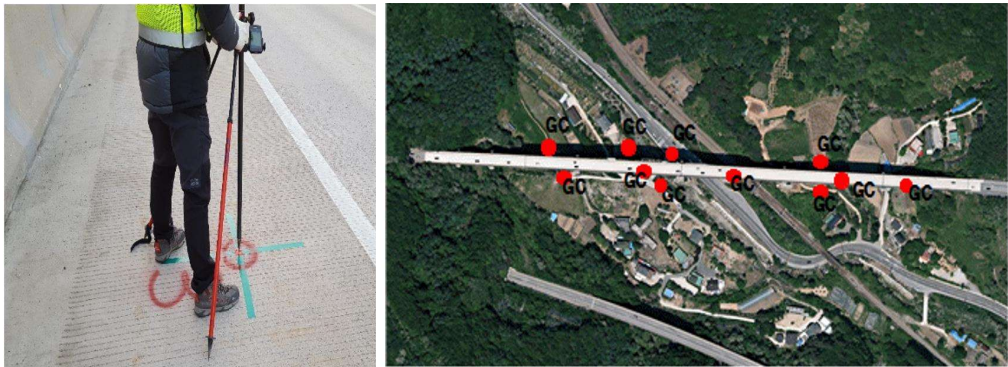
Figure 6. GCP surveying and installation points

A total of 11 GCPs were installed for the study purpose. Depending on the altitude of the bridge, three GCPs were installed on the bridge deck and the remaining eight were installed directly on the ground below the bridge. The GCPs were measured by VRS (Virtual Reference System) observation according to aerial photogrammetric regulations. Figure 6 shows the installation points of the GCPs and the scene of the installation.

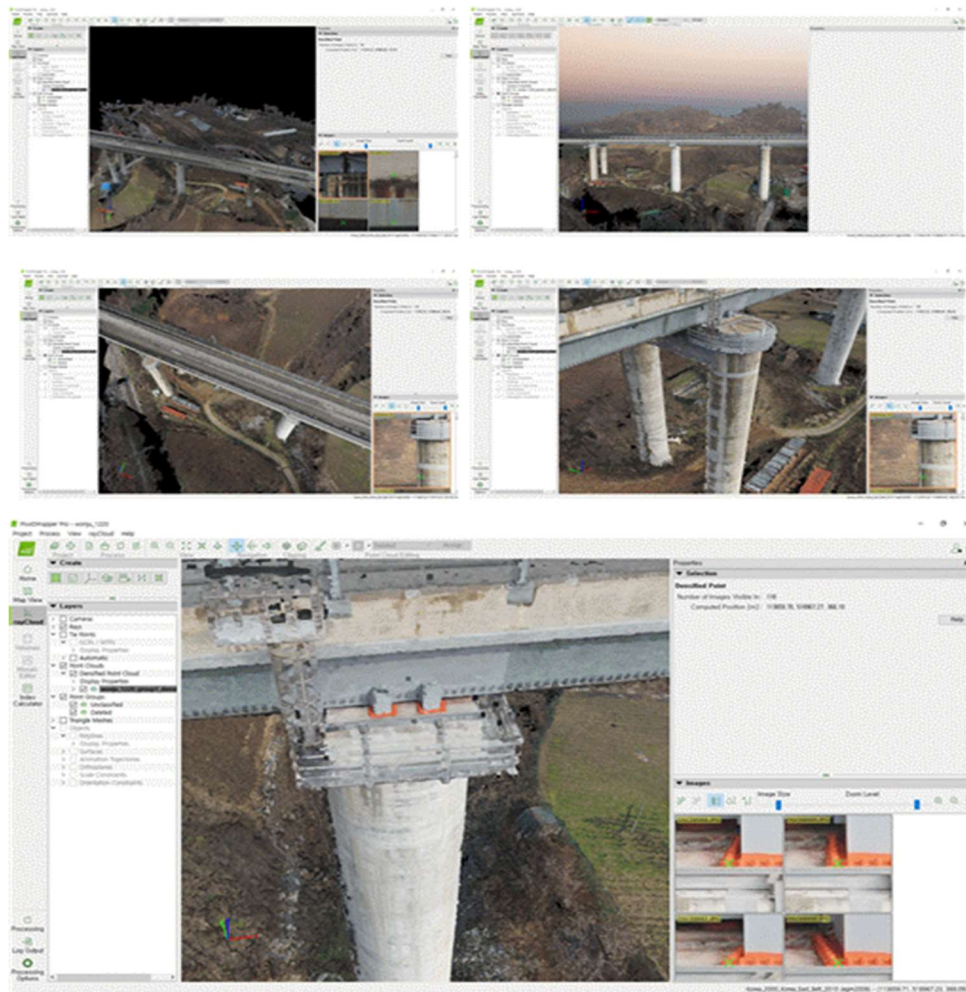
Figure 8. Results of image matching

Figure 8 shows the outcomes depicted as 3D models that are generated from the image processing.

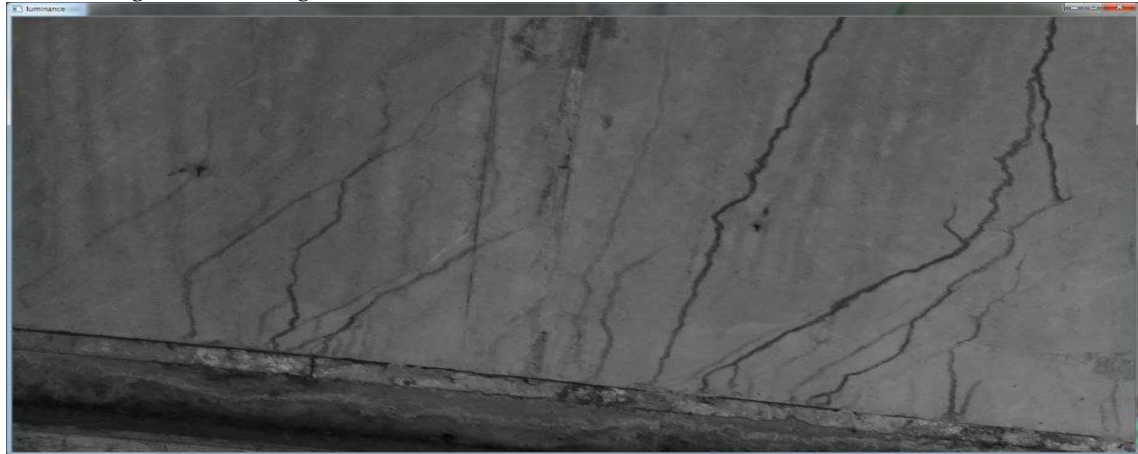
**Figure 11.** Data extracted from channel L (luminance)

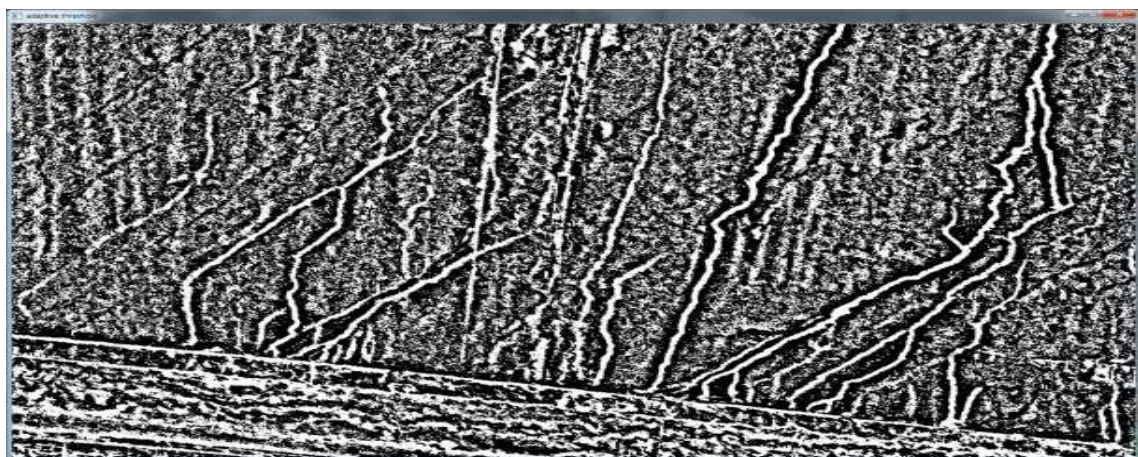
**Figure 12.** Resulting image obtained using Gaussian adaptive threshold method

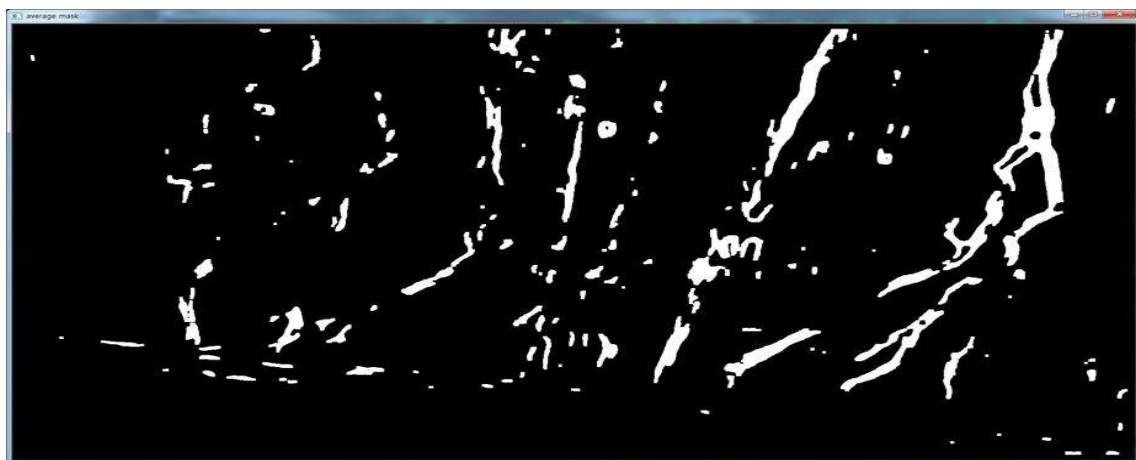
**Figure 14.** Resulting image obtained after applying local average filter

In stage 107, histogram equalization was carried out using the contrast-limited adaptive histogram equalization (CLAHE) method to minimize the effects of external brightness. The CLAHE method was used because it could minimize the impact of the difference in regional illumination when carrying out histogram equalization. Using the resulting image obtained from the histogram equalization in stage 108, a local average filter was applied to each area to compare the average brightness and the current pixel brightness. A darker image was detected by comparing the entire pixels with the local average, and it was designated as crack candidate 3 (Figure 5).

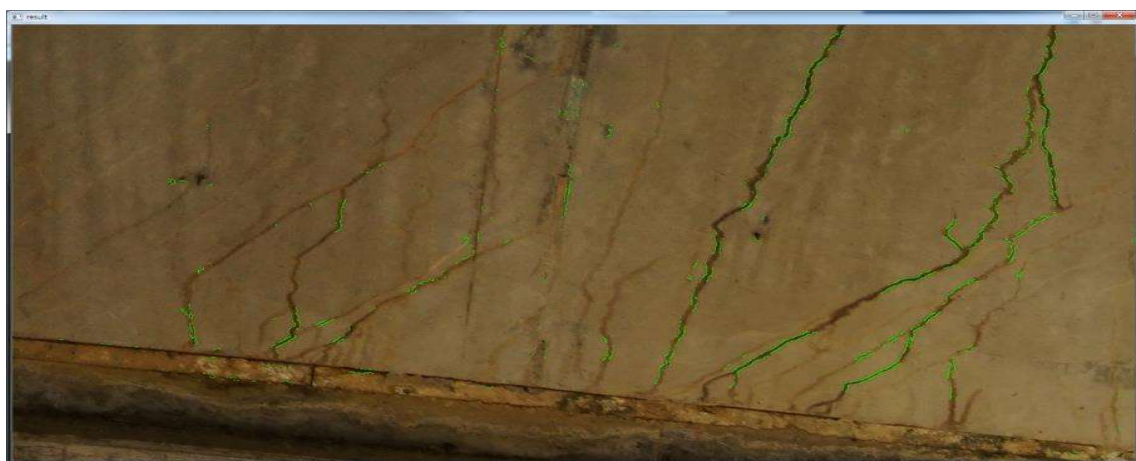
**Figure 15.** Resulting image obtained from crack detection

After extracting crack candidates 1, 2, and 3, all the detected intersections in each candidate were measured, and in stage 109, the areas with boundaries equal to or greater than a certain width and the areas with darker brightness values than the surrounding areas were assumed to be cracks.

The crack detection result was verified based on the inspector's assessment on the site and direct comparison. This verification was carried out because the inspection result was based on the naked-eye inspection by inspectors as mandated by the current regulations. One of the objectives of this study was to improve the objectivity of the inspection that is dependent on the subjective assessment

of inspectors and explore such a possibility through comparative analysis. Therefore, only the cracks with a width of 0.5 mm or greater were taken into consideration, and the comparison was carried out only in the quarter span of the lower part of the bridge.

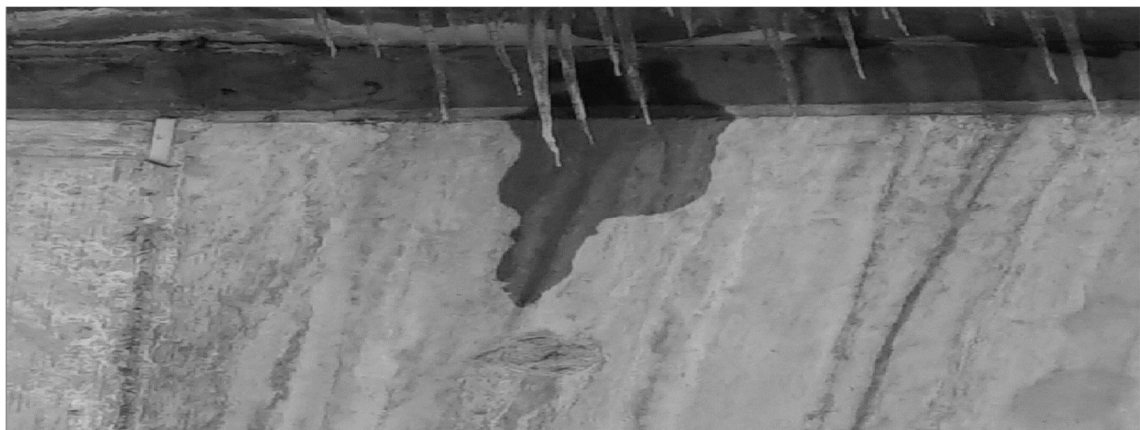
Figure 17. Channel L (luminance) data

To detect the leak in the image (Figure 16), the data for the brightness channel were used as the primary data, as in the case of the crack detection. The leak area also had a darker brightness value than the other areas. Therefore, to detect the leak area, the channel L data (Figure 17), which indicated the brightness in the Lab color format, were extracted through stages 701 and 702 (Figure 7). The data extracted from channel L were then used in the subsequent stages, i.e., 703 and 705. In stages 703 and 704, the binary images were extracted using the same method used in the crack detection. Darker areas were detected in the binary images to obtain the resulting image, as shown in Figure 18, and were used as leak candidate 1.

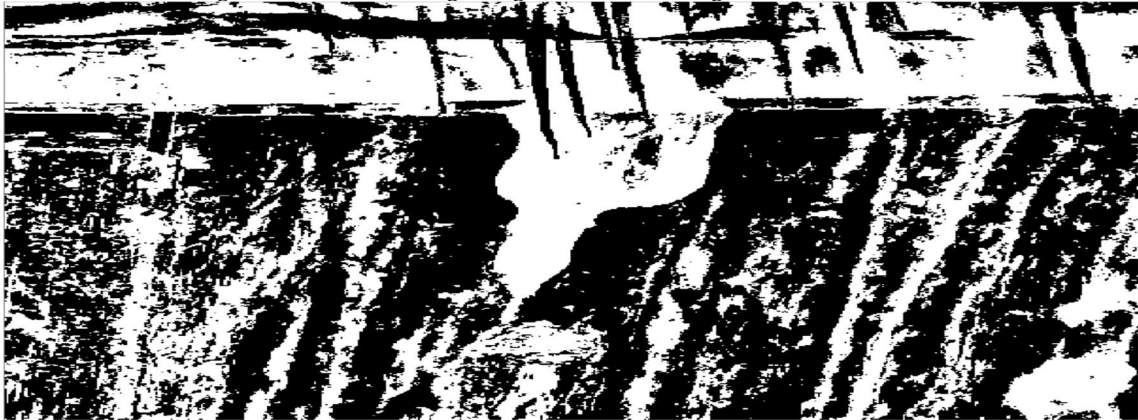
Figure 18. Resulting image obtained from Gaussian adaptive threshold method

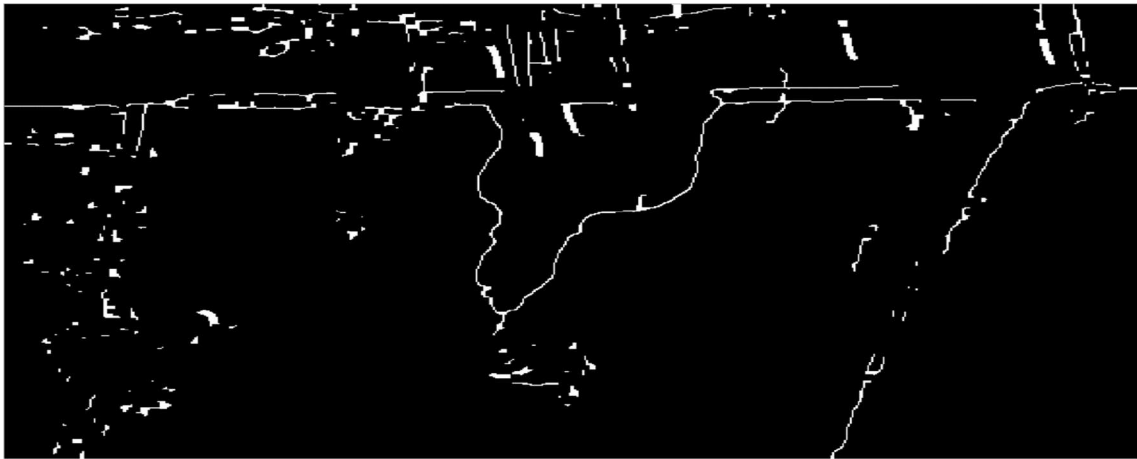
Figure 19. Resulting image obtained from Canny edge detection

In stage 705, the data representing the edges in the image were extracted using the Canny edge detection algorithm. For the edges in the bridge image, the threshold values were set as 0 and 150 for experimental purposes, and the resulting image was obtained, as shown in Figure 19. Because the data representing the edges included data for all the edges in the image, a top-hat morphological filter was applied in stage 706 to detect the edges of the comparatively darker area. When using a

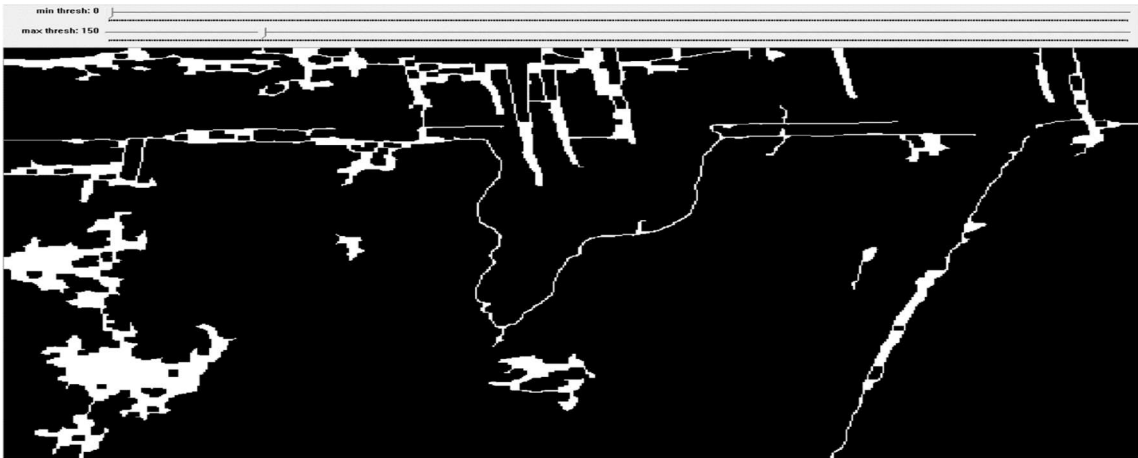
Figure 20. Resulting image obtained from top-hat morphological operation

morphological filter, a filter kernel with a size of  $5 \times 5$  was used. Figure 20 shows the edge image to which the filter was applied and the image was then used as leak candidate 2.

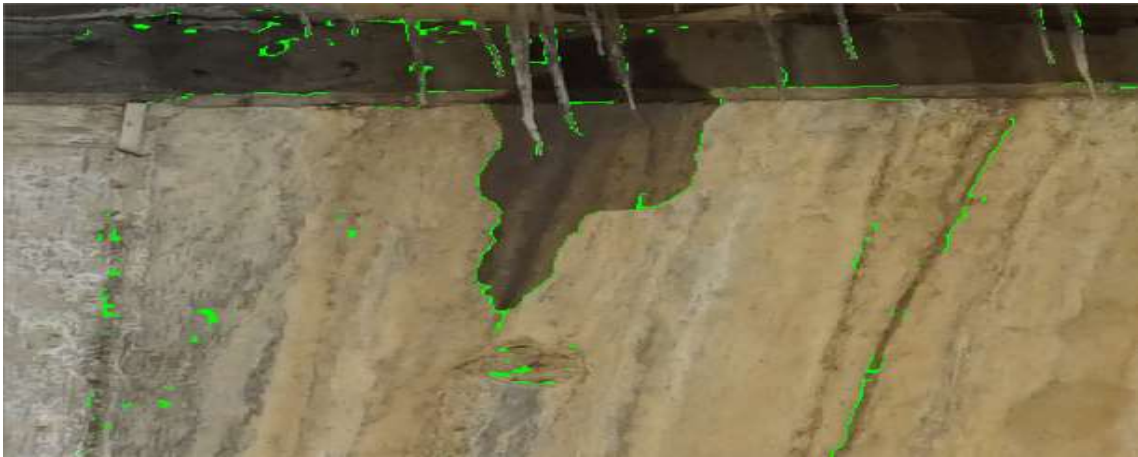
Figure 21. Resulting image obtained from water leak detection

The intersection of the areas detected in leak candidates 1 and 2 was measured, and the leak areas with darker brightness values than the surrounding areas and the edges in the darker areas were detected in stage 707. The resulting image is shown in Figure 21.

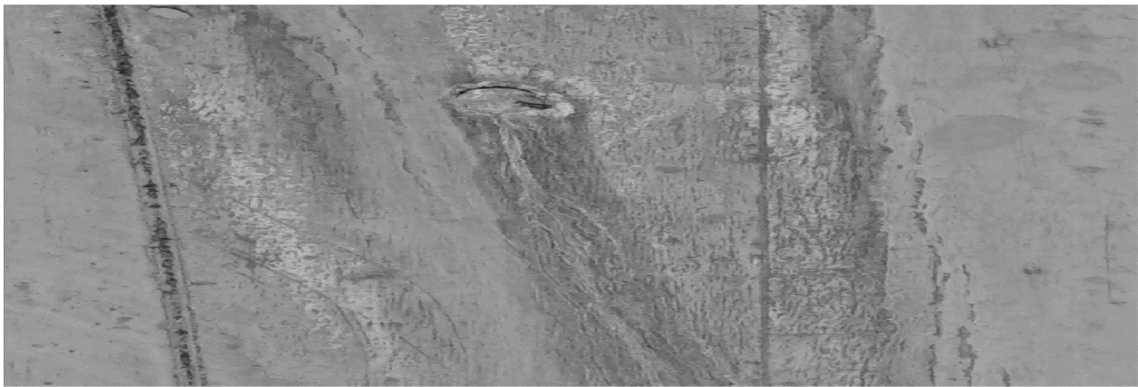
Figure 23. Channel L (luminance) data

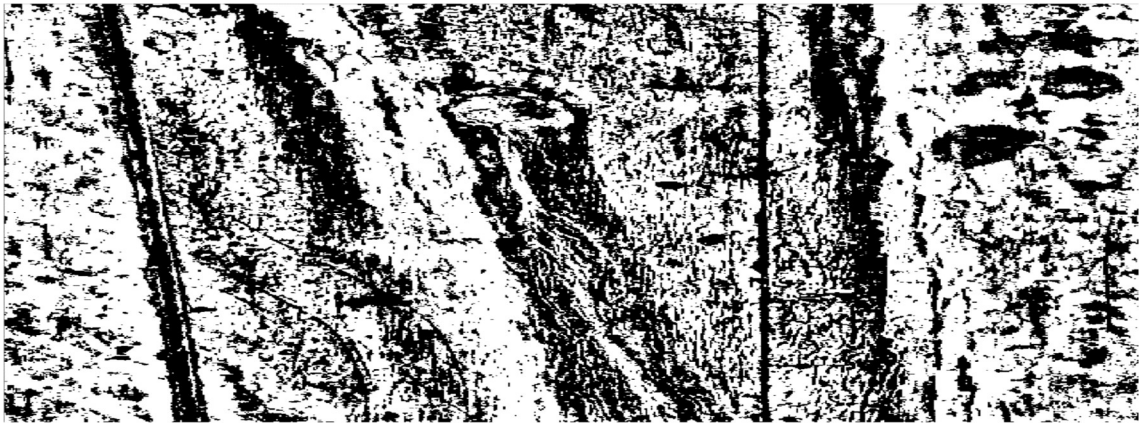
Figure 24. Resulting image obtained from Gaussian adaptive threshold method

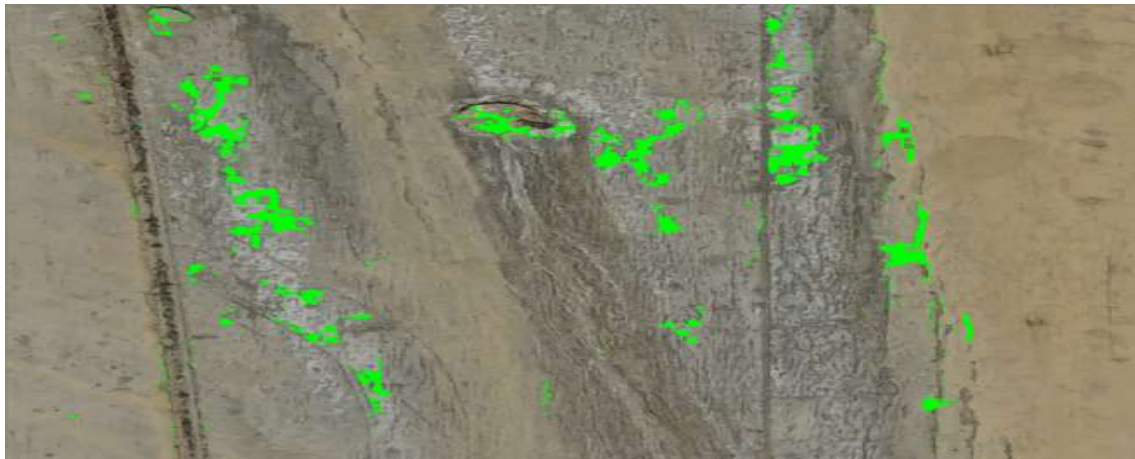
**Figure 26.** Resulting image from white-coated detection

The white coated area in the bridge image had lighter brightness values than the surrounding areas. To use this feature, as in the cases of crack and leak detections, the channel L data (Figure 23) obtained in stage 1302 were extracted for use in the Lab color format in stage 1301 (Figure 13). As in the other cases, in stage 1303, the channel L data obtained from stage 1302 were used to apply the Gaussian adaptive threshold method. As the efflorescence area had a lighter brightness value than the surrounding areas, the data was extracted only when the value exceeds the threshold value, and a binary image was obtained in stage 1304, as shown in Figure 24. This image was designated as efflorescence candidate 1. When efflorescence occurred, more edges were found in the efflorescence area than in the other areas. Therefore, the edges were detected through the Canny edge detection in stage 1305. The detected edges were designated as efflorescence candidate 2, as shown in Figure 25. Then, the intersection of the designated efflorescence candidates 1 and 2 was measured, and the efflorescence areas with comparatively lighter brightness values than the surrounding areas as well as many edges within the efflorescence areas were detected in stage 1306. The detected efflorescence areas are shown in Figure 26.
