# Computing the Effect of Environmental Damage on Aircraft Structural Integrity

**Abstract:** This paper studies the combined effect of corrosion and fatigue on the growth of cracks in aircraft and on the effect of skin corrosion and stress corrosion cracking on the load bearing capacity of rib stiffened aircraft wings. In this context it is shown that the growth of cracks from surface pitting, and also from intergranular cracking at a fastener hole, can be accurately computed using the Hartman-Schijve variant of the NASGRO crack growth equation. The examples studied support the lead crack approach, that has been independently developed by the USAF and the Australian Defence Science Technology Group, in which the growth of lead cracks is often exponential. In the case of skin corrosion it is shown that to be consistent with the US Joint Service Structural Guidelines (JSSG2006) assessment of its effect on the load bearing capacity of the wing should involve an assessment of whether at 115% DLL the remaining material exceeds the yield stress of the material.

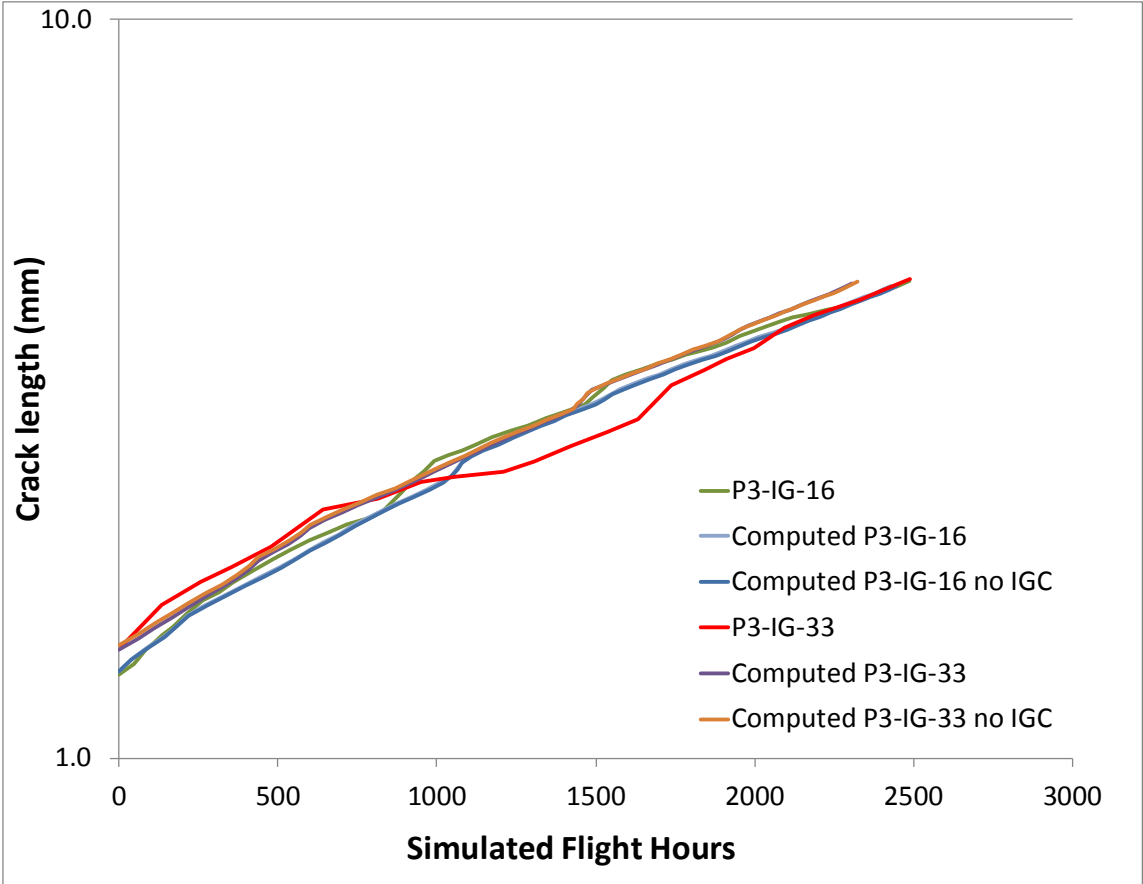
Figure 6. Comparison of the computed and measured crack growth histories for specimens P3-IG-16 and P3-IG-33, from [38].

with the constants for this material as given in [19]. The computed crack growth histories are shown in Figure 6 together with the measured crack length histories. Here the term ΔK<sub>thr</sub> accounts for the fatigue threshold, see [8, 19] for more details. As can be seen in Figure 6 the computed and measured crack growth histories are in good agreement. Of particular interest is the fact that, in this instance, the computed results with and without IGC were almost identical. This reflects the fact that IGC does not significantly change the local stress field.

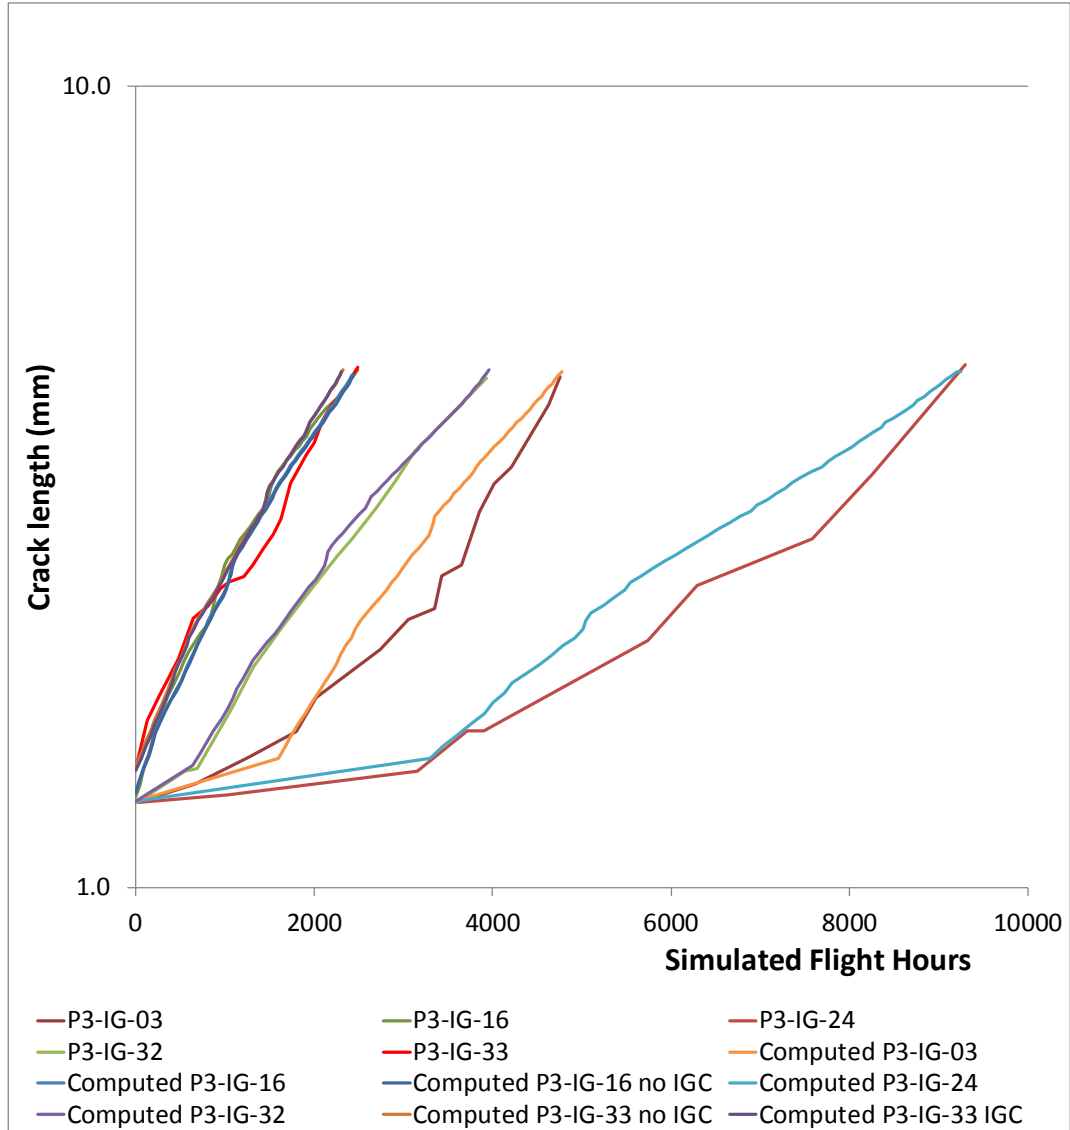
**Figure 7.** Comparison of the computed and measured crack growth histories for specimens P3-IG-16 and P3-IG-33, from [38].

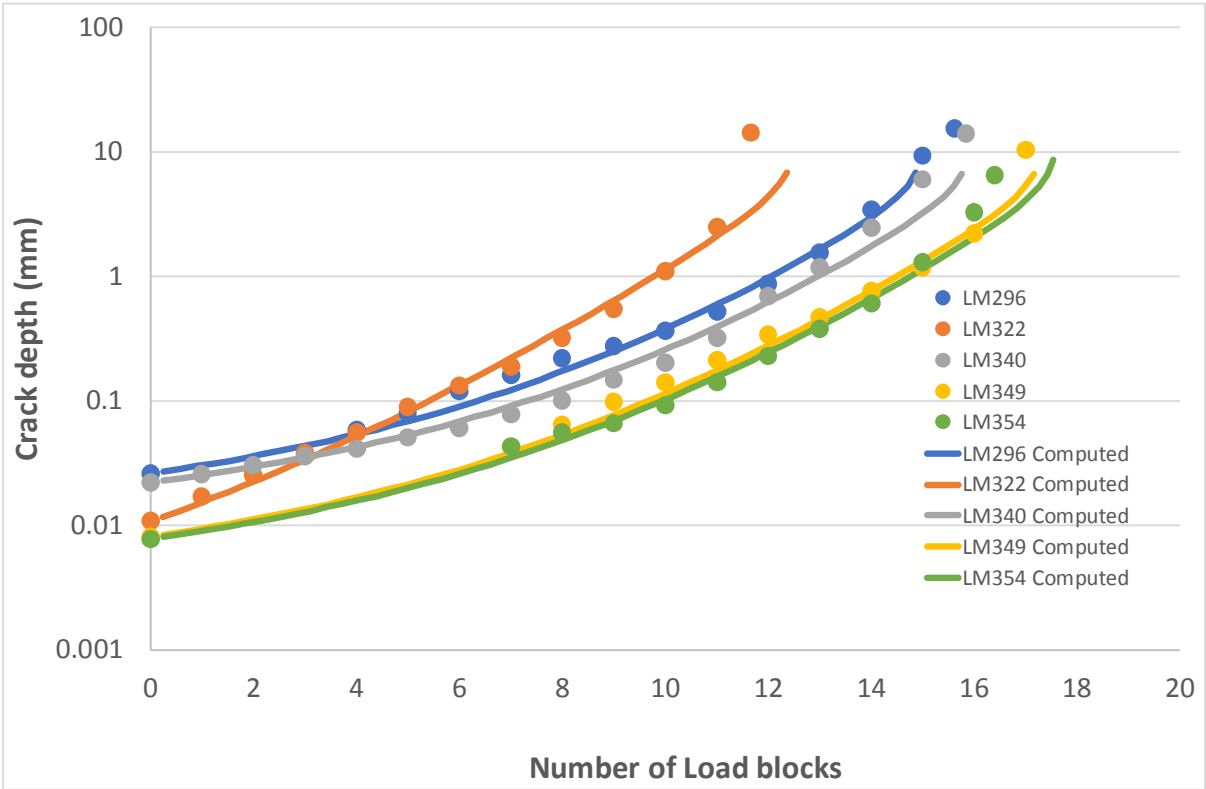
**Figure 9.** Comparison of measured and computed crack growth histories of AA7050-T8451 under a miniTWIST spectrum, from [20].

and are also shown in Figure 9. Here it can again be seen that the growth of both long and short cracks growing from etch pits on the surface of an AA7050-T7451 coupon, which was cycled under the miniTWIST spectrum, can be reasonably accurately captured by allowing for relatively small

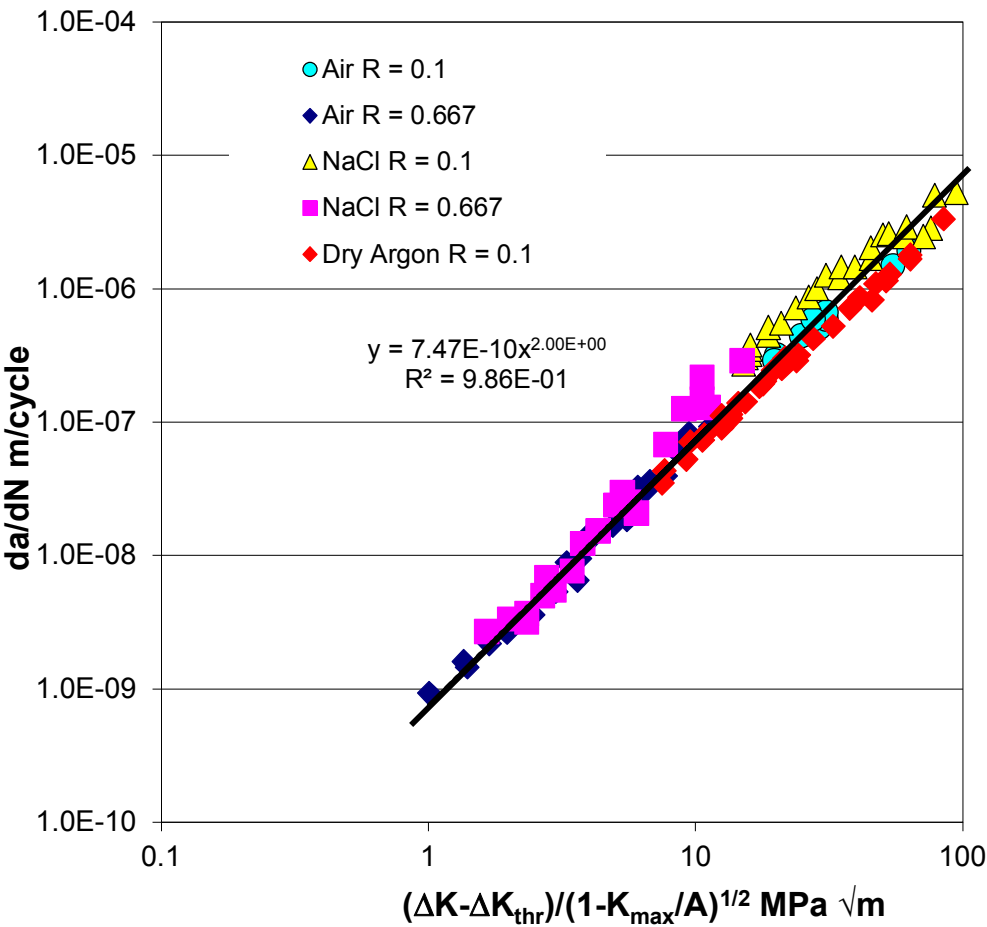
Figure 11. Crack growth in IMI130 replotted.

To illustrate that the effect of the environment can sometimes be represented by allowing for its effect on the value of  $\Delta K_{thr}$  consider the data presented by Wanhill [45] for the crack growth in the commercial titanium alloy IMI130 tested in dry argon (less than 20 ppm water vapour), normal air (40-60% relative humidity) and 3.5% aqueous NaCl. The associated da/dN versus  $\Delta K$  curves are given in Figure 10. Figure 11 presents this data replotted as per equation (1), i.e. by plotting da/dN against  $(\Delta K - \Delta K_{thr})/\sqrt{(1 - K_{max}/A)}$ . Here we see that the various curves now (essentially) all fall onto a single curve regardless of the R ratio or the test environment, i.e. that the difference in the crack growth rates can be accounted for by allowing for changes in the term  $\Delta K_{thr}$ . The values of  $\Delta K_{thr}$  and A used in Figure 11 are given in Table 6.

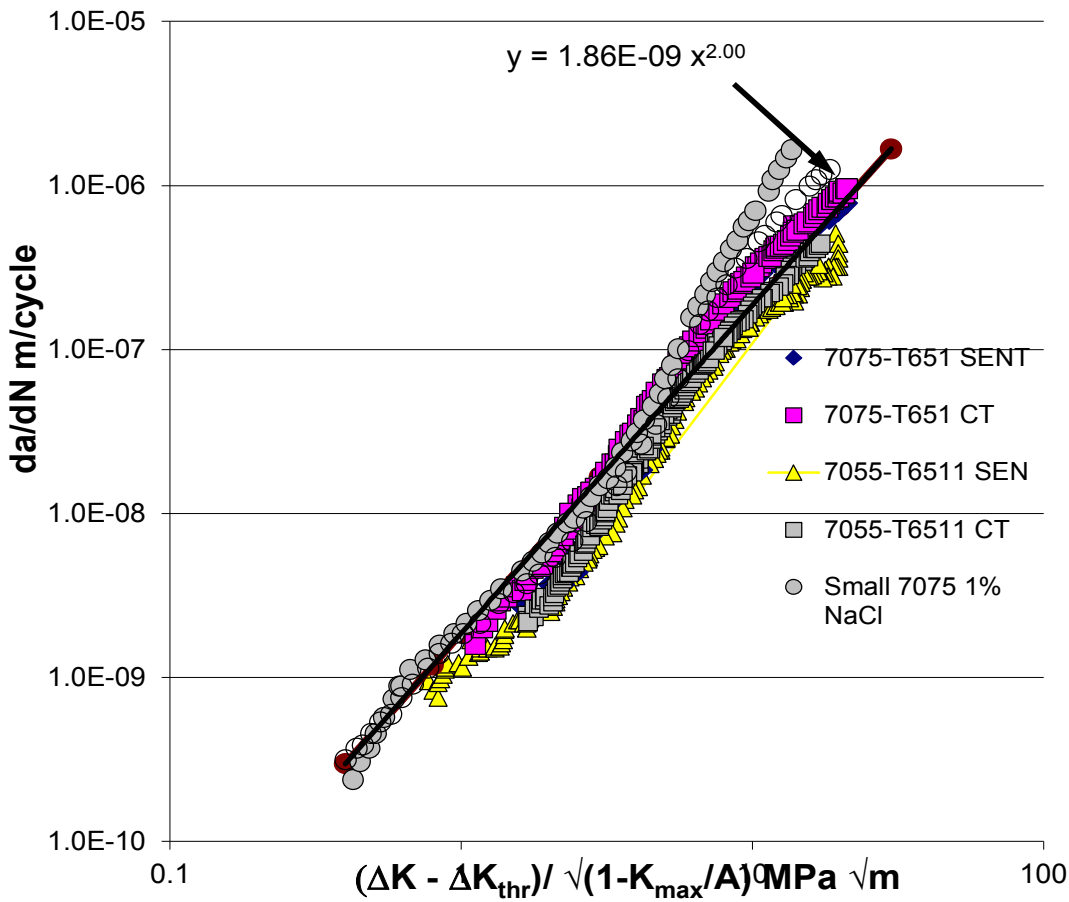
**Figure 13.** Crack growth in 7075-T651 and 7055-T6511 tests replotted, from [47].

that was determined in [41] for the growth of long cracks in 7075-T6511 in room temperature laboratory conditions. The values of ΔK<sub>thr</sub> and A used in Figure 13 are given in Table 6.

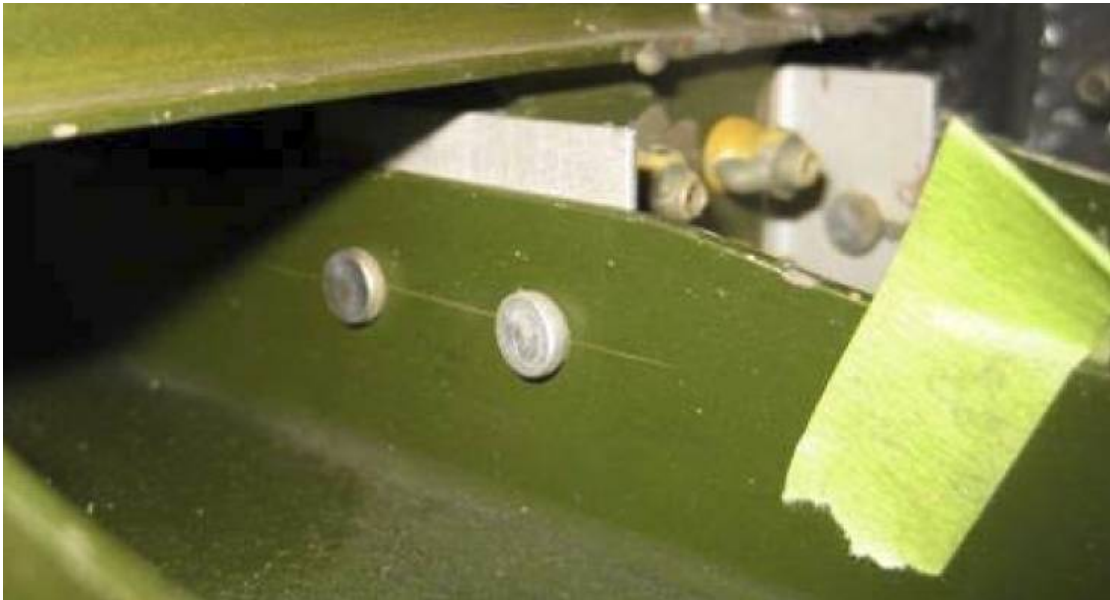
**Figure 15.** Typical SCC in a P3C (Orion) wing, photograph courtesy of M. Dorman, RAAF MPSO.

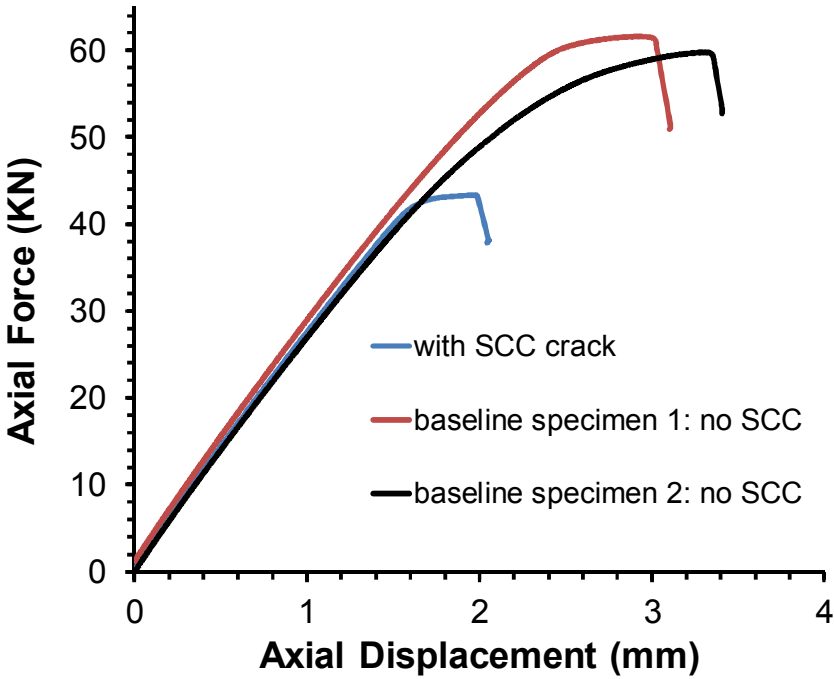
Figure 20 - Load displacement curves, from [Error! Reference source not found.49].

The difference in the load deflection curves arising due to the presence of SCC is shown in Figure 20. Here, in addition to the dramatic reduction in strength due to the SCC, we see that prior to failure the compliance of the specimen was unchanged by the presence of SCC. This suggests that the presence of SCC will not affect the load flow in a wing plank and hence not compromise the structural integrity of any nearby structural repairs.

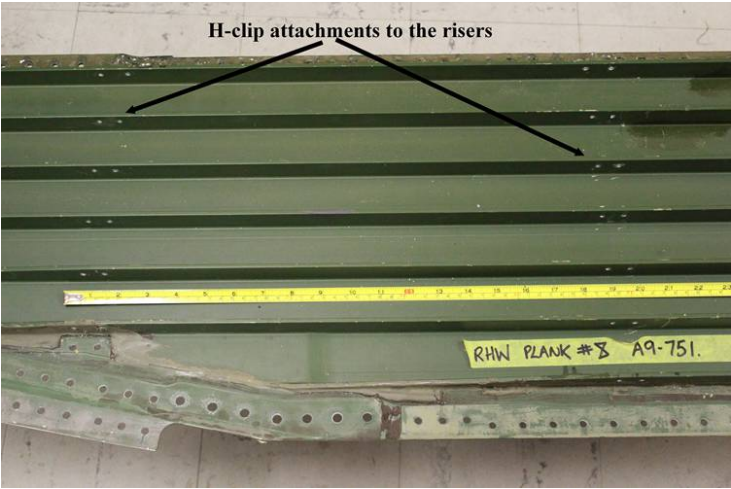
Figure 22 - Underside of a typical P3C wing plank showing the attachment points, from [44].

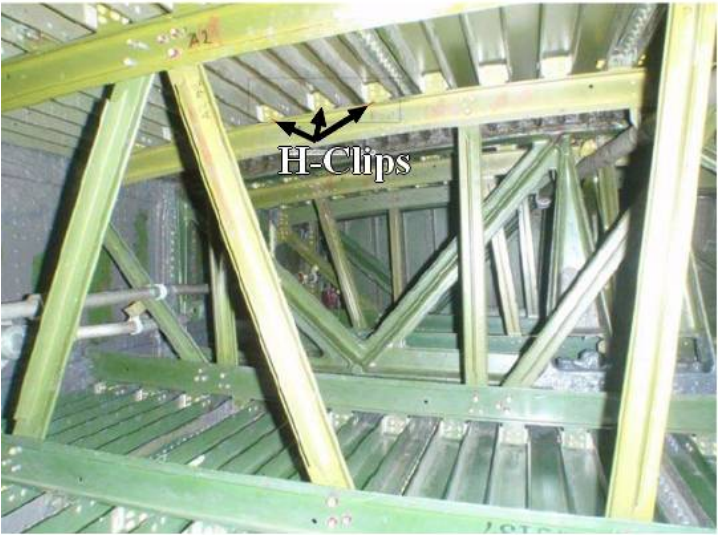
Figure 23 - Underside of a typical P3C wing plank showing the attachment points, from [44].

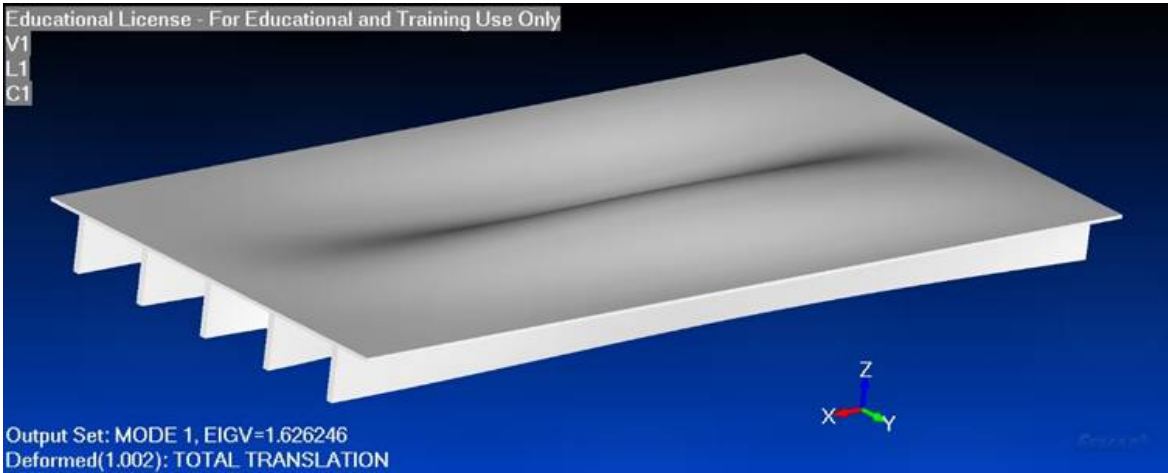
Figure 24 - Buckling loads for the baseline panels (no corrosion), from [44].

The finite element model developed in [44] consisted of 961,579 nodes and 583,696 twenty one node isoparametric element elements. Both a liner buckling analysis and a non-linear analysis, allowing for both material (material yielding) and geometric nonlinearities (large displacements), were performed. This analysis used the stress strain curve for the material as given in Mil Handbook 5. A linear buckling analysis of the baseline (no corrosion) panel was conducted first. This yielded a buckling load of 325 kN. The associated buckling mode is shown in Figure 24. The linear buckling
