Article

# Non Linear Strain Measures on Concrete Structures by Means of Embedded Optical Fiber Sensors

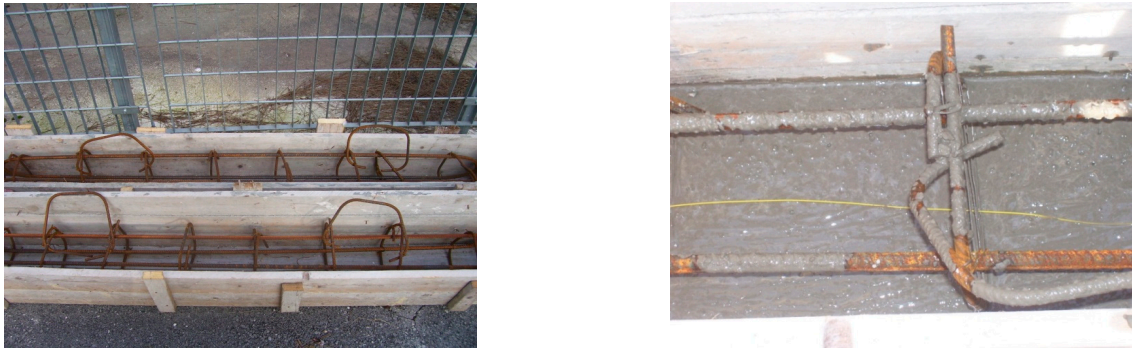
**Figure 1.** Building of the specimen: (a) description of the reinforcement pattern; (b) casting phase and optical fiber embedding.

Laboratory experiments have concerned reinforced concrete (RC) beams, casted by using designed concrete in order to obtain the prescribed of resistance  $f_{ck} = 25MPa$ . Figure 1 shows the casting phase, the reinforcement pattern and the fiber positioning.

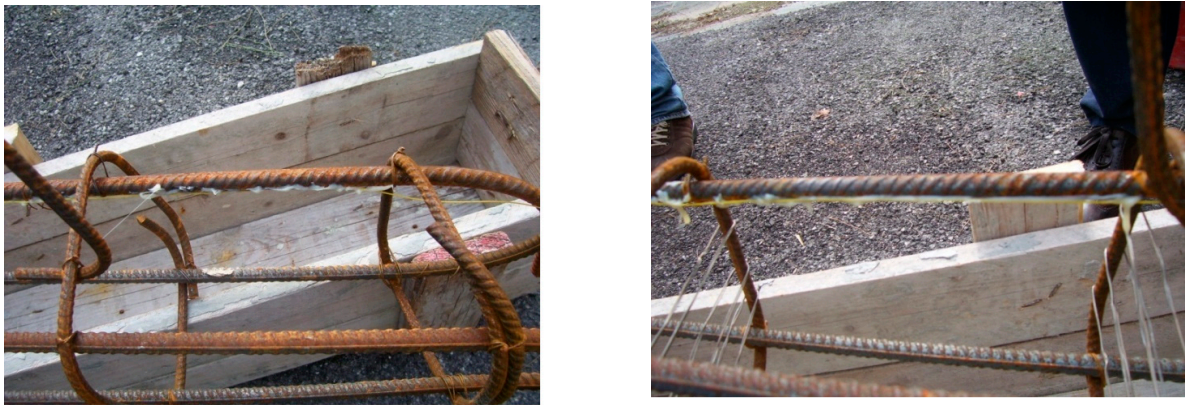
**Figure 2.** Fiber fixing: (a) the upper fiber is glued to the reinforcement; (b) an iron wire grid to fix the lower fibers.

The beam shape is summarized hereafter:  
Length  $l = 1.82m$  , square cross section, side  $0.20m$  . The reinforcement consists of four longitudinal steel bars, at the vertex of the beam; the bars have diameter  $\phi_l = 12mm$  . Finally, eight steel brackets whose diameter is  $\phi_b = 8mm$  complete the reinforcement. The sensing device has been designed to monitor the axial strain within the beam at different locations along the longitudinal directions at different vertical positions. Then, it has been possible to get the longitudinal curvature of the beam axis provided by Bernoulli's hypothesis to hold; for the scope, each beam has been instrumented by coiling a single optical fiber four times along the whole beam's length. The sensor disposition allowed us to record four strain patterns at different heights. The fiber has been glued to the brackets and along the longitudinal bars by epoxy resin; moreover, a grid made of iron wires has been applied through the brackets so that the optical fiber could be suspended at the prescribed position, as depicted in Figure 2.

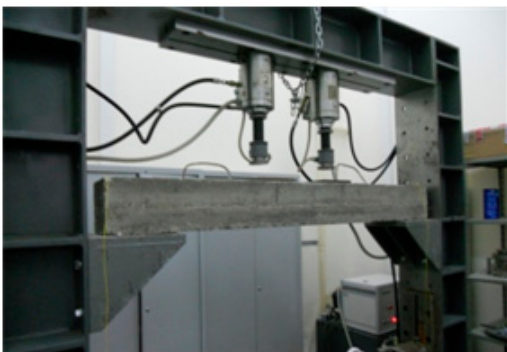
Figure 3. Testing apparatus, load frame and hydraulic jacks

110 The loading equipment consists of a steel frame, where rolling cylindrical supports are positioned at  
111 the testing span distance, in order to provide the supports that allow horizontal displacements.  
112 Hence, the beam is subjected only to transversal actions (i.e. zero axial force).

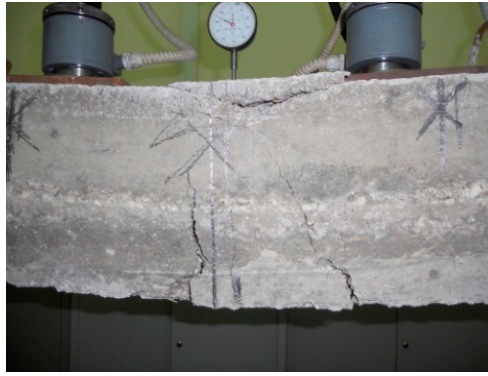
Figure 5. Dial displacement gauge position.

118 In order to have a redundant control of the electronic measures, the structure has been equipped  
119 with a displacement dial gauge, positioned at the middle span of the beam, as represented in Figure  
120 5.

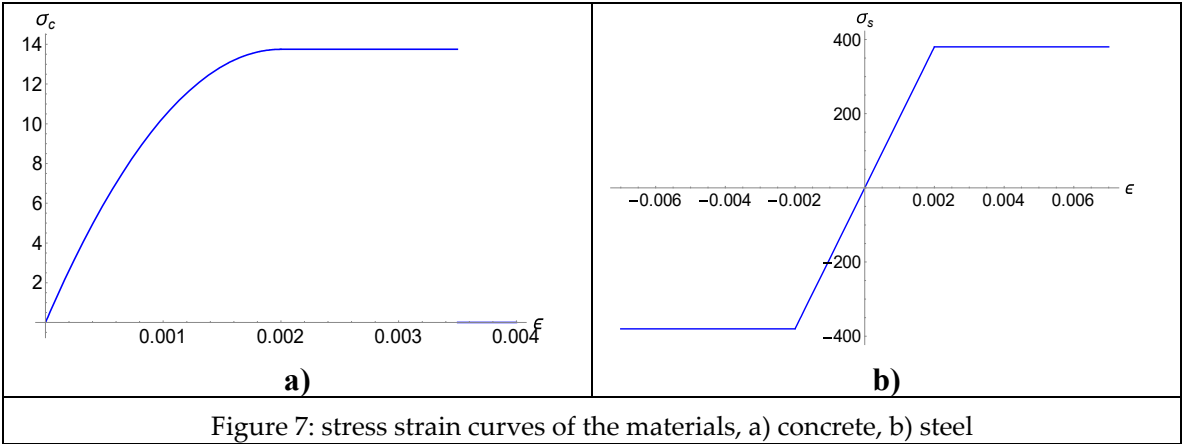
Figure 7: stress strain curves of the materials, a) concrete, b) steel

140 The stress strain curves for the two materials are drawn in figure 7.

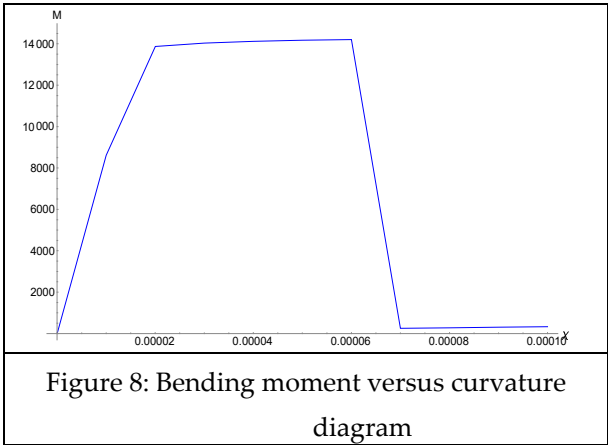
Figure 8: Bending moment versus curvature diagram

141  
142 By means of the above definitions and by integrating the stress moment about the x axes along  
143 the beam thickness, one can calculate the moment–curvature relationship. The moment–curvature  
144 diagram is drawn in Figure 8.
