Article

The effect of using chip and slash in reducing sheet erosion on forest road slopes

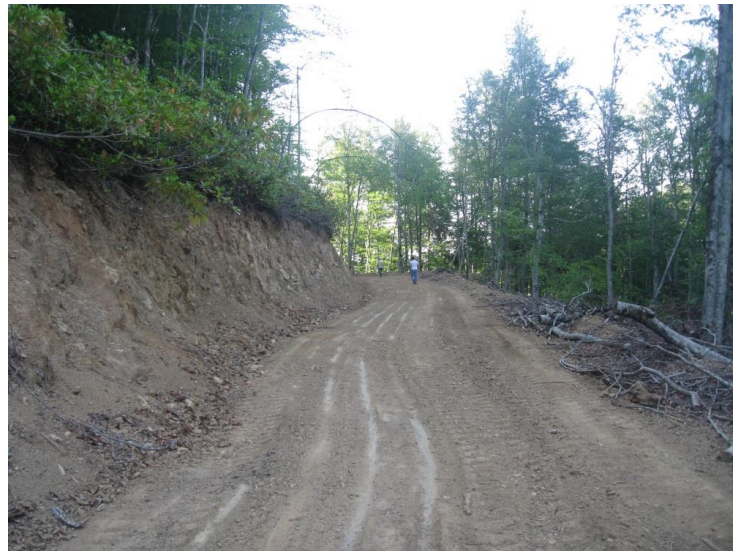
been constructed. Hydraulic excavators were used in the construction of the forest road in the study. The platform of the forest road in the study area is on average 5.26 m wide with an average road slope of 8%. It is a low-volume, secondary forest road constructed without asphalt (Fig. 1).

Figure 1. Forest road in study area.

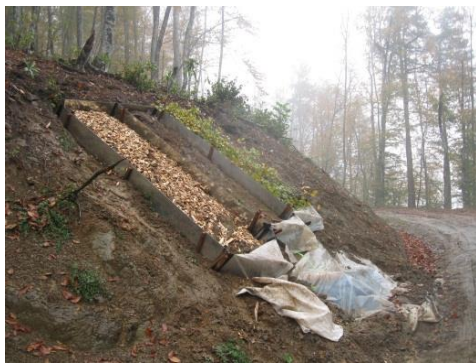
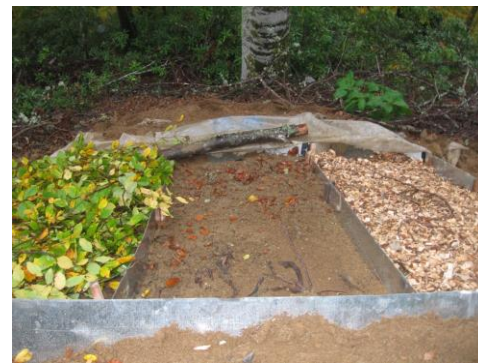
The field work began after the construction of the forest road. A runoff block (sample field) was established for each of the four designated test sites. Two of the blocks (fillslopes) had gradients of 67% and the other two (cutslopes) of 70%. Two of the blocks were planted facing north and the other two facing south (Table 1). Each block had three runoff plots. One of the runoff plots was left empty for the control (CNT), while chip (C) and slash (S), respectively, were deposited in the other two. The chip plots were laid with 12 kg (4 kg m^{-2}) of chips at a thickness of 1 cm. The chips were obtained from a private workshop in the study area region. In the slash plots, slash (branch/leaf) logging residues obtained from the test area was placed so as to cover the whole of the plot (1.5 kg m^{-2}). The $1 \times 3 \text{ m}$ plots were established with the long sides parallel to the direction of the slope. The sides and upper edges of the plots were constrained by 20 cm-wide metal sheets, buried in the soil to a depth of 10 cm. The joints of the sheets were suitably connected and sealed with silicone to prevent leakage of water at the sides. An inlaid structure was formed by inserting a plastic nylon layer at the bottom edge and the runoff water was deposited in a collection tank (Fig. 2). The runoff water was measured by scale cylinders in the collection vessel and converted to mm units according to the plot area of 3 m^2 [20].

Figure 2. Establishment of runoff plots on road slopes: (a) Cutslopes (left, chip; center, control; right, slash); (b) Fillslopes (left, slash; center, control; right, chip).

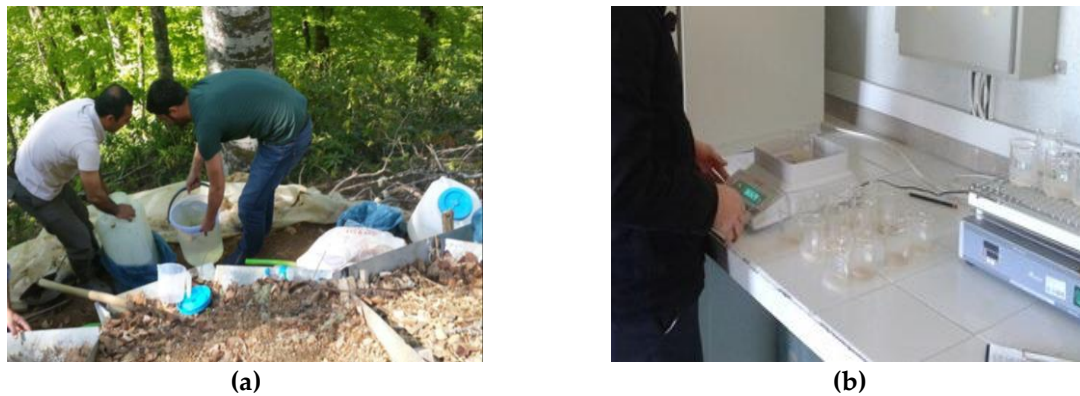
The runoff passing through the soil after a rainfall which accumulated in the collection tank was measured using scale cylinders and the amount recorded. During the study, the runoff measurements were recorded repeatedly after each rain. The amount of runoff occurring after prolonged and heavy rainfall was measured on the same day or the next day. In this way the risk of exceeding the capacity of the storage tanks was prevented. When rainfall was not long-term or severe, monthly measurements were taken. Nine measurements were taken from the study area throughout the period of October 2014–March 2016. A total of 108 water samples were collected from the test sites, 36 each from the control, chip and slash plots. After the measurement and recording process was completed, the runoff in the storage tanks was completely drained.

In order to determine the amount of suspended sediment for each plot, a 0.5 L sample of water taken from the runoff storage tank was brought to the laboratory and put into the ash furnace. After the runoff water was evaporated, the samples of residual suspended sediment were weighed on a precision scale. The specified value was calculated according to the total runoff amount accumulated in the storage tank and the total suspended sediment it carried (Fig. 3). The materials coming from the slash plot collecting areas were trapped in a sieve in the collection tank and were not used in determining the amount of suspended sediment [21–22].

Figure 3. (a) Water sample collection; (b) Water sample analysis at the laboratory.

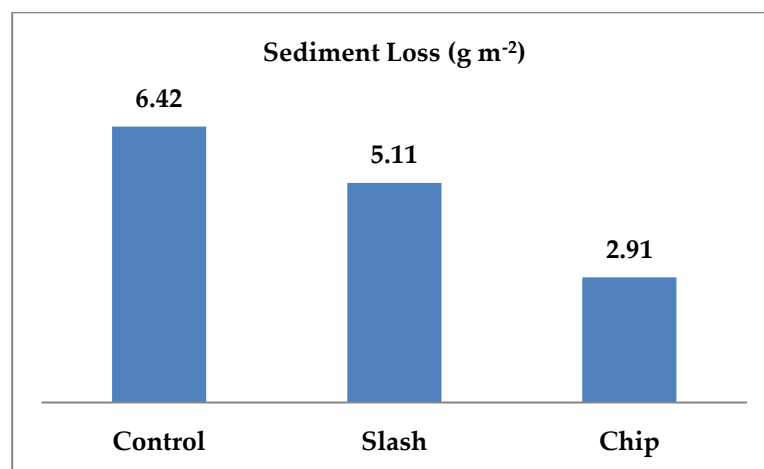
According to the results of a total of 108 water samples taken to determine the soil loss from the plots in the test sites, the average amount of soil loss was measured as 6.42 g m⁻² in the control plots, 5.11 g m⁻² in the slash plots and 2.91 g m⁻² in the chip plots. In other words, it was determined that the soil loss in the control plots was about 1.26 times higher than that in the slash plots and 2.21 times higher than that in the chip plots. In addition, it was determined that the soil loss in the slash plots was about 1.76 times higher than that in the chip plots (Fig. 5).

**Figure 5.** Soil loss in the test plots.
