Micro hydro power plant Shanping (Site reconstruction)

Štefan Tkáč

Technical University of Košice,
Faculty of Civil Engineering,
Department of Architectural Engineering
stefan.tkac@tuke.sk

This research paper is part of the wider project concerning the very first detailed mapping of the overall Taiwanese hydro-power plants that took place from 2013 up to 2015 and it is currently in evaluation and finalization stage. The case of Shanping hydro-power plant has been carefully studied, photographed, documented and mapped in situ. It was one of the isolated hydro-power plant projects originally built to supply the remote area with the specific designation. Shanping hydro-power plant, as well as the other units from the early hydro-power generation era in Taiwan, are considered to be the technological heritage of civil and mechanical engineering that reflects later in all the further projects up to nowadays modern Taiwanese hydro-power plants. Unfortunately, most of the hydro-power houses from the older periods were severely damaged or destroyed by natural causes which were also the case of Shanping unit. The research is trying to reconstruct the original location of the powerhouse an

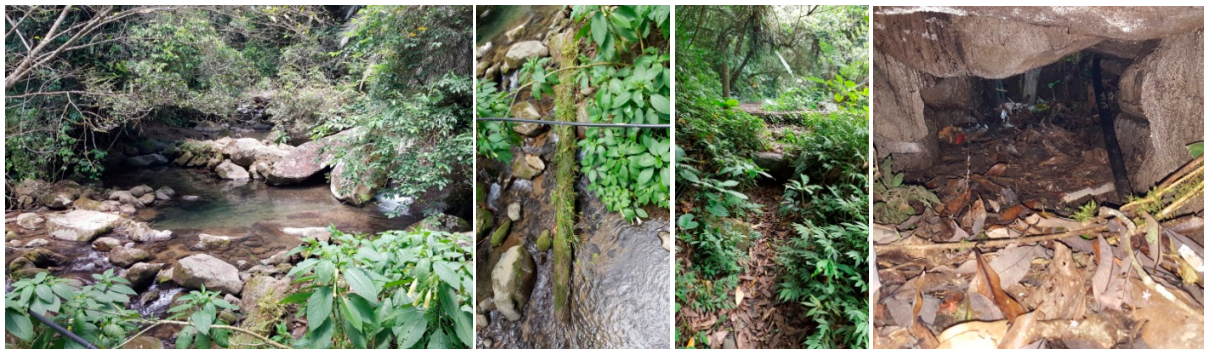
Fig. 1. clearly traceable remains of the Neiwan power house water structures on Matai old road (diversion weir, diversion channel and inflow). Pictures were taken during three mappings carried on August 25th, 2017, May 18th and 30th, 2018. (Source - Author)

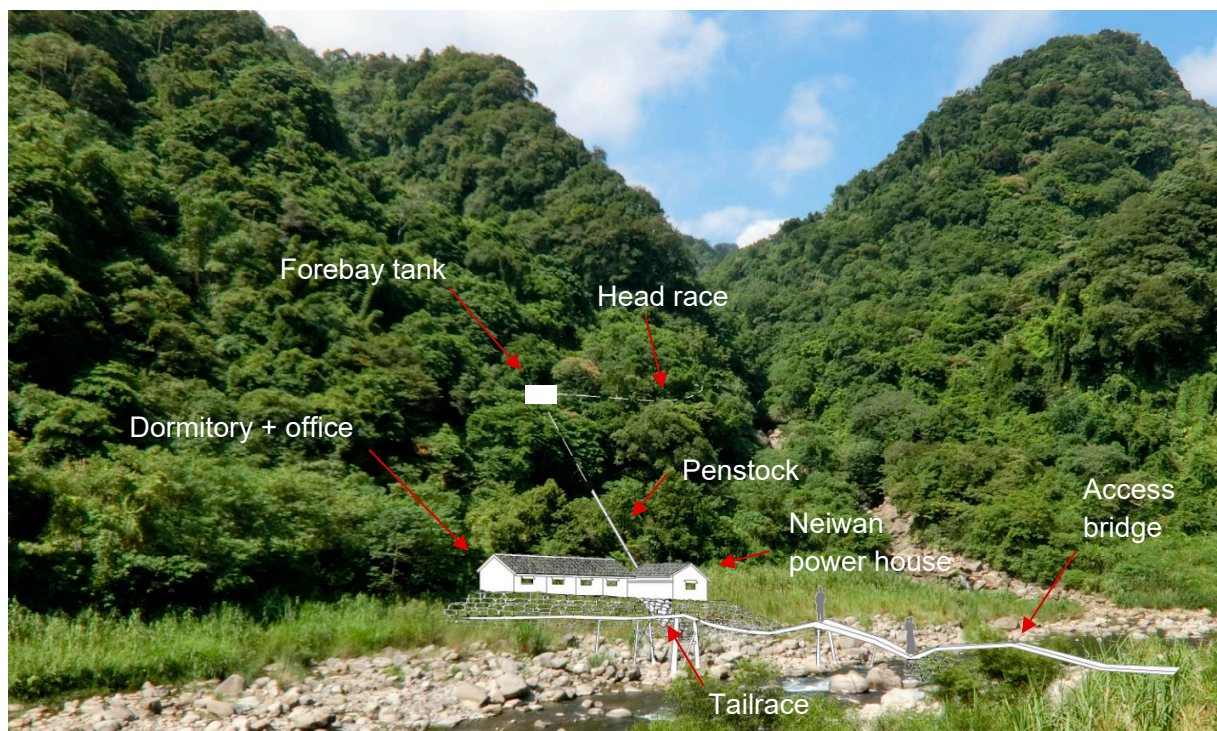
Fig. 2. Analysis and reconstruction of the Neivan power plant site (Source - Author)

The first one is Neivan power house from 1910 located little above the Neivan Township on Mkmauty also known as Matai old road. Based on the remains it is assumed that Neivan powerhouse had a very simple diversion weir consisted of naturally formed pond backed up by heavy stones with concrete spillway diverting water to supply channel made from a combination of natural stones and concrete, ending up by forebay tank and tubular penstock (Fig. 1,2),[2]. Another good example would be Ruanqiao hydro powerhouse built in 1919 as a support for Neivan powerhouse. Although Ruanqiao was destroyed and abandoned after 1945 it was renewed between 1988-1992. It has a 7.7m active head which is similar to Shanping and it is using diversion weir and long irrigation channel as a supply channel[3]. The last example would be Fanshekeng powerhouse from around 1908 which probably had the larger diversion weir then Neivan, but smaller then Runchiao. It was made from natural stone segments with a concrete finish (pieces of the base could be still seen in the river bed) and a combination of natural stone

and wood supply channel rose on to a bamboo construction ending with rectangular shape penstock made from steel[4].

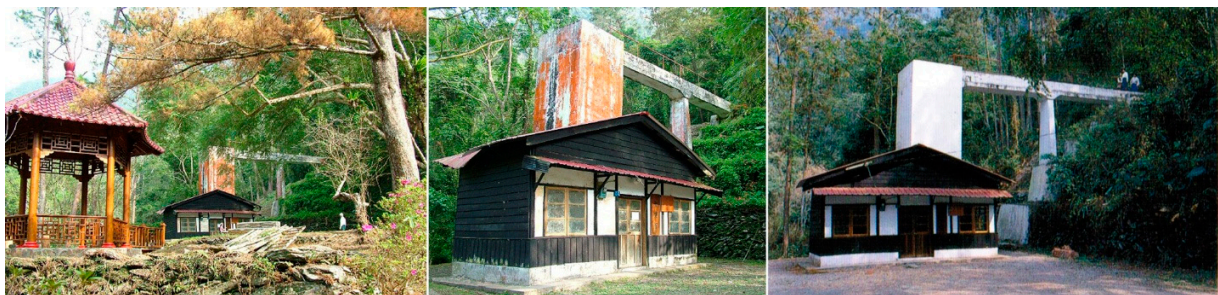
Fig. 3. Series of pictures of the Shanping hydropower plant before being struck by the typhoon Morakot on August 8th, 2009. (Source - Courtesy of the Council of Agriculture Executive Yuan[6].)

Shanping hydropower plant(*Fig. 3.*) known also as Shanping hydro powerhouse or room falls according to the installed capacity into the category of pico and after retrofitting into the micro hydropower plants[9]. It was designed by Taiwan Power Company, Gaoping power plant - Liugui unit formerly known as Tulong power plant.

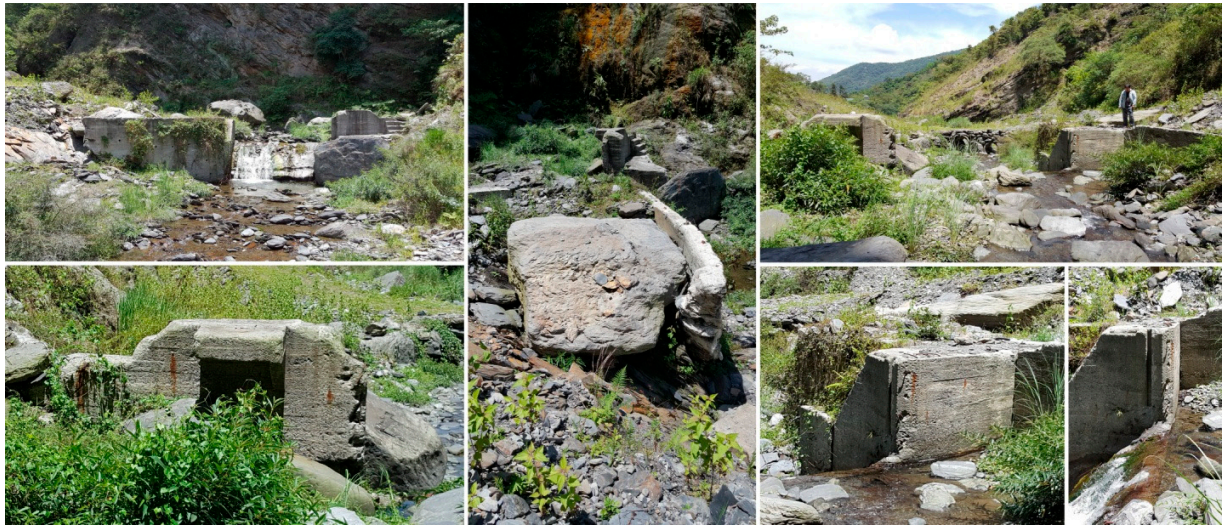
Fig. 5. Remains of the water intake weir show clearly shift of the dam body due to giant rocks from a landslide. (Source - Author)

During the typhoon, the whole weir was torn into parts and significantly shifted forward by a sudden flood from torrential rains and mostly replacement of the heavy stones falling from the naturally created dam above (Fig. 5). The weir was designed as a standard rectangular diversion weir with single-leaf water control gate placed on the top of the 140cm high crest of the ogee type spillway. Most parts of the spillway including deflector are missing and were peeled off by cavitations during enormous water discharge which the spillway was obviously not designed to withstand. The main weir body construction consisted of reinforced concrete with 15 up to 30cm wide wings. The water level was regulated by 600cm wide and 120cm high slide gate. The rails for the slide gate could be still visible in the concrete on both sides of the weir. By investigating old pictures and onsite remains of the weir, the access stairs were on the right side along with desilting opening as well as placement of the intake for the supply channel, the regulation wheels for the gate and supply channel was located on right(Fig. 7). Normally water

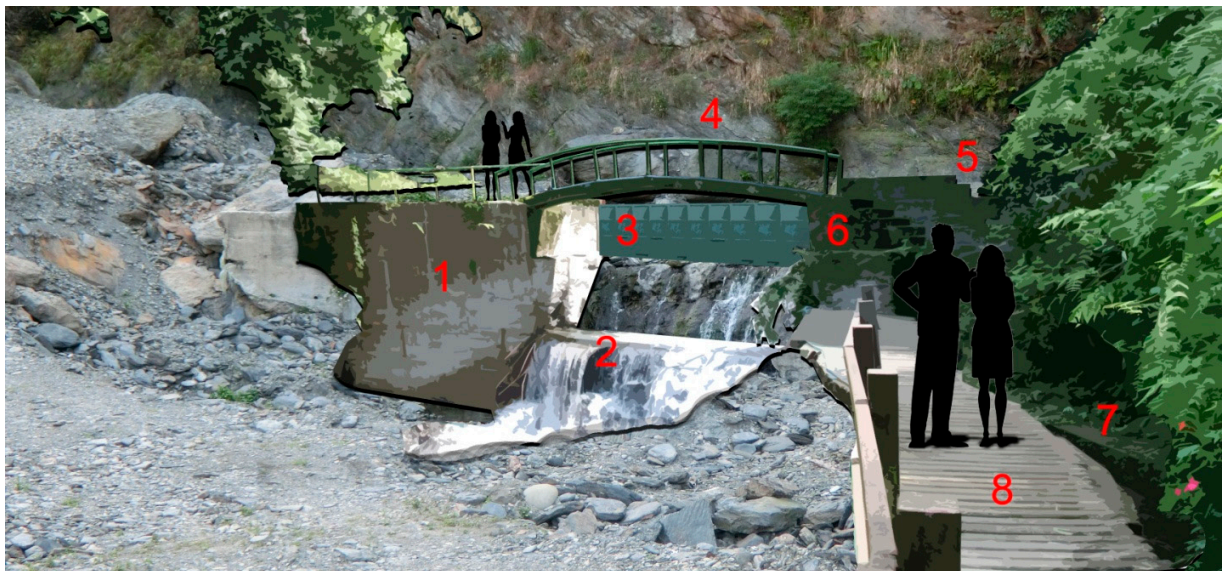
Fig. 6. Reconstruction of the diversion weir according to the old imagery. 1-the main body of the weir, 2-deflector, 3-original spillway gates, 4-Green bridge, 5-access stairs, 6-bridge stairs, 7-supply channel, 8-old plank path. (Source - Author)

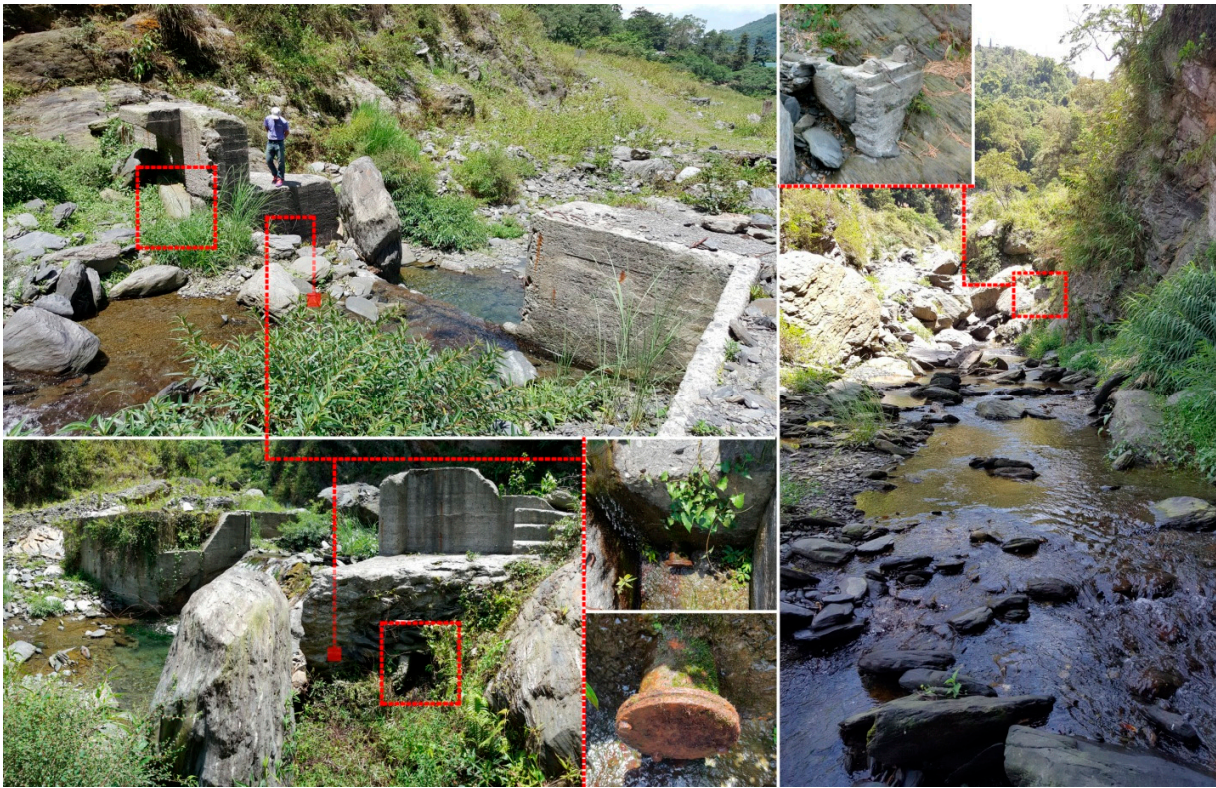
Fig. 7. Details of the intake weir showing the position of inflow and desilting openings on left. On right there is Shanping creek riverbed in front of the intake weir indicating the remains of the Lovers bridge. (Source - Author)

The inflow opening had a rectangular shape 35x35cm placed on the right side of the weir (Fig. 8). Currently, it is hidden behind a large rock which was probably moved there via strong water current. The desilting opening DN150 is placed at the bottom of the weir on the right covered by Blind Pipe Flange with 20cm diameter mounted originally by 4 bolts but only 3 are remaining now. The desilting opening is covered by rust and moss and it is clear that it was not used for a long time.

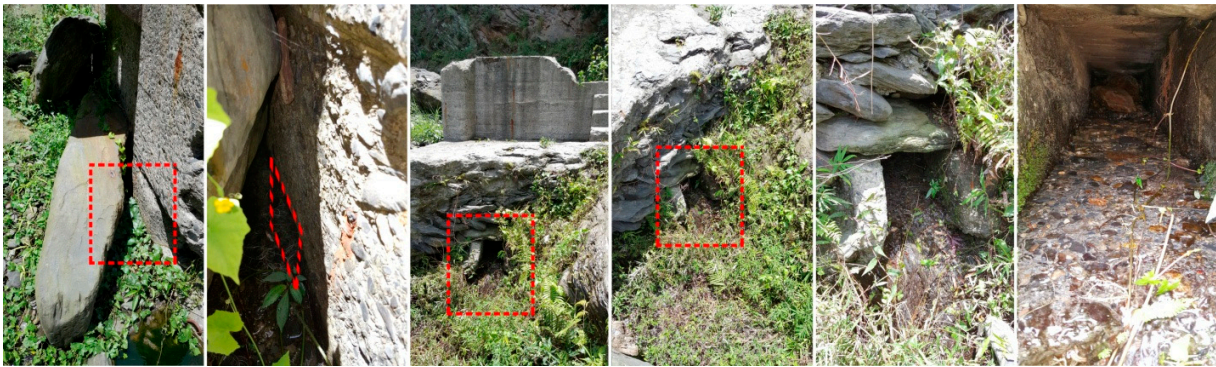
Fig. 8. Inflow opening is located behind a rock and is blocked with alluvial sand and rocks. On the other side of the dam the opening is clearly visible (Source - Author)

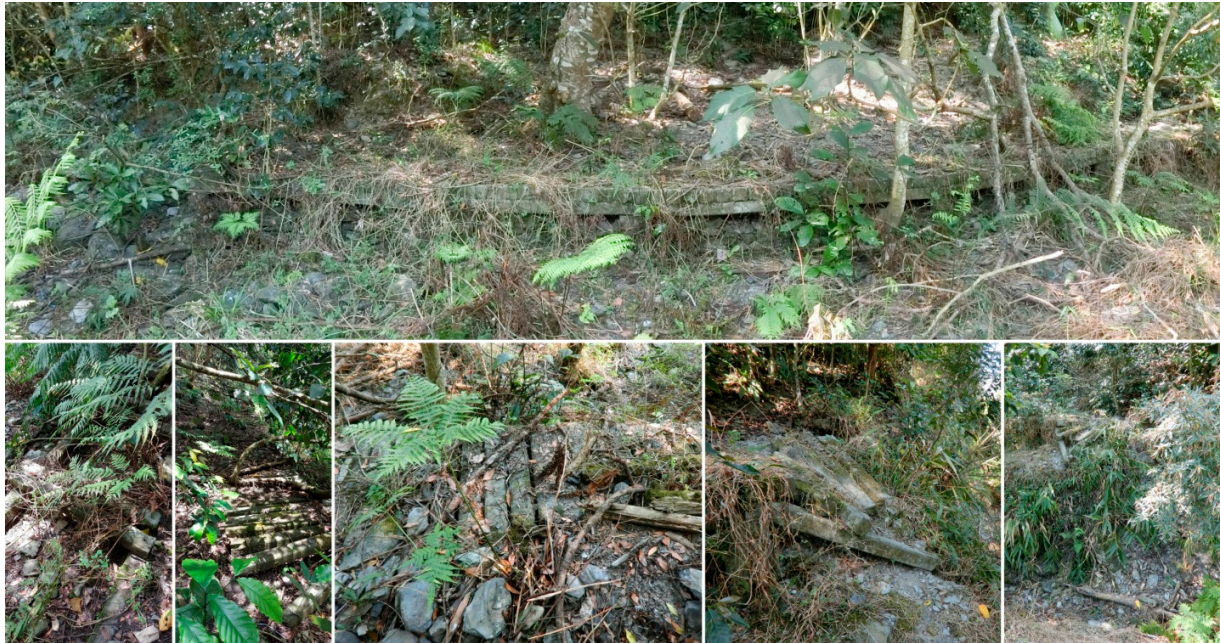
Fig. 9. Remains of the old plank path and supply water channel that was originally on the right side of the path (Source - Author)

There are fragments of damaged old plank path with water supply channel still clearly tractable in the forest (Fig. 9). Based on the onsite measurements the overall path was 150cm wide including the supply channel and its construction. The 120x12x12cm planks were laid on 12x12cm concrete rails in 110cm distance between axis supported by concrete pillars mainly on the side facing the Shanping creek. The supply channel followed the plank path on right side. It was embedded into the ground approximately on the same level as the edge of the path rails and had U shape with inner dimensions 35x35cm and construction thickness around 12cm.

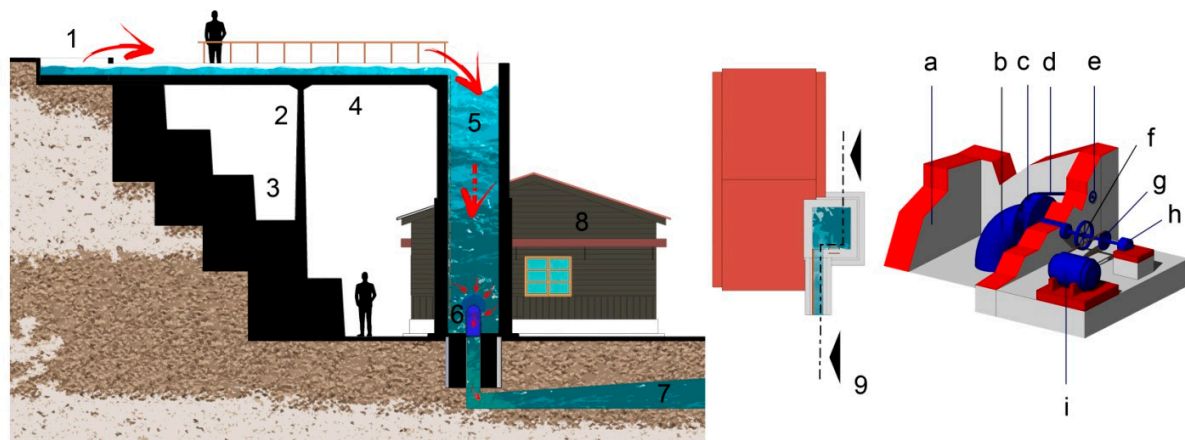
Fig. 10. Cross section of the hydraulic structure of Shanping hydropower plant and details of the turbine 1-forebay tank, 2-column supporting the aqueduct, 3- Slope reinforcement and base for the hydraulic structures, 4-Aqueduct, 5-Water shaft, 6-Openflume Francis turbine, 7-Power house draft tube, 8-Power house, 9-Crosssection plan, a-Water shaft walls, b-Turbine draft tube, c-guided vanes regulation, d- guided vanes regulation levers, e- throttle valve for steeples speed control, f- Flywheel, g-Transmission via belt, h-turbine axel bearing, i-Generator. (Source - Author)

The shaft (Fig. 10,11) is the eye-catching part once entering the former powerhouse site. It is laying nearby the old public toilettes both filled with alluvial sand and rocks. The shaft was clearly flushed on the side, away from the original area during the disaster. The shaft was made from steel reinforced concrete with further specifications. The shaft has a rectangular shape, approximately 800cm of the total visible height with 20cm wide and 40cm deep footing. The overall height of the shaft can be clearly divided into two parts, the 450cm tall top, and the 350cm tall bottom.

Unfortunately, the shaft leans the slope by the side where the turbine was attached to the powerhouse via axle so that there are no side opening visible. The turbine was an open flume horizontal axis Francis type (known in Germany as Shaft turbine) with marking FH-IROS [12](Fig. 10,12) attached to the wall of the shaft therefore it is most likely still buried inside the shaft, however it is not visible due to sand and rocks which filled the 2/3 of the shaft volume and block even the draft tube opening.

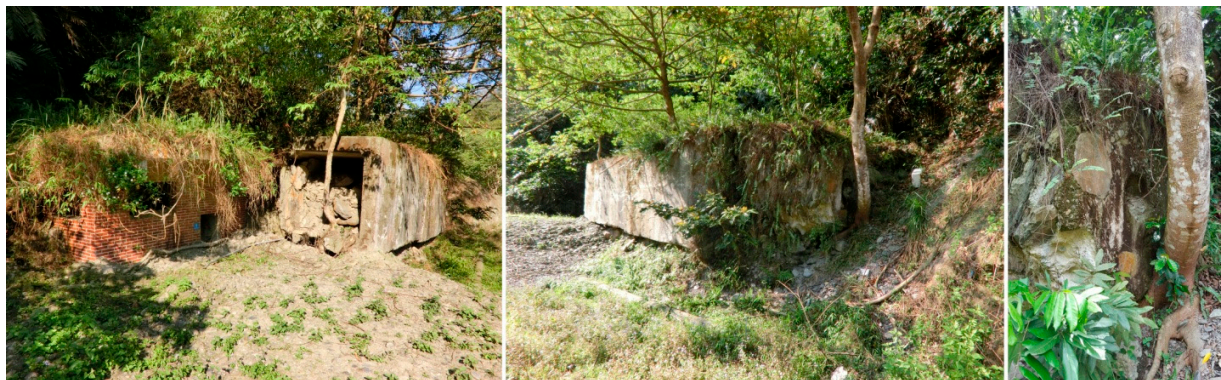
Fig. 11. The remains of the concrete shaft with outflow opening and turbine most likely buried inside. (Source - Author)

The outside width of the shaft varies, ranging from 200cm on the top part and changing to 212 on the bottom part due to necessary reinforcement for withstanding the water column pressure. The inside width is 140cm, walls are 30cm thick on top and 36cm on the bottom part. There are 13x13cm inside chamfers reinforcing the corners of the shaft. On the top of the shaft, there is exposed reinforcement consisting of no patterned reinforcing bars with width ranging from 1 up to 1,5cm. These were clearly sheared off during typhoon indicating the place of the aqueduct attachment. Accept the reinforcement, there are also steel tubes with 2cm diameter exposed on the top of the shaft, these were most likely anchors for steel aqueduct and also ladder used for inspections of the turbine.

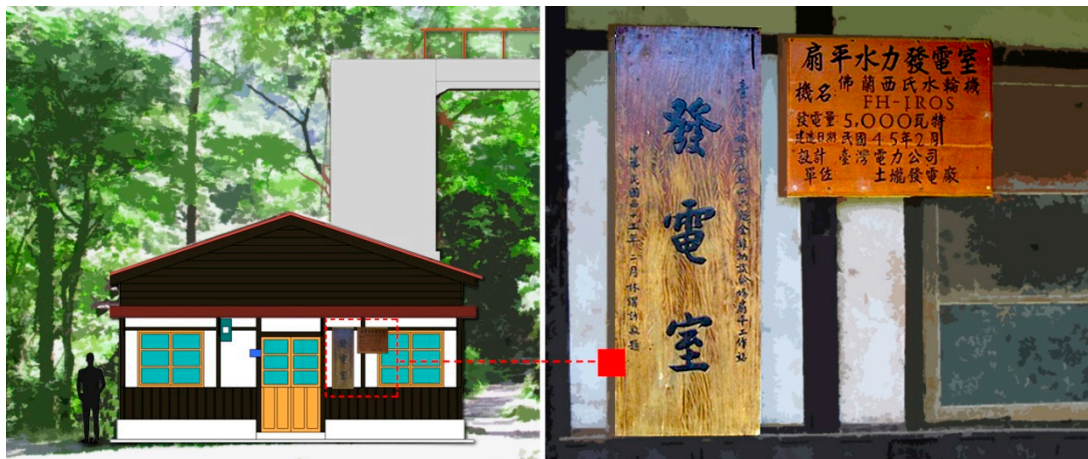
Fig. 12. The name and data plate originally mounted on the powerhouse revealing the name of the powerhouse, turbine type, installed capacity, builder-contractor, and date of commissioning. (Source - Taipower, Liugui Unit, and Author)

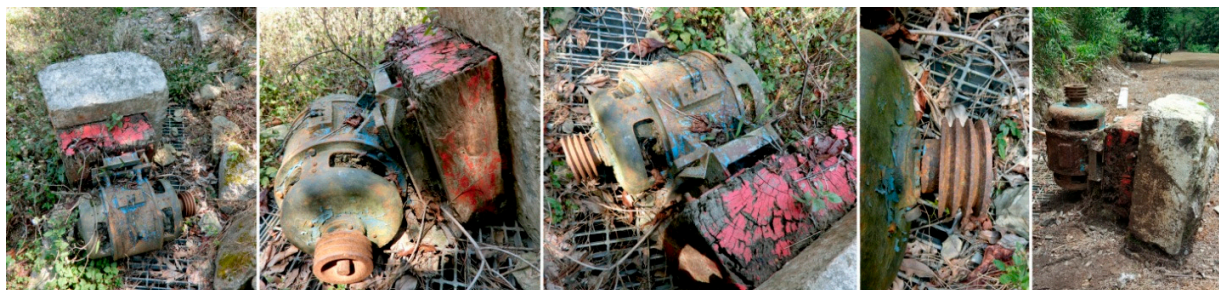
Fig. 13. Electric generator, the last picture shows that the data plate is already rusted. (Source - Author)

The three-phase blue colored generator with green steel anchor construction mounted on wooden bed fixed on concrete base is located in the middle of the parking area (Fig. 13), where it was obviously brought during the aftermath reconstruction works. The generator data plate is already rusted, therefore any details were lost. However judging from the wooden information plate at the powerhouse from the old pictures, introduction video clip made by TFRI(Fig. 14) and individual interviews, the installed capacity was 5kW, it was placed horizontally on the left side from the turbine axle with flywheel to which it was connected via triple V-belt. The country of origin was suggested either Taiwan or the same as the turbine.

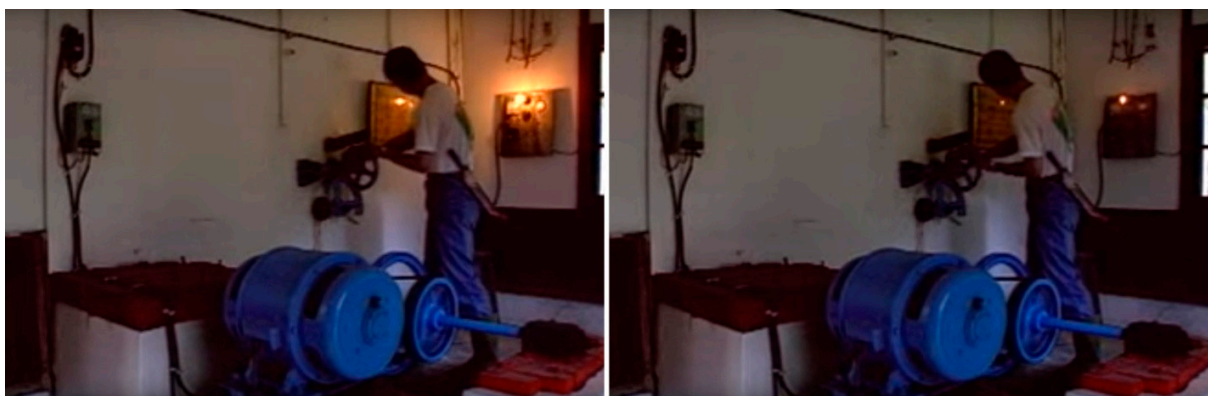
Fig. 14.[13] Interior of the Shanping hydropower plant including three phase self-excited generator powered by triple V-belt transmitting torque from turbine shaft with flywheel connected to the horizontal Francis turbine behind the wall.

The power plant operator is clearly synchronizing the frequency by turning the turbine throttle valve for steeples speed control looking at the luminosity of synchronizing lamps before he switches the transmission handle. He may do so when both lamps got the same luminosity, therefore, the frequency of the generator and frequency of the grid are the same. (Source - Courtesy of Council of Agriculture Executive Yuan)

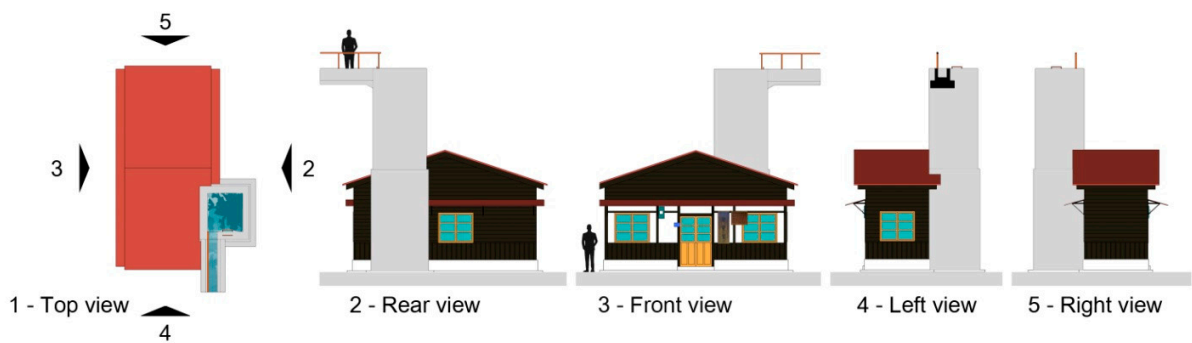
Fig. 16. 3D orthogonal vies of the Shanping hydropower house along with the concrete water shaft. (Source - Author)

The map of the overall Shanping riverbed area was made based on GIS maps from Academia Sinica (Fig. 4) The powerhouse reconstruction was carried away by CAD drawings, Sketch-up - 3D drawings and original site fitting(Fig. 16, 17).

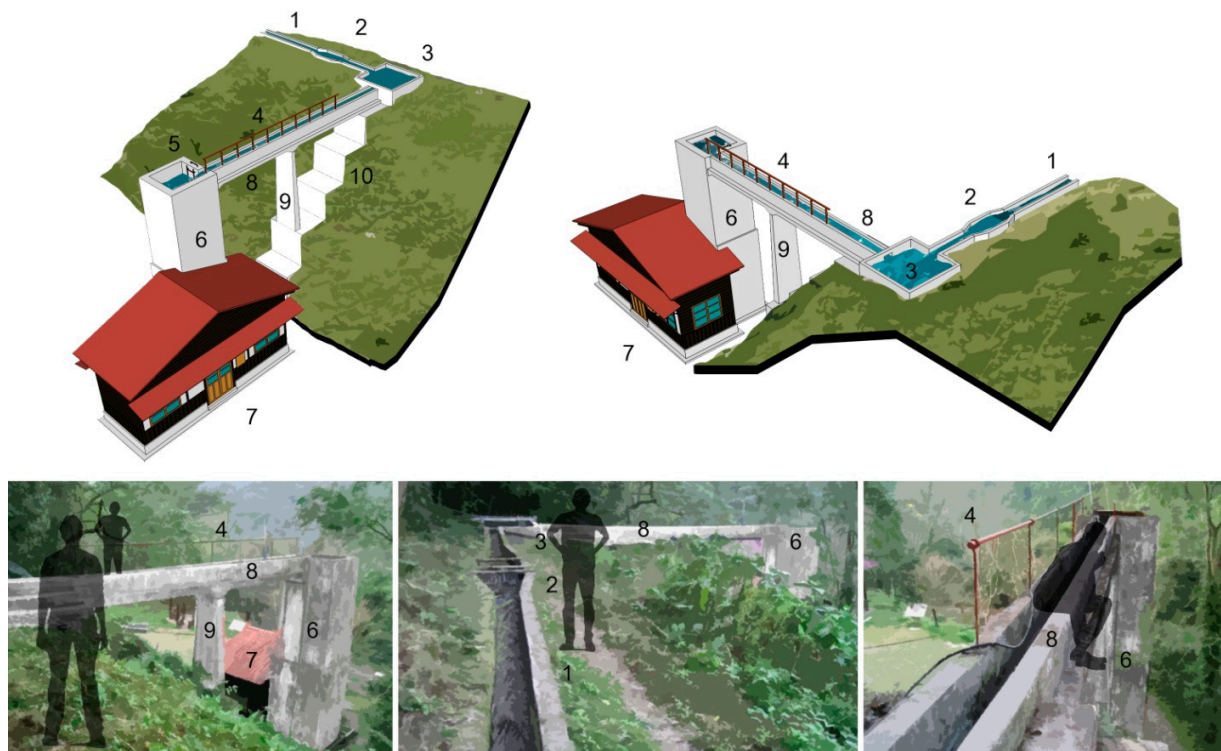
Fig. 17. Perspective views of the Shanping hydropower house with the entire hydraulic construction system. 1-Water supply channel, 2-Trash rack, 3-Forebay tank, 4-Aqueduct rail, 5-Concrete shaft ladder, 6-Concrete shaft, 7-Powerhouse, 8-Aqueduct, 9-Supporting column, 10-Slope reinforcement and base for the hydraulic structures. (Source - Author)

The remaining visible section is the final curve before the powerhouse where the channel originally departed from the path and continued toward the small channel diagonal enlargement about 70cm wide and 200cm long with screens which served as trash rack for keeping leaves and twigs from entering the turbine. After trash rack, the channel entered the small 200x200x50cm forebay tank without overflow spillway, where water accumulates and if too much, water simply flowed over the ridge. From forebay, the water continued via enlarged flipped T shape aqueduct towards the water shaft with the turbine on the bottom. The beam of the aqueduct was 15cm thick and approx. 95cm width. The overall height of the aqueduct with base was 65cm and the U shape channel had most likely the same dimension as the supply channel to keep the water flow volume equal. As to the stress analysis, the aqueduct construction was supported in three points. It was laid on stepped face gravity wall mainly for slope stabilization which also worked as a grounding for forebay and single flat slab-column placed in the middle of the aqueduct and at the end, it laid on column bracket protruding from concrete water shaft at the powerhouse side. Despite the strong aqueduct axial and torsion stress resistance, the lateral security was performed only by middle column entasis which was also the cause of easier collapse during the flood event (Fig. 3,11,17).
