Case Report

# A Clinical Challenge & Solution: Detecting Cracks in Teeth Using PTR-LUM-The Canary System; A Case Report

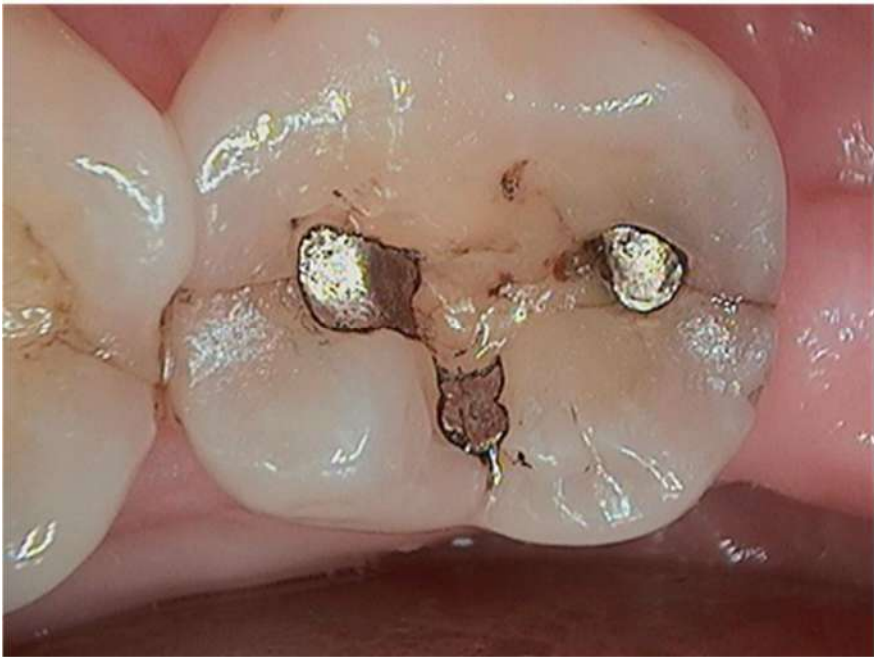
Figure 2 Occlusal view of the Mandibular Right Second Molar

The image in Figure 2 shows the clinical condition of the occlusal surface of the mandibular second molar. There were three shallow amalgams placed in the central area of the occlusal surface. There were stained grooves on both the mesial and distal marginal ridges. There was a grey shadow on the distal aspect of the distal amalgam. The bite wing radiograph did not indicate

that there was caries on the distal aspect of the tooth and visual examination did not show any open lesion or staining on the distal surface.

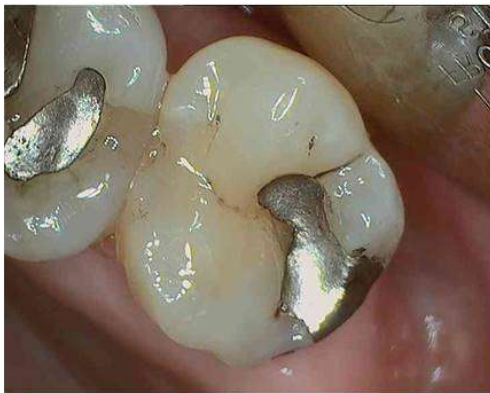
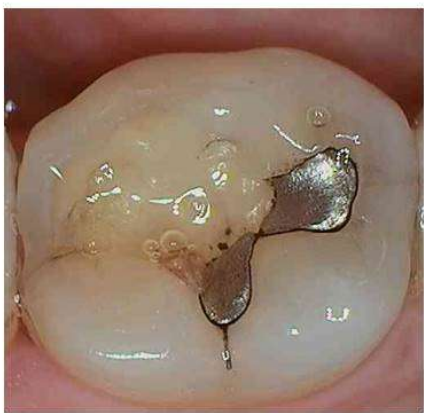
Figure 3 Occlusal View of Molar Teeth on the Right Side

Visual inspection of the maxillary right first molars and mandibular right first molar did not show any evidence of cracks or caries. The margins of the amalgam restorations (see Figure 3) were intact. There was no pain on cold

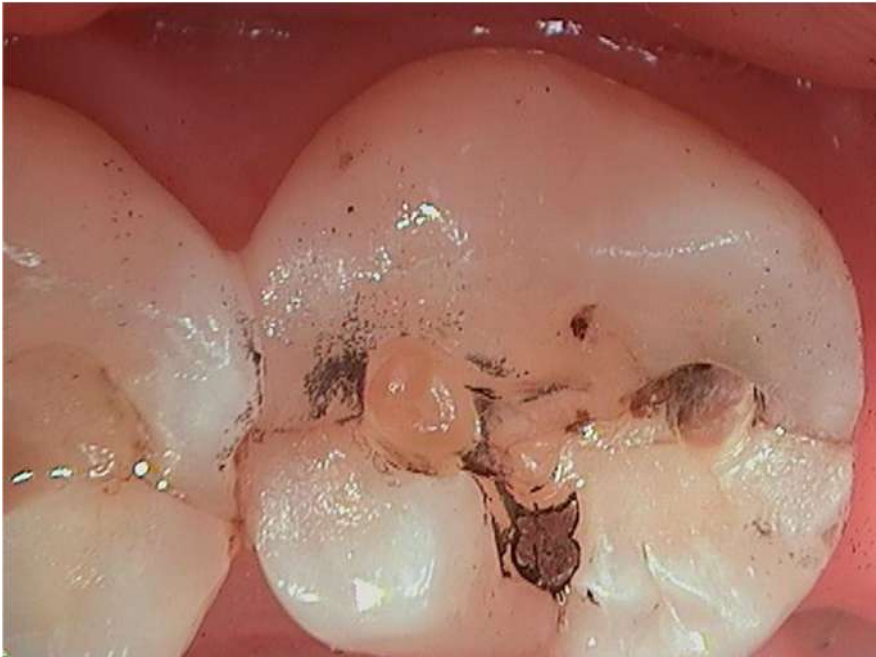
Figure 5 Initial Removal of the Amalgam shows cracks on both marginal ridges and some cracks or caries in the central pit.

With the findings from The Canary System examination it was decided to remove the amalgams on the mandibular second molar and examine the interior of the preparation. If the cracks were minimal, we would place a bonded composite restoration and monitor the tooth. Upon removal of the amalgams cracks were found on the mesial (red circle) and distal proximal boxes. The crack on the distal appeared to be much more extensive (Figure 6 green circle). There was also some demineralized dentin beneath the amalgam on the distal and some stain from the amalgam (indicated with the green circle). On removal of the amalgam in the central pit, we noted a small crack and leakage around the amalgam margin.

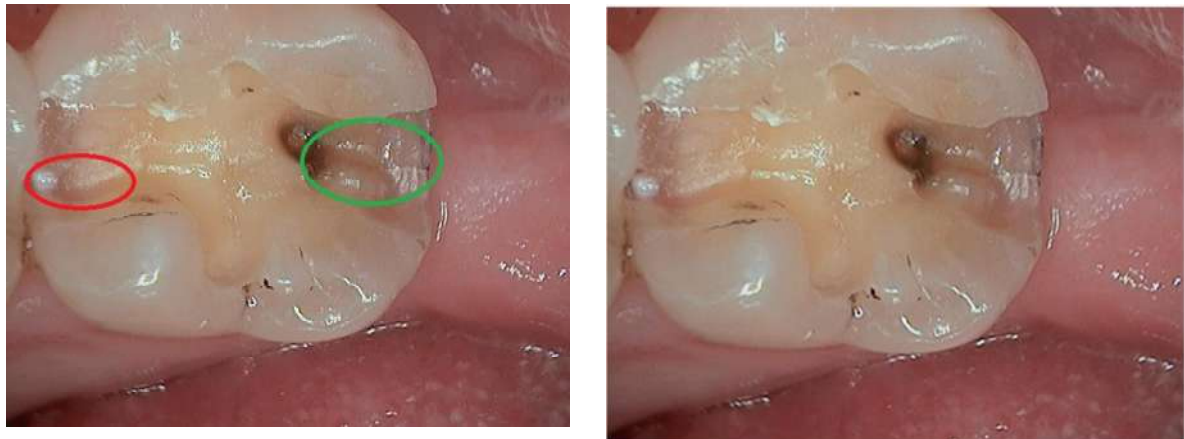
Figure 6 Image taken after removal of the amalgam and preparation of the proximal boxes. There are still cracks present on the mesial and distal proximal boxes.

With the amalgam restorations removed and cracks identified, we decided to place a bonded composite restoration. In our clinical experience, with the size and orientation of the cracks, this should help to retain the integrity of the clinical crown and eliminate the pain on chewing and temperature change..
