Type of the Paper (Article)

Multi-Scale Physical-Chemical-Mechanical Characteristics of Marine Mortar, Part I—Primary Performance

Abstract: Marine mortar was the goal material and its multi-scale physical-chemical-mechanical characteristics were the principal interest in this study. The on-line multi-scale damage detection experiments art was designed to quantify the characteristics mathematically and graphically. The normal cylinder specimen with 70-day age was produced and investigated by dynamically global MSHCT scan and local detection of EDS, SEM and XRD. The experiments results indicated that the marine mortar offered the appreciable strength at the early age at least, although some saline minerals were generated during the preparation. The micro-interfacial behavior and the parental foci controlled the damage development of the marine mortar the performance of which was still the adjustable one by the composition optimization.

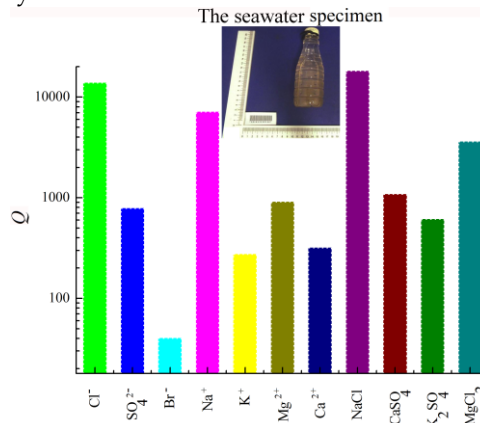
Figure 4. Quantitative distribution of the key ions and the saline minerals of the seawater specimen (The unit of Q, namely, the quantification, is 10⁻³‰)

Sea water The marine mortar was prepared with the sea water that was got from Changzhi Bay of Zhoushan Seas located at 29.98° N and 122.18° E where the expectation value of pH was 7.86. The acquisition time of the seawater specimen was a.m. 9:30 on Dec 10th, 2016 and the quantitative fabric experiment lasted from a.m. 10:30 to p.m. 17:50 on Dec 10th, 2016. The quantitative fabric of the sea water specimen including the key ions and the saline minerals was shown in Figure 4.

The highest concentration was the one of NaCl with 17997.65 × 10⁻³‰ and the descending sequence of the others was Cl⁻ with 13768.18 × 10⁻³‰, Na⁺ with 7076 × 10⁻³‰, MgCl₂ with

$3574.38 \times 10^{-3}\%$, CaSO_4 with $1074.74 \times 10^{-3}\%$, Mg^{2+} with $903 \times 10^{-3}\%$, SO_4^{2-} with $780 \times 10^{-3}\%$, K_2SO_4 with $607.66 \times 10^{-3}\%$, Ca^{2+} with $316.1 \times 10^{-3}\%$, K^+ with $272.4 \times 10^{-3}\%$ and Br^- with $40 \times 10^{-3}\%$.

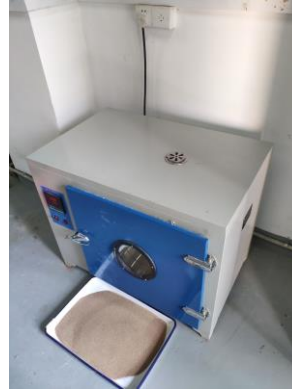
Figure 5. Drying process for the natural marine sand

Particularly, the natural marine sand has been treated by dryer BH-002 (power 4.5 kW, in Figure 5) for 48 hours to remove the natural water content thoroughly for the precise material design.

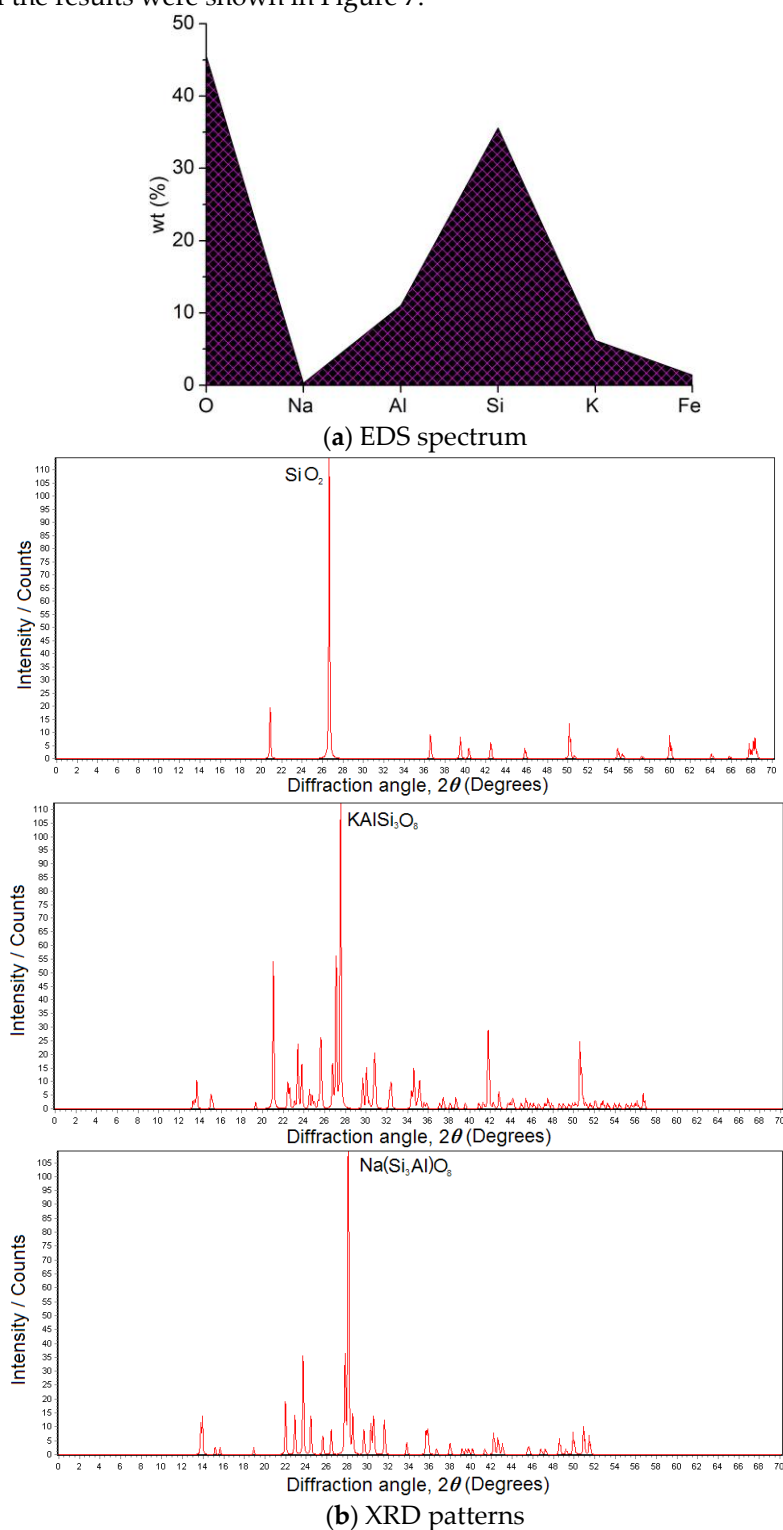
Figure 7. EDS spectrum and XRD patterns of the marine sand

Meantime, the study carried out the EDS and XRD analysis to explore the marine sand composition and the results were shown in Figure 7.

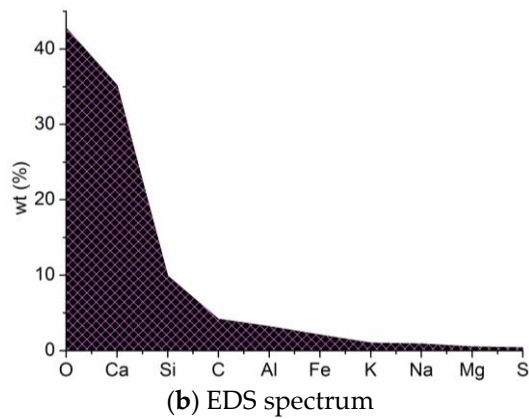
Figure 9. Micrograph and principal elements' content from EDS analysis on the composite Portland cement P.C 42.5 R

EDS analysis was applied to detect the principal elements' content of the composite Portland cement P.C 42.5 R and the results were shown in Figure 9 where the values of wt% were the expectations derived from 3 scanned positions.

**(a)** EDS scanned positions in the composite Portland cement P.C 42.5 R micrograph

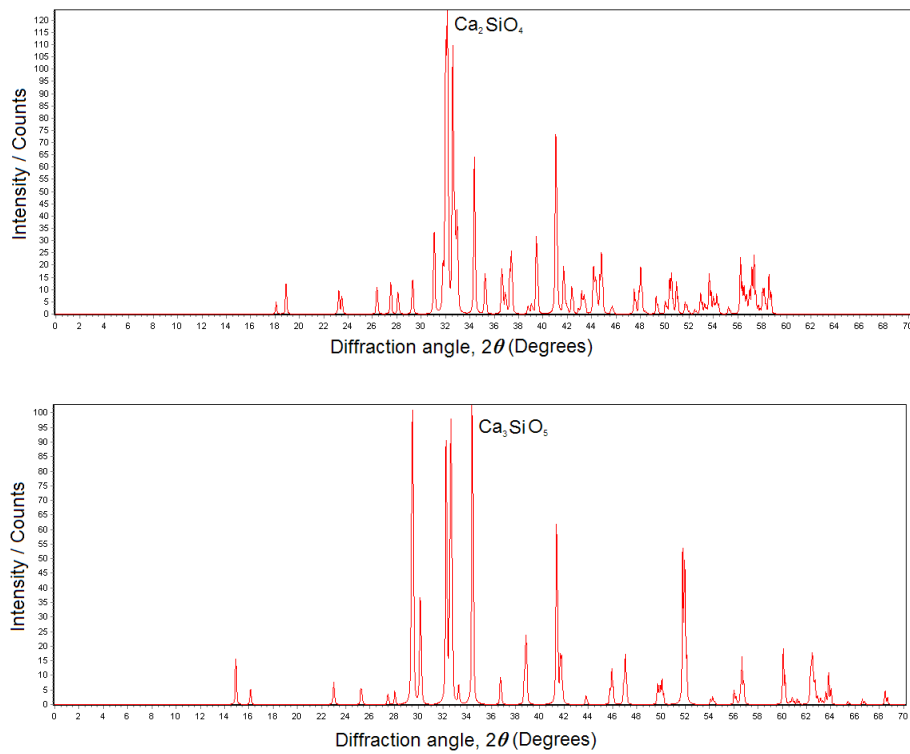
Figure 10. XRD patterns of the composite Portland cement P.C 42.5 R

XRD analysis was also implemented to investigate the principal composition of the composite Portland cement P.C 42.5 R and the XRD patterns were given in Figure 10.

4. The principal constituents of the composite Portland cement P.C 42.5 R included Ca_2SiO_4 , Ca_3SiO_5 and $\text{Ca}_3\text{Al}_2\text{O}_6$ that contributed to the hydrate generation of the marine mortar.

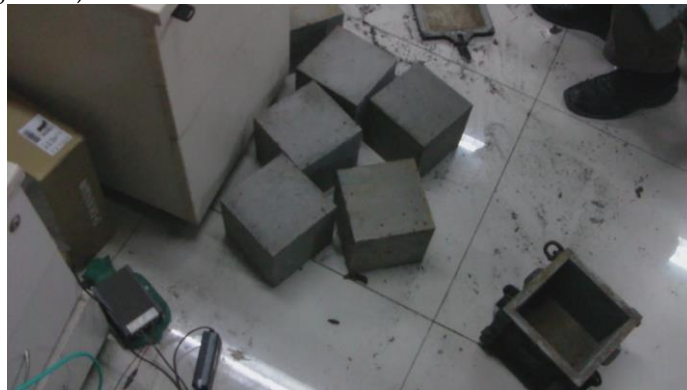
Figure 11. Marine mortar specimens unloaded from the normal moulds

The marine mortar paste in the normal moulds rested for 24 hours indoor where the temperature and percentage relative humidity (RH) were 20 ± 5 °C and $75 \pm 5\%$, respectively. The marine mortar specimens (namely, the cubic ones) that have achieved the initial strength then were unloaded from the normal moulds (Figure 11)

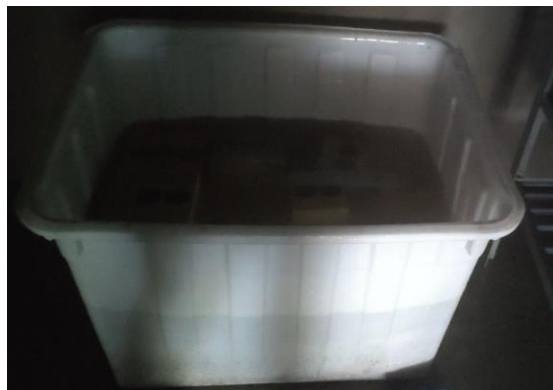
Figure 12. Sea water curing condition

Curing The unloaded marine mortar specimens were collected into the curing chamber where the temperature and percentage relative humidity (RH) were 20 ± 5 °C and $90 \pm 5\%$, respectively. Particularly, in order to simulate the marine environment, the cubic specimens were submerged into the tank full of the sea water that was got from Changzhi Bay of Zhoushan Seas (Figure 12). The curing age for the cubic specimens in sea water was 59 days and the total age including the resting indoor period was 60 days.

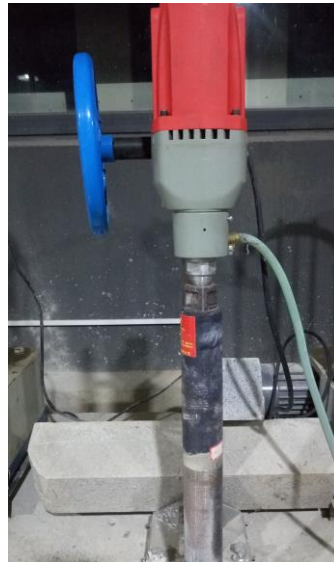
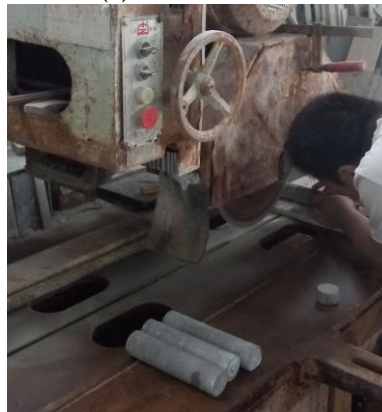
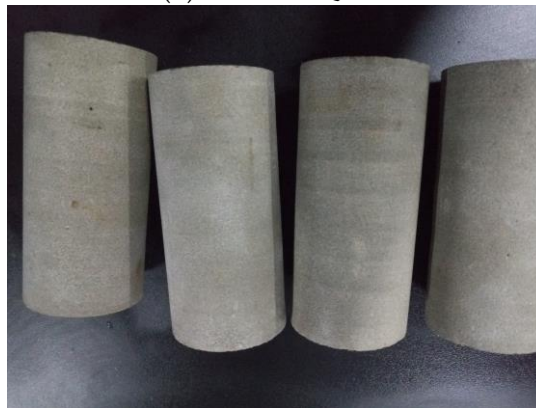
Figure 13. Production of the normal cylinder specimens

Coring and cutting The marine mortar cores were then drilled from the cubic specimens by corer HZ-18B (power 2.5 kW and maximal rotational speed 1100 r / min) at 60-day age. Meanwhile, the coarse cores were cut into be the normal cylinder specimens (diameter \times height = 50 mm \times 100 mm) by cutter ZDQ95-8 the extreme power and the maximal dimension of the treated specimen of which were 11 kW and length \times width \times height = 3000 mm \times 1200 mm \times 150 mm, respectively (Figure 13).

(a) Corer HZ-18B

(b) Cutter ZDQ95-8

(c) Cylinder specimens

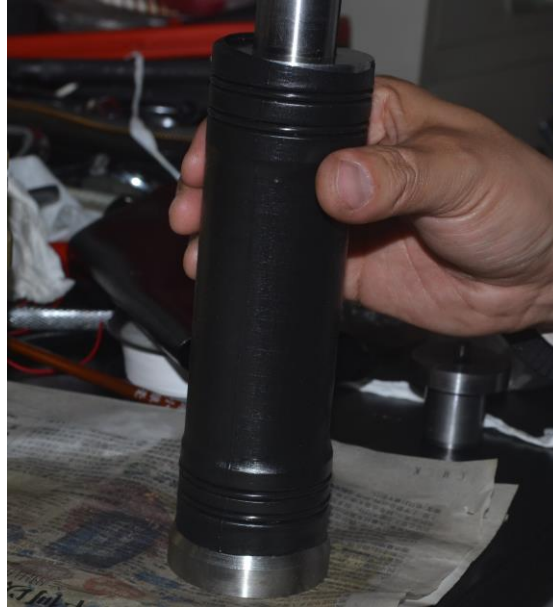
Figure 14. Normal cylinder specimen covered with HDPE jacket

The axial load σ_a was executed with the rigid condition by the vertical main-shaft made by DCCr12Mov steel and the principal stress σ_1 was generated in the marine mortar in the same direction of the axial load. The confining load σ_c was conducted with the soft condition by the oil pressure that was worked on the HDPE (High Density Polyethylene) jacket (Figure. 14) the thickness and the density of which were 1mm and 0.963 g/cm³, respectively. Meantime, the principal stress σ_2 was produced in the marine mortar in the same direction of the confining load.

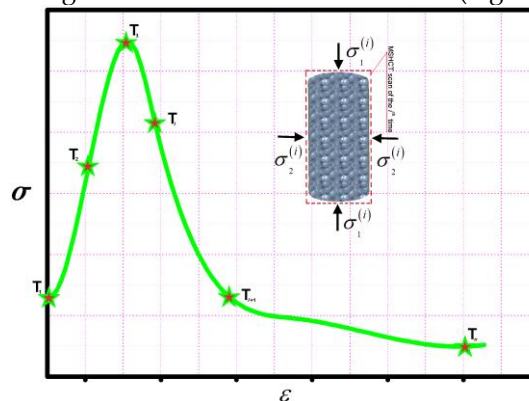
Figure 15. Synchronization of the multi-scale visualization and metrization

The term 'on-line' indicates that the normal cylinder specimens can be scanned by MSHCT during the tri-axially loading procedure to detect visually and dynamically the multi-scale damage evolution in it. Therefore, the synchronization of the multi-scale visualization and metrization can be carried out to investigate the damage evolution of the marine mortar (Figure 15).

(T_i on the strain and stress curve was the corresponding position of MSHCT scan of the i th time and n was the total of MSHCT scan ($n = 6$ in the study). ε and σ represented the strain and stress states (i.e., SSS) of the marine mortar. $\sigma_1^{(i)}$ and $\sigma_2^{(i)}$ designated the principal stress states of the i th time. Particularly, the SSS that could quantified the damage mathematically and the MSHCT images that could quantified the damage graphically were collected synchronically by the help of the tri-axial CT scanner system)

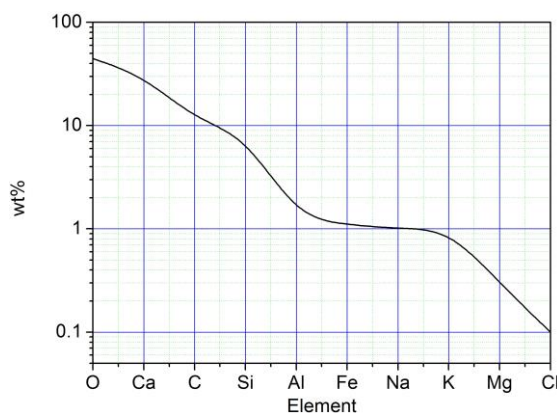
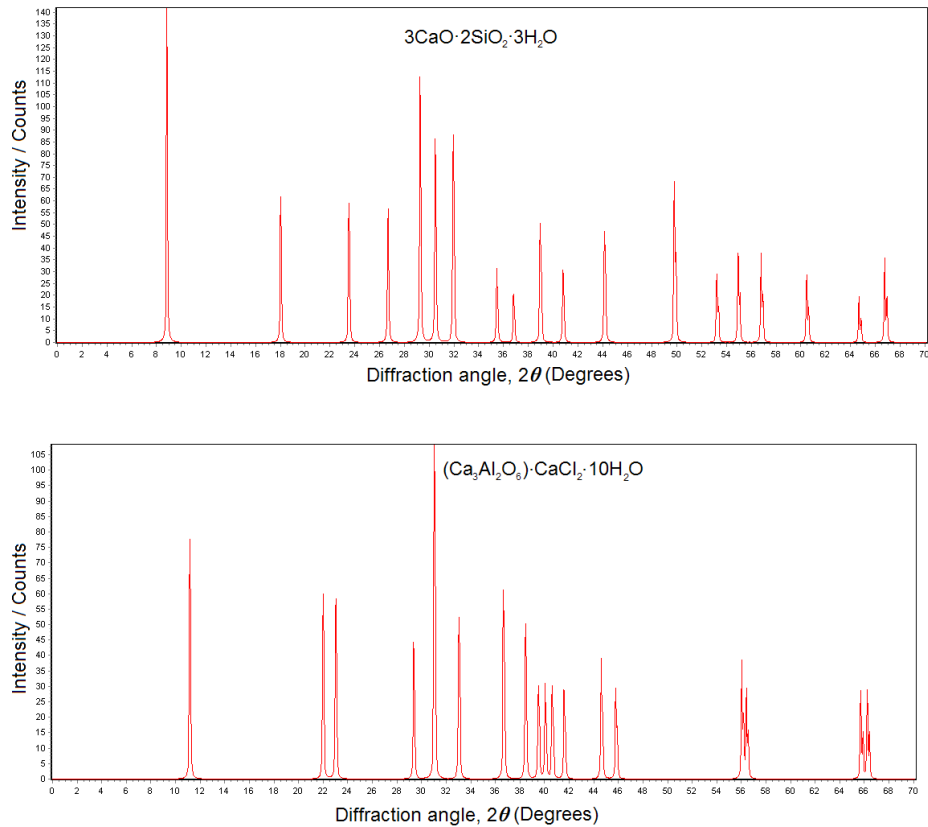
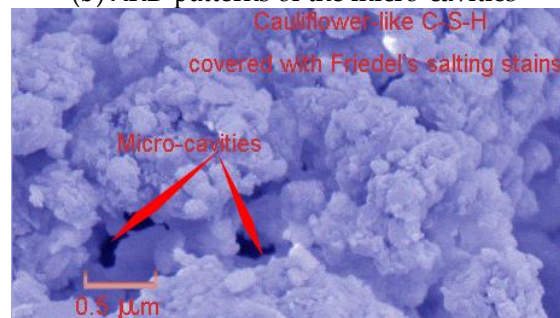
Figure 19. Behaviors of micro-cavities in the marine mortar

(a) EDS spectrum of the micro-cavities

(b) XRD patterns of the micro-cavities

(c) SEM state at point A

(d) SEM state at point B

The generation of the hydrate and the salt in Figure 19 was interpreted by the following equations.
