# Nondestructive Testing of High Reinforced Concrete Chimneys

**Abstract:** The nondestructive testing of reinforced concrete chimneys, especially the high ones, is an important element of the assessment of their condition, making it possible to forecast their safe service lifespan. Industrial chimneys are often exposed to the strong action of acidic substances – they are adversely affected by the flue gas condensate on the inside and by acid precipitation on the outside. Initially, this results in the corrosion of the shell concrete and then in the corrosion of the reinforcing steel. During the service life of such chimneys their condition should be monitored in order to prevent structural failures and indicate the most endangered parts of the structure. Owing to thermographic surveys one can monitor the hazards leading to the degradation of the chimney structure, which is particularly vital when due to the character of the production process the chimney cannot be put out of operation. The methods for the interpretation of results from thermovision studies to determine the safety and durability of industrial chimneys are shown.

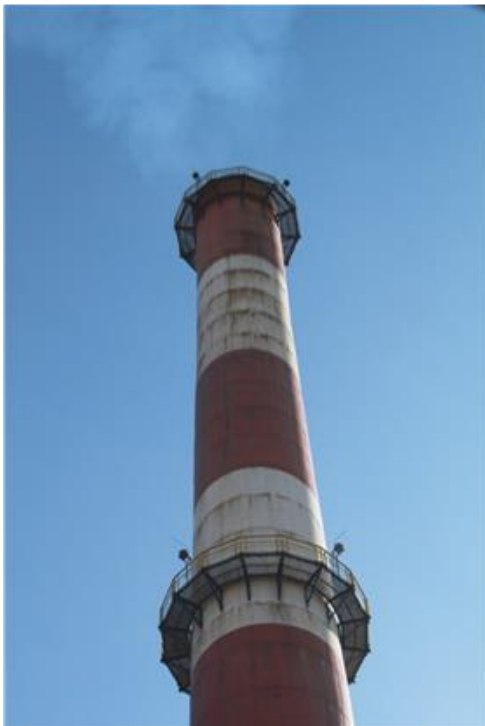
**Figure 1.** Deposition of condensation on outer surface chimney wall along construction joints.

As the condensate penetrates through cracks in the lining, it makes the mineral wool damp, whereby the latter loses its insulating properties. Moreover, the damp mineral wool sinks down and as a result, areas devoid of thermal insulation are created. As the coefficient of thermal conductivity decreases, the temperature of the chimney's inner wall falls further and so does the temperature of the flue gas. As a result, more and more flue gas condenses on the chimney's inner wall, whereby the degradation processes in the chimney's RC shell intensify (Figures 1, 2, 3).

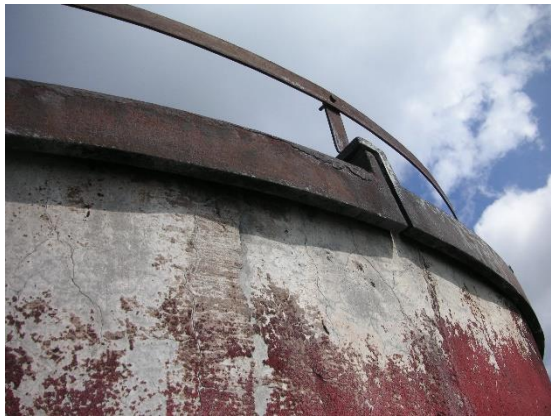
**Figure 3.** Condensation dripping down from chimney upper ring

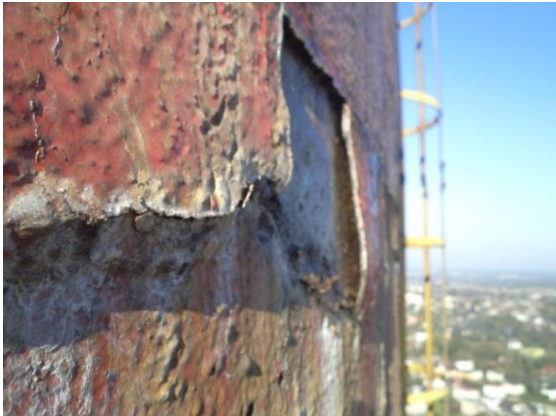
**Figure 4.** Condensation penetrating chimney crown wall

As condensation drips down the inner wall it penetrates via cracks to the mineral wool and outside to the reinforcement of the concrete wall, causing intense corrosion of the concrete and the reinforcing steel (fig. 4).
