Wire Ropes and CFRP Strips to Provide the Masonry Walls with Out-of-Plane Strengthening

Elena Ferretti

Department of Civil, Environmental and Materials Engineering – DICAM, Alma Mater Studiorum
Università di Bologna, 40136 Bologna, Italy; elena.ferretti2@unibo.it; Tel.: +39-051-209-35-15

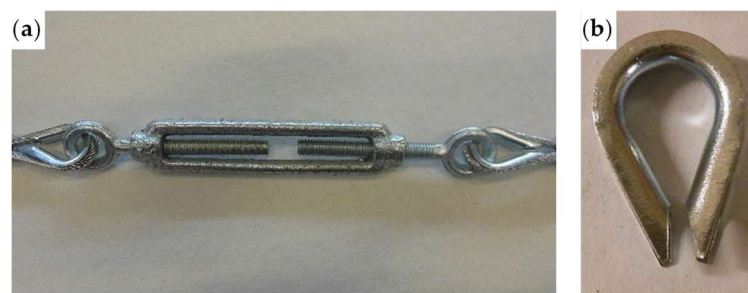
Figure 12. The fastening system of the second combined technique: (a) two Flemish eyes connected by an eye-eye turnbuckle and (b) detail of the thimble placed inside a Flemish eye.

In the fastening system of the second combined technique, both loose ends of each steel wire rope form a Flemish eye (Figure 12a), which consists in turning the end back to form a loop and fixing the loose end back on the steel wire rope. A thimble installed inside the loop (Figure 12b) prevents the steel wire rope to bend too tightly when a device connected to the loop concentrates the load on a relatively small area. Furthermore, the thimble prevents the load from coming into direct contact with the steel wires, protecting the cable from pinching and abrading on the inside of the loop.

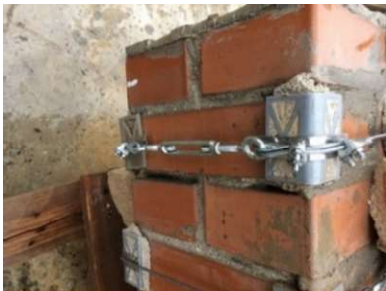
Figure 14. The fastening system of the second combined technique: detail of the clamping system positioned along the lateral face of the brick wall (23 cm).

The eye-eye turnbuckles of the shorter horizontal straps are too long to lie on the two main faces. However, they find an optimal positioning on the lateral faces of the masonry wall, which is a two-headed wall (Figure 14), with the bricks that measure 24.5 cm in length, 5.5 cm in height, and 11 cm in depth (Bolognese type). As the planned dimensions of the brick wall are 50 × 146 × 23 cm, the geometric features of the Bolognese bricks do not exactly fit the length of the wall. Therefore, it was necessary to shorten the end bricks of the odd rows in Figure 15 to obtain the desired length.

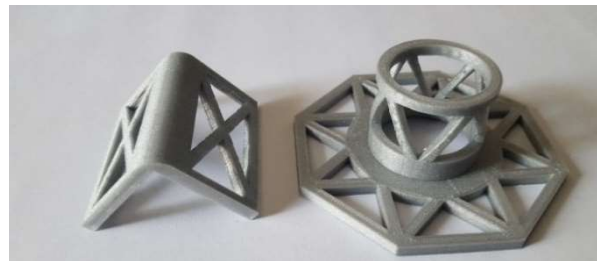
Figure 16. 3D printed funnel-shaped plates and rounded angles.

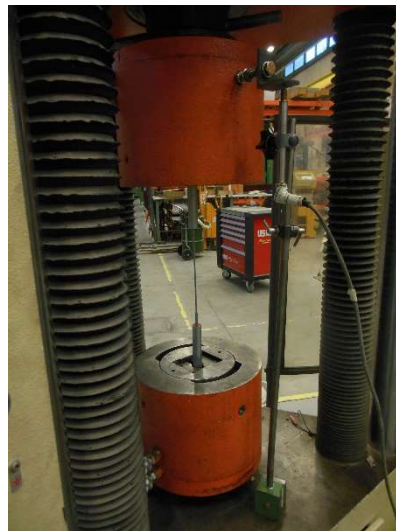
Figure 19. Positioning the LVDT to measure the displacement of the crosshead.

Figure 19 shows the experimental set-up of the tensile test performed on one spiral strand rope of the experimentation. As usual for steel ropes, an LVDT (Linear Variable Differential Transformer) measured the crosshead displacement to obtain the extension of the specimen (Figure 19). In fact, due to high-energy specimen failures, using a traditional contacting extensometer there is a risk of damaging and/or transforming the extensometer into a projectile. To avoid this, it is necessary to remove the extensometer prior to specimen failure. However, since the specimen will be under load, this entails a significant risk for the operator, as there is the possibility that the specimen will break during the removal of the extensometer.

Furthermore, if the extensometer remains attached to the sample, reduction in rope diameter due to Poisson effect and twisting can cause the contact points to slip or the device to fall off. It could also happen that the edges of the knife cause stress concentrations, resulting in premature failure.

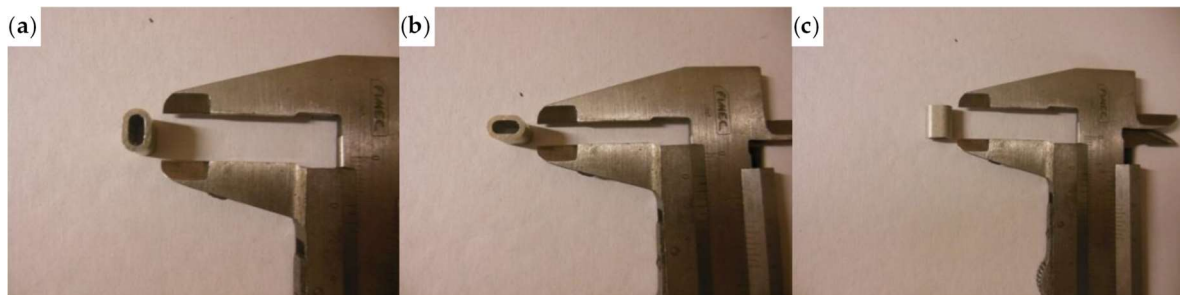
Figure 23. The ferrules of the experimentation: (a) longitudinal dimension, (b) transversal dimension, and (c) thickness.

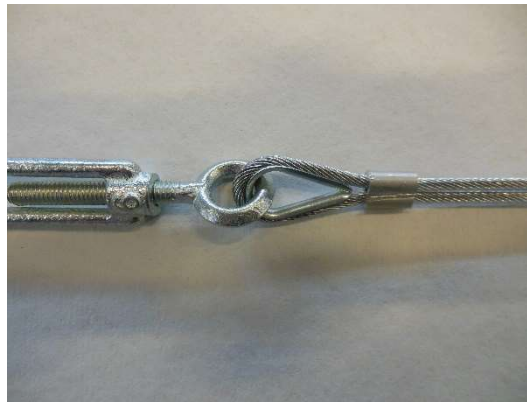
Figure 26. Specimen 1: Flemish eye closed by 1 ferrule.

Specimens 1 and 2 had a very bad behavior, because they failed for a load value much lower than the maximum load of the steel wire rope without a joint (Table 3). Moreover, both specimens showed an excessive deformation of the Flemish eyes, which squashed despite the use of the thimble. However, since the maximum load of Specimen 2 was more than double the maximum load of Specimen 1 (Table 3), the use of a second ferrule helps the joint to withstand higher loads.

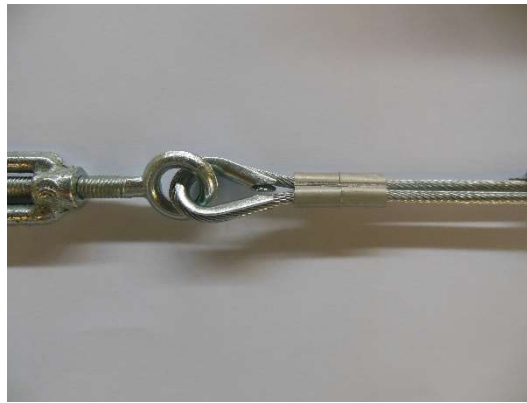
Figure 27. Specimen 2: Flemish eye closed by 2 ferrules.

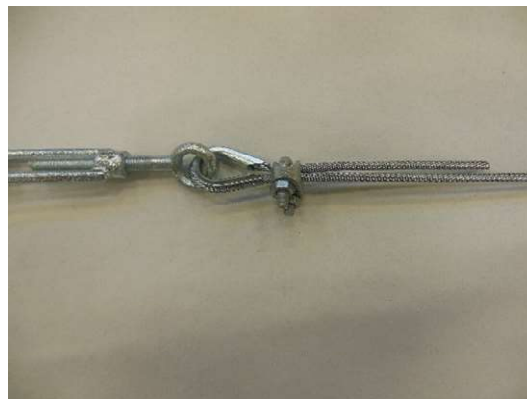
Figure 28. Specimen 3: Flemish eye closed by 1 clip.

- The load of Specimen 3 increased linearly up to a value of about 2.4 kN. Then, the slope of the load/displacement diagram decreased due to the yield behavior of the steel wires and the load continued to increase monotonically up to a value of about 2.9 kN. At this point, the specimen suffered a load drop due to the squashing of the Flemish eyes. Once the squashing of the Flemish eyes was over, the load started to rise again, up to its maximum value. Afterwards, the fraying of the steel wires quickly led the specimen to failure. It is worth noting that the fraying has started from one of the two clips used to close the Flemish eyes (Figure 34). In fact, the eccentricity of the load supplied to the steel wire rope—due to the non-perfect coaxiality between the turnbuckle and the “live” side—brought the flat bearing seat of the clip to rotate, until its edge came into direct contact with the steel wires. This caused pinching and abrading of the steel wires and, consequently, their failures in rapid succession.

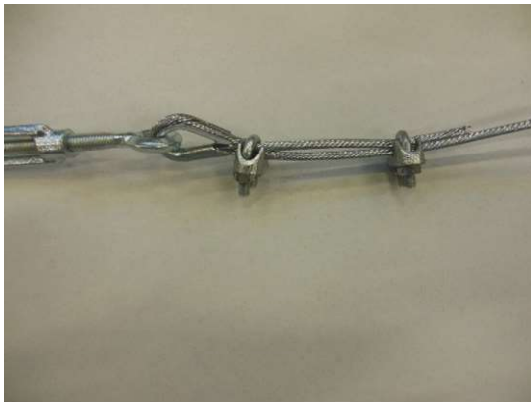
Figure 29. Specimen 4: Flemish eye closed by 2 clips.

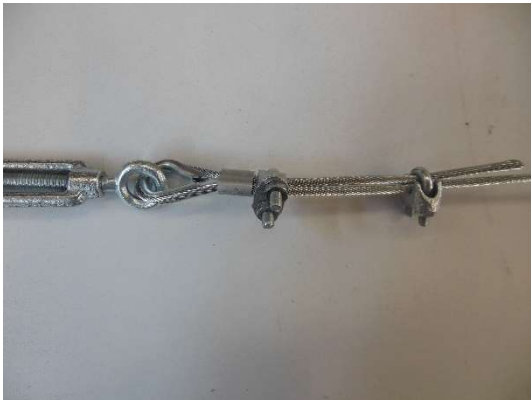
Figure 30. Specimen 5: Flemish eye closed by 1 ferrule and 2 clips, in succession.

- The purpose of the fifth fastening scheme was to eliminate the torsion of the first clip of the fourth fastening scheme, that is, the clip closest to the Flemish eye. In other words, the function of the ferrule was to center the load on the two clips (Figure 36). Specimen 5 did not actually fray near the first clip (Figure 37): it frayed near the second clip. The improved load centering allowed the specimen to withstand a higher ultimate load, comparable to the ultimate load of the steel wire rope without a joint. However, the ferrule caused an excessive deformation of the Flemish eyes, as for Specimens 1 and 2. This greatly reduced the stiffness of the specimen.

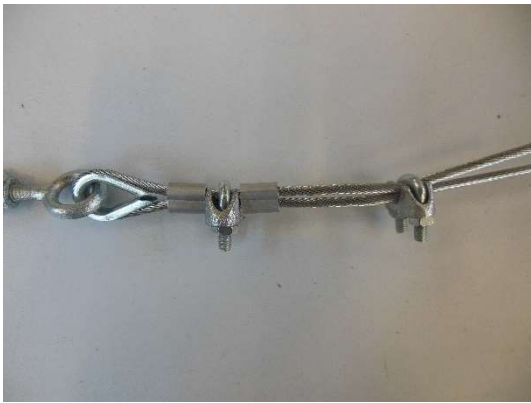
Figure 31. Specimen 6: Flemish eye closed by 1 ferrule, 1 clip, 1 ferrule, and 1 clip, in succession.

- The sixth fastening scheme introduces an additional ferrule between the two clips to eliminate even the rotation of the second clip, with the aim of preventing the specimen from fraying near both clips. The second ferrule actually further improved the load centering, eliminating fraying near both clips. However, this concentrated the deformation phenomena on the thimble that twisted, cutting off the steel wires (Figure 38). The twisting of the thimble occurred due to the excessive squashing of the Flemish eye. In fact, once the two ends of the thimble come into contact, the further squashing of the Flemish eye is possible only by forcing the two ends of the thimble to slide one over the other in the direction orthogonal to the load. This causes the twisting borders of the thimble to cut the steel wires. Also in Specimen 5 the excessive deformation of the Flemish eye caused a twist of the thimble (Figure 35), but this did not lead to damage to the steel wires. Lastly, the concentration of the deformations on the Flemish eyes greatly reduced the stiffness of the specimen, as for Specimen 5: Specimen 6 and Specimen 5 have practically the same stiffness.

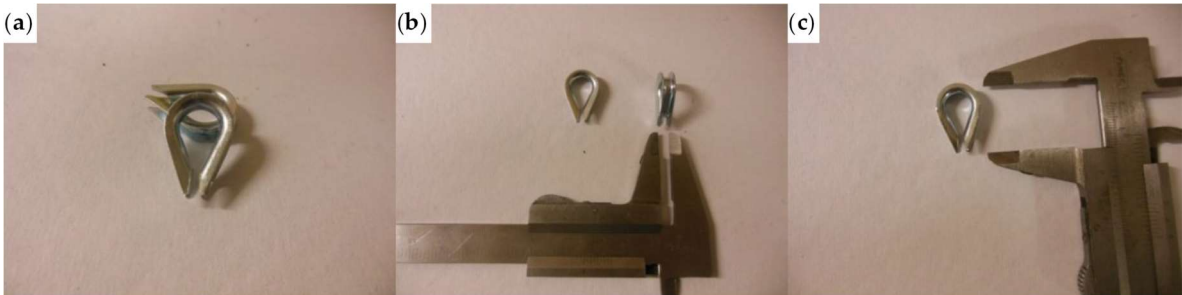
Figure 32. The thimbles of the experimentation: (a) overview, (b) thickness, and (c) longitudinal dimension.

The thimbles used to preserve the natural shape of the Flemish eyes for the specimens listed above have the geometrical characteristics shown in Figure 32.

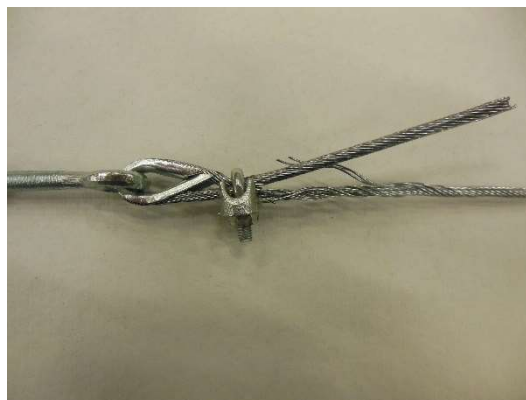
Figure 34. Failure mechanism of Specimen 3.

allowed by a clip is the main responsible for the rotation of the clip and the consequent fraying of the steel wires that came into contact with the edge of its flat bearing seat. On the other hand, however, the elimination of the sliding by means of a ferrule causes exaggerated deformations of the Flemish eyes, which diminish the stiffness of the fastening system. The fastening system chosen for the next phase of the experimentation is the fourth fastening scheme (Figure 29) because, for the purposes of experimentation, the fastening system must be as stiff as possible.

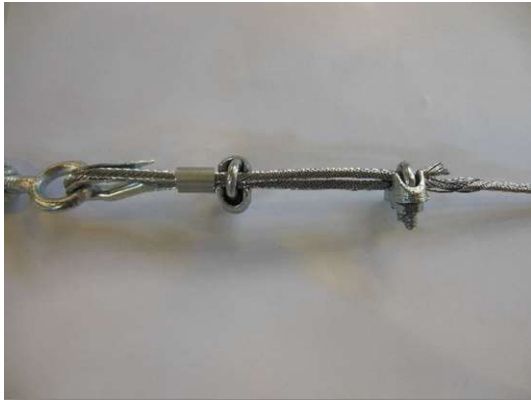
Figure 37. Failure mechanism of Specimen 5.

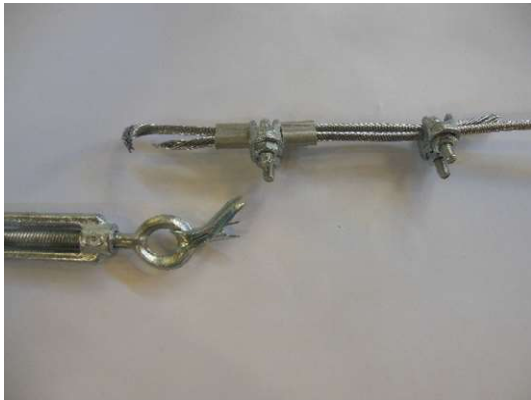
Figure 38. Failure mechanism of Specimen 6.

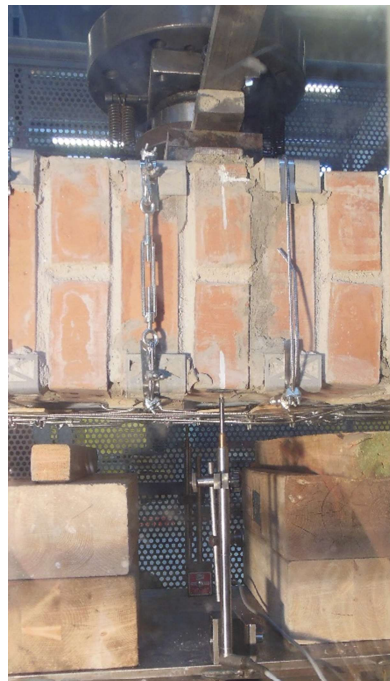
Figure 50. A snapshot of when the disconnection became visible for the first time (load value of about 27.122 kN), on the right of the middle cross-section: the stiffness of the longitudinal straps does not allow free rotation around the inner hinge (back view, the vertical white marks indicate the middle cross-section).

The disconnection along the 11th mortar bed joint occurred for a load value of about 23 kN. This disconnection did not result in any appreciable load drop in the load/deflection diagram of Specimen W5, but led to a slight decrease in the slope of the diagram (Figure 49). Moreover, the disconnection was not appreciable to the naked eye, at first, since the straps took up the load no longer supported by the failed mortar, not allowing the disconnection to open. This increased the load on the longitudinal straps positioned above the disconnected cross-section. As a result, some steel wire ropes began to fray. The four load drops observed in the load/deflection diagram of Specimen W5 for the load values of about 27.122 kN, 29.520 kN, 31.698 kN, and 34.444 kN occurred precisely because of the fraying (Figure 49b). After each of these load drops, the load started to rise again, exceeding the load reached before fraying. Furthermore, the first load drop made the disconnection visible along the 11th mortar bed joint (Figure 50).
