# Investigation of failure mechanism of Lungchok landslide, Sikkim (India)

Neharika Rao Ganta <sup>1\*</sup>, Neelima Satyam<sup>2</sup>

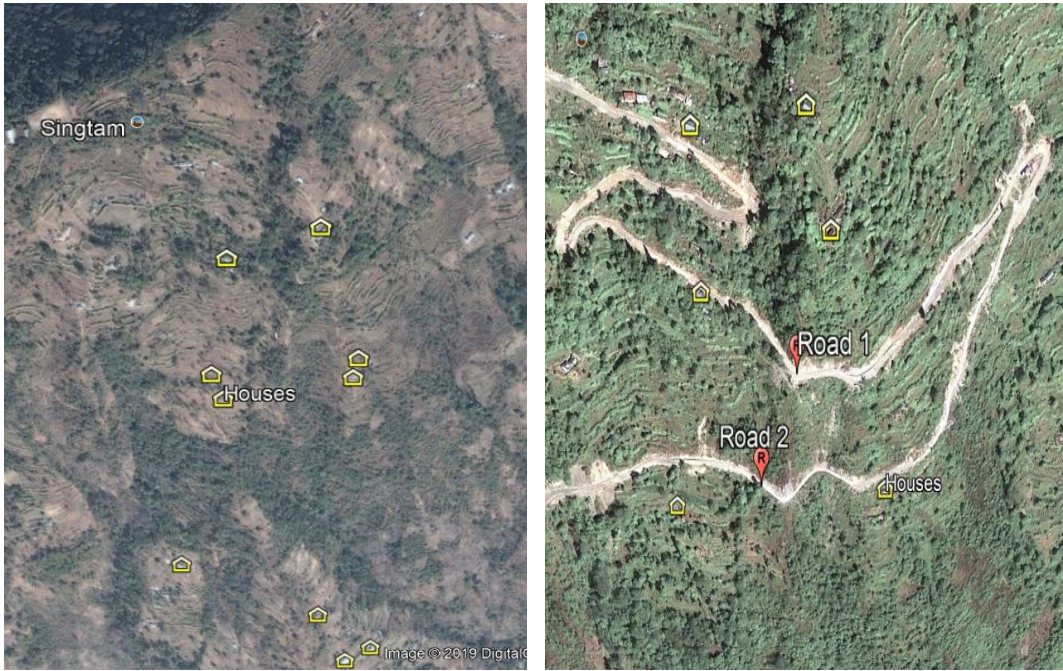
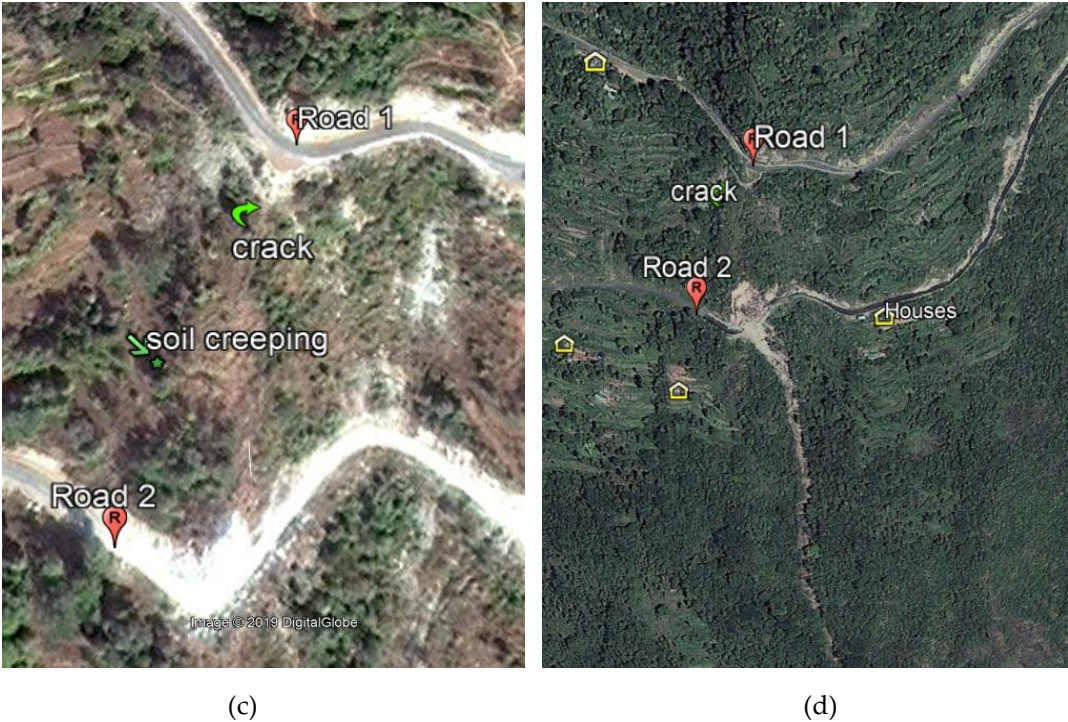
From Google images, it is observed that the roadway was not constructed until the year 2006 shown in Figure 3a. A few years later in 2009, an earthen road 1 and 2 one above the other with an elevation of 0.127 km difference was made on the slope as shown in the Figure 3b. The minor cracks underneath the road one was observed. After a year, the flexible pavement was constructed, and slightly enlarged cracks were found with creeping of soil down towards road two due to the distress of vehicle loads as shown in Figure 3c. The loosen soil abruptly failed when triggered with an earthquake event on September 18th, 2011. The failure slope in between two road section due to the 2011 Sikkim earthquake event is shown in Figure 3d. The rotational failure with deformation extended up to 41.3 m towards the road section 2 and completely damaged. The collapse initiated new cracks of 404 m length with 1.30 m width approximately underneath the road 2.

Figure 3. Aerial photographs of the study area: (a) The roadway was not constructed until the year 2006; (b) A few years later in 2009, an earthen road 1 and 2 one above the other was constructed and the minor cracks underneath the road one was observed; (c) After a year in 2010, the flexible pavement was constructed, and slightly enlarged cracks were found with creeping of soil down towards road section two; (d) The failure slope in between two road section during 2011 Sikkim earthquake event.

The deformations were increased with time in both dry and saturated slope conditions. The deformation of the saturated slope is high when compared to the dry slope. The maximum deformations observed in both slopes are 6.3 cm and 7.69 cm in 24 months. The deformations are gradually increased beneath the road 1 and extended up to road section 2. The deformation obtained due to vehicle loads created cracks beneath the road 1, and this was observed based on the failure in the ground just after the 2011 Sikkim earthquake event as shown in Figure 3c. These cracks further increased during an earthquake event shown in the Figure 3d.

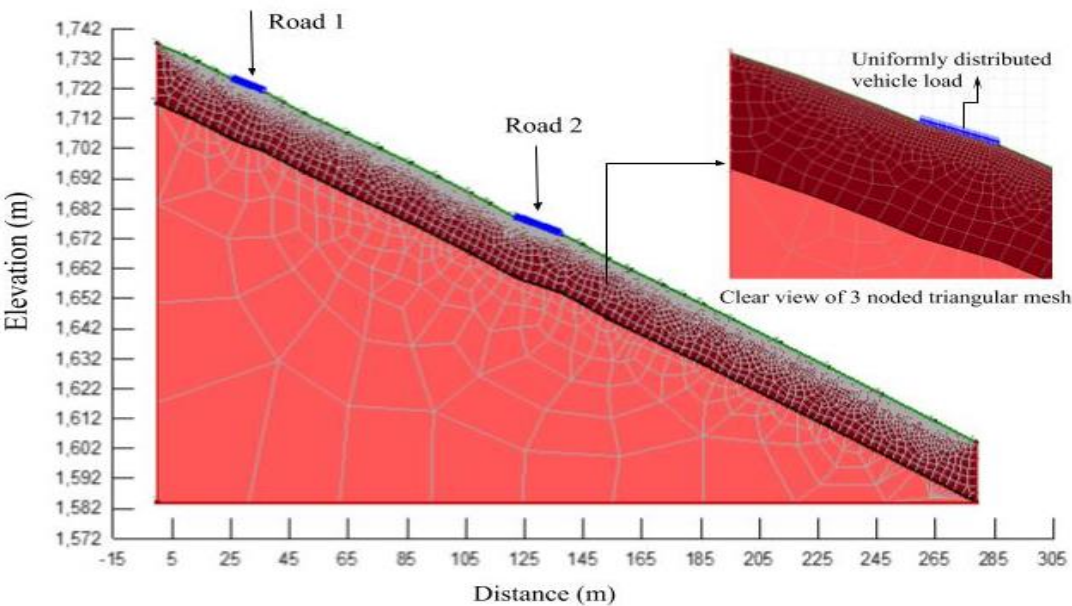
The finite element analysis has been carried out to estimate the deformation of the slope. Finite element approach is widely used due to its connectivity in joint elements [31]. The numerical slope model considered for the analysis is of 280 m distance with elevations at the front and rear edge being 1737 m and 1585 m shown in the Figure 6.

**Figure 6.** FEM model of slope and clear view of mesh with three node triangular element and vehicle loads at road 1 and 2 sections.

The homogeneous slope considered for the analysis was about 152 m elevation. The triangular plane strain elements having three nodes are used for discretization of elements with a total of 6403 elements thereby considering 6758 nodes for the entire model and discretized with three nodes of triangular elements. The boundary condition along the base of the slope was fixed at X and Y direction, and the elevation of the slope was kept free in the Y direction. The boundary conditions along the slope face were set free in both X and Y directions for determining the displacements. For the dynamic analysis, the input horizontal ground motion along the base of the slope was applied. The vehicle load has been applied uniformly of 392.26kN/m<sup>2</sup> as per Indian Road Congress (IRC): 6, 2014 at road 1 and 2.

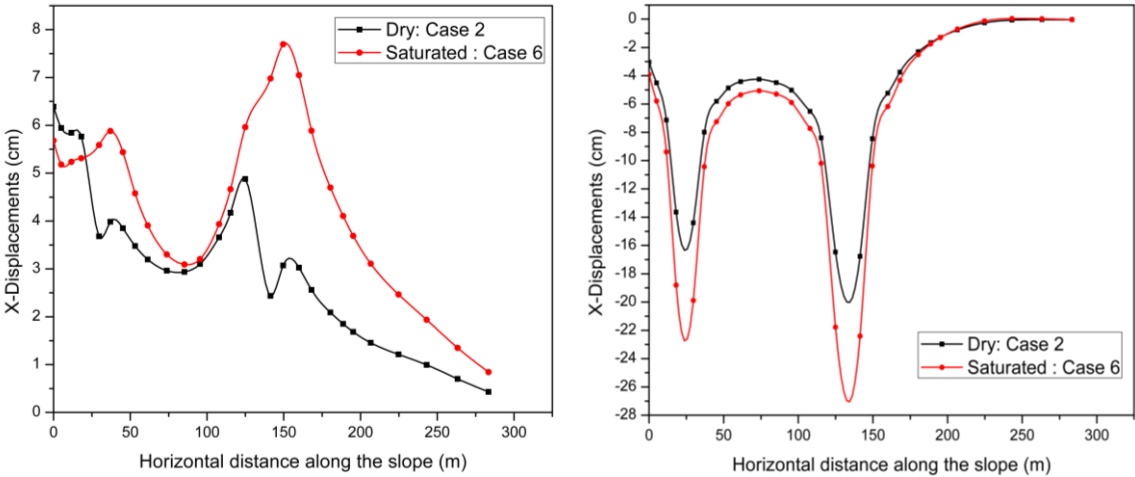
Without the influence of vehicle loads dry and saturated slopes were safe with zero movements. The Horizontal and vertical displacements of both the slopes were increased with the application of vehicle loads were vary from 0 to 6.32 cm and 0 to 22.40 cm as shown in the Figure. 7(a &b). The vehicle loads influenced the vertical deformations compared to horizontal. It clearly shows that the major deformations were increased due to the influence of vehicle loads from zero to 22.40 cm within two years of road construction. Further stability of slope was lowered during heavy monsoon season. The rotational displacements were observed clearly in saturated slope by creating the failure surface underneath road one to two. Thus, create a weak shear zone, and this further degrades due to the percolation of the water into the cracks created by the vehicle loads. Consequently, the stability of soil decreased and failed during the earthquake event.

**Figure 7.** (a) Horizontal displacements; (b) Vertical displacement of dry and Saturated slope under static loads with vehicle loads.

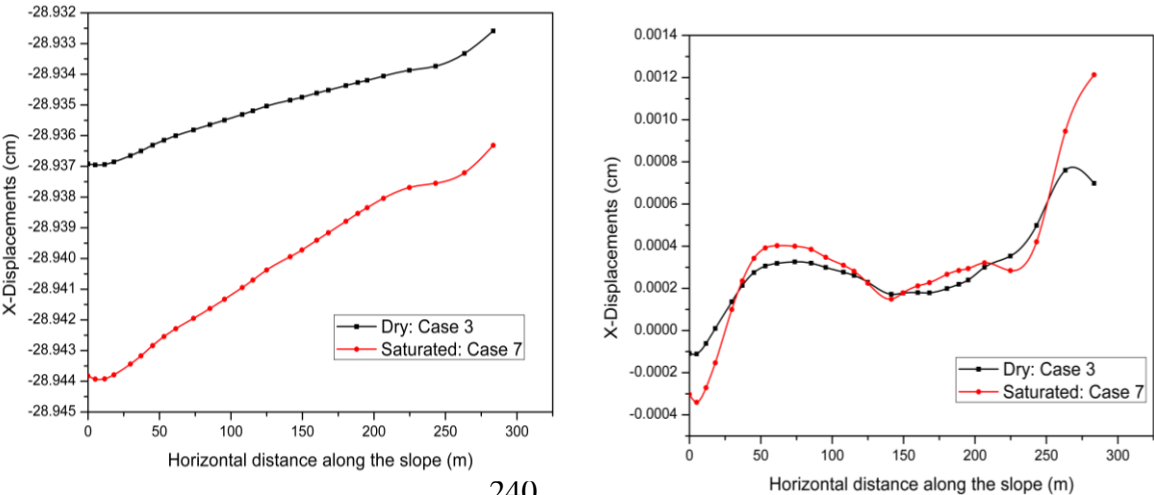
The rotational failure pattern was not observed both in the dry and saturated slopes when no vehicle loads applied in Figure 8a. The vertical deformations observed are also mostly zero as shown in the Figure 8b. The displacements were gradually increased throughout the slope without any deflation, this failure mostly significant creeping of the soil downwards without creating any failure surface.

**Figure 8.** (a) Horizontal displacements; (b) Vertical displacement of dry and Saturated slope under dynamic loads without vehicle loads.

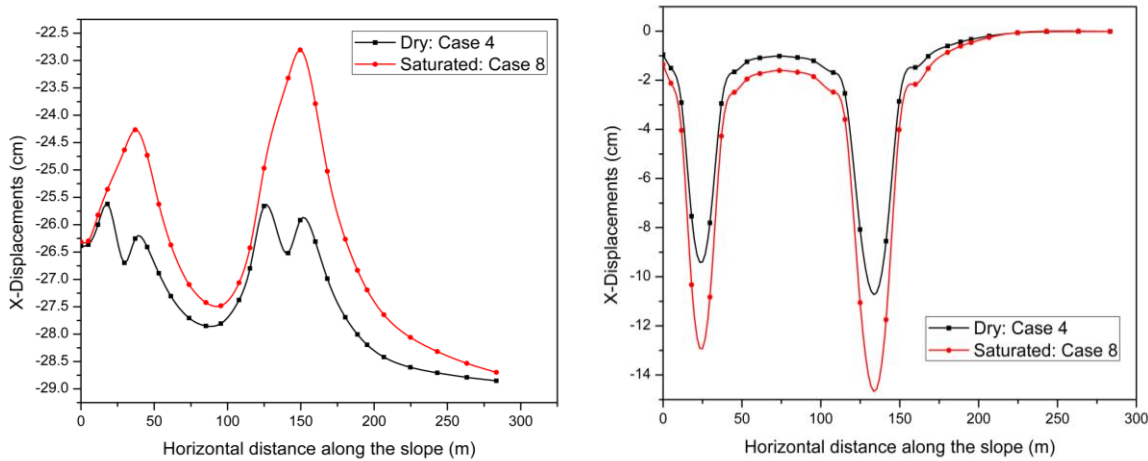
The failure surface was observed when the vehicle loads were applied under dynamic loading shown in the Figure 9 (a, b). The failure pattern observed clearly in saturated condition is more rotational than the dry condition.

**Figure 9.** (a) Horizontal displacements; (b) Vertical displacement of dry and Saturated slope under dynamic loads with vehicle loads.

From all the eight cases observed that, the horizontal displacements in dry and saturated slopes are mostly similar but varied much in vertical displacements due to the influence of vehicle loads. The maximum displacements were observed both in dry and saturated slope under dynamic load along the two road sections with a minute difference in displacements. The vertical and horizontal displacements of the dry and saturated slope are very high in between the two road sections only during the applied vehicle loads. The rotational type of deformation pattern was observed during the application of vehicle loads. The failure observed was identical when cross validated with Google images after 2011 earthquake event.

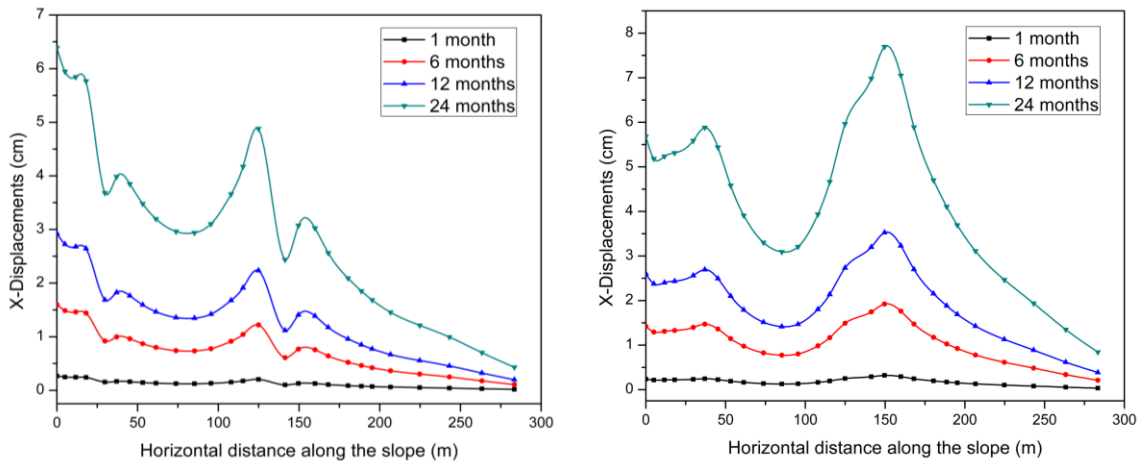
The behavior of both slopes before the disaster was studied under load deformation analysis at different time intervals of 1, 6, 12 and 24 months shown in the Figure 10(a, b).

Figure 10. Horizontal displacements of (a) dry; (b) Saturated slope under dynamic loads with vehicle loads.
