Article

Earthquake Safety Assessment of Buildings Through Rapid Visual Screening

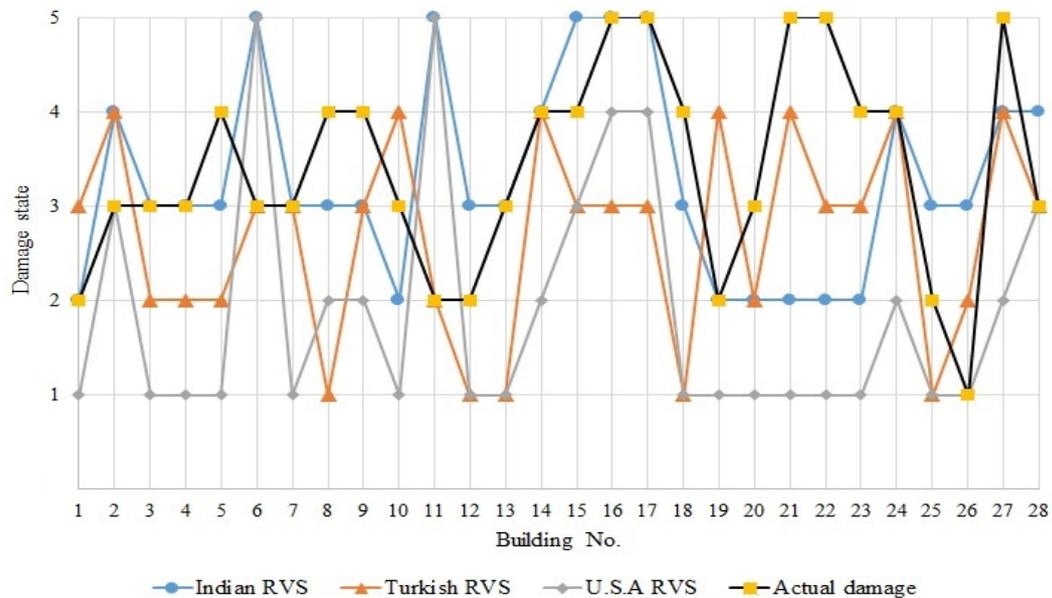
Figure 1. Damage state of selected building data from RVS methodologies [22]

From Equation 2, when scaling the results from RVS methodologies, the lowest value 1 is calculated for FEMA P-154 and Indian RVS but 1.4 for Turkish RVS. The range for the considered integer was between 0.5 and 1.5. As 0.5 lies between the high probability of Grade 5 and Grade 4 (0.3 and 0.7 range), it was considered to be Grade 5 and Grade 4. For this reason, each definition includes 2 damage states. Initially, the scaled values were plotted against the actual damage as shown in Figure 1. This Figure presents the followings: first, the estimation of each building via different RVS method

is displayed and compared with each other. Second, the actual damage of each building has been compared to the assessments. Accordingly, for better illustrating the achievements and difficulties of understanding the figure, a similarity system was worked out based on several buildings to express the results. These requirements were called similarities in this paper, which are as follows:

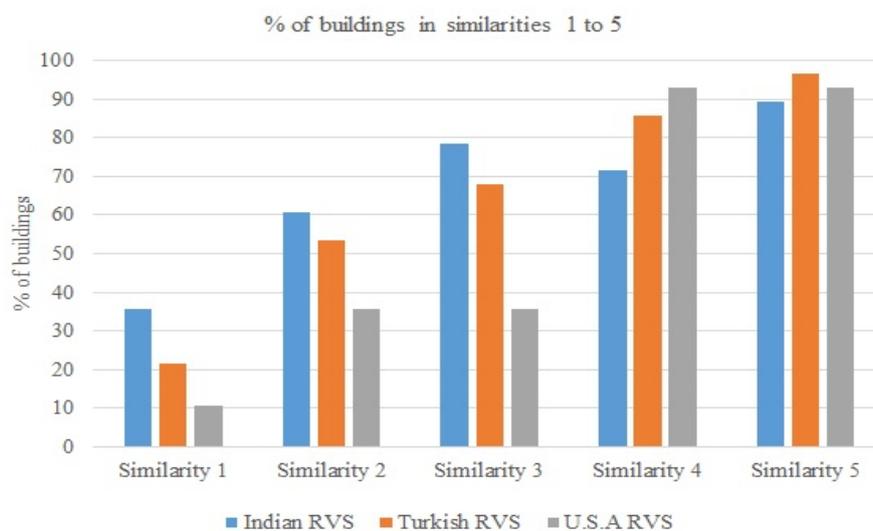
**Figure 2.** Percentage of buildings in each similarity from RVS methodologies

Achieving final decisions based on similarity 1 alone is not advisable, as the results may not always be exact. Similarity 4 should be considered if safety was of primary concern irrespective of cost and time it takes for a detailed assessment of more buildings. Similarity 2 and 3 provide closeness of RVS methodology to actual damage. Similarity 5 was performed only to check how many building estimates were inaccurate. As the results from similarity 5 are more than 90 percent of buildings, it has not used for conclusion purposes. The results for all 5 similarities from three RVS methodologies are illustrated in Figure 2. It has been inferred from the graph that in similarity 1, 2, and 3, Indian

RVS presented a large amount of buildings as did Turkish RVS, but FEMA P-154 addressed a fewer number of buildings in the first 3 similarities. In similarity 4 and 5, FEMA P-154 assessed 93 percent of buildings, Turkish RVS addressed 80 percent of buildings, and Indian RVS presents a fewer number of buildings compared to the other two RVS shown in Table 12. It is clear that FEMA P-154 gives higher damage grade even for buildings with fewer negative influential parameters, although the damage may not be severe. On the other hand, in Indian RVS, similarity 2, 3 and 4 are close to each other with only 10 percent indicating most of the buildings that were in similarity 4 were also in similarities to 2 and 3. This means Indian RVS provided closer results to actual damage followed by Turkish RVS. It would be of interest to check the numbers of buildings categorized in damage state 1 by RVS methodologies before coming to a conclusion. This damage state included both damage grades 1 and 2 and hence the damage state 1 from RVS methodologies will be compared against grades 1 and 2 of actual damage. The RVS methodology with the most accurate assessments of damage versus actual damage can be considered the most efficient methodology.

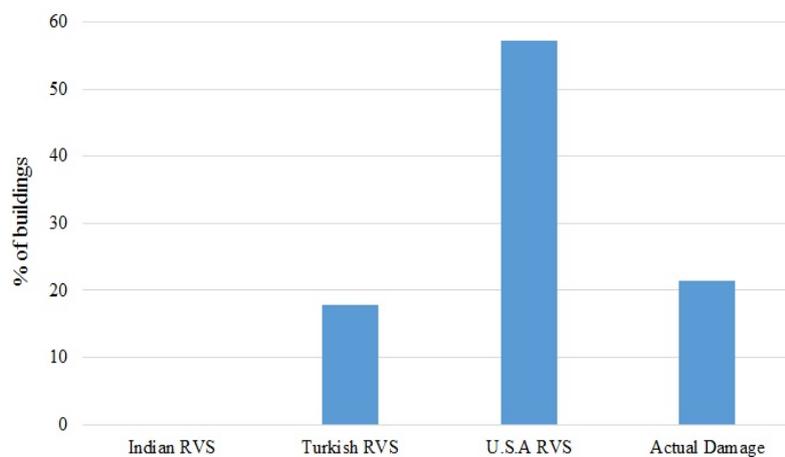
Figure 3. Percentage of buildings in damage state 1 assessed by different RVS methodologies

Figure 3 shows a clear trend that FEMA P-154 estimated almost 58 percent of buildings as damage state 1, which was not appropriate in consideration, as there were fewer buildings that showed state 1 and 2 in the actual damage data. Meanwhile, Indian RVS did not estimate any building as damage state 1, which is also not acceptable as there are fewer buildings having damage grade 1 and 2 in actual building data. Moreover, Turkish RVS provided around 17 percent of buildings as damage state 1, which can be accepted, as around 20 percent of buildings were actual damage state 1 and 2 were.

According to the similarity level, although Indian RVS is significant, it can be highlighted from Figure 3, that Indian RVS might not be considered as a suitable method since it did not classify any building in damage state 1. It is very hazardous for health safety if a building can suffer more severe damage but has been estimated as a moderate or lighter damageable building. For this reason, the Turkish method can be preferred among the three RVS methodologies and also in similarities, as Turkish RVS was close to the results of Indian RVS. However, the RVS methodologies may not give the same damage as that of the actual damage, hence the best method must be selected based on the requirement of the user.
