# Assessment of mechanical properties of corroded prestressing strands

**Abstract:** The corrosion of prestressing steel in prestressed concrete bridges is a critical issue for bridge maintenance. To assess structures with corroded strands, it is necessary to define the mechanical properties of the strands and their influence on the structural behavior. In this study, corroded strands are taken from external tendons in existing bridges and tested to define the effects of corrosion on the tensile properties of the strand. Empirical equations for the tensile strength and ductility of the corroded strand are proposed using test results. The most corroded wire governs the mechanical properties of the strand. Experiments on prestressed concrete beams with a single corroded strand are conducted to investigate the structural behavior. A reduction in the flexural strength and maximum deformation is observed from the experiment. According to the section loss of a wire in a strand and its location in a beam, the flexural capacity can be evaluated using the proposed equation. The reduced ultimate strain of the corroded strand can be the governing factor of the flexural strength.

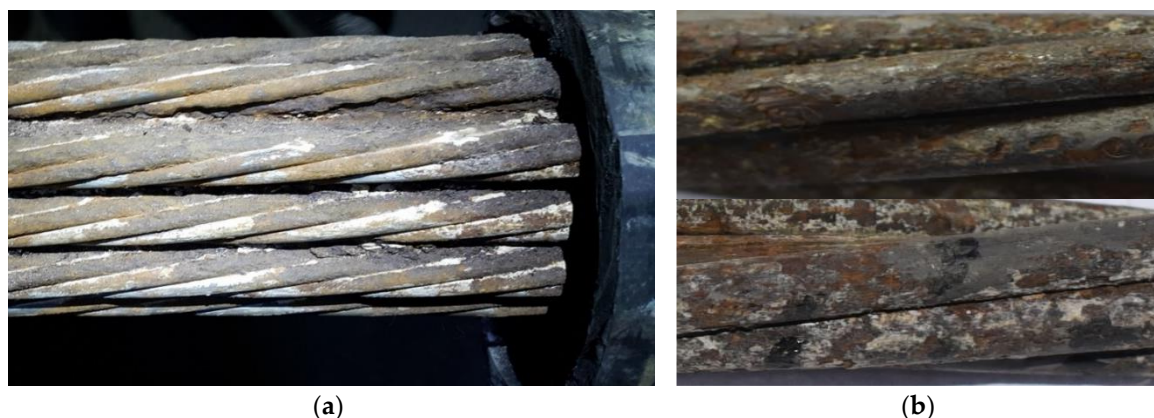
**Figure 1.** Observed corroded strands in existing bridges: (a) Corroded tendon; (b) Corroded strand

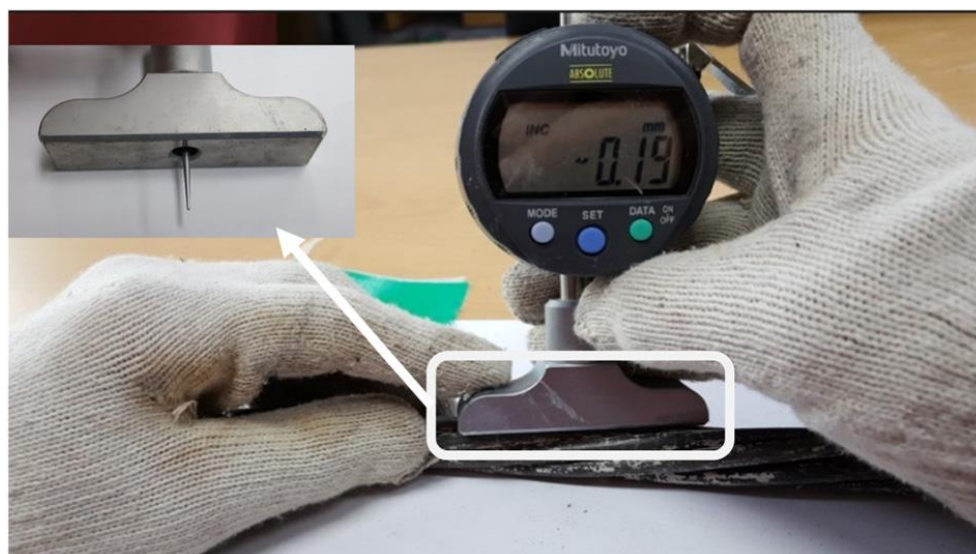
**Figure 2.** Measuring pit depth of corroded wire [15]

In the corroded strands, owing to corrosion along their length, the pit is very irregular, making it difficult to determine the worst part of the corroded wires by a visual inspection. To quantify the corrosion of the specimen, the ASTM G46-94[8] corrosion measurement method as introduced in a previous study [15] was used. This method uses a pit depth gauge to measure the depth of the pit as shown in Fig. 2; however, this method is unable to evaluate the section loss. Therefore, as in the previous research, a section loss evaluation method using the pit depth was suggested.
