On the Construction of Raindrop Erosion Maps for Steel

J. A. Sloan, M. M. Stack

Department of Mechanical and Aerospace Engineering,

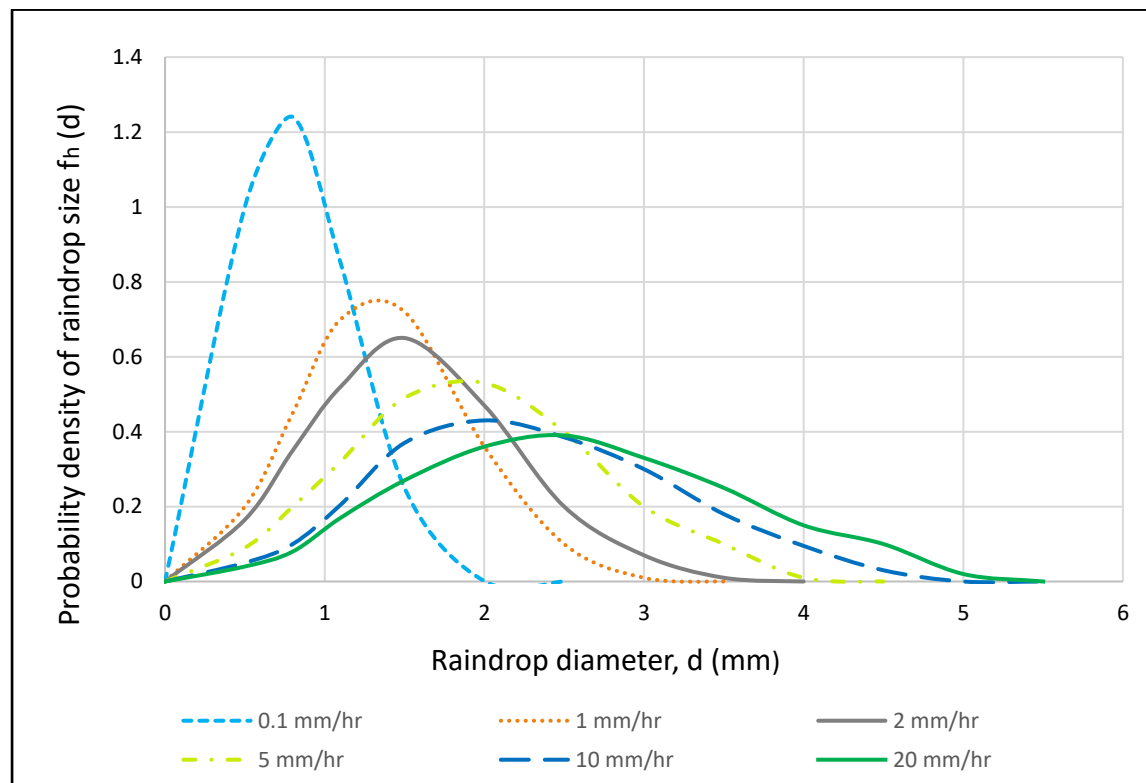
Figure 1: Probability density of raindrop size. Calculated using equation from ^{xii}

As can be observed in the probability graph above, Fig. 1, the average rain droplet diameters during moderately calm rain fall range between 0.5mm and 3mm. The peak or most common raindrop diameters in all variations of rain conditions tested and recorded in the graph, range between 1.4mm and 3mm respectively, ignoring the 0.1mm/h rainfall.

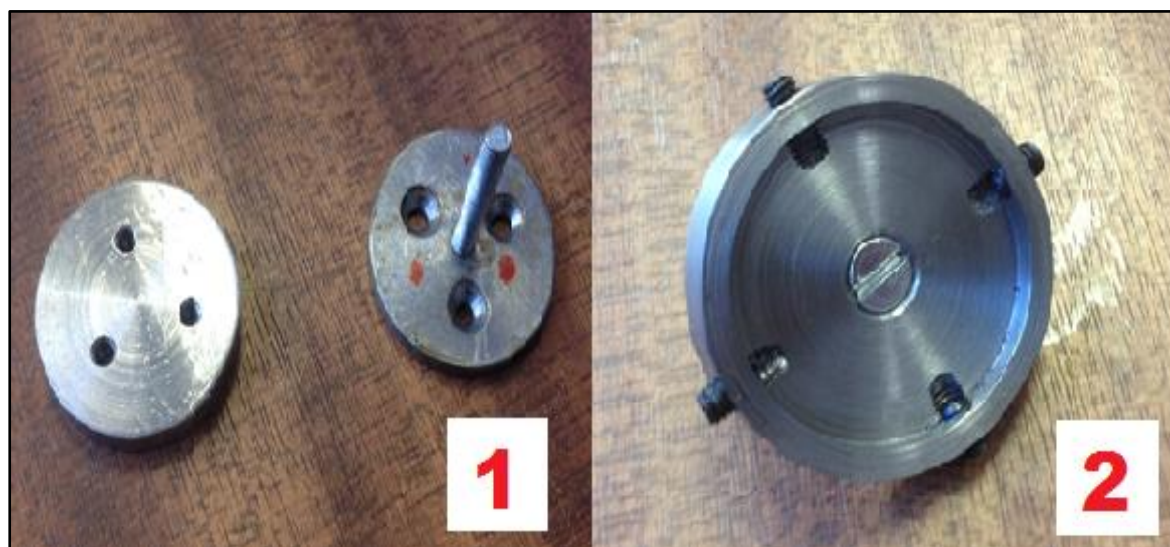
Figure 3: a) Test specimen holder design No. 1 b) Test specimen holder design No. 2

New designs of the test specimen holder were created and tested. The new design was developed to run tests quicker and more efficiently. By being able to remove the samples at the end of testing allowed a comparison of the corrosion and wear scars for various different test conditions. Figure 3 shows the two final designs that were sent to the workshop for construction. Design number 1 demonstrated the most potential with a strong connection due to three small screws. Designs had to be made to produce minimal wear on the test specimens as any mass loss would affect the final results of the tests; for this reason design 1 was used as the mount during this project.

to erode the surface of fibre reinforced-plastics. The rig was modified to run at faster velocities to produce larger impact energies that will erode the surface of the composites. Initially test specimens were made from 2mm thick mild steel with a circular diameter of 30mm. In-light of the new mount the test specimens were altered to have a thickness of 5mm, with three M3 holes drilled at 120 degree intervals, 3mm deep, on the bottom surface of the test specimen. An image of the test samples and mount can be observed in Figure 3[a].

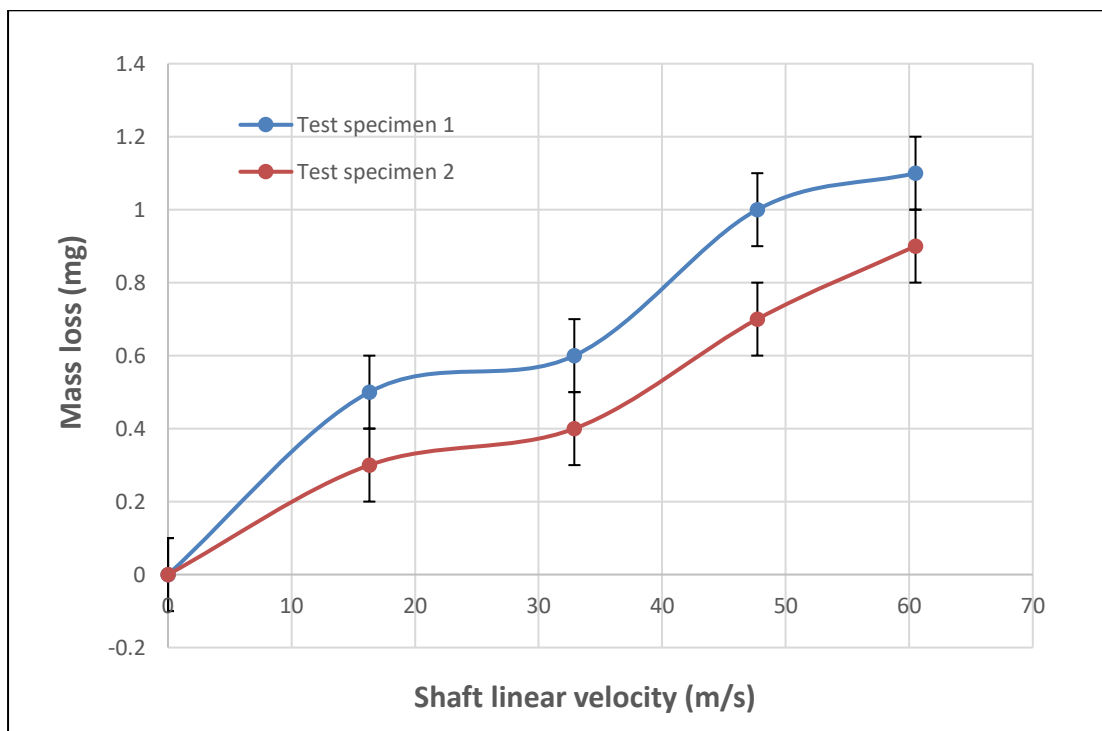
Figure 6: Cumulative mass loss of steel specimens

The results from (Table 4) are presented in (Figure 6) below, indicating a mass loss as the velocity is increased from 16.3ms^{-1} to 60.5ms^{-1} over 80 minutes of testing. Two test specimens were tested and the mass loss can be seen to increase almost linearly. Both test specimens have a fluctuation in the mass loss at 20ms^{-1} . The uncertainty in the results from the weighing scales was found to be roughly $\pm 0.1\text{mg}$ indicated by the error bars in Figure 6. It was presumed the mass loss vs velocity graph would indicate an increasing gradient as the impact energy increased exponentially with the rising velocity. An increasing impact energy would suggest more impact damage and a larger mass loss.^{xiii} Interestingly McGechaen (2013) discovered a similar trend and from Lee (1990), the mass loss measurements of steel are linearly related to the quantity of ferrite in the microstructure, suggesting a tribo-corrosion mechanism in operation.^{xiv}

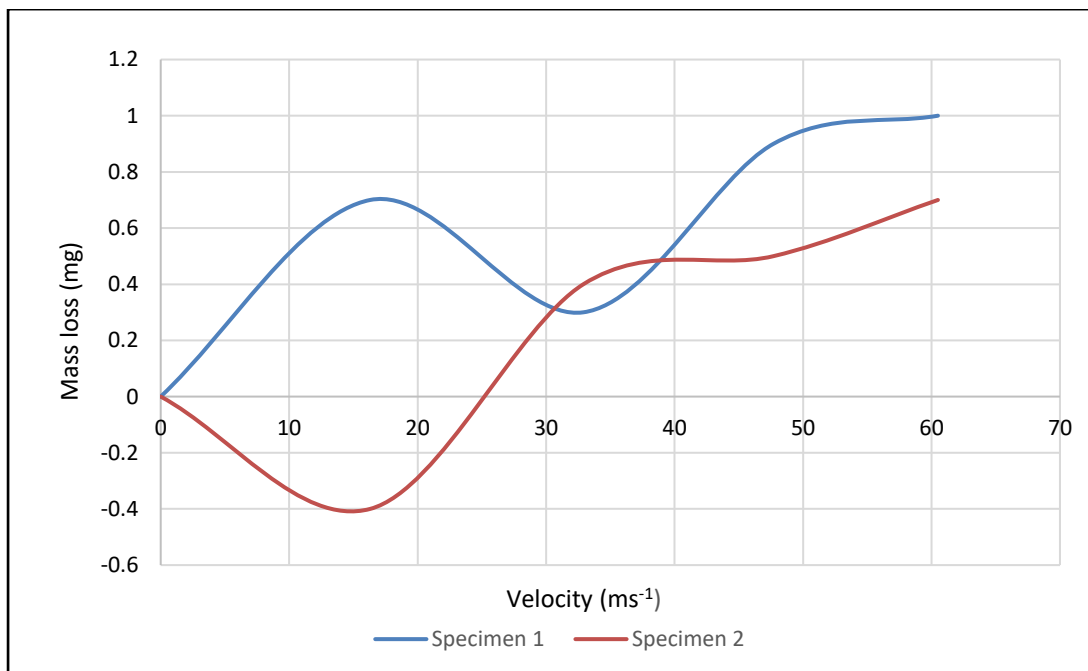
Figure 10: Mass loss at raindrop diameter 2.8mm with increasing linear velocity

The following graphs in Figures 8, 9 and 10 represent the total mass at the end of testing for various linear wind velocities, using a constant raindrop diameter. Each test was run for 1 hour and the total mass loss was recorded. All three graphs show signs of the updraft having an effect on the mass loss between 20ms^{-1} - 30ms^{-1} highlighting a similar conclusion that the updraft must be affecting the number of raindrops colliding with the surface. In all three graphs there is a rise in mass loss at higher wind velocities at around 50ms^{-1} , this could be related to the increasing impact energy. Although many rain droplets are not colliding with the surface the few that are will be causing greater damage, leading to the increase in mass loss.

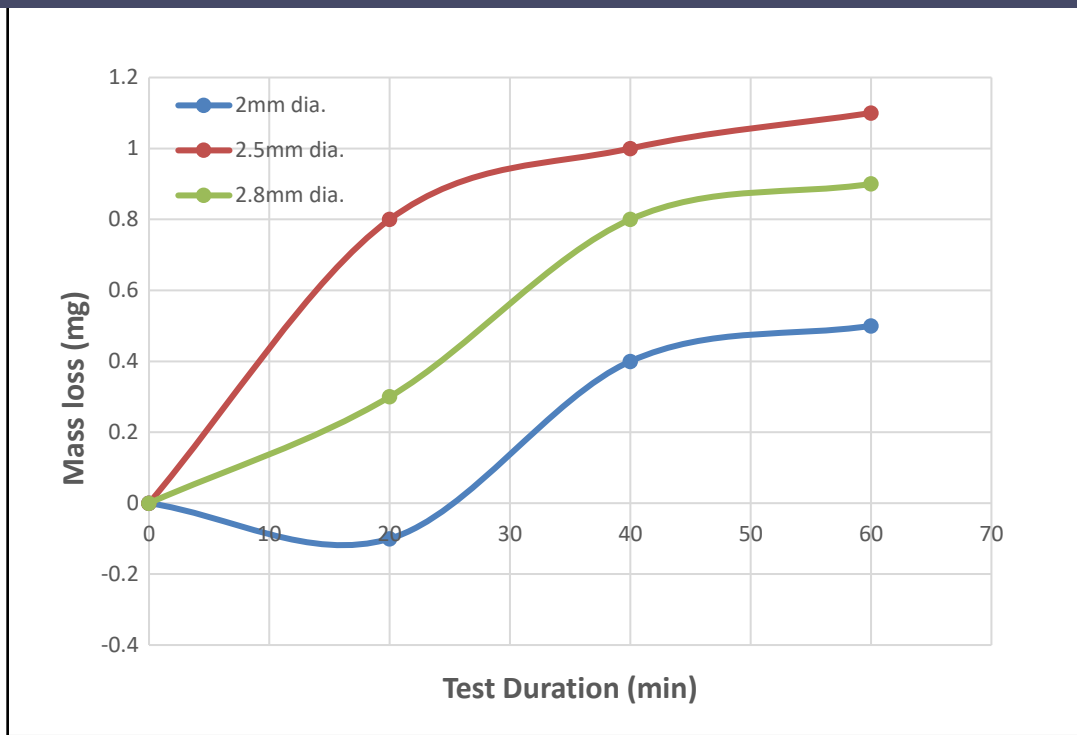
Figure 13: Total mass loss of steel at 47.7 ms^{-1} with varying rain drop diameter

As the velocity further increases there appears to be a transition phase where the larger raindrop diameters start producing greater mass loss, which is demonstrated in Figures 13 and 14. A theory was that the larger rain droplets are heavier in mass resulting in the updraft having less affect compared to the smaller raindrop diameters. For future research it could be considered to take the weight measurements after 5 minute periods and to increase the test duration, which in theory would improve the accuracy of the graphs and would help determine a more realistic incubation period.

47.7ms⁻¹ test shows an increase in the mass loss rate after 20 minutes of impact testing indicating the end of the incubation period (Figure 13).

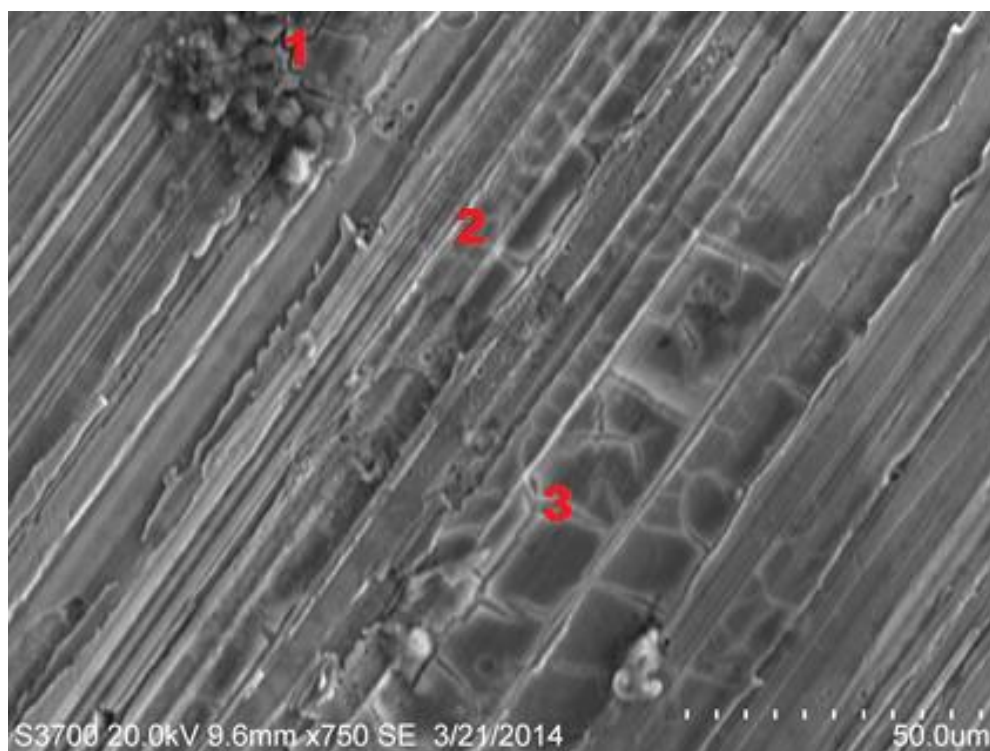
SEM micrographs in Figure 17 shows the surface of the oxidised mild steel after liquid impact testing. Several sites of interest have been numbered in the image and (EDS) analysis was run to observe the conditions on the surface at these specific locations. By comparing the results from (Table 9) and (Table 11) it can be seen that a high percentage of oxygen is established on the surface after impact testing however no oxygen was present prior to testing. The heat produced from the raindrop impacts and the wet conditions provided the perfect environment for corrosion to occur. Corrosion was seen visually from images in Figure 16.

Figure 17: SEM micrograph of oxidised steel

The elemental analysis demonstrates the spread of the scale with each site 1, 2 and 3 having variations of oxygen and iron percentages. From Figure 17 site 1 can be seen to be a lot rougher than sites 2 and 3 indicating that corrosion is further developed in this location. Many elements such as potassium, chlorine, copper and sodium are deposited on the surface of the mild steel from the water during testing.

Site 3 indicates a low oxygen level of 2.46% (*Table 13*) which indicates the scale of the passive film has not developed as much as site 1 which has an oxygen level of 26.9% (*Table 11*). From the micrograph formations of stress cracks can be seen at site 3. This could be an indication of an erosion-corrosion dominant phase where the passive film is being eroded by the liquid impacts.

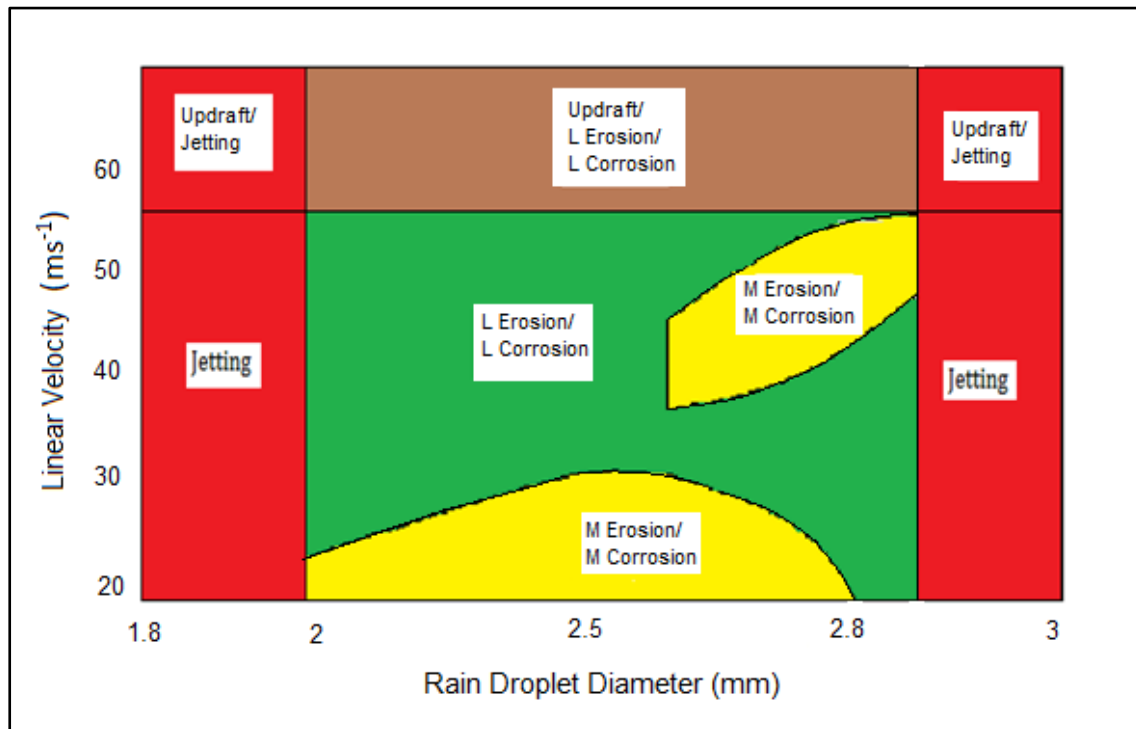
Figure 19: Wastage map showing various raindrop processes at given test conditions

During testing of raindrop diameters 1.8mm, formation of jets were occurring instead of rain droplets from the ends of the needles. An attempt to produce rain droplets of 1.8mm diameter was done by reducing the flow rate to 10 mL/min, less than half of the required volume flow rate. A reduction in pressure could still not produce rain droplets, so tests had to be voided. A similar problem arose from needles producing 3.0mm diameter raindrops, where the formation of water jets would occur from a couple of the needles. Figure 19 is used to illustrate the transition of rain droplet effects encountered during testing caused by jetting from the needles and updraft from the whirling arms. L and M symbolises Low erosion/ corrosion and Medium erosion/ corrosion respectively.
