On the Construction of Raindrop Erosion Maps for Steel

J. A. Sloan, M. M. Stack

Department of Mechanical and Aerospace Engineering,

University of Strathclyde, Glasgow UK

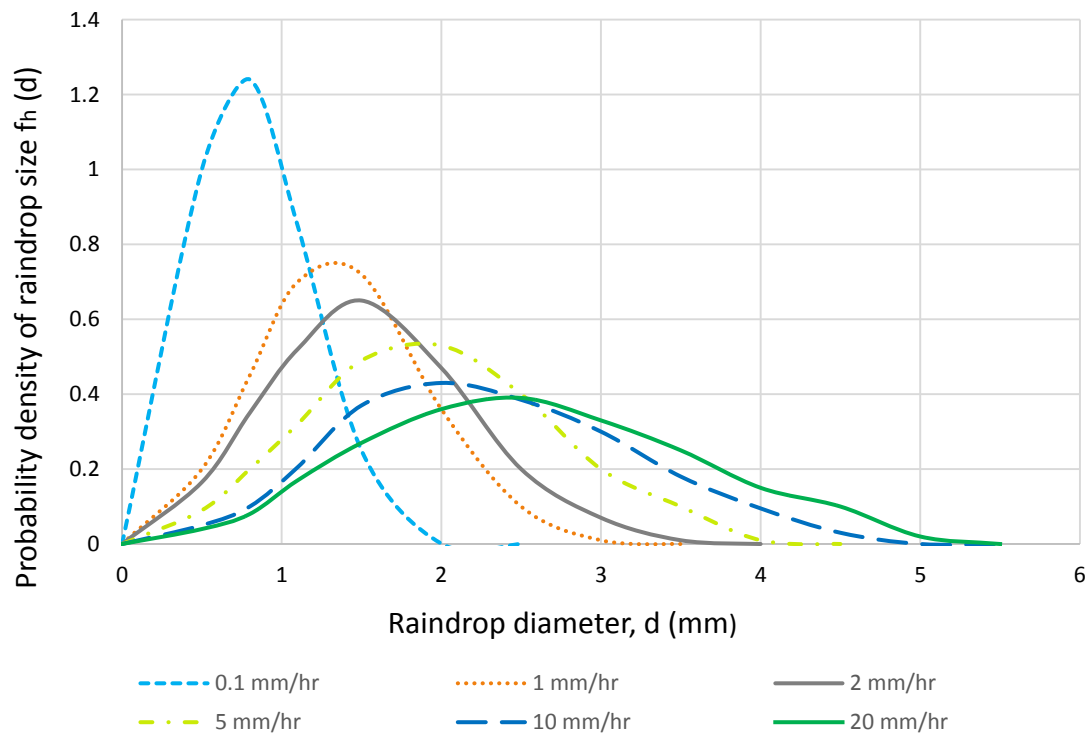
Figure 1: Probability density of raindrop size. Calculated using equation from ¹

Kubilay et al. [10] produced a graph for the probability density for the raindrop diameters using the equations derived by Best, [10, 11] as shown in Figure 1.

As can be observed in the probability graph above, Fig. 1, the average rain droplet diameters during moderately calm rain fall range between 0.5mm and 3mm. The peak or most common raindrop diameters in all variations of rain conditions tested and recorded in the graph, range between 1.4mm and 3mm respectively, ignoring the 0.1mm/h rainfall.

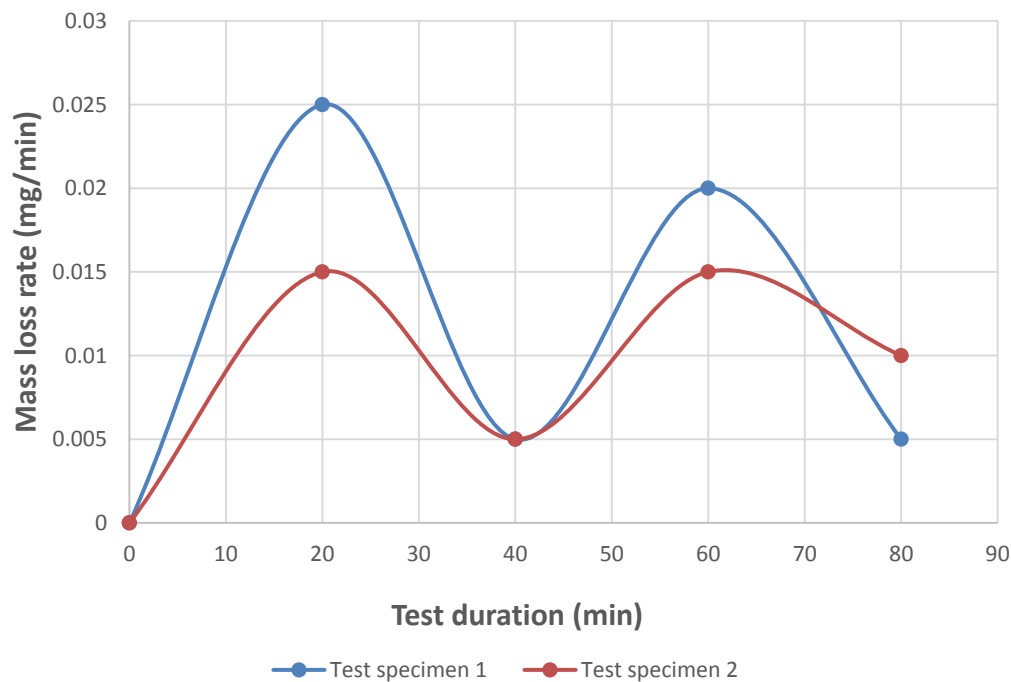
Figure 7: Mass loss rate of steel specimens

In an attempt to explain the effect of increasing linear velocity on the mass loss of mild steel the data was normalized to produce a graph of the mass loss rate during the test, represented in Figure 7. Previous work showed a gradual increase in the mass loss rate with rising linear velocity.[14].⁶ The graph presented in Figure 7 on the contrary indicates a very different trend, between 20 min and 40 min in that there is a rapid depletion in mass loss rate. Interestingly during testing in previous work a drop in the mass loss rate was found, although slightly later into the test which could be an indication of an incubation period. [15]. Measurements were only taken every 20 minutes and thus it is quite possible that the incubation period was missed. Lee (1990) [15] identified an incubation period of roughly 2 minutes for steel containing 0.41% Carbon. After 40 minutes the mass loss rate starts increasing again signifying erosion of the mild steel as expected after the incubation period, which was proposed by Tobin et al. [12]. Extending the test duration and increasing the number of intervals the specimen is weighed would greatly improve the chances of identifying the incubation period.

Unexpectedly (Figure 7) shows another large drop in the mass loss rate 60 minutes into testing. Tobin et al. proposes after the incubation period the wear mechanism tends towards an erosion-corrosion process and the mass loss rate should continue increasing at higher velocities. [16]. During testing, visual observations indicated that at high velocities rain droplets would accumulate on the wall of the container and slowly spiral downwards, suggesting many raindrops may not be colliding with the surface of the test specimen. There is no theoretical evidence to verify this theory as the rig is unable to identify raindrop collisions on the surface of the test specimen. A reduction of impacts would certainly contribute to a reduced mass loss rate at higher velocities.

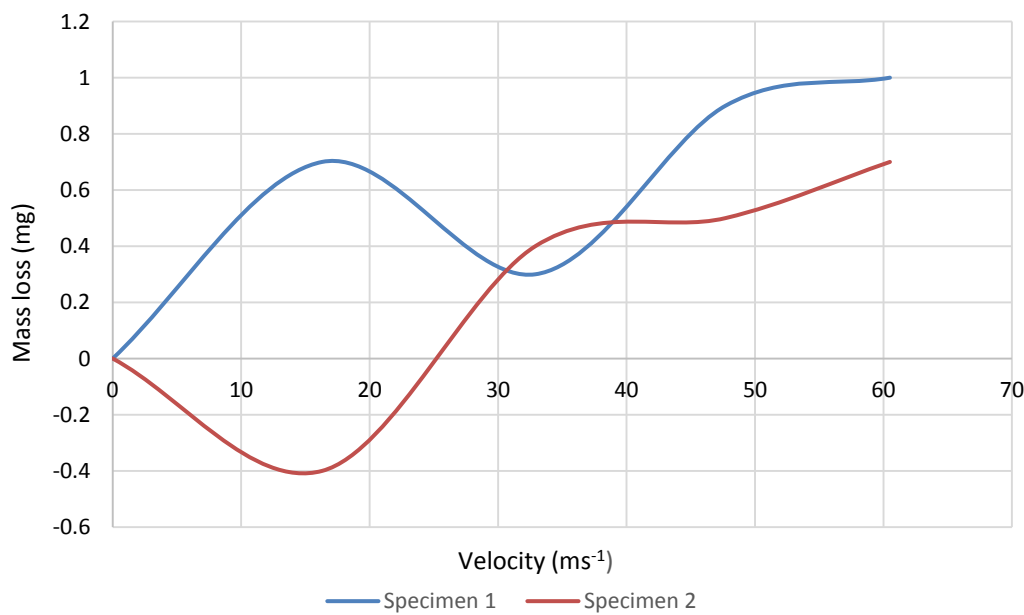
Figure 10: Mass loss at raindrop diameter 2.8mm with increasing linear velocity

The following graphs in Figures 8, 9 and 10 represent the total mass at the end of testing for various linear wind velocities, using a constant raindrop diameter. Each test was run for 1 hour and the total mass loss was recorded. All three graphs show signs of the updraft having an effect on the mass loss between 20ms^{-1} - 30ms^{-1} highlighting a similar conclusion that the updraft must be affecting the number of raindrops colliding with the surface. In all three graphs there is a rise in mass loss at higher wind velocities at around 50ms^{-1} , this could be related to the increasing impact energy. Although many rain droplets are not colliding with the surface the few that are will be causing greater damage, leading to the increase in mass loss.

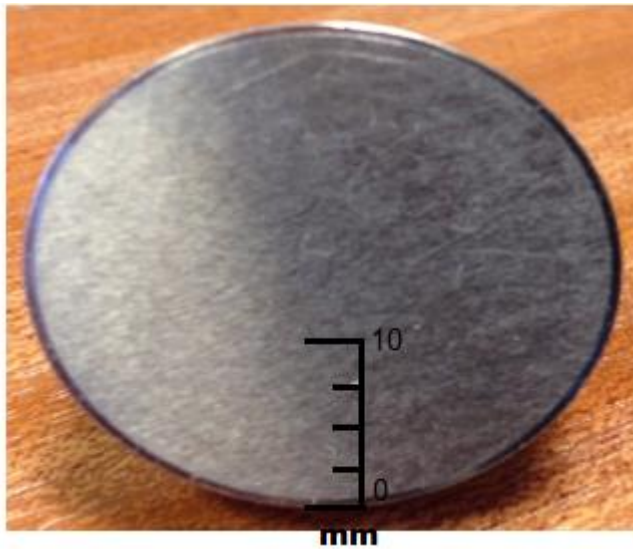
Figure 15: Steel sample prior to impact testing

From section 4.2, there were clear signs of erosion taking place on the surface of the test specimens due to raindrop impacts. Images were taken with a camera to give a clearer representation of the whole test specimen compared to SEM micrographs, allowing the oxide layer to be seen more clearly.

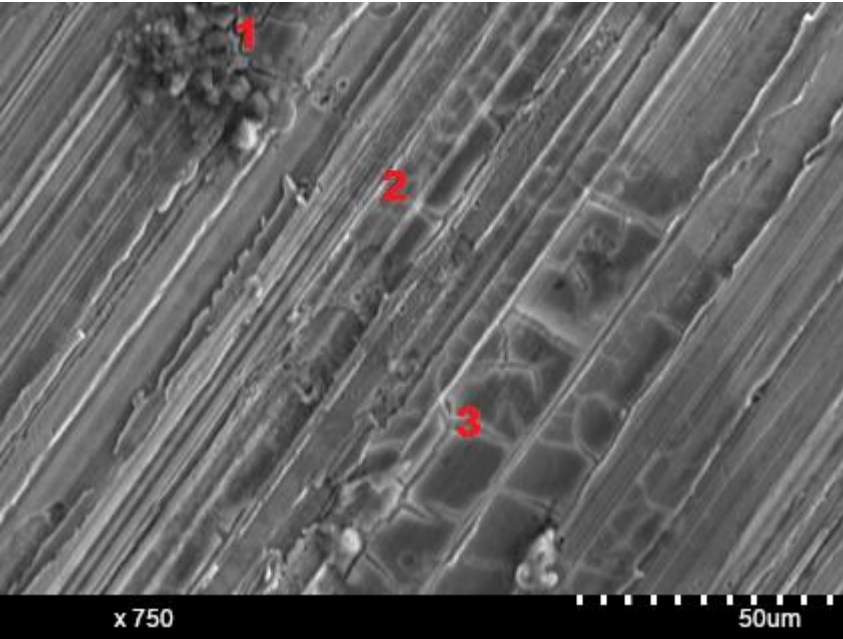
Figure 17: SEM micrograph of oxidised steel

SEM micrographs in Figure 17 shows the surface of the oxidised mild steel after liquid impact testing. Several sites of interest have been numbered in the image and (EDS) analysis was run to observe the conditions on the surface at these specific locations. By comparing the results from (*Table 9*) and (*Table 11*) it can be seen that a high percentage of oxygen is established on the surface after impact testing; however no oxygen was present prior to testing. It is possible that the frictional heating heat produced from rotational process of the raindrop impact and the wet conditions provided an optimal environment for corrosion to occur. Corrosion was seen observed from images in Figure 16.

The elemental analysis demonstrates the spread of the scale with each site 1, 2 and 3 having variations of oxygen and iron percentages. From Figure 17 site 1 can be seen to be a lot rougher than sites 2 and 3 indicating that corrosion is further developed in this location. Many elements such as potassium, chlorine, copper and sodium are deposited on the surface of the mild steel from the water during testing.

Site 3 indicates a low oxygen level of 2.46% (*Table 13*) which indicates the scale of the passive film has not developed as much as site 1 which has an oxygen level of 26.9% (*Table 11*). From the micrograph formations of stress cracks can be seen at site 3. This could be an indication of an erosion-corrosion dominant phase where the passive film is being eroded by the liquid impacts. Previous work indicates that erosion begins to enhance corrosion through the removal of an iron oxide layer, as the temperature will increase with repetitive impacts on the surface enhancing the corrosion. [20] Removal of oxide scale thus becomes the main mass loss mechanism.¹⁴

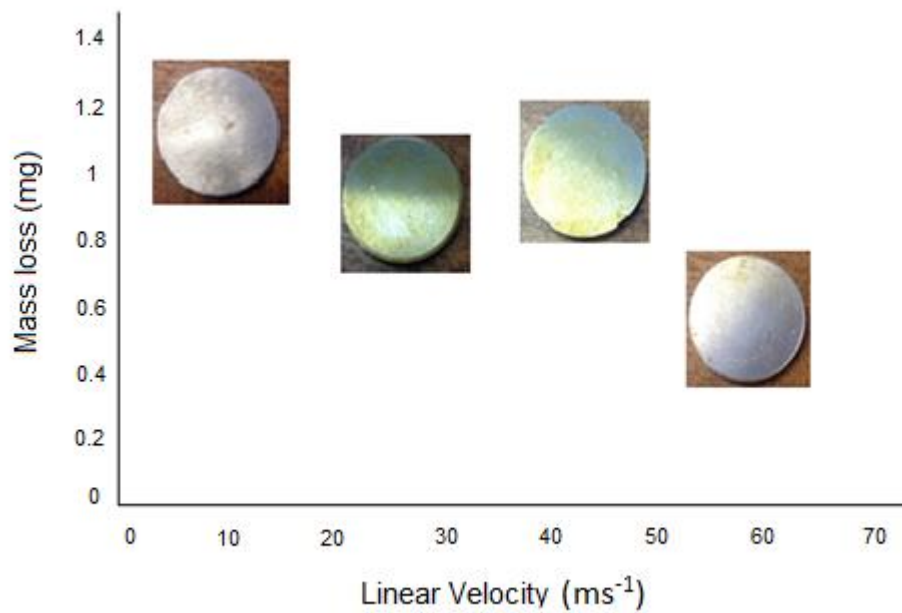
Figure 20: Mass loss graph visualising the effects of corrosion

A further visualization map of the surfaces was produced to compare with the above wastage maps. The graph below (*Figure 20*) was created to illustrate morphological changes on the surfaces of the specimen. Clearly the surface appearances of corrosion product correspond to areas of higher wastage, *Figures. 18 & 19* above.
