# Numerical Investigation of the Collapse of the Steel Truss Roof and a Probable Reason of Failure

**Abstract:** This study investigates the failure of a roof with steel truss construction of a factory building in Tekirdag in North-western part of Turkey. The failure occurred under hefty weather conditions including thunderbolt, lightning strikes, heavy rain and fierce winds. In order to interpret the reason for the failure, the effects of different combinations of factors on the design and dimensioning of the roof are checked. Therefore, finite element analysis is performed several times under different assumptions and considering different factors aiming to determine the dominant ones that are responsible for the failure. Each loading condition gives out a characteristic form of failure. The scenario with the most similar form of failure to the real collapse is considered as the most likely scenario of failure. Also, the factors included in this scenario are expected to be the responsible factors for the partial collapse of the steel truss structure.

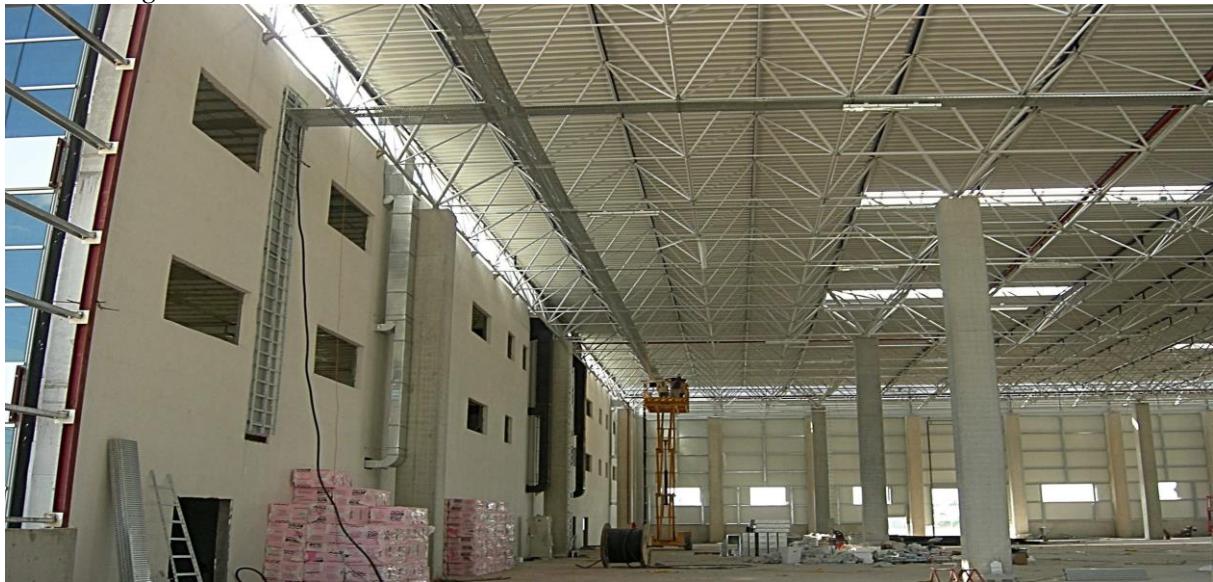
**Figure 3.** Overview of the roof structure.

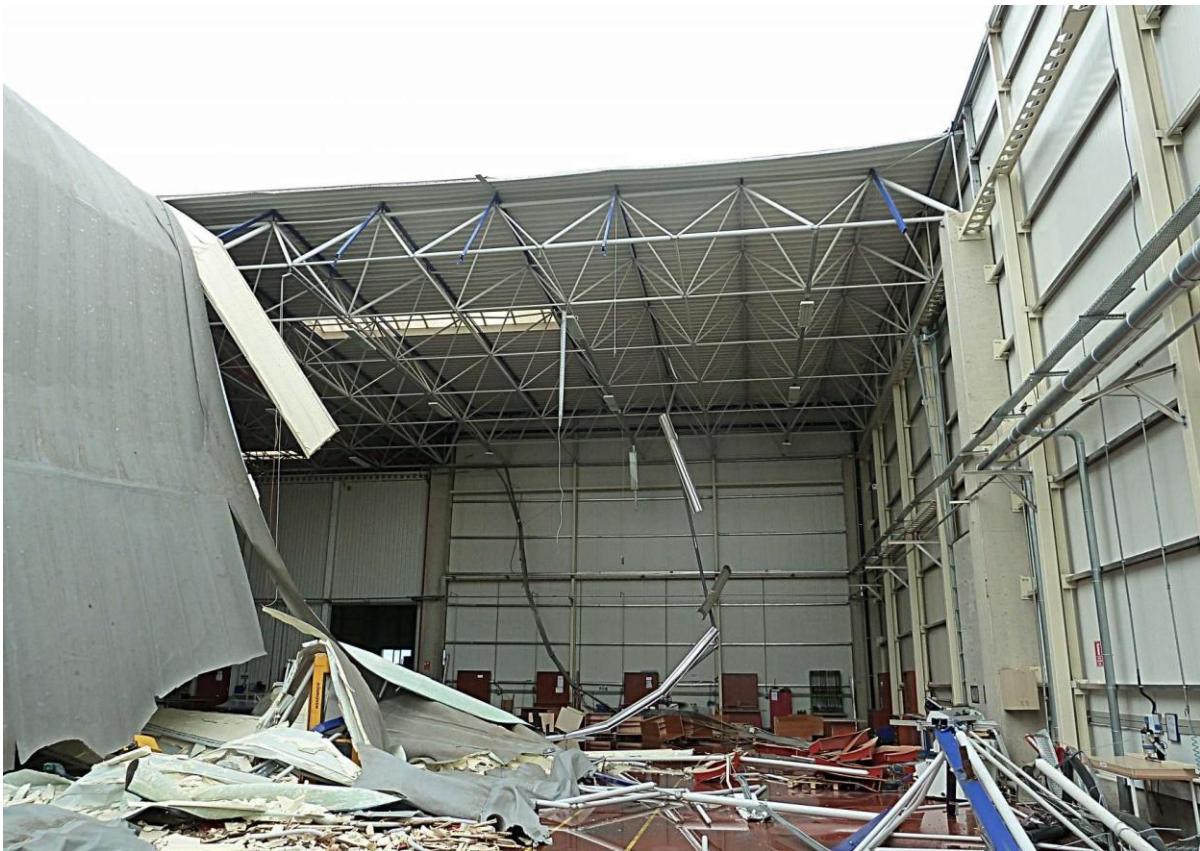
The steel space truss roof structure is mounted on the reinforced concrete columns having 11 m height and 80 cm by 80 cm cross-sections. The number of columns and their configuration can be seen in the plan view of the building which is given in Figure 1. No failure, no deformation and no cracks are observed on these columns during the investigations. Only some broken wings are observed on their top section which is estimated to happen during the collapse of the roof construction. Thus, it is concluded that the columns did not play a significant role in the collapse mechanism of this building. On top of the columns, the spherical joints that are welded to the bearing plates. Figure 3 represents an overview of the real building structure and Figure 4 shows the damaged roof of the space frame system on the night of the incident.

**Figure 4.** Damage on the roof of the space truss system.

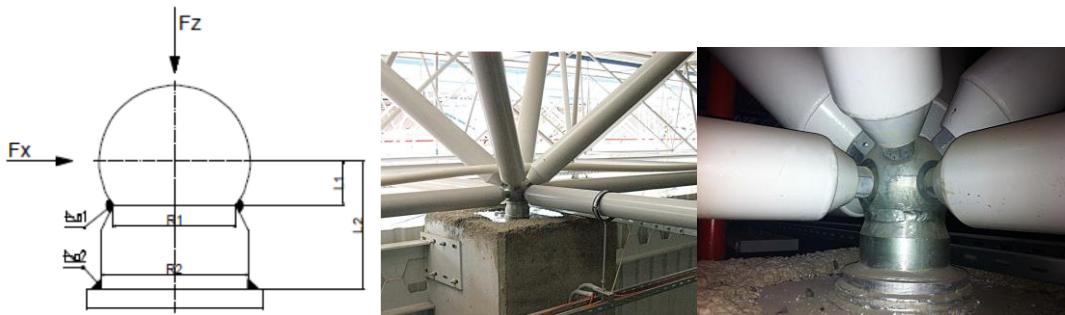
The support spheres are fixed onto the concrete columns by using square or circular plates bolted to the columns. The supports are made of EN C45 steel and Teflon plates are placed under the sliding ones to reduce friction. The details of the joints and supports are given in Figure 5.

Figure 5. View of the spherical joints and the supports

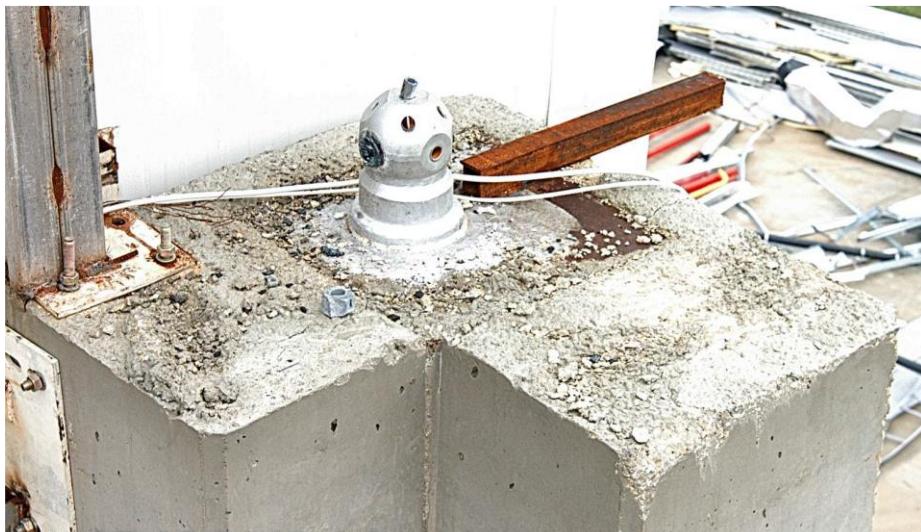
**Figure 16.** Damage on the support to which the space truss roof system is attached.
