Material Origins of Accelerated Operational Wear of RD-33 Engine Blades

Keywords: turbine jet engine; material tests; ember-resistant alloys

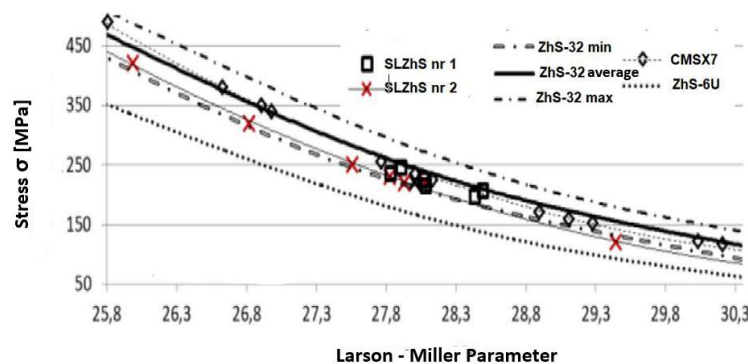
Figure 3. Influence of temperature and exploitation time on the exploitation stress of ZhS alloys used in the construction of engine RD-33 turbine blades, defined by the Larson-Miller parameter P [1.].

The scope of application of alloys used to construct blades of the RD-33 engine, and in particular the creep resistance depending on temperature and duration of its long-term impact on the material, is best represented by the Larson-Miller parametric coordinates defined by the formula(1) (Figure 8.):

Higher permissible exploitation stress of the ZhS-32 alloy compared to ZhS-6U should be explained by a higher volume content of the phase γ' in the material structure, 67% and 57% respectively, as well as its higher thermal stability, caused by Re and Ta additives, which increase the temperature of the solidus from 1240°C (ZhS-6U) up to 1310°C (ZhS-32) [4.]. It is obvious that the long-drawn process of exploitation, linked with the high-temperature influence of exhaust gases, causes the grain coarsening and decrease of the phase γ' content in the blade material structure (Figure 4.).

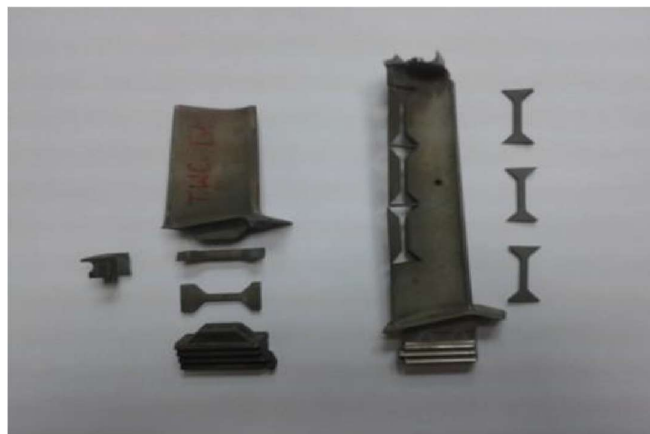
Figure 7. View of specimens cut out, by using the electro-discharge method, of a material of the LPT blade and view of specimens for static tensile testing, cut out of material of HPT blade and LPT blade.

This blade design poses serious problems in selecting a place to take the strength test specimens to properly perform the static tensile test. Therefore, taking into account the nature of the mechanical loads carried by the material of the component tested, it was assumed that the specimens for the static tensile tests will be cut along the blade feather of the LPT, i.e. in the direction of centrifugal forces, and in case of HPT from the lock material, i.e. the component subjected to the highest mass loads (Figure 7.).

A static tensile test, considered a destructive test, was carried out with the Instron 8501 Plus universal testing machine in accordance with PN-EN ISO 6892-1:2010 standard. Due to the non-standardized, small dimensions of the strength specimens obtained (Figure 7.), in order to execute the static tensile test it was necessary to design and manufacture special holders enabling proper performance of the test (Figure 9.).

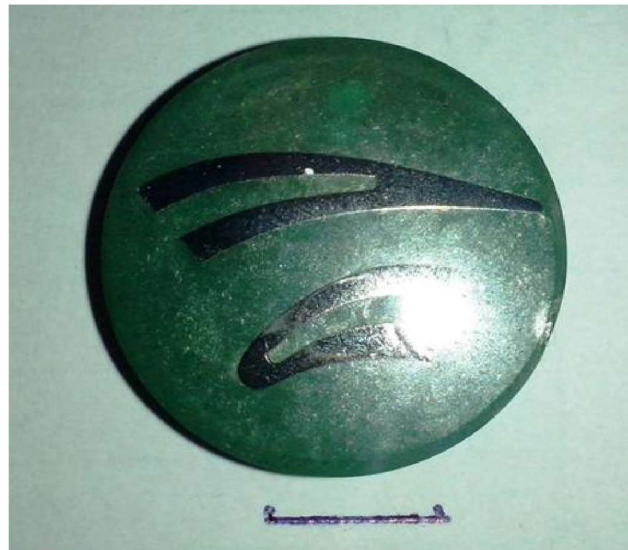
Figure 8. Metallographic specimen of material of the LPT blade.

In order to make microscopic observations to reveal the grain structure of the blade material, metallographic samples were prepared (Figure 8.) by mounting them in a conductive resin and then grinding them with abrasive papers of varying granulation in the range 100#1000, and by final polishing with a diamond slurry of polishing powder, using the Struers polishing machine.

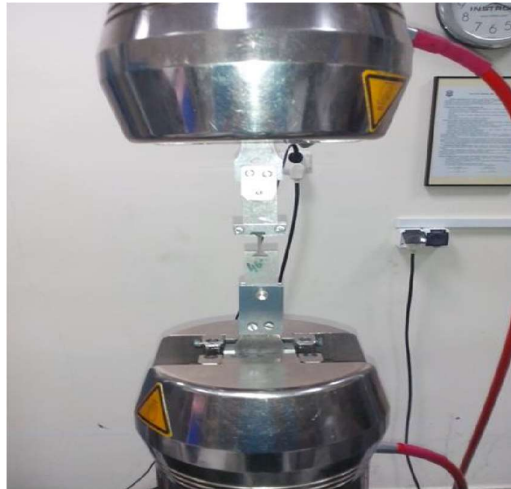
Figure 9. View of the test sample in specially designed holders.

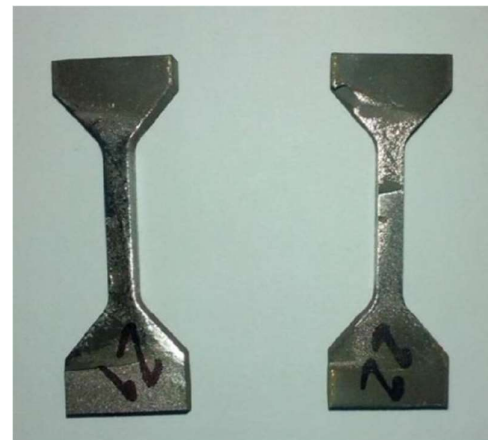
1	2	3	Average	SD	
$R_{0.2}$	643	743	650	678	55	[MPa]
R_m	851	870	899	873	24	[MPa]
E	213	219	220	217	3,8	[GPa]
A	5,3	5	10,38	6,9	3,0	[%]

Figure 18. Tensile curve of blade material (a), view of specimens before and after the tensile test (b) and determined strength parameters.

The decrease in strength properties is confirmed by the results of the static tensile test (Figure 18).

The decrease in the share of the γ 'phase in the material structure and there is growth, caused, in accordance with the Hall-Petch relationship, a decrease in the yield point from the original level of 770MPa for the ZhS-6U alloy to 678MPa of the material of the tested blade (Table 3).
