Article

A conceptual design approach for archeological structures, a challenging issue between innovation and conservation: a studied case in the ancient Pompeii

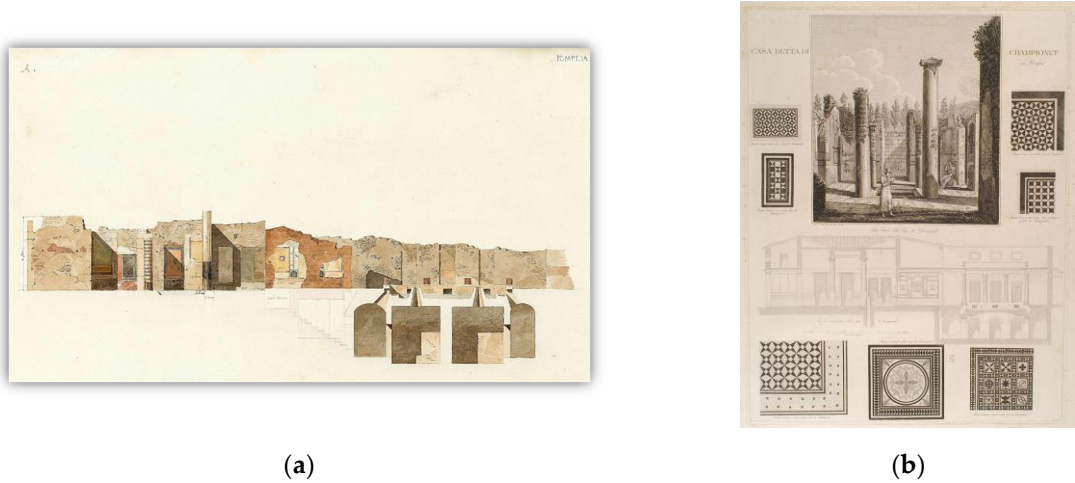
Figure 3. a) The Documentation: the domus of Championnet by Jacque Felix Duban 1887; b) The historic documents regarding Championnet houses discovery, famous for its decorative floors.

This part of the roman city has a long and complex history, that started on the 2nd century B.C. but successively have been subjected to several transformations until the 79 A.D., when the structures where covered by the volcanic materials erupted by Vesuvius. Primarily, as proposed in parag. 2 a documentation on the aggregate of houses has been collected, Figure 3 a shows some documents, in particular a picture of the area made by Felix Duban on 1887. Figure 4a presents the area before the restoration and rehabilitation works, finished on 2017 during the execution of the *Grande Progetto Pompei*, while Figure 4 b shows the new roofs in steel and corian.

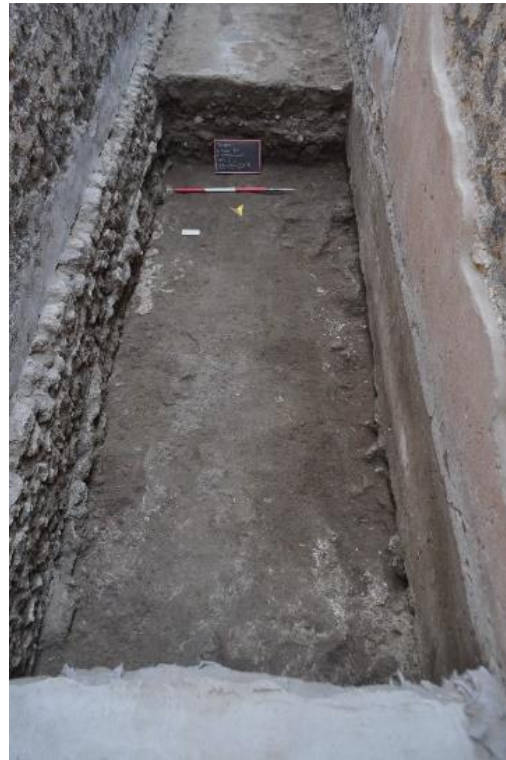
Figure 5. Foundation sample in Regio VIII.

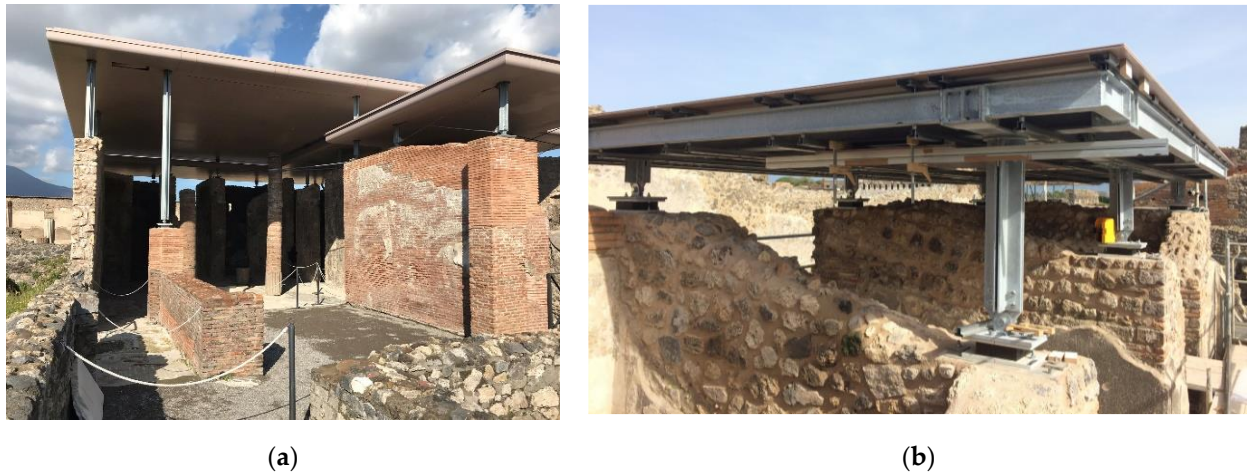
Figure 6. The new roof in the Championnet area: (a) a view of the new roof; (b) Steel structures before coating

The innovative aspects of the conceptual structural design of the rehabilitation interventions on the ancient walls and new roof construction (Figure 6) in the Championnet area can be summarized as follows. First, the testing results are herein presented in order to evidence how the test results have influenced the final design, successively, the structural design and its innovation for the archaeological environment are shown. Finally, the efficiency of the proposed solutions is discussed.

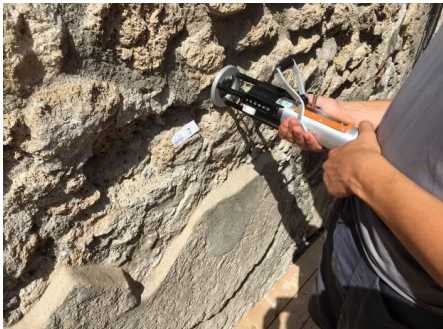
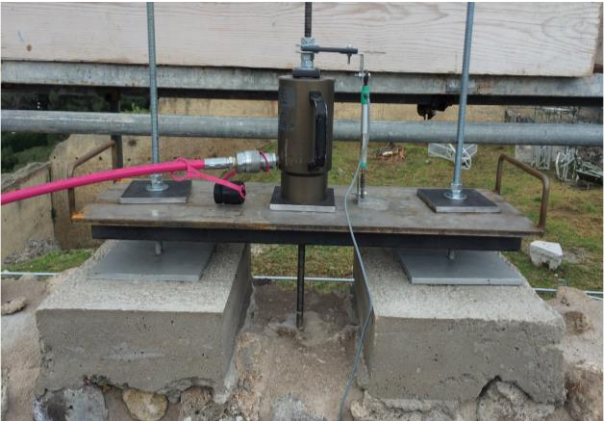
Figure 8. Tests (a) Penetration test on mortar; (b) Pull-out test on steel bar.

In order to obtain information about the efficiency of the connection steel roof (between the steel bar bolted to steel plates and the underneath walls), in particular three pull-out tests on the steel bar that connects the steel structure to the masonry walls bar have been conducted, a maximum load of 26 kN has been reached, this proves the efficiency of injection technique with fluid mortar that has been used to lock the bar of the steel roof-skeleton inside the masonry walls. Figure 8b shows the pull-out test setup.

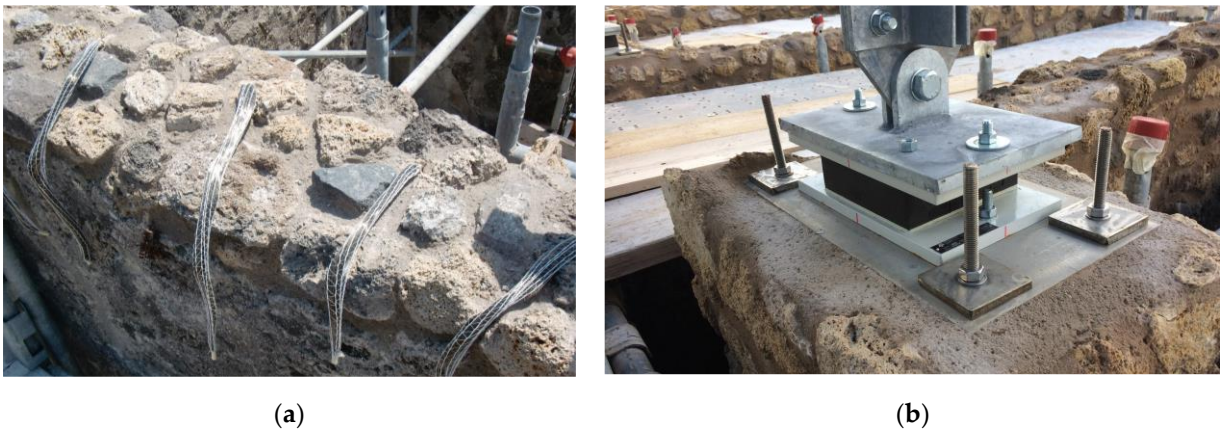
Figure 11. (a) Basalt fibre ropes in the masonry top wall. (b) The rubber support device.

The characteristics of the devices Elastofip 1.5EF 7.2 produced by Fip Industriale (Figure 11 b) are described in the following Table 4. The device is a rectangular block of rubber with the insertion of a number of horizontal steel laminated plates, vulcanized to the rubber, that increase the vertical stiffness and improve the stability under horizontal load. The bearings are designed according to European standard EN 1337-3 in which they are classified as type C bearings. The elastomer which forms the core is made of natural rubber, the reinforcing plates class S355, while the anchoring counter plates are made of class S275.

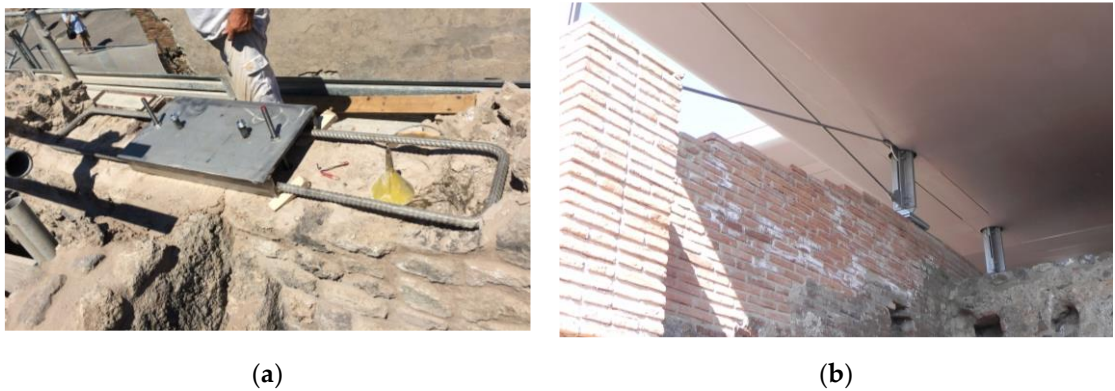
Figure 16. (a) Steel slab detail; (b) steel rob detail.

At the base of the columns the bearing device are modelled with elements having the stiffness of the Elastofip 1.5EF 7.2. The structural detailing (Figure 15, 16 and 17) is designed according to NCT2008. The masonry walls have been verified locally on the bearing according to Eurocodes and against overturning mechanisms according the limit analysis [16]. Figure 15 shows the structural design of the details, while Figure 16, 17 the structural elements on place during construction.

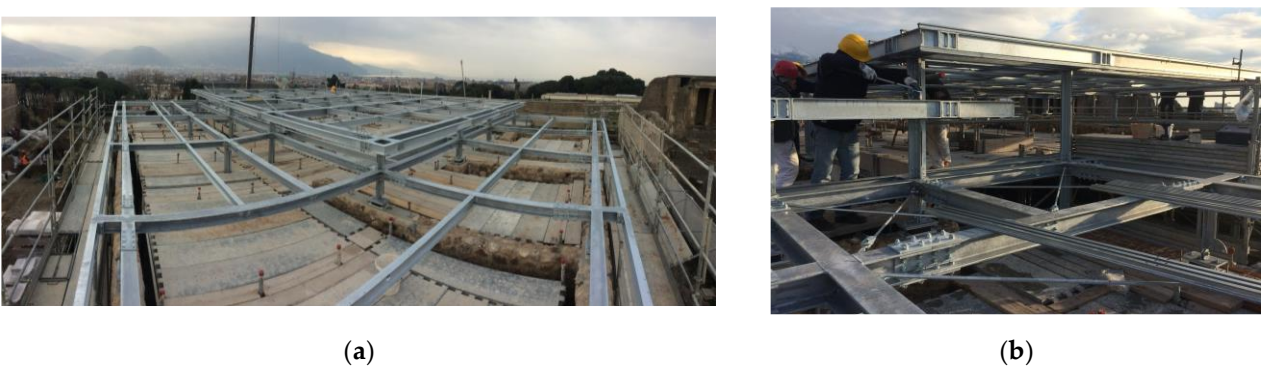
Figure 17. (a) Steel beams during structural work; (b) details under construction.
