Static and Dynamic Testing of Sei Dareh Cable-Stayed Bridge West Sumatera, Indonesia

Abstract: The Sei Dareh Bridge is a cable-stayed bridge located in West Sumatra Province, Indonesia. The bridge, has a main span of 123 meters length and 9 meters wide, crosses the Batanghari River. Traffic load is transmitted through 4 prestressed cables to a 42.4 meter high pylon made of concrete. Bridge deck and traffic loads are directly supported by steel box girders as main beams that are reinforced laterally with cross beams IWF 800.300.16.24 and stringers IWF 350.350.12.19. This paper discusses static and dynamic testing on the bridge which aims to assess the feasibility before it is opened for public. Based on the test, it was concluded that the 73% static load could not be achieved because the deflection that occurred was beyond the allowable deflection. This is exacerbated by the sound of a loud clanging sound on the ST2-X1 prestressed cable when loading to 240 tons or 58% of the targeted load. In addition, this bridge is included in the "lazy bridge" category because it takes 24 hours to return to an undeformed condition after loading. As a recommendation for this bridge, it is necessa

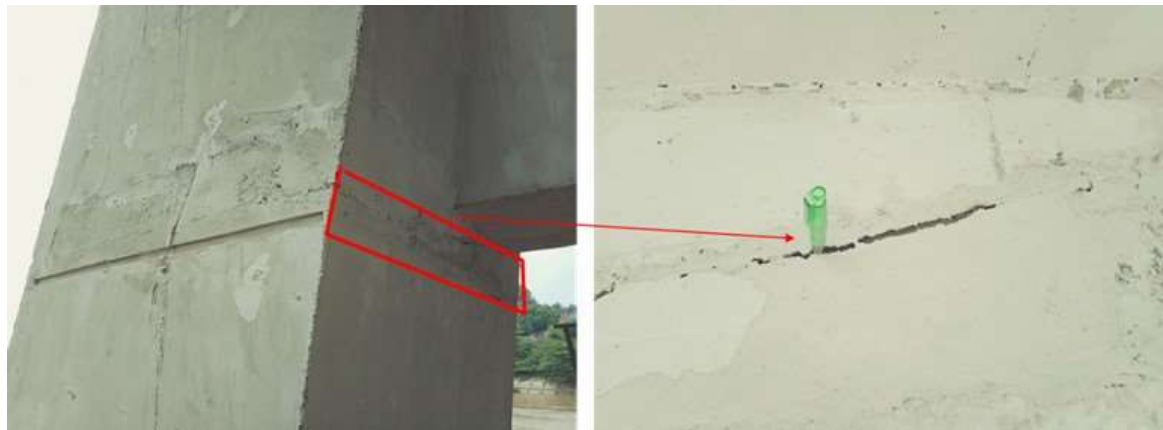
Based on the visual inspection that was carried out right before the test, it was found that all the conditions of the structural elements were in good condition, it was just that there were cracks as big as the contents of the pen on the pylon foot of the bridge as in **Figure 3**

Figure 3. Crack at pylon leg

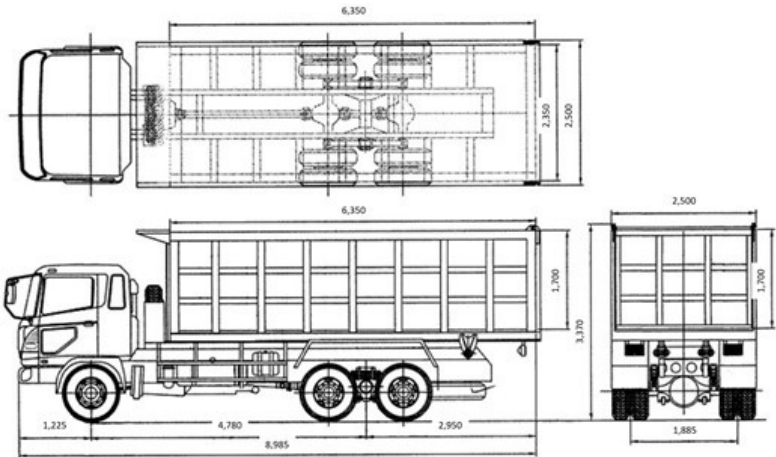
with loading stages of 60, 120, 180, 240 and 300 tons. In addition, there were also five other loading schemes that are carried out simultaneously on both spans, namely 120, 240, 360, 480, and 600 tons. The load scheme for the P1-P2 span in the static test is as shown in **Figure 5**, the same scheme is also applied to the P2-P3 spans and for other schemes, the simultaneous loading is carried out on the P1-P2 and P2-P3 spans. The dimensions and capacity of the trucks used during the test are as shown in **Figure 4**.

Figure 4. Dimension of truck loaded by sand

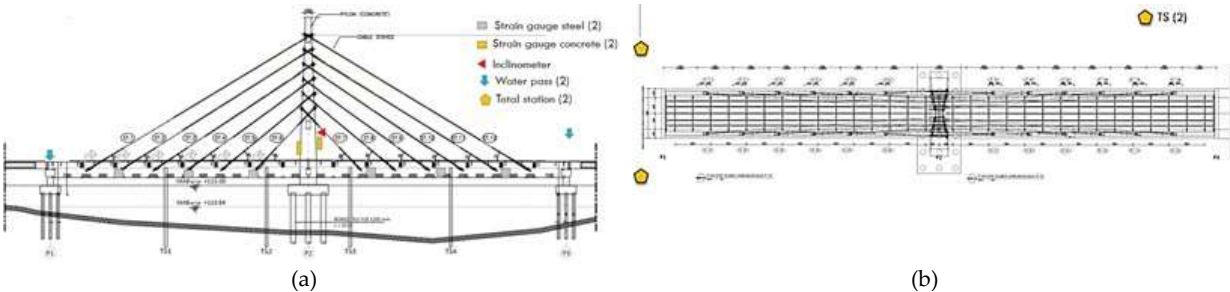
The loading is carried out in stages for both loading and unloading schemes and measuring deflection on the bridge beam using a water pass and total station (TS) measuring device. The use of the two measuring instruments simultaneously aims to mutually validate the two results. The placement of the measuring instrument during the test is shown in **Figure 6**. The execution of load test as shown like **Figure 7**.

Figure 6. (a) Placement of strain gauge, inclinometer, and waterpas; (b) Placement of total station

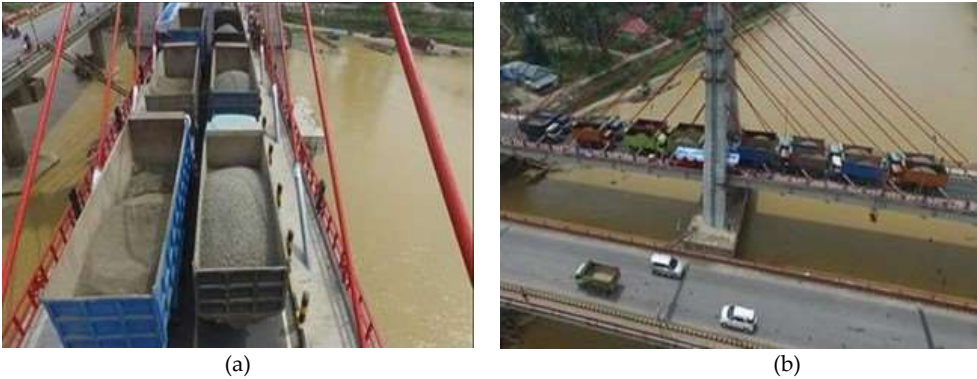
Figure 7. The execution of static load test

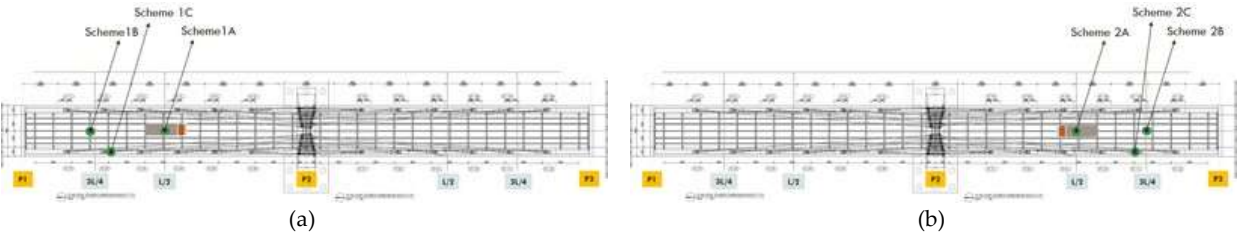
The dynamic test is carried out by giving a sudden impact through a truck moving forward from a jumper with a certain dimension. At the same time, the acceleration of the structure is measured using an accelerometer which is placed at several points. The accelerometer installation determination is based on the maximum response value obtained based on modeling in Midas Civil. The illustration of each loading scheme and placement of the accelerometer during dynamic loading is described in Table 1, Figure 8 and Figure 9.

Scheme	Load impact position	Position Accelerometer
1A	L/2 of P1-P2	L/2 of P1-P2
1B		3L/4 of P1-P2
1C		Sidewalk of P1-P2
2A	L/2 of P2-P3	L/2 P2-P3
2B		3L/4 P2-P3
2C		Trotoar P2-P3

Figure 8. (a) Schematic type 1; (b) Schematic type 2

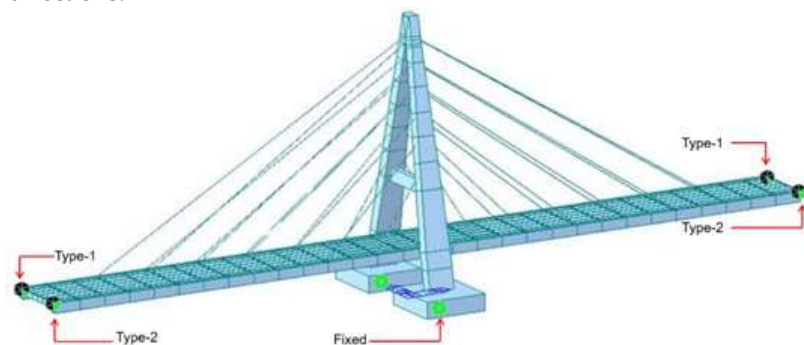
Sei Dareh Bridge needs to be modeled in 3D with a finite element model. This modeling is intended to compare the theoretical bridge behavior and the bridge behavior in the field test results. In addition, this modeling is also the basis for an inspector to estimate the placement of the measuring instrument during real testing in the field because usually the inspector will place the instrument on the bridge elements that experience the greatest internal force based on the results of 3D analysis. 3D modeling was carried out in the “Midas Civil-2011 v.2.1” program as shown in **Figure 10**.

Based on the figure, this bridge consists of three components, namely the floor structure, pylons and cables. The floor structure consisting of steel box elements, cross girders and stringers is modeled in the software as beam elements so that these elements can experience bending, shear and axial forces. The same is modeled on the pylon. Meanwhile, the cable component is modeled as a cable-pretension element so that the element can only experience axial tension and the initial tension force of the cable can be adjusted. The base of the pylon is modeled using a clamp positioning which has translation and rotation restraint in all directions. Meanwhile, the placement at both ends of the bridge girder is modeled into two types. The first type, placement has a z-axis translational restraint. The second type, placement has translational constraints in the z- and y-axis directions.

Figure 10. Finite element model of the Sei Dareh Cable Stayed Bridge

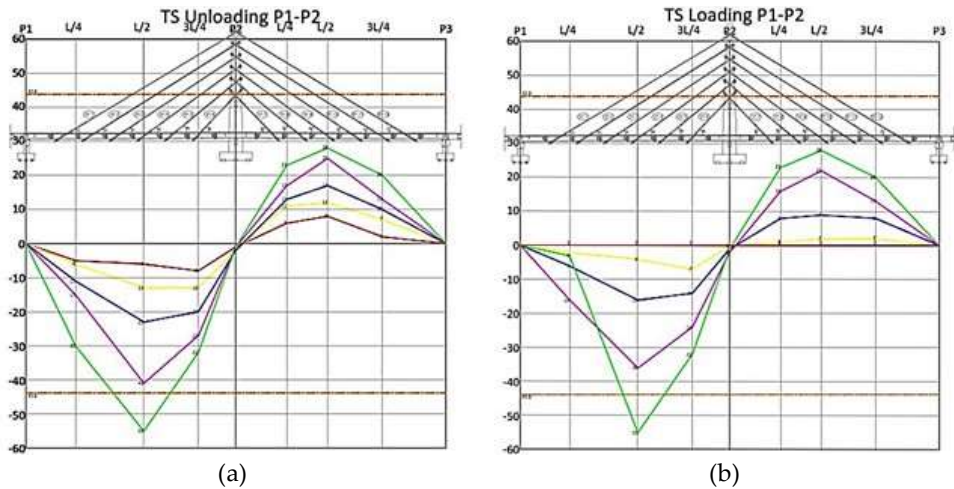
Figures 11 to 14 show the deflection that occurs in the P1-P2 and P2-P3 spans due to truck loading on the P1-P2 span and vice versa which is measured using a water pass and total station. Based on measurements, the deflection that occurs in the fifth stage of

loading with a load of 240 tons is 55 mm. That is, the deflection that occurs exceeds the allowable deflection of 44,895 mm. At the same time, there was a loud clanging sound from the ST2-X1 cable and the large vibration of the bridge. This caused the Indonesian Bridge and Road Tunnel Safety Commission decided not to continue loading up to 300 tons. In addition, it can be seen from the results of field testing that the amount of deflection at zero loading and unloading has a different value, meaning that the floor of the bridge did not return to its original position after the unloading stage where all loads had been removed. Based on field observations, the beam returned to its original state in its entirety after 24 hours so that this bridge is called a "lazy bridge".

Figure 11. Graph of deflection measurement with total station when ; a) loading and b) unloading span P1-P2

- The results of the static test were stopped at loads that were lower than planned, namely 240 tons from 300 tons and 480 tons from 600 tons due to deflection that was greater than permitted.
- Several dynamic tests show consistent natural frequency results, namely $f = 1.18$ Hz for the first peak and $f = 1.88$ Hz for the second peak.
- The dynamic tests carried out on the P1-P2 and P2-P3 spans also provide the same frequency for the two symmetrical spans.
- The results of the analysis give a natural frequency of $f = 1.186444$ Hz while the test gives a natural frequency of $f = 1.18$ Hz. This shows that the structural model with Midas is in accordance with the measurement results in the field.
- Furthermore, on this bridge it is recommended to carry out continuous monitoring to measure deformation and stress at critical points.

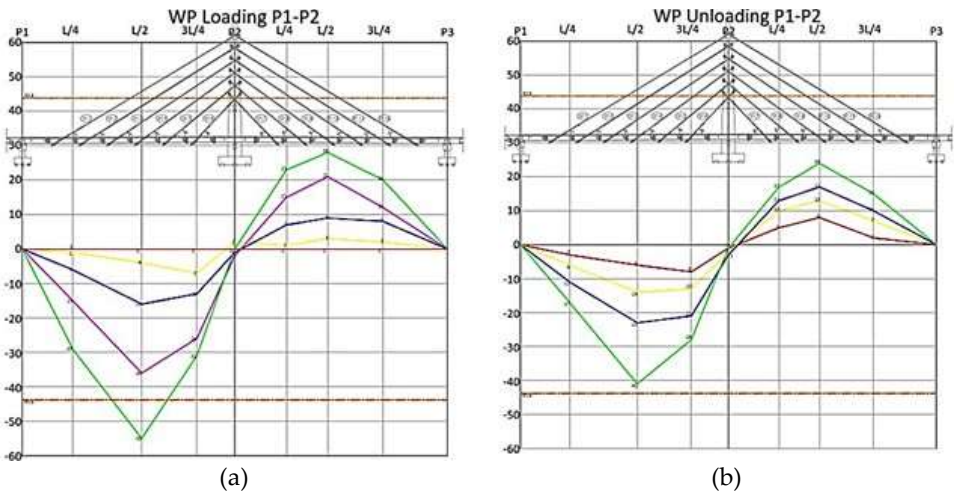
Figure 12. Graph of deflection measurement with waterpass when ; a) loading and b) unloading span P1-P2

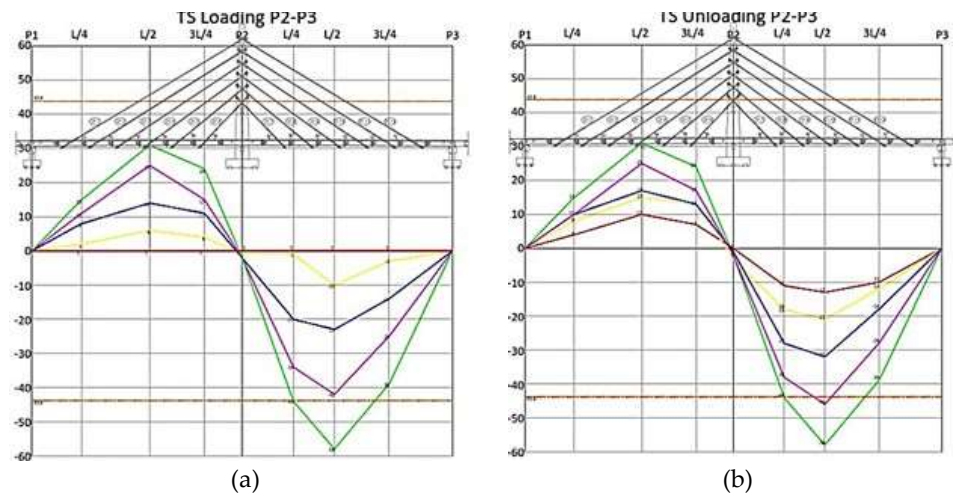
Figure 13. Graph of deflection measurement with total station when ; a) loading and b) unloading span P2-P3

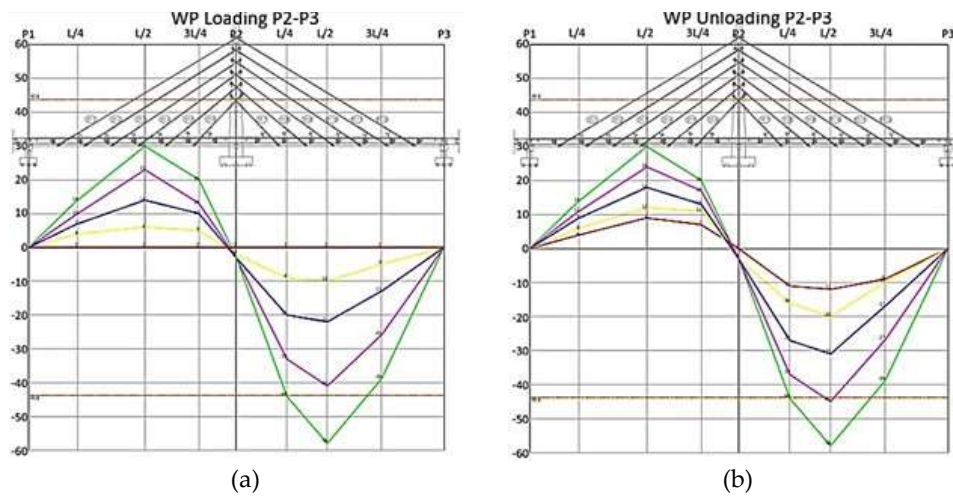
Figure 14. Graph of deflection measurement with waterpass when ; a) loading and b) unloading span P2-P3

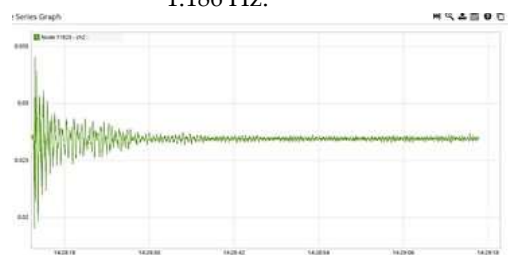
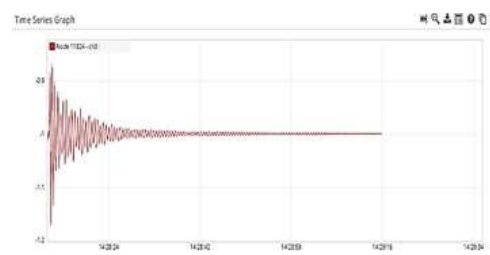
Among the results obtained from dynamic testing is a graph of the acceleration versus time (time series) as shown in **Figure 14** which is converted into the frequency domain with fast fourier transform (FFT) as shown in **Figure 15**. Based on one of these measurement results it is known that the natural frequency of the structure is 1.18 Hz. Furthermore, the dynamic test results are compared with the theoretical frequency of the 3D modeling results as shown in **Figure 16**. Based on these comparisons it can be concluded that the structural model made in Midas Civil is in accordance with the results of tests carried out in the field with the natural frequency value in the first mode, namely 1.186 Hz.

Figure 15. Graph of time series, a) transverse 1A; b) transverse 1B; c) transverse 1C; d) transverse 2A; e) transverse 2B; f) transverse 2C

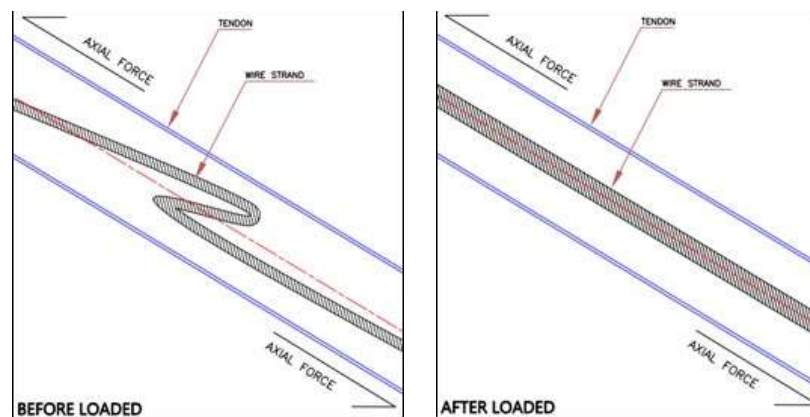
As in the previous description, it is known that during the loading of the 240-ton truck, a loud clanging sound was heard. Based on field observations, the sound comes from the stay cable. This sound is caused by an imperfect pulling of the strand during the construction period which causes the cable to stay in the tendon to fold. When the bridge is loaded, the strand is stretched so that what was originally folded straight back. The following is an illustration of this phenomenon as in **Figure 18** below.

Figure 18. Condition of the strand before and after loaded by 240 ton truck
