Understanding Corrosion Morphology of Duplex Stainless Steel Wire in Chloride Electrolyte

Abstract

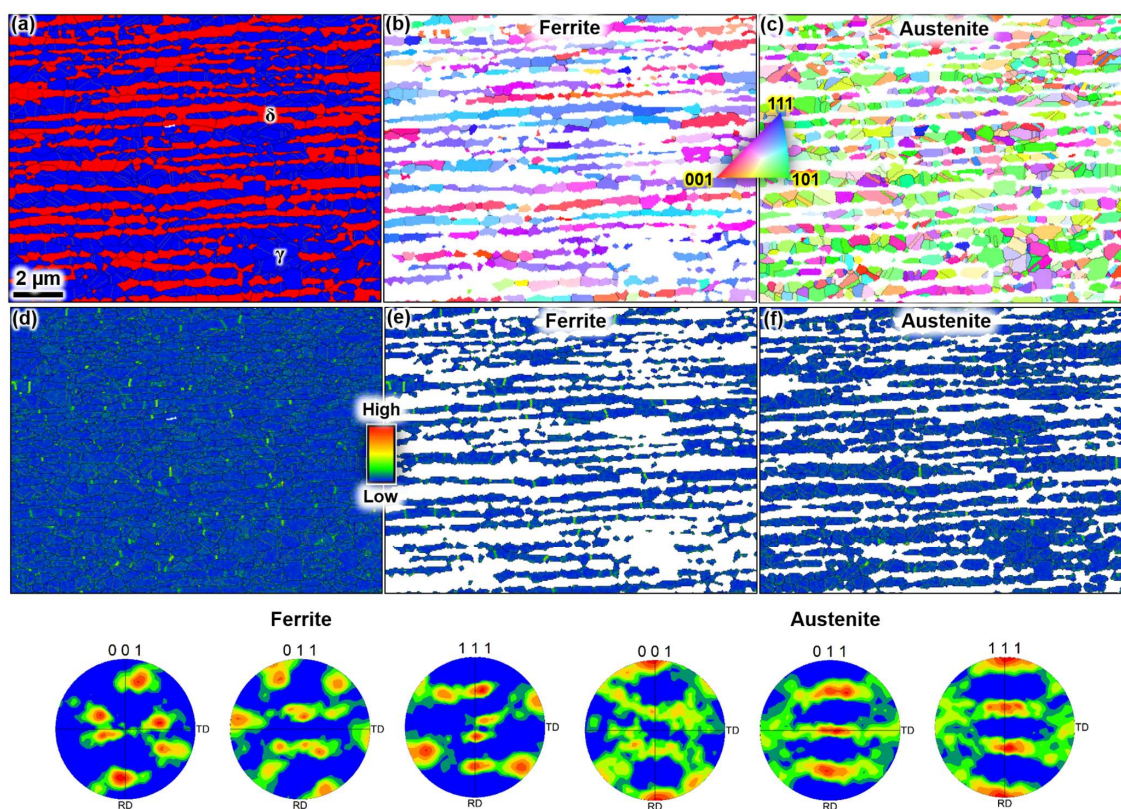
Figure 1: EBSD analysis results showing (a) the phase distribution of ferrite (red) and austenite (blue) grains, (b) the grain orientations (IPF map) for the ferrite phase, (c) the grain orientations (IPF map) for the austenite phase, (d) local misorientation distribution (Kernel average) of the entire microstructure and (e) for the ferrite phase and (f) for the austenite phase. The pole figures in the bottom show crystallographic texture of ferrite and austenite grains with the colour contours showing the strength of the texture.

Microstructure – The wire duplex microstructure consisted of an approximate ratio of 50:50 ferrite and austenite, with an averaged grain size of 1 μm (**Figure 1**). Extensive local misorientation hot spots were detected on the grain and phase boundaries. The ferrite and austenite grains were elongated along the rolling direction. The pole figures and IPF maps in **Figure 1** reveal that the main texture components are (111) // normal direction (ND) for the ferrite phase; and (011) // ND for the austenite phase. Those crystallographic textures are typical for deformed and recrystallized face-centred cubic (FCC) and body-centred cubic (BCC) materials. Residual deformation strains existed in both phases, as indicated by the Kernel average misorientation (KAM) maps.

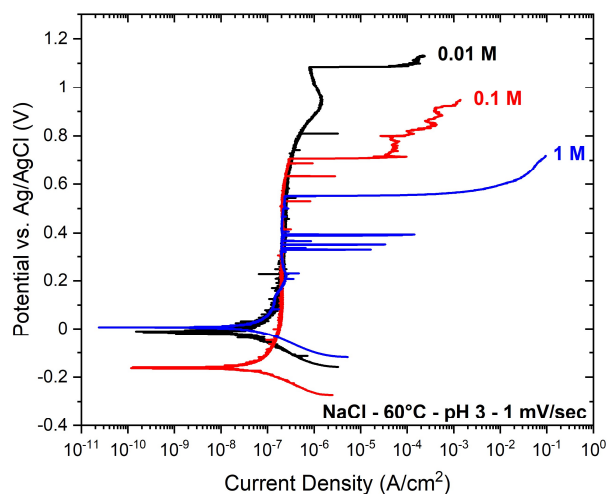
Figure 2: Potentiodynamic polarisation (1 mV/sec) in NaCl solutions at pH 3 and 60°C.

Polarisation behaviour – The electrochemical polarisation results performed in 0.01 M, 0.1 M, and 1 M NaCl solutions at pH 3 and 60°C are summarised in **Figure 2**. The passive film's local breakdown potential at 1 M, 0.1 M and 0.01 M solutions was 550 ± 25 mV, 700 ± 25 mV, 1100 ± 25 mV, respectively. The breakdown was facilitated by increasing chloride concentration in line with other reports [2, 29, 47-49]. In all conditions, the steel was spontaneously passive with passive corrosion currents of $\sim 10^{-7}$ A/cm². Grade 2205 duplex stainless steel is immune to pitting at room temperature and only suffers from pitting corrosion above the critical pitting temperature which is 40°C [50]. Next, the steel was polarised at 900 mV vs Ag/AgCl under potentiostatic control in the respective chloride solutions. The results are summarised in **Figure 3**. The currents in 0.01 M and 0.1 M chloride solutions were similar on the order of $\sim 5 \cdot 10^{-2}$ A/cm², whereas, in 1 M electrolyte, the current was two orders of magnitude higher on the order of ~ 0.5 A/cm². In all cases, the currents rapidly rose, reaching high values, resulting in localised corrosion.

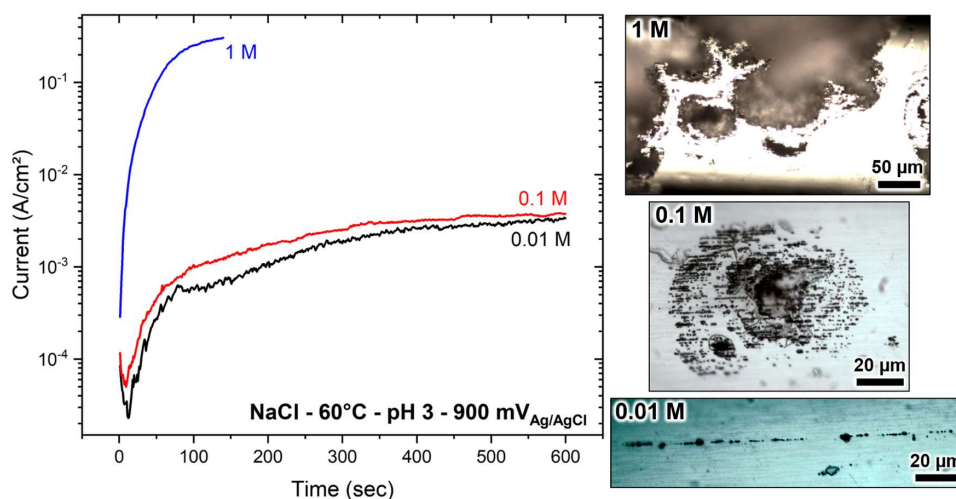
Figure 3: Potentiostatic polarisation in NaCl solutions at 60°C, pH 3, and 900 mV vs. Ag/AgCl. The micrographs show the representative corrosion morphology after the polarisation measurement.

Corrosion morphology – The corrosion morphologies were characterised under an optical microscope, depicted in **Figure 3**. From a macroscopic point of view, two distinctive corrosion forms were observed; (i) selective corrosion of the ferrite phase and (ii) large pit formation with perforated covers. The steel formed lacy cover pits in 0.1 M and 1 M solutions, whereas the ferrite's preferential breakdown was seen in 0.01 M chloride solution, with the austenite remaining mainly passive. The large corrosion pits were far more extensive and progressed to bigger sizes in 1 M NaCl than in 0.1 M NaCl solution. The lacy cover pits were in dimensions on the order of 100-300 μm in diameter. The pit covers in 1 M solution mainly were damaged, but those formed in 0.1 M electrolyte remained primarily intact. The pit dissolution kinetics were more rapid in 1 M solution, leading to metal dissolution with high volumes, apparent from the larger cavity sizes.

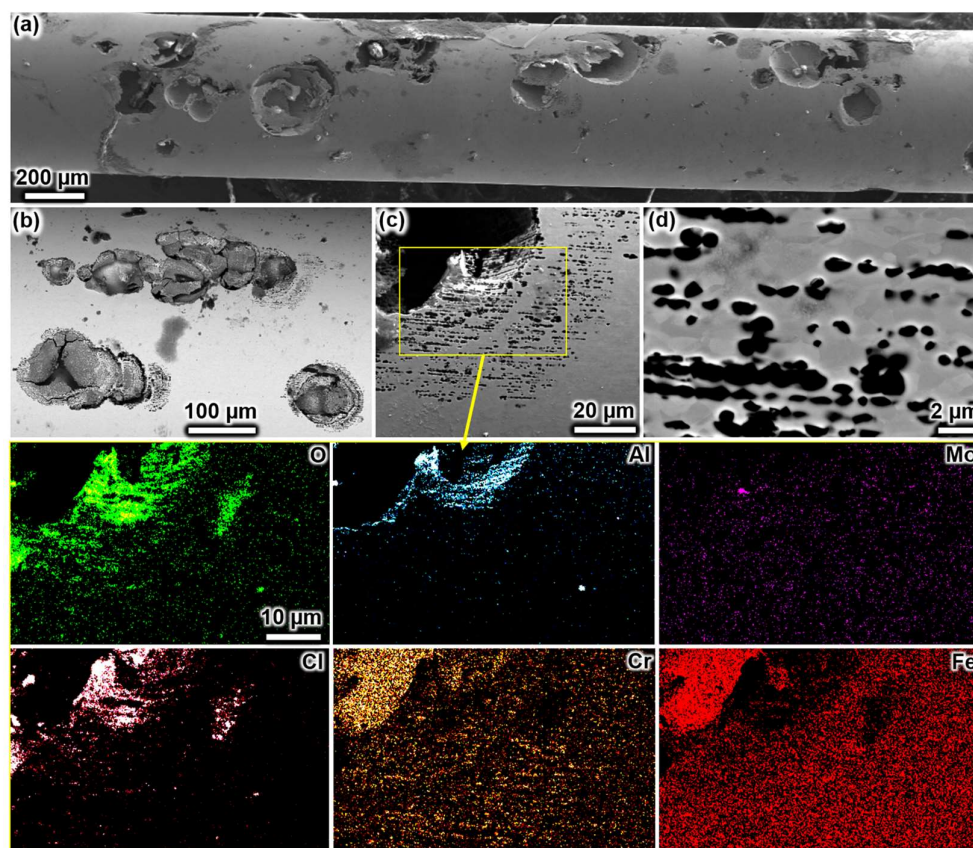
Figure 4: SEM images showing the corrosion morphology after potentiostatic polarisation in 1 M NaCl at 900 mV vs. Ag/AgCl at pH 3 and 60°C (see **Figure 3**). The sample underwent extensive pitting corrosion. The micrograph in (a) shows numerous corrosion pits with partially collapsed lacy covers (SE image), (b) a magnified view (BSE image), (c) a zoomed view near the pit mouth on a perforated cover remnant, (d) magnified view of the perforated cover. The chemical maps depict the detected elements in the highlighted region in (c).

The corrosion morphology after anodic polarisation in 1 M NaCl solution is shown in **Figure 4**. Discrete large corrosion pits with partially destroyed perforated metal covers (**Figure 4a**), having cracks on the pit cover, were seen (**Figure 4b**). EDX mapping was performed over a cover remnant near the pit mouth (**Figure 4c**), which revealed intense aluminium and oxygen signals. Aluminium is an impurity element originating from metallurgical purification processes and is present with silicon in the form of oxide inclusions [56]. It seems that aluminium in the inclusions preferentially oxidised and formed thick anodic oxides on the cover surface. Interestingly, dissolved aluminium seemed to redeposit on the pit cover. Seemingly, the surface anodic oxides' thickness and composition over the pit cover differed over the entire pit area. The perforation occurred in discrete grains without, however, resulting in the dissolution of an entire grain (**Figure 4c**). The perforation occurred on both ferrite and austenite grains but seemingly was influenced by the grain alignment along the rolling direction. Our results do not entirely confirm *Eguchi et al.*, who reported pit cover perforation associated with the dissolution of whole ferritic grains of lean 2202 duplex stainless steel [44]. Our interpretation of the SEM micrographs provided in their work is that the corrosion (perforation) occurred on partial grains instead of entire grains, being in line with our observations. In line with *Eguchi et al.* [44], our work shows that the pitting in duplex stainless steel has an undercutting nature independent of the grain size.

The pits in **Figure 4** were on the order of 100 µm in diameter. We assumed hemispherical pit morphology and calculated the loss of metal by considering a pit radius of 50 µm. Hence, the metal loss associated with a pit with 100 µm diameter is 2 ng. With Faraday's law, the liberated charge was 155 mC, and with 140 sec of potentiostatic control, the electrochemical current was 1.11 mA. Hydrogen evolution in acidic electrolyte occurs via a two-electron transfer. However, monatomic hydrogen is produced first by which adsorbed hydrogen atoms are formed. Approximately 99% of all hydrogen formed dissipates as hydrogen gas, but ≈1% can enter the microstructure. So, the amount produced per liberated charge ($n = 2.19$) is about 4 mM which corresponds to 400 ppm. Thus, nearly 4 ppm of atomic hydrogen entered the microstructure, causing hydrogen embrittlement to occur. It has been reported that 0.7 ppm is sufficient to

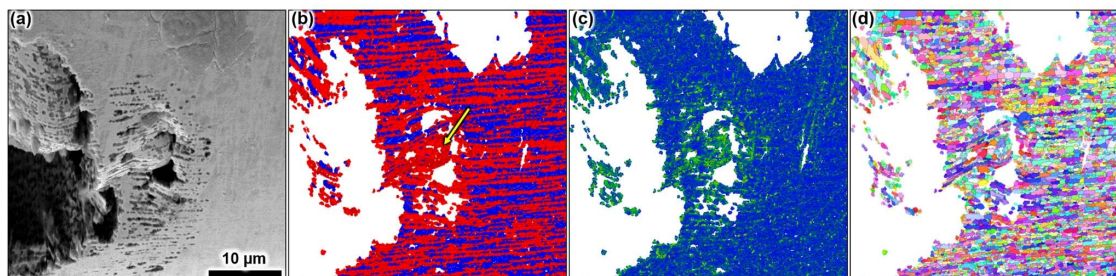
Figure 5: SEM/EBSD analysis over a corrosion pit that formed after potentiostatic polarisation at 900 mV vs. Ag/AgCl in 1 M NaCl solution at pH 3 and 60°C. The pit shows a partially-collapsed perforated lacy cover. The micrograph in (a) is BSE image, (b) the corresponding EBSD phase map with ferrite (red) and austenite (blue), (c) the corresponding local misorientation map showing strain localisation (green), and (d) shows the corresponding grain orientations. The scale bar in (a) applies to all images.

Figure 5a shows a corrosion pit (developed in 1 M solution) with a lacy cover having collapsed partially. We analysed this region with EBSD (**Figure 5b-d**). The local misorientation map in **Figure 5c** highlights strain localisation formed on the perforated cover indicating plasticity involved in the cover's collapse (green colour code in **Figure 5c**). The phase map in **Figure 5b** shows a high density of grain boundaries, indicating heavy local plastic deformation. The phase

map further indicates a large portion of ferrite around the collapsed region as pointed by the arrow in **Figure 5b**, which is unusual for the studied wire microstructure.

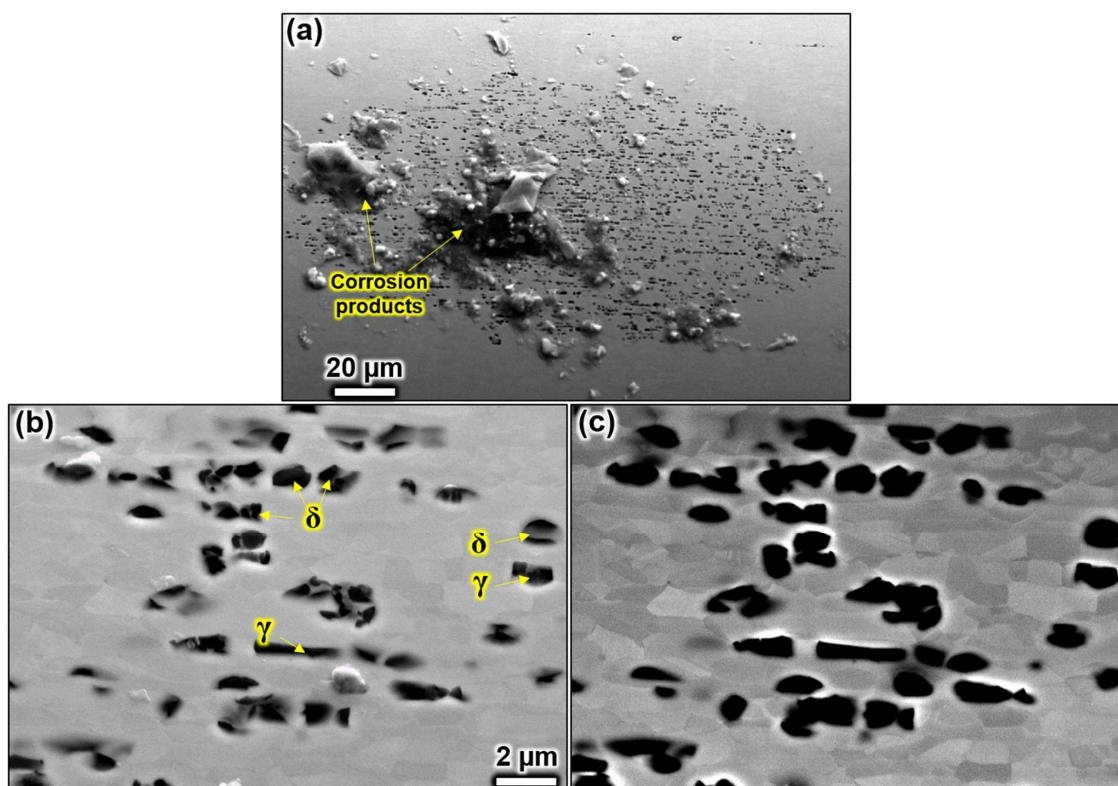
Figure 6: SEM analysis after potentiostatic polarisation in 0.1 M NaCl solution at 900 mV vs. Ag/AgCl at pH 3 and 60°C. The SE image in (a) shows a perforated pit with a non-collapsed pit cover. The SE image in (b) provides a magnified view on the perforation. The image in (c) shows the same region with BSE signals. The perforation occurred on grains of both phases by a partial attack. The scale bar in (b) also applies to (c).

Figure 6a shows a lacy cover pit observed after polarisation in 0.1 M NaCl solution. None of the pit covers collapsed and showed numerous perforations. As observed in the 1 M solution, the holes were not associated with any phase and evolved seemingly in a more stochastic manner on ferrite and austenite grains. Interestingly, the corrosion occurred on sub-grains and showed perforation sites smaller than the average grain size in both phases (**Figure 6b,c**). It remained unclear why some parts of grains remained passive during the pit evolution. Grains from the ferrite and the austenite phase showed similar behaviour. It seems that the corrosion chemistry was aggressive so that no selective dissolution of any phase occurred. Pit cover formation is, however, influenced by the grain alignment as seen in corrosion in 1 M NaCl electrolyte.

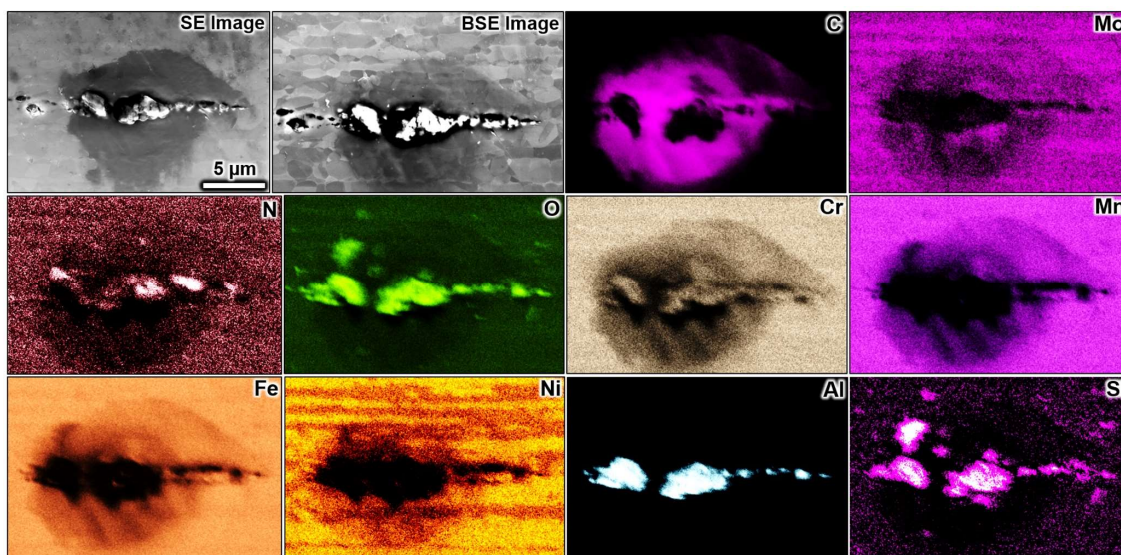
Figure 7: SEM and EDX analysis over a selectively corroded region after potentiostatic polarisation in **0.01 M** NaCl at 900 mV vs. Ag/AgCl at pH 3 and 60°C. The ferrite phase underwent selective corrosion. Corrosion products (Al-Si-N-O) were formed along the corroded ferrite grains indicating selective dissolution of Al, Si, and N. Some minor undercutting dissolution are also seen showing less signals for Fe, Cr, Ni, and Mo. The rolling direction is directed to the horizontal axis of the images. The scale bar in the SE image applies to all images.

Figure 7 and **Figure 8** summarise SEM and EDX analyses performed over the specimen after polarisation in 0.01 M NaCl solution. Here, no macroscopic pit cavity occurred, and only selective corrosion of the ferrite phase was observed, which progressed along the processing direction along the wire. The preferential dissolution front often spanned over the entire exposed wire surface with multiple initiation sites, with numerous densely-arrayed pits forming the corrosion front of selective corrosion. The ferrite's selective dissolution in grade 2205

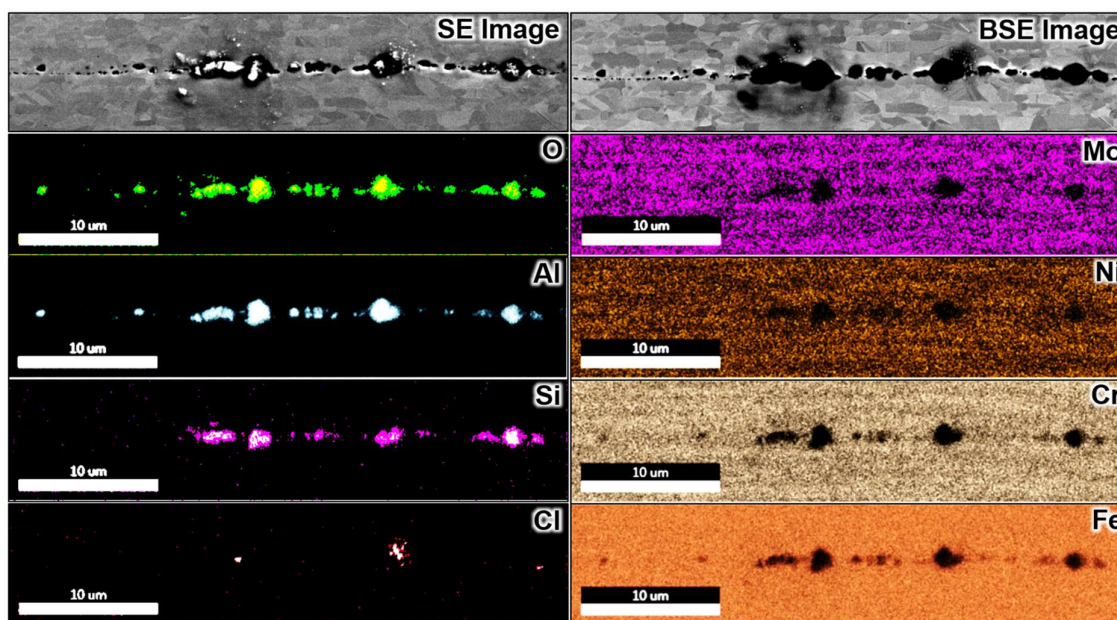
Figure 8: SEM and EDX analysis over a selectively corroded region after potentiostatic polarisation in **0.01 M** NaCl at 900 mV vs. Ag/AgCl at pH 3 and 60°C. The images show that selective corrosion of the ferrite phase proceeded by the initiation of individual corrosion pits along the rolling direction (horizontal axis of the images). The scale bar in the chemical maps also apply to the SEM images.
