Microfactory for valorization of e-waste plastics (acrylonitrile-butadiene-styrene, polycarbonate, and polypropylene) on additive manufacturing sector

Alejandro Moure Abelenda ^{1,*} and Farid Aiouache ^{1,*}

School of Engineering, Lancaster University, Lancaster, LA1 4YW

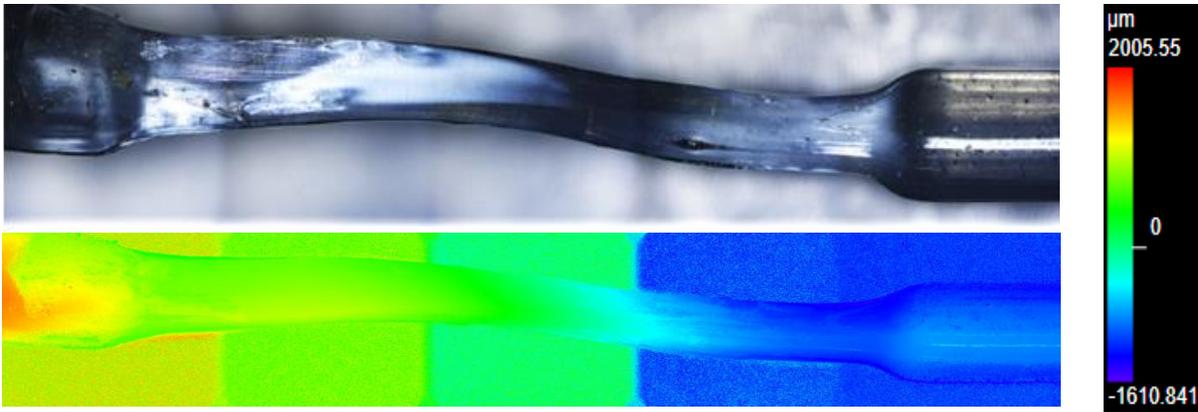
Figure S1. Laser microscope (x10) of the neck formation in the PP filament during the tensile test.

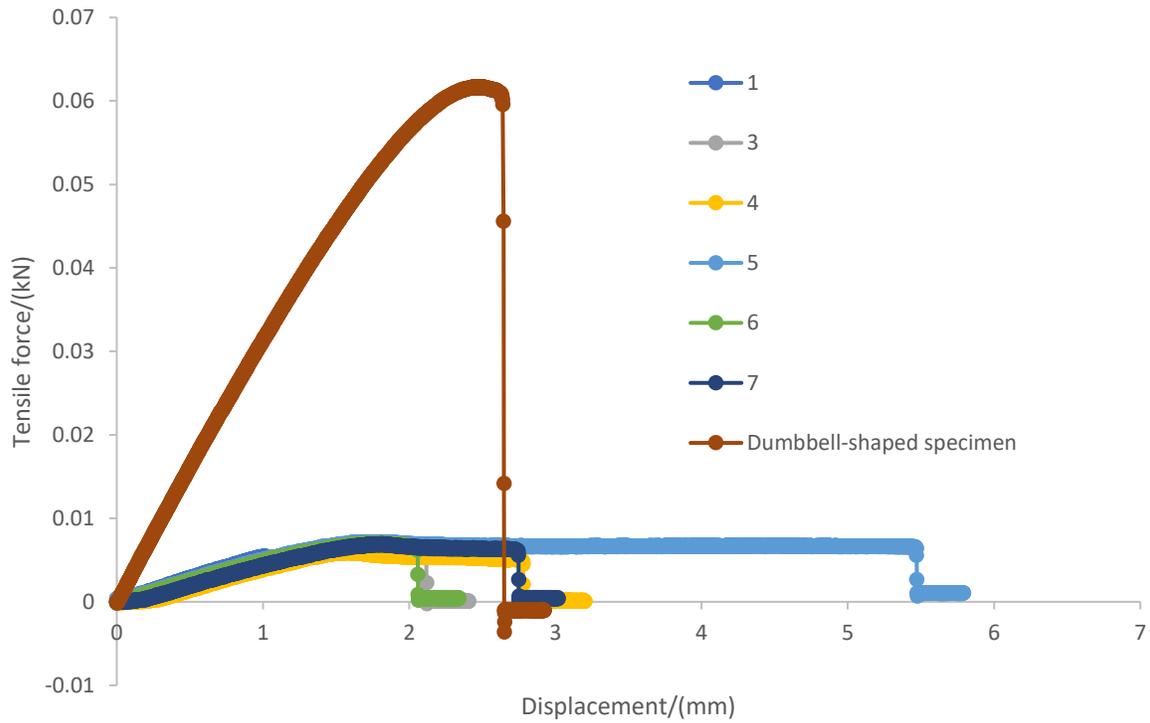
Figure S2. Profile tensile force vs extension of the white ABS filament and the dumbbell shaped specimen prepared following the British Standard EN ISO 527-2:2012 (test conditions for molding and extrusion).

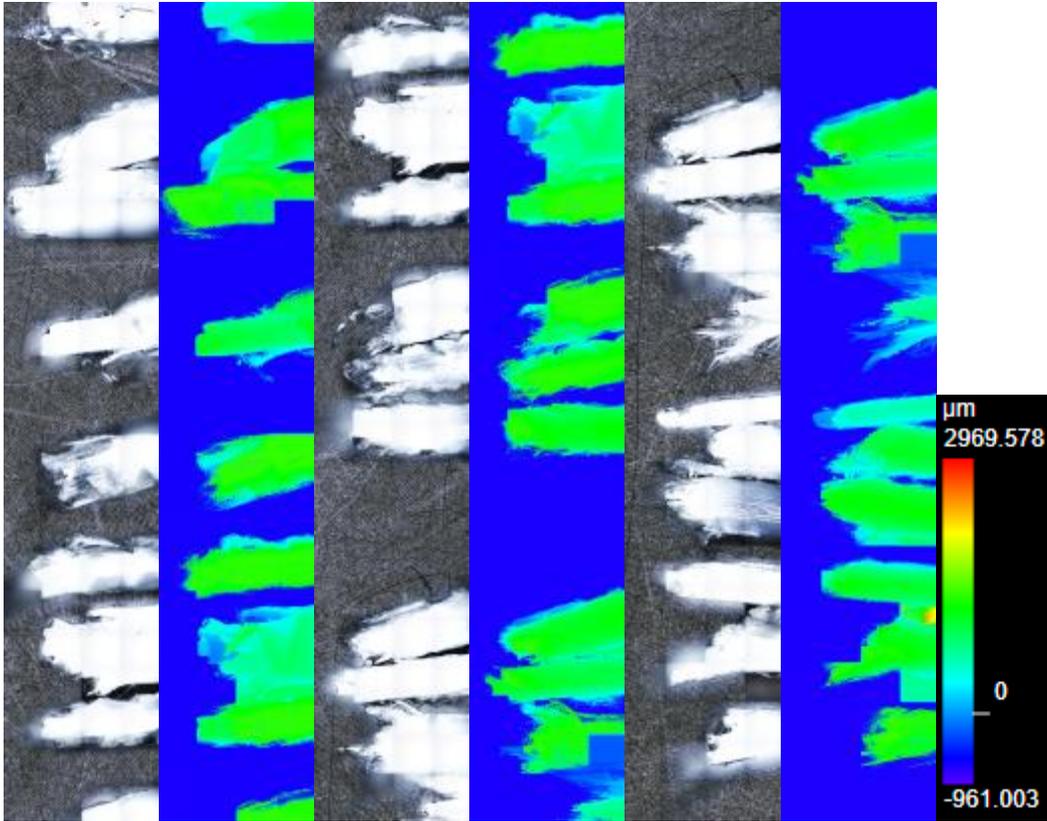
Figure S3. Lose threads that can be seen in the filament made of 50 % virgin HDPE and 50 % virgin ABS upon rupture in the tensile testing.

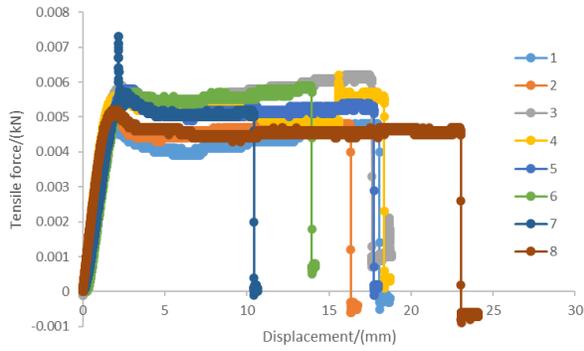
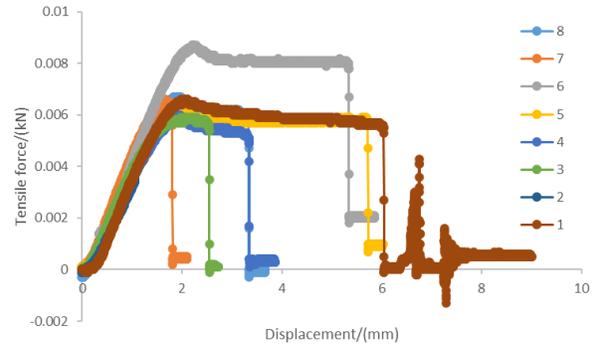
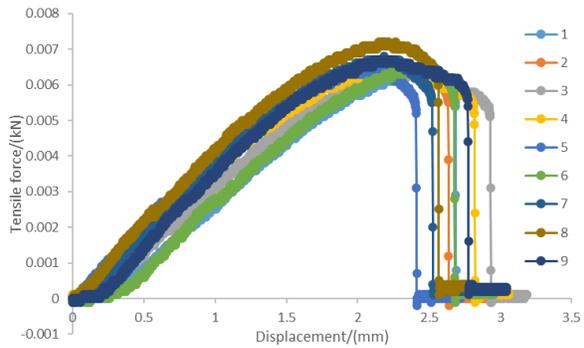
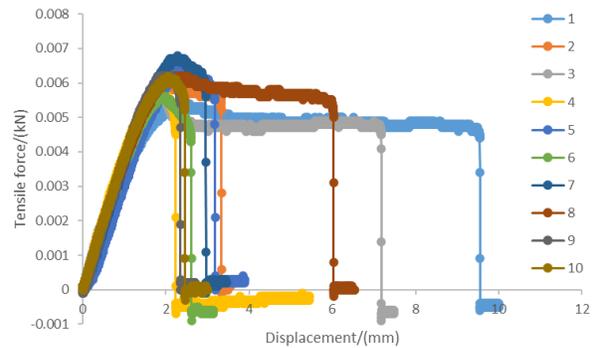
Figure S4. Tensile testing profiles for: (a) Commercial black ABS (8 replicates), (b) acetone smoothen white ABS (8 replicates), (c) virgin ABS (9 replicates), and (d) 10% white ABS + 90 % virgin ABS (10 replicates).

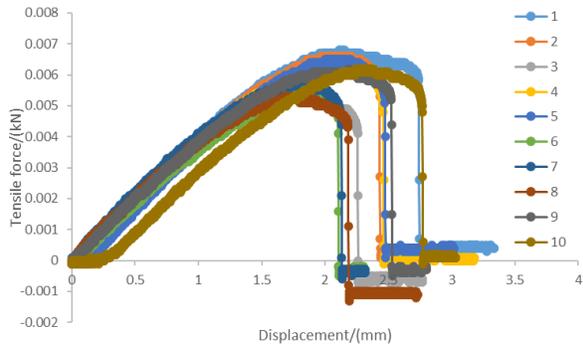
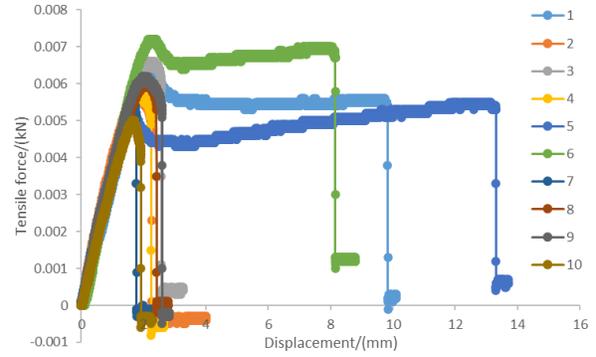
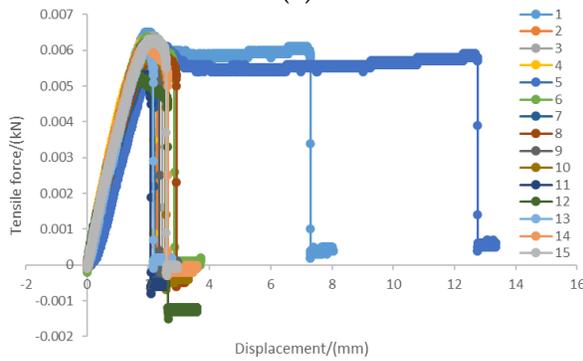
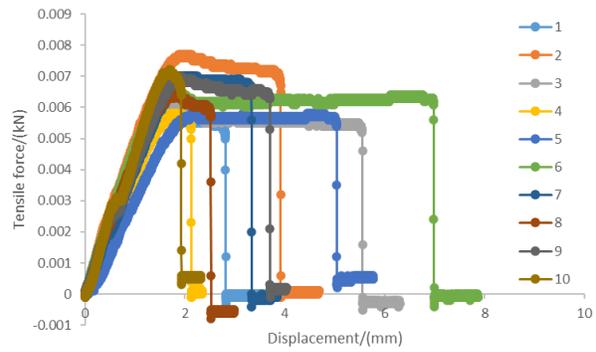
Figure S5. Tensile testing profiles for: (a) 18 % white ABS + 82 % virgin ABS (10 replicates), (b) 35 % white ABS + 65 % virgin ABS (10 replicates), (c) 40 % white ABS + 60 % virgin ABS (15 replicates), and (d) 70 % white ABS + 30 % virgin ABS (10 replicates).

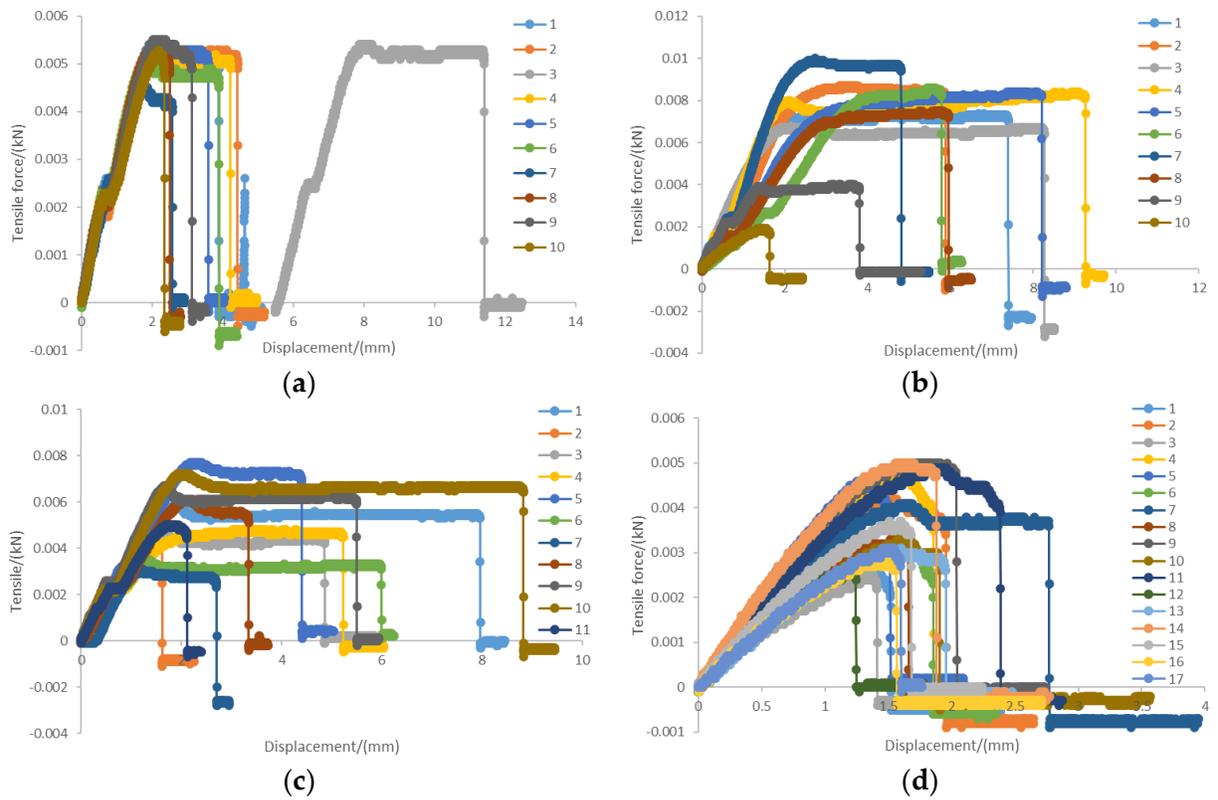
Figure S6. Tensile testing profiles for: (a) 90 % white ABS + 10 % virgin ABS (10 replicates), (b) clogging ABS (10 replicates), (c) 50 % white ABS + 50 % black ABS (11 replicates), and (d) 50 % ABS+PC + 50 % black ABS (17 replicates).

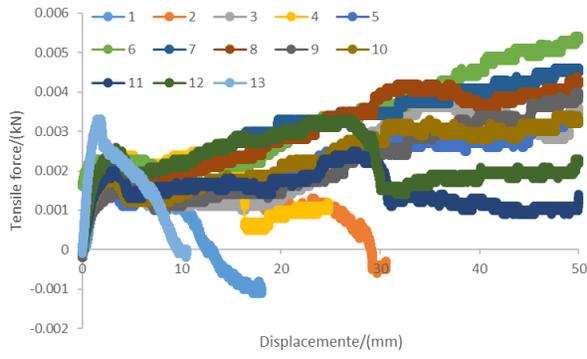
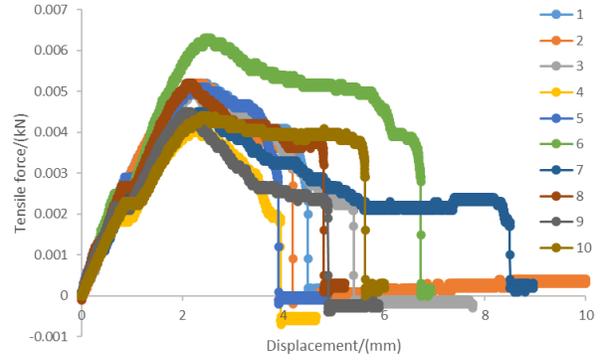
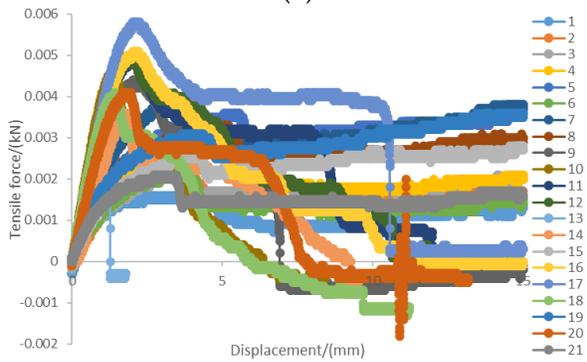
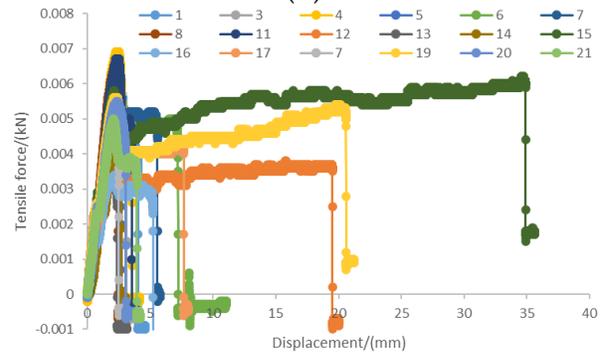
Figure S7. Tensile testing profiles for: (a) 50 % black ABS + 50 % HDPE (13 replicates), (b) 50 % virgin ABS + 50 % HDPE (10 replicates), (c) 50 % PP + 50 % PLA (21 replicates), and (d) 10 % PP + 90 % PLA (21 replicates).

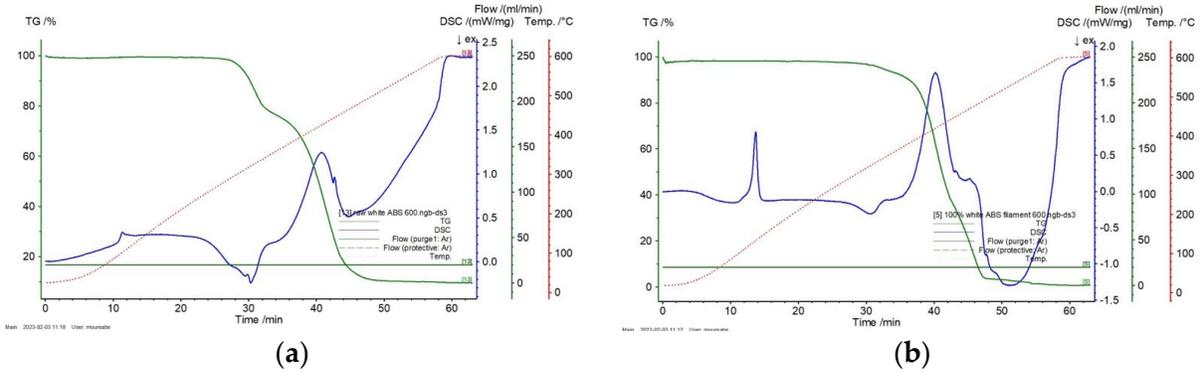
Figure S8. Thermogravimetric analysis (green line) and differencing scanning calorimetry (blue line) performed up to 600 °C (red line) for the white ABS: (a) unprocessed waste and (b) the 1.75-mm filament obtained with the melt-blend extrusion.

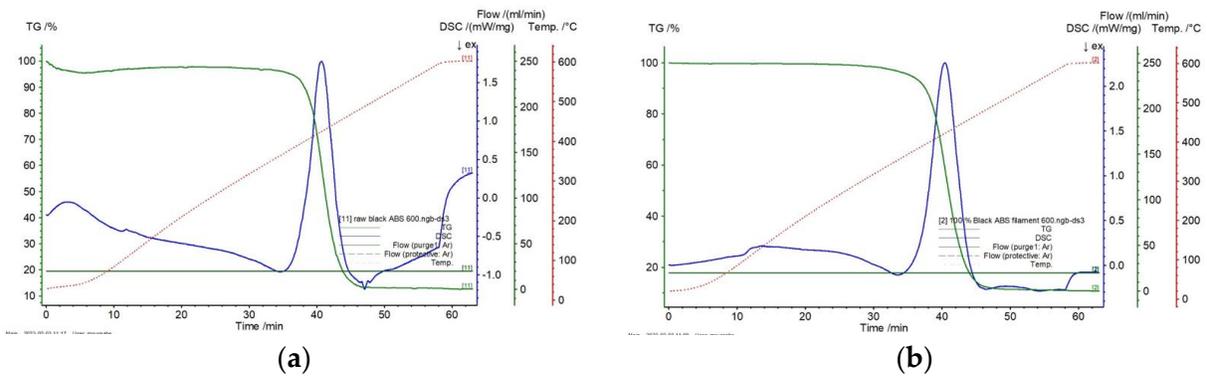
Figure S9. Thermogravimetric analysis (green line) and differencing scanning calorimetry (blue line) performed up to 600 °C (red line) for the black ABS: (a) unprocessed waste and (b) the 1.75-mm filament obtained with the melt-blend extrusion.

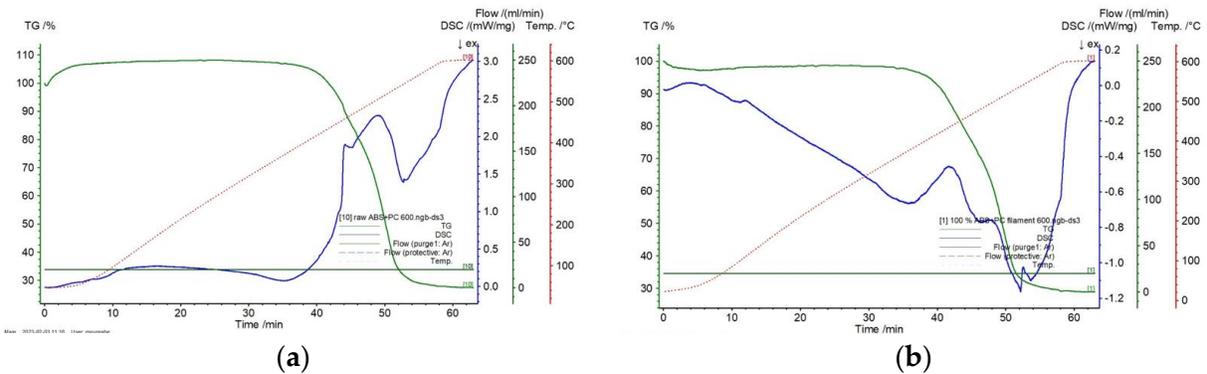
Figure S10. Thermogravimetric analysis (green line) and differencing scanning calorimetry (blue line) performed up to 600 °C (red line) for the ABS+PC: (a) unprocessed waste and in (b) the 1.75-mm filament obtained with the melt-blend extrusion.

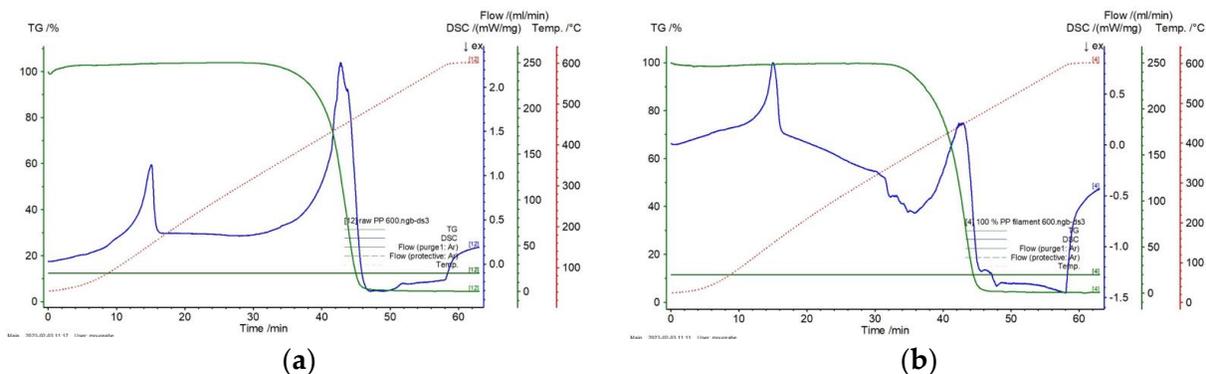
Figure S11. Thermogravimetric analysis (green line) and differencing scanning calorimetry (blue line) performed up to 600 °C (red line) for the PP: (a) unprocessed waste and in (b) the 1.75-mm filament obtained with the melt-blend extrusion.

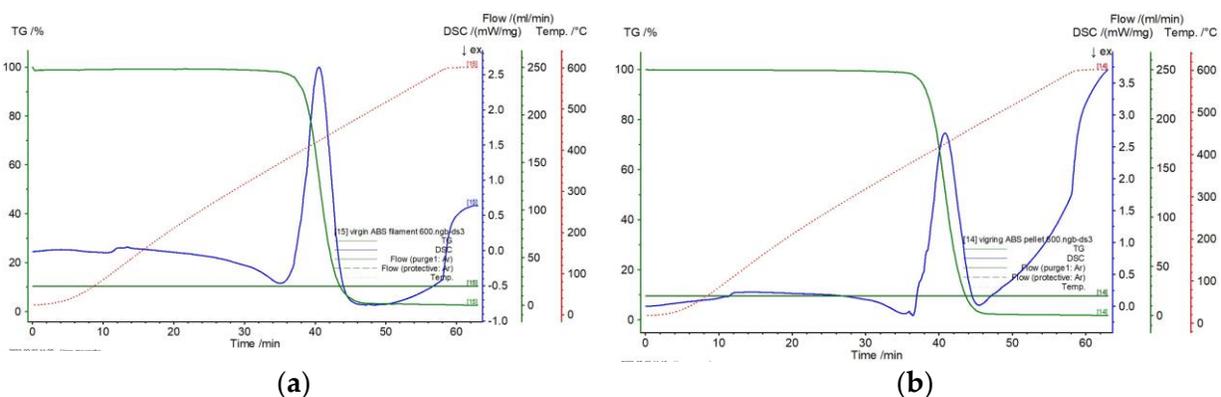
Figure S12. Thermogravimetric analysis (green line) and differencing scanning calorimetry (blue line) performed up to 600 °C (red line) for the virgin ABS: (a) unprocessed pellet and in (b) the 1.75-mm filament obtained with the melt-blend extrusion.

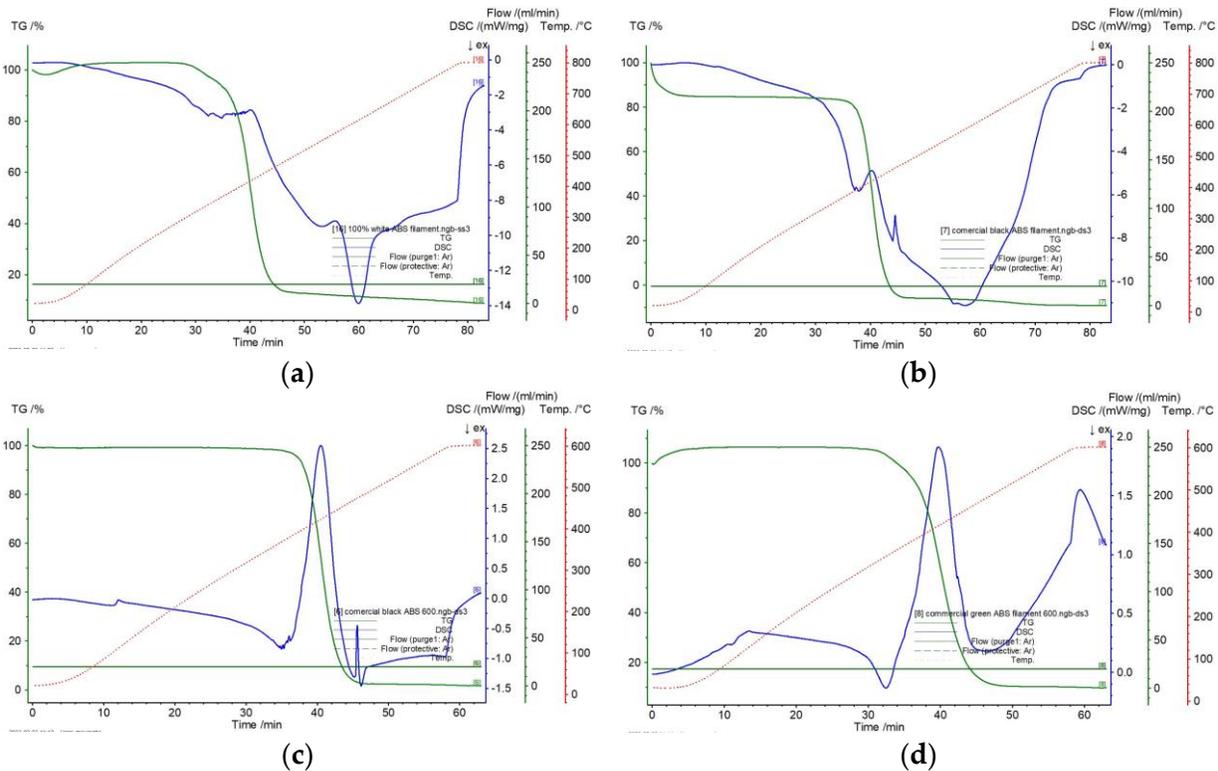
Figure S13. Thermogravimetric analysis (green line) and differencing scanning calorimetry (blue line) performed at the temperature informed by the red line for: (a) white ABS filament @ 800 °C; (b) commercial black ABS filament @ 800 °C; (c) commercial black ABS filament @ 600 °C; (d) commercial green ABS @ 600 °C.

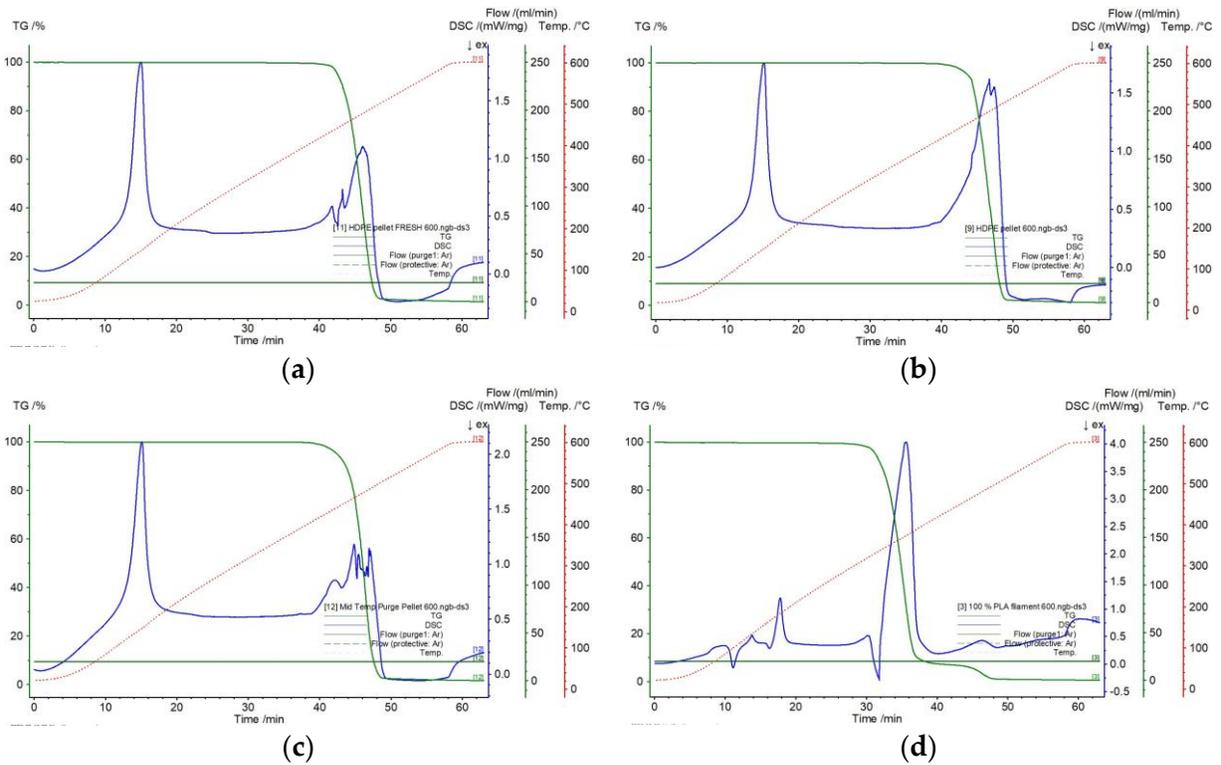
Figure S14. Thermogravimetric analysis (green line) and differencing scanning calorimetry (blue line) performed up to 600 °C (red line) for: (a) fresh HDPE; (b) HDPE stored at room condition for a year; (c) MidTemp purge; (d) PLA filament.

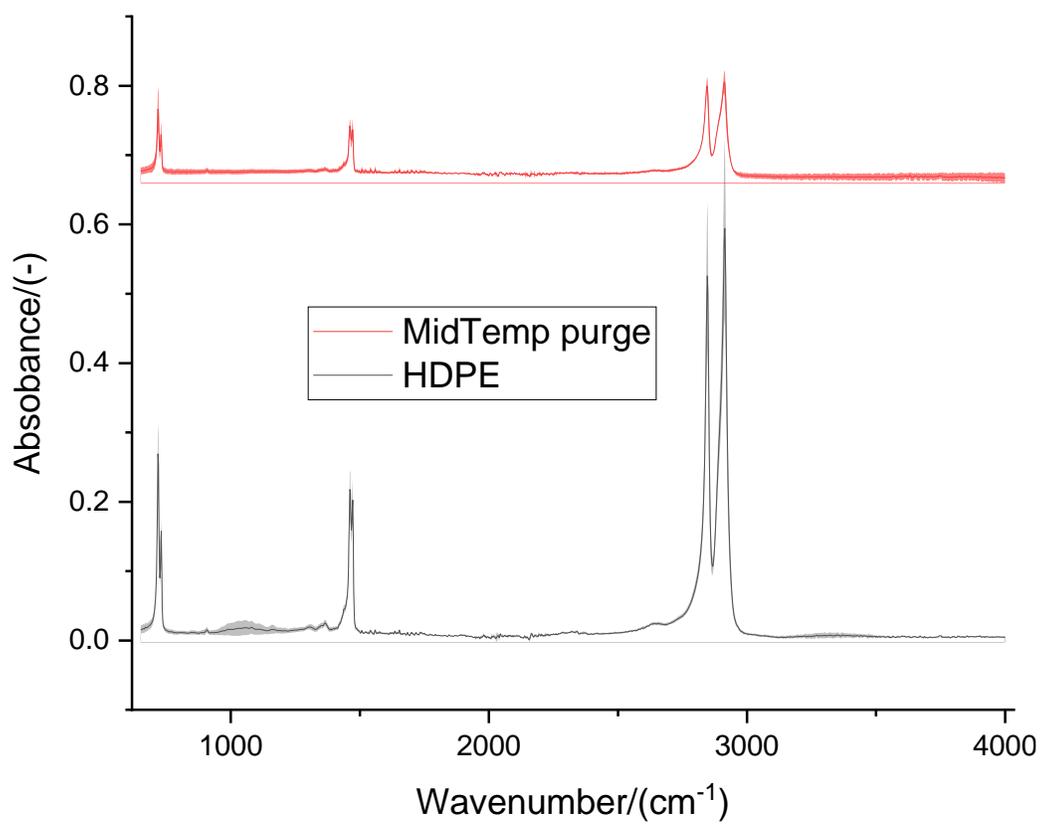
Figure S15. Comparisons of the FTIR spectra of the HDPE and the Devoclean MidTemp purge.

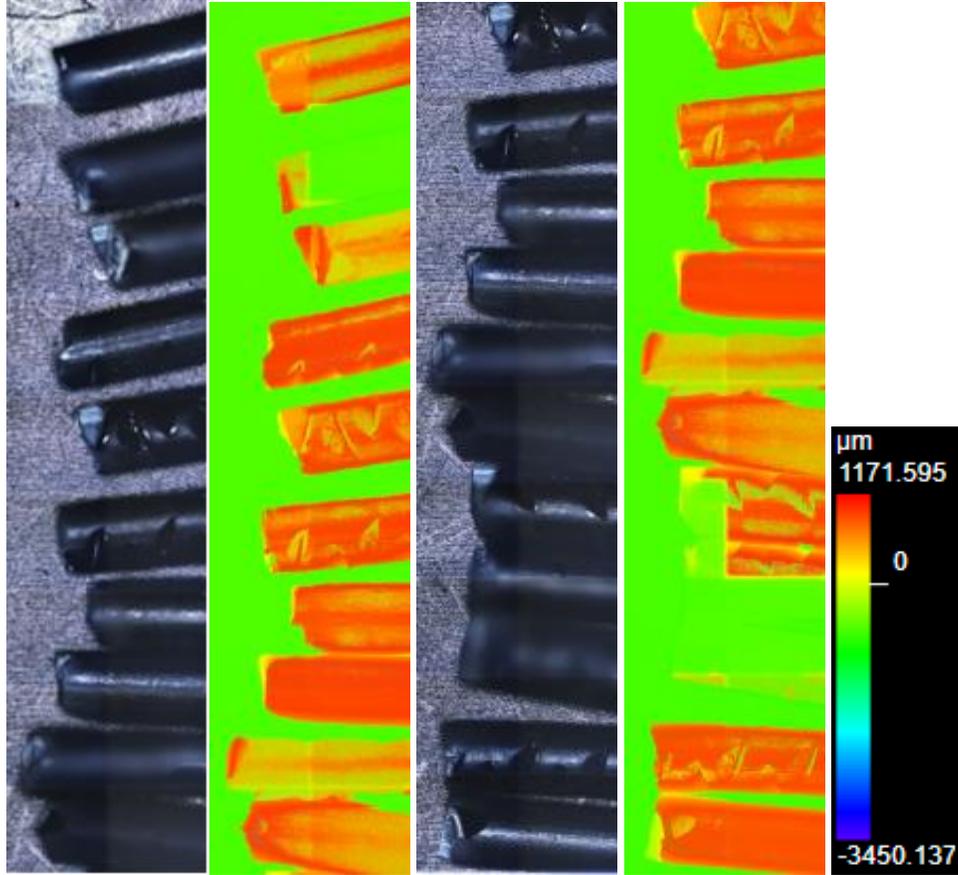
Figure S16. Laser microscope images (x5) of the rupture of the filaments of Commercial black ABS filament in the tensile test.

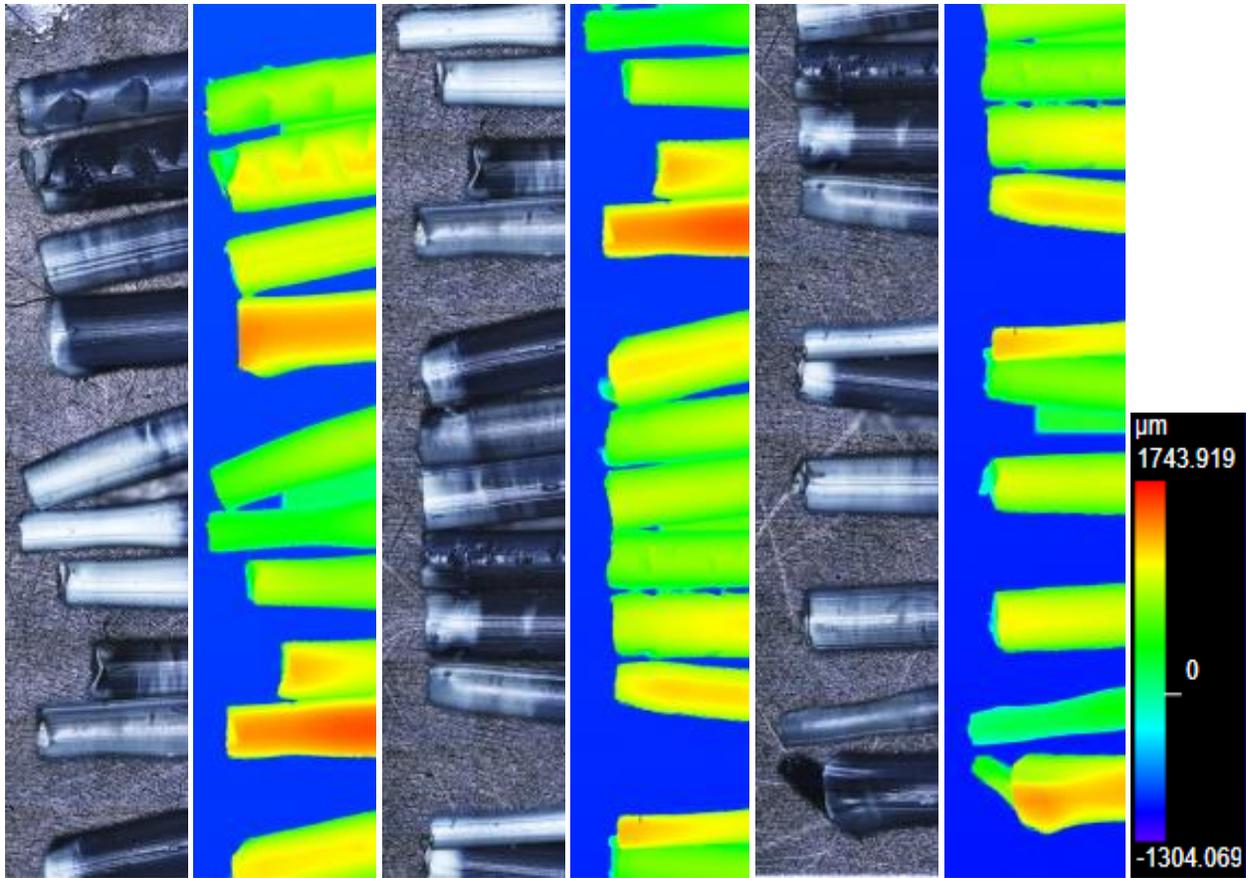
Figure S17. Laser microscope images (x5) of the failure of the filaments of 50 % white ABS 50 % Black ABS in the tensile test.

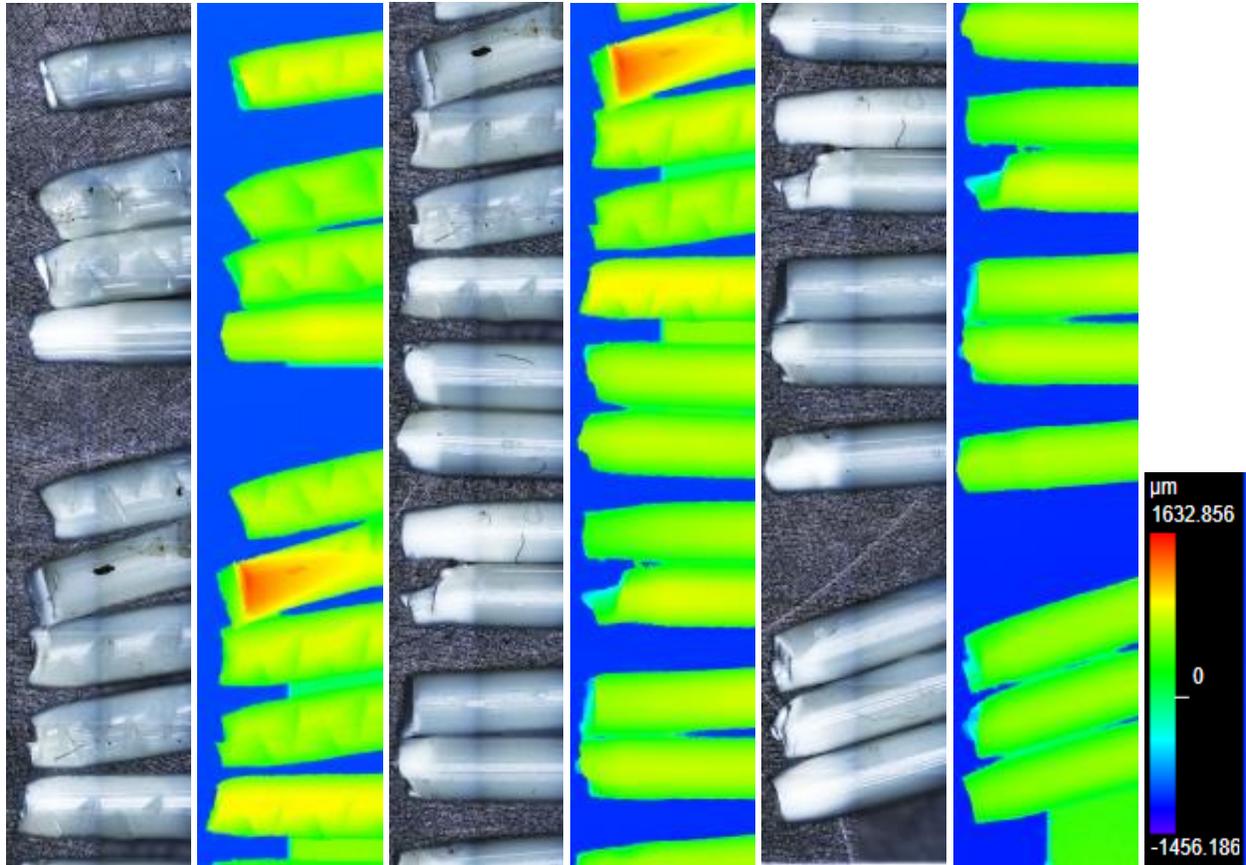
Figure S18. Laser microscope images (x5) of the failure of the filaments of 10 % white ABS 90 % virgin ABS in the tensile test.

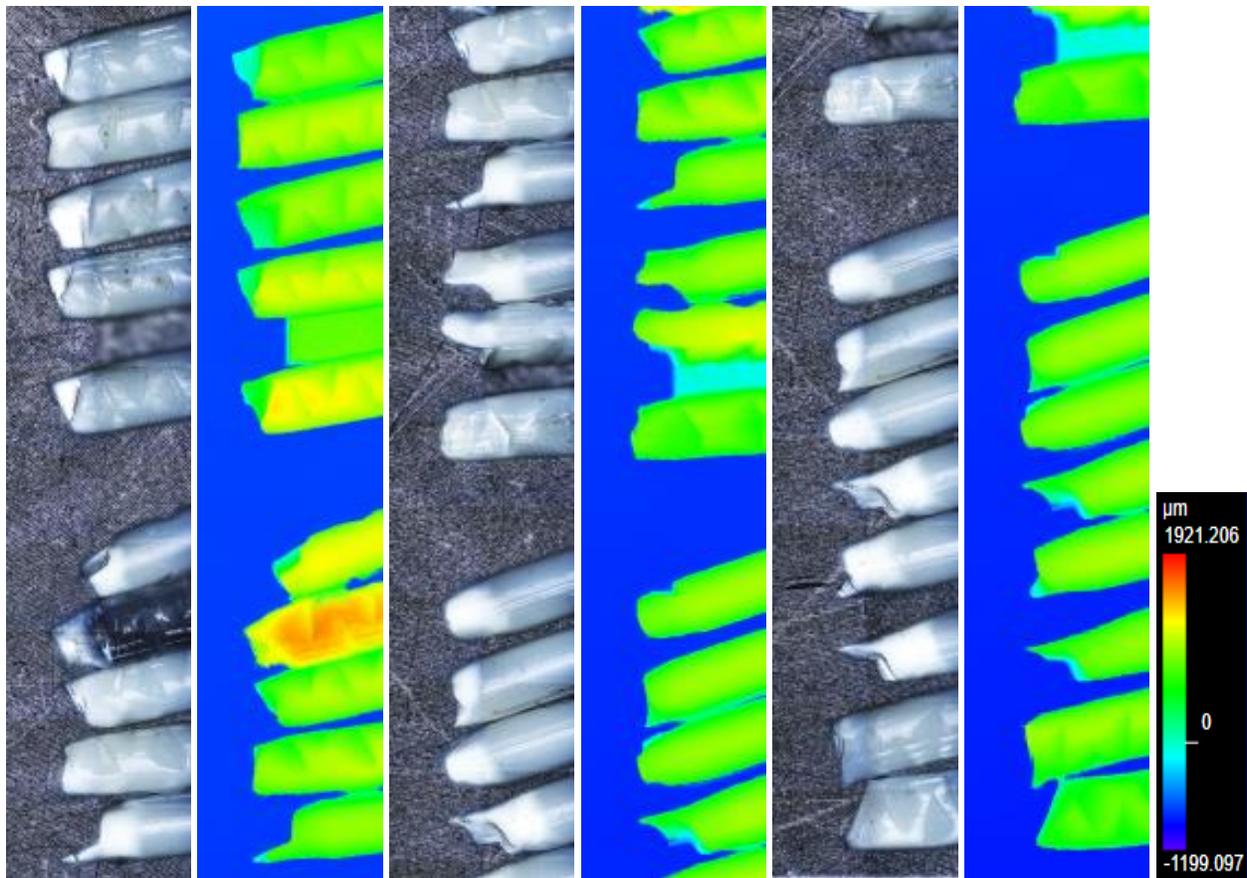
Figure S19. Laser microscope images (x5) of the rupture of the filaments of 18 % white ABS 88 % virgin ABS in the tensile test.

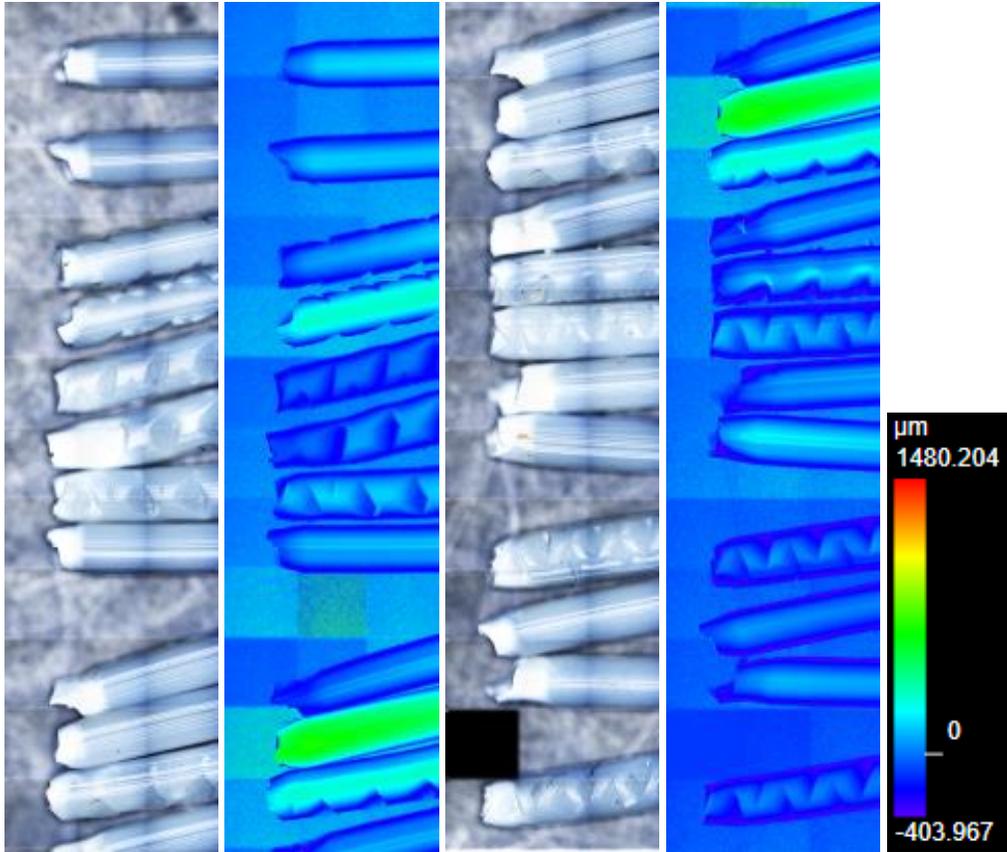
Figure S20. Laser microscope images (x5) of the failure of the filaments of 25 % white ABS 75 % virgin ABS in the tensile test.

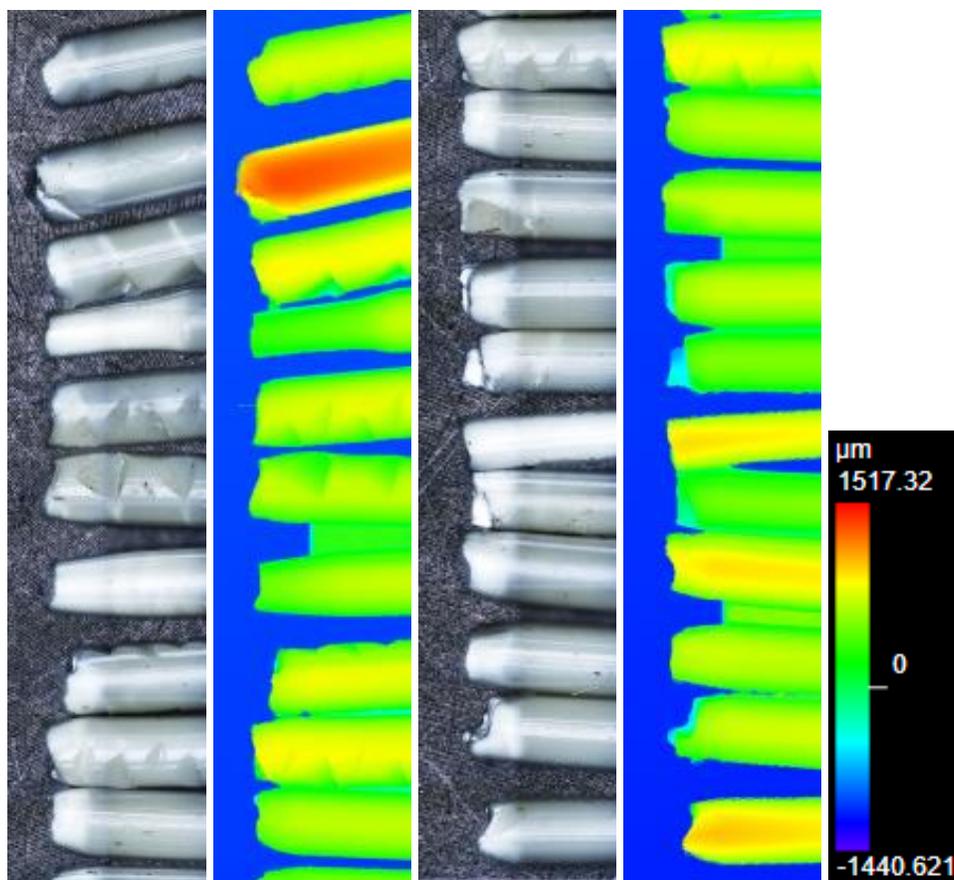
Figure S21. Laser microscope images (x5) of the failure of the filaments of 35 % white ABS 65 % virgin ABS in the tensile test.

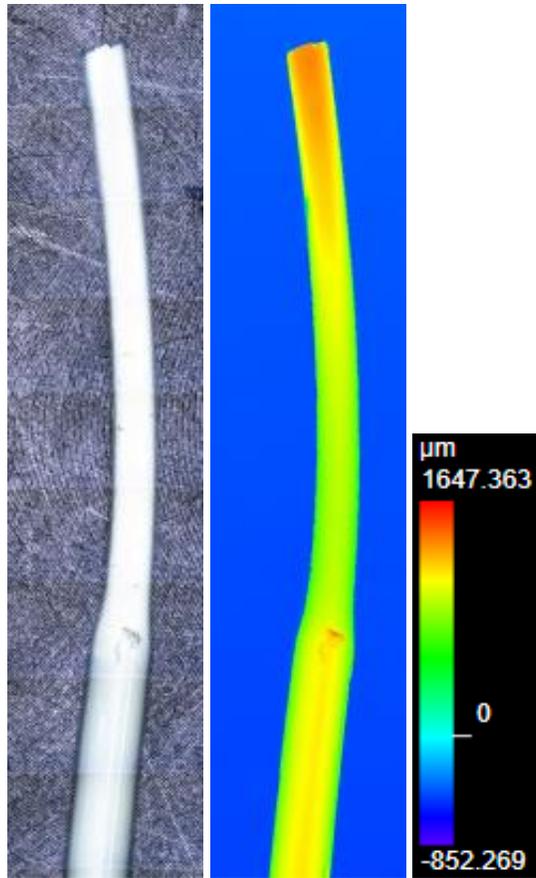
Figure S22. Neck formation in the filaments of 35 % white ABS 65 % virgin ABS during the tensile test.

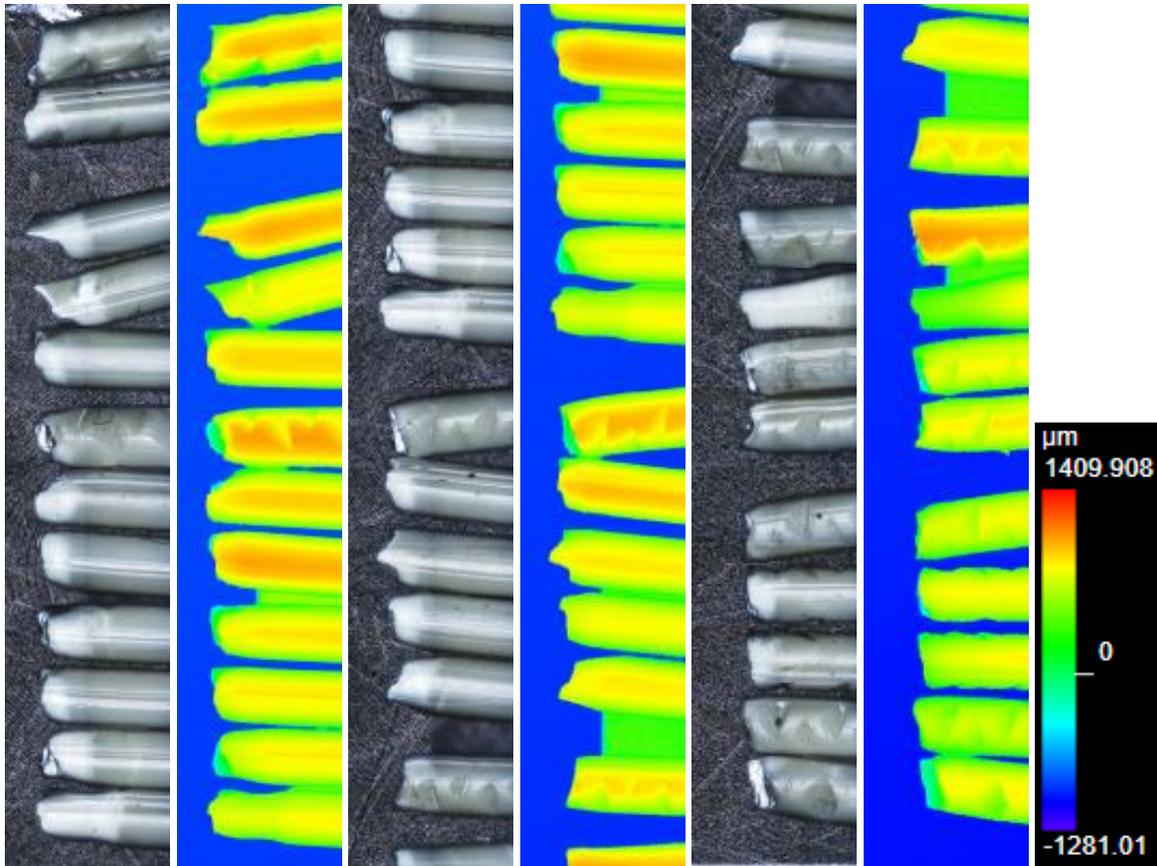
Figure S23. Laser microscope images (x5) of the rupture of the filaments of 40 % white ABS 60 % virgin ABS in the tensile test.

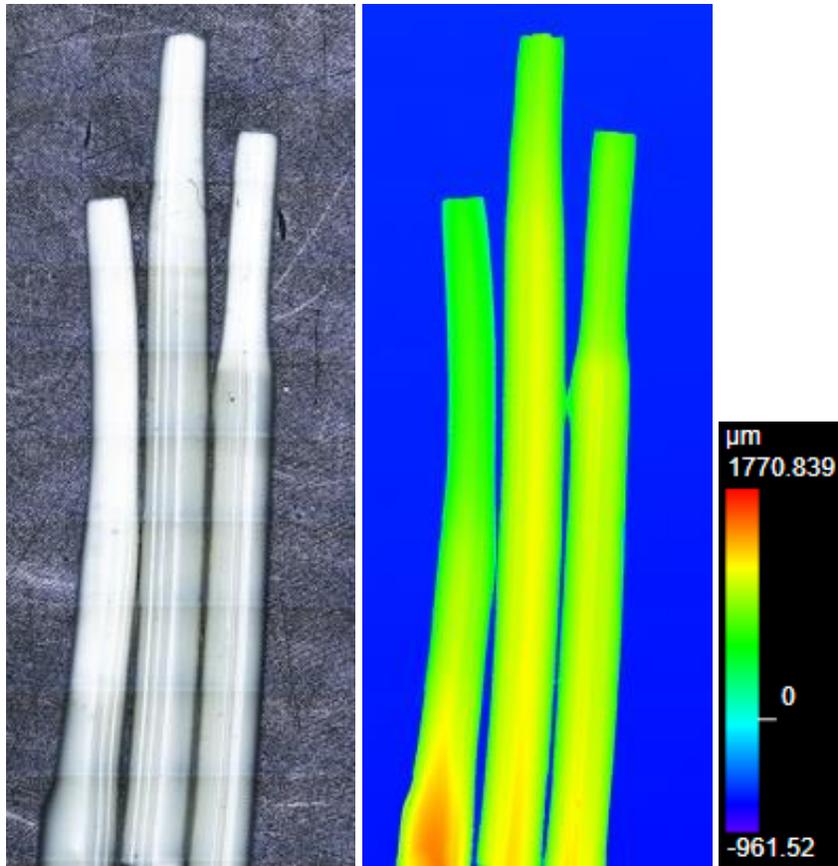
Figure S24. Neck formation in the filaments of 40 % white ABS 60 % virgin ABS in the tensile test.

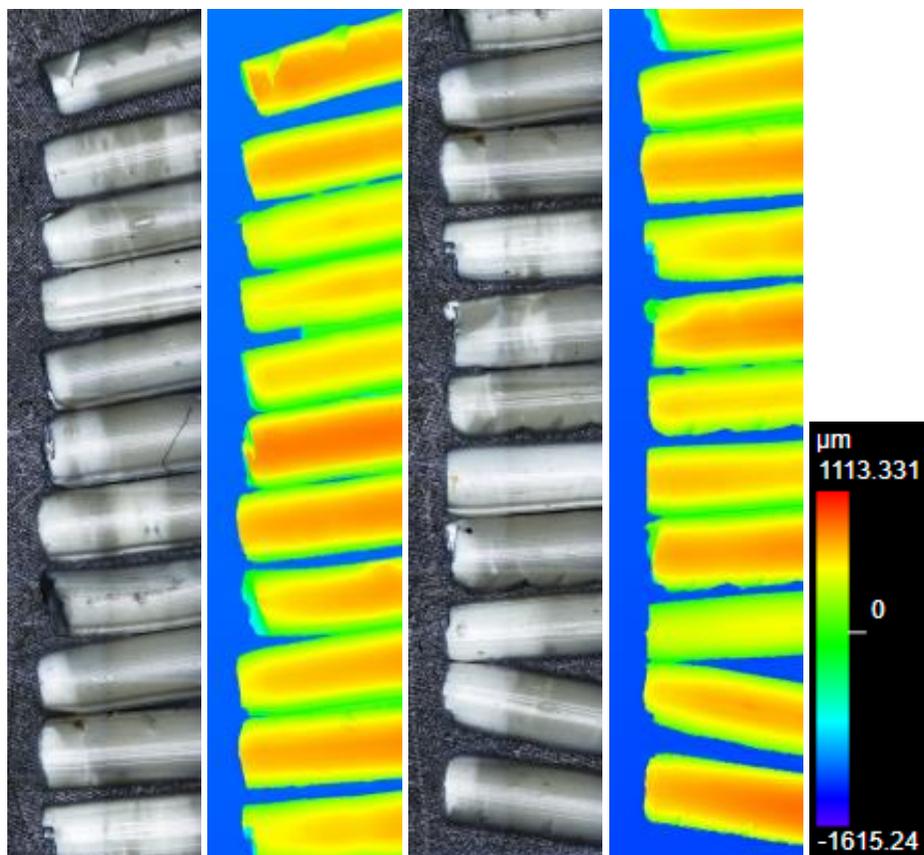
Figure S25. Laser microscope images (x5) of the rupture of the filaments of 70 % white ABS 30 % virgin ABS in the tensile test.

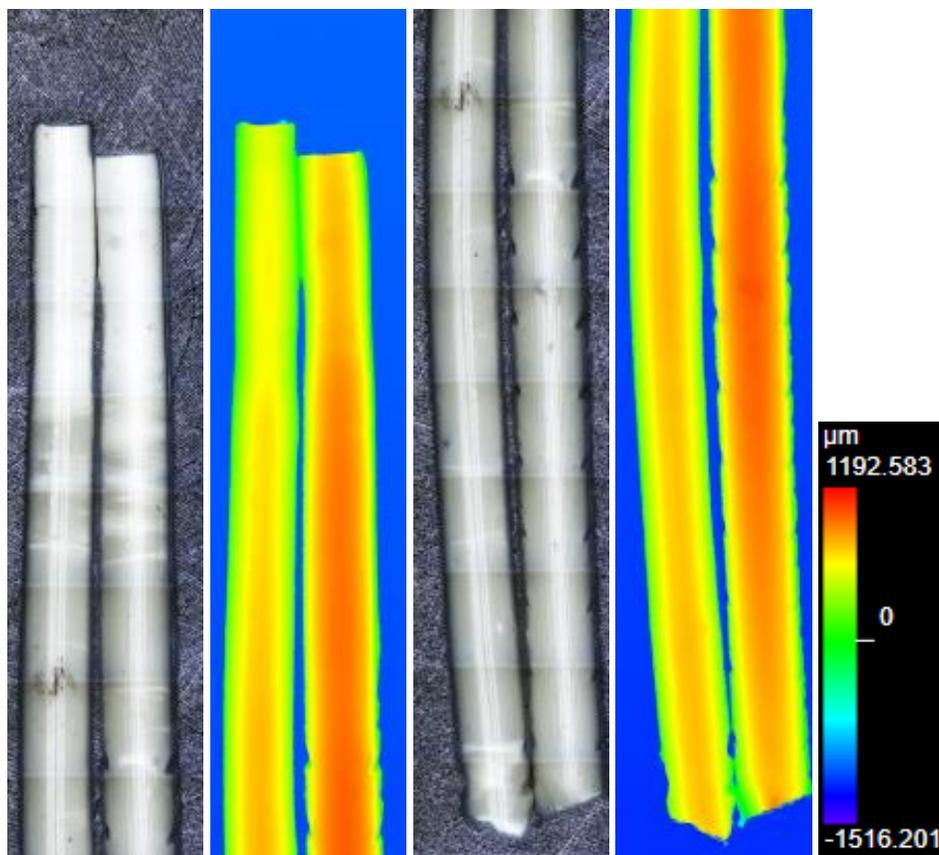
Figure S26. Laser microscope images (x5) of the failure of the filaments of 70 % white ABS 30 % virgin ABS in the tensile test.

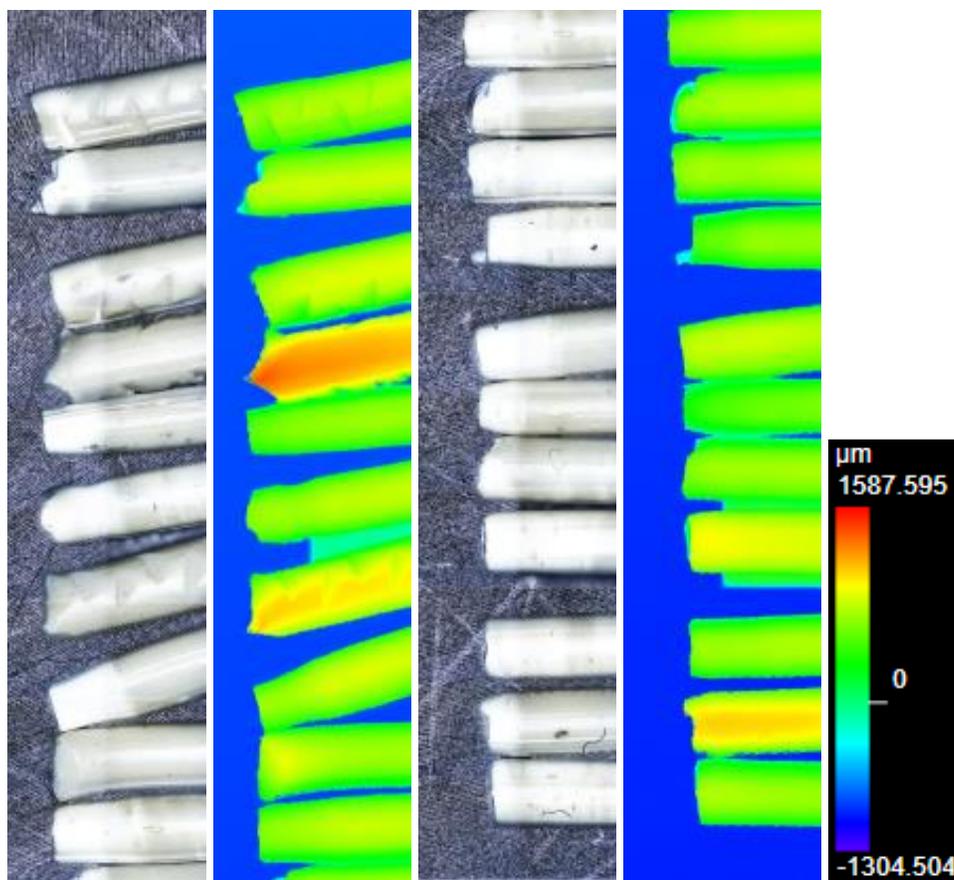
Figure S27. Laser microscope images (x5) of the rupture of the filaments of 90 % white ABS 10 % virgin ABS in the tensile test.
