Microfactory for valorization of e-waste plastics (acrylonitrile-butadiene-styrene, polycarbonate, and polypropylene) on additive manufacturing sector

Alejandro Moure Abelenda ^{1,*} and Farid Aiouache ^{1,*}

School of Engineering, Lancaster University, Lancaster, LA1 4YW

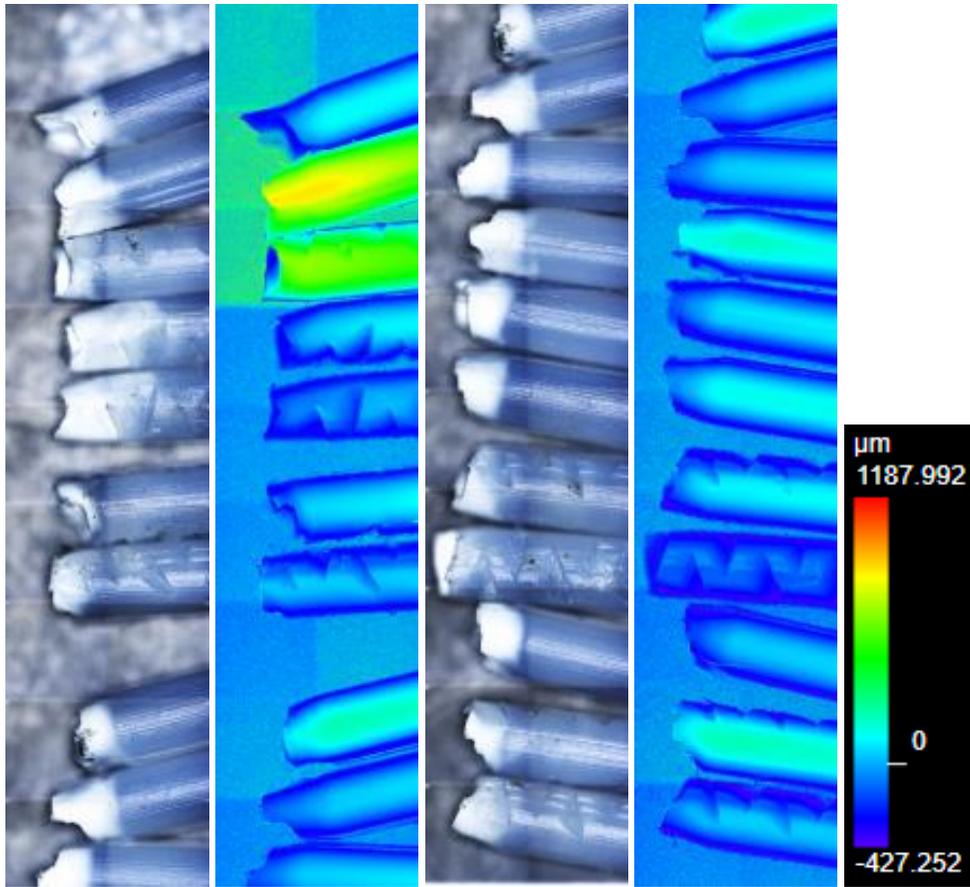
Figure S28. Laser microscope images (x5) of the failure of the filaments of virgin ABS in the tensile test.

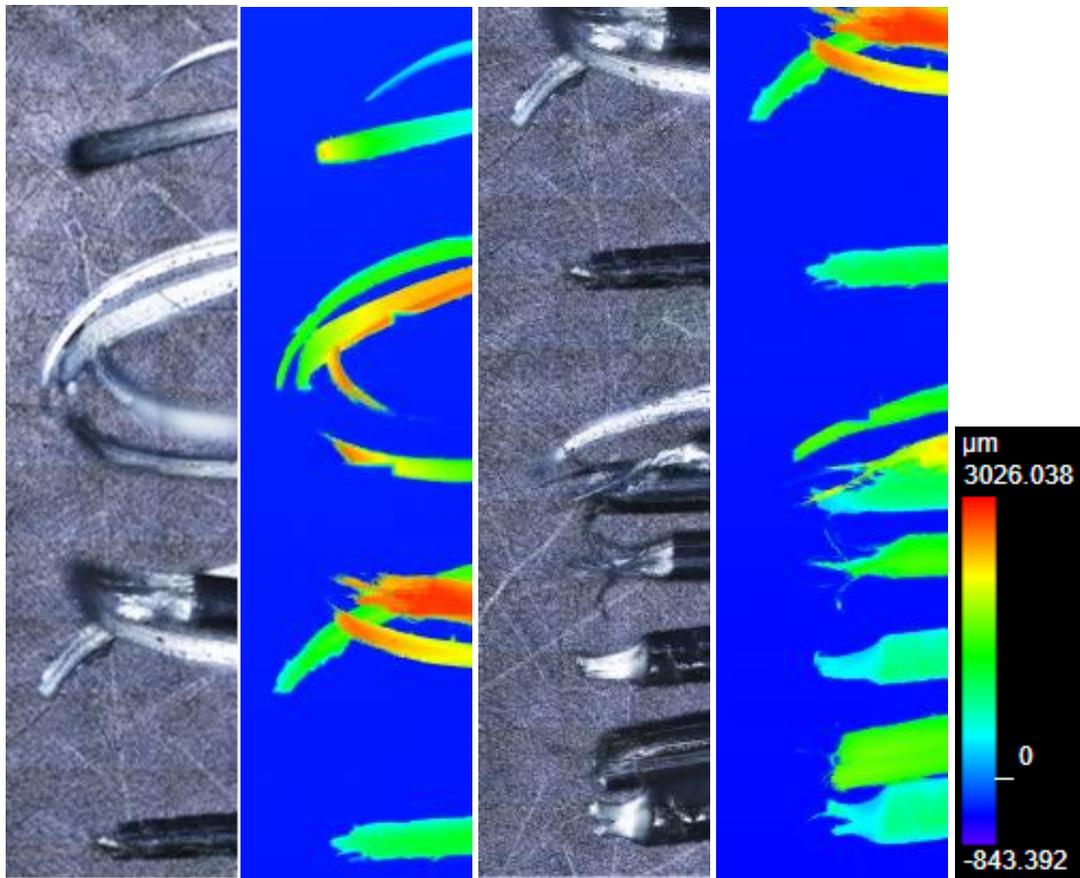
Figure S29. Laser microscope images (x5) of the rupture of the filaments of 50 % HDPE and 50 % Black ABS in the tensile test.

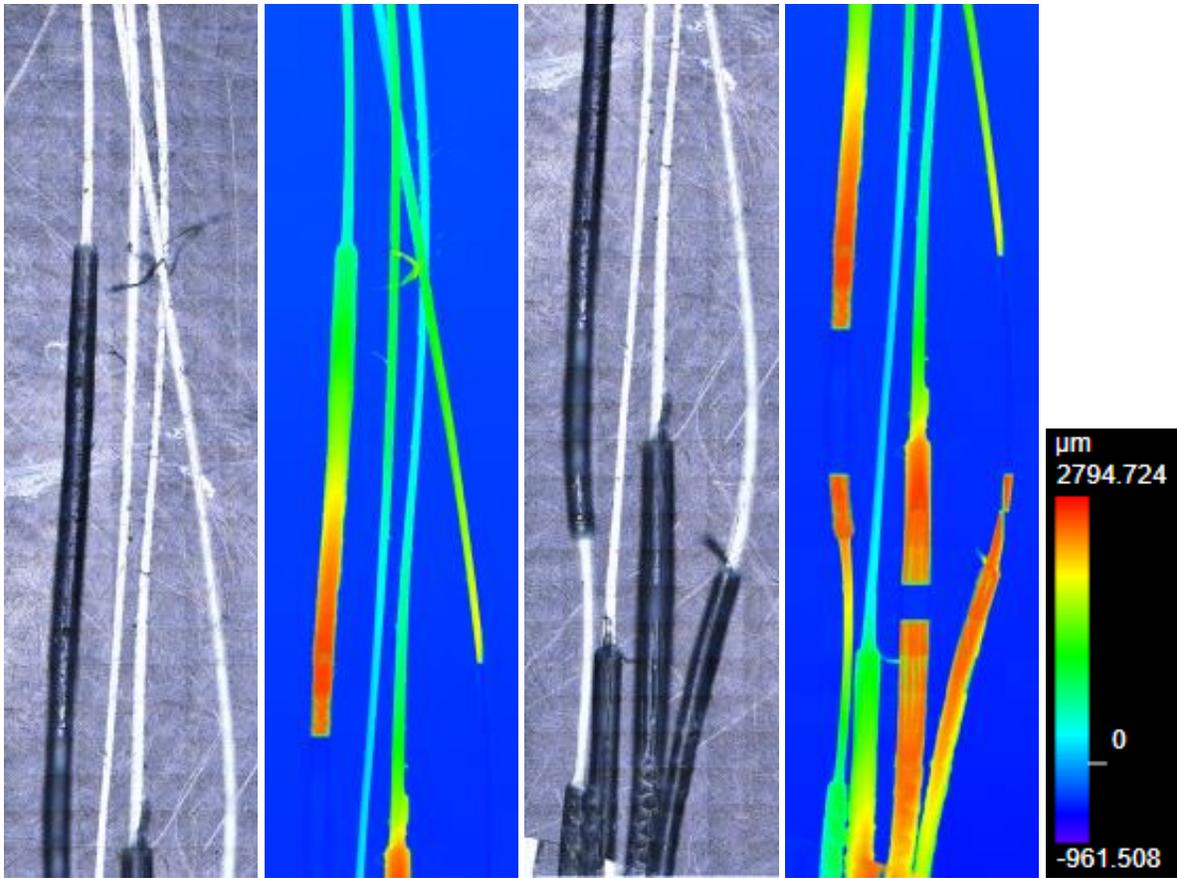
Figure S30. Laser microscope images (x5) of the failure of the filaments of 50 % HDPE 50 % Black ABS in the tensile test.

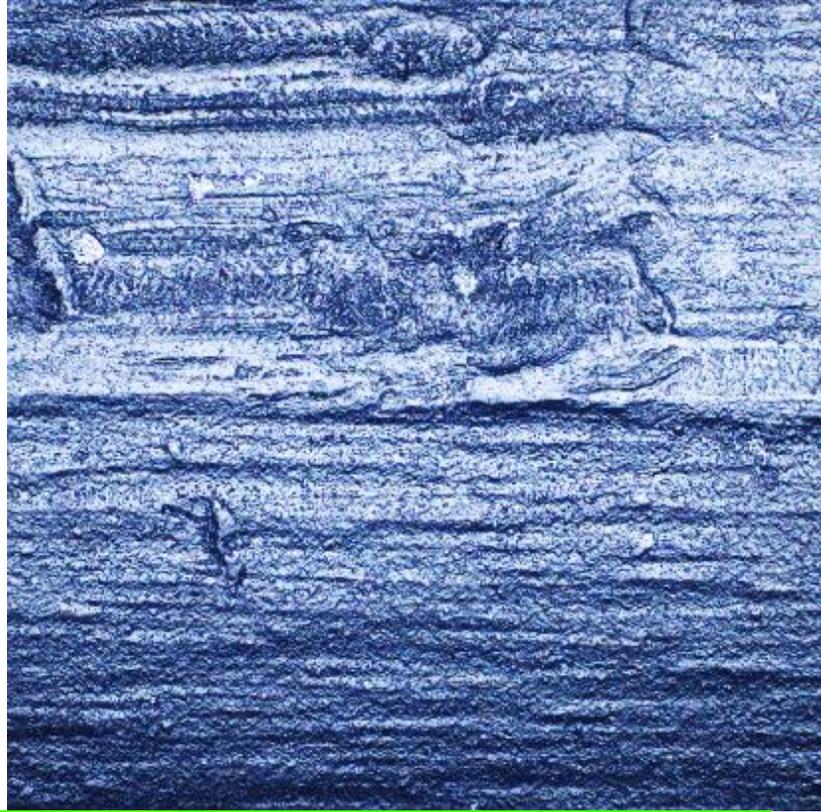
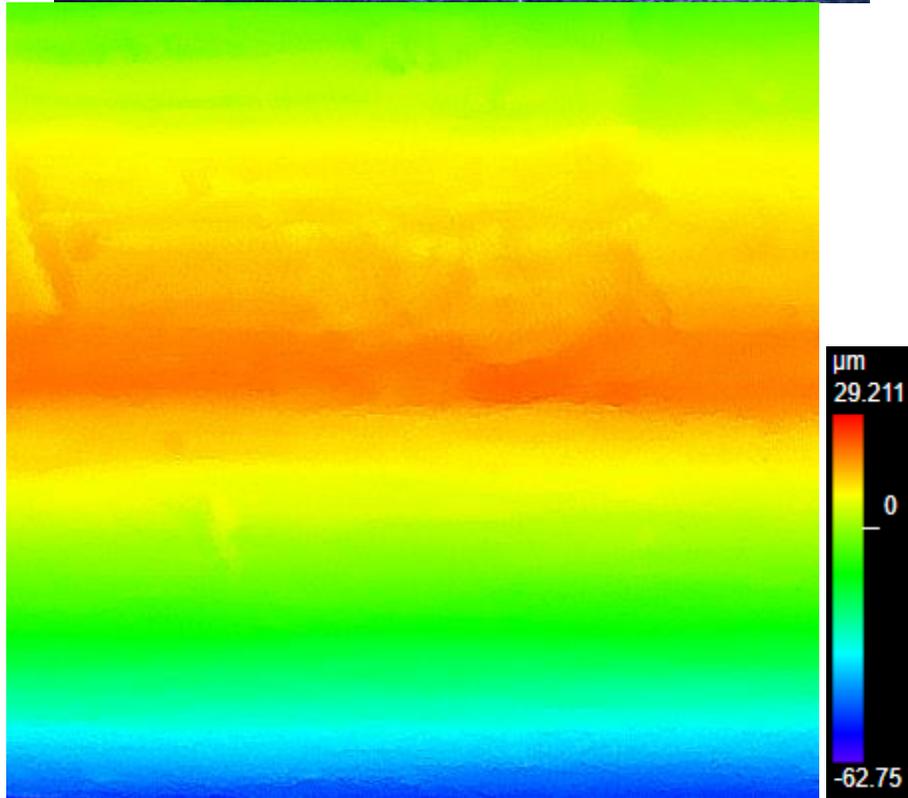
Figure S31. Laser microscope images (x5) of the rupture of the striations of the filament of ABS+PC.

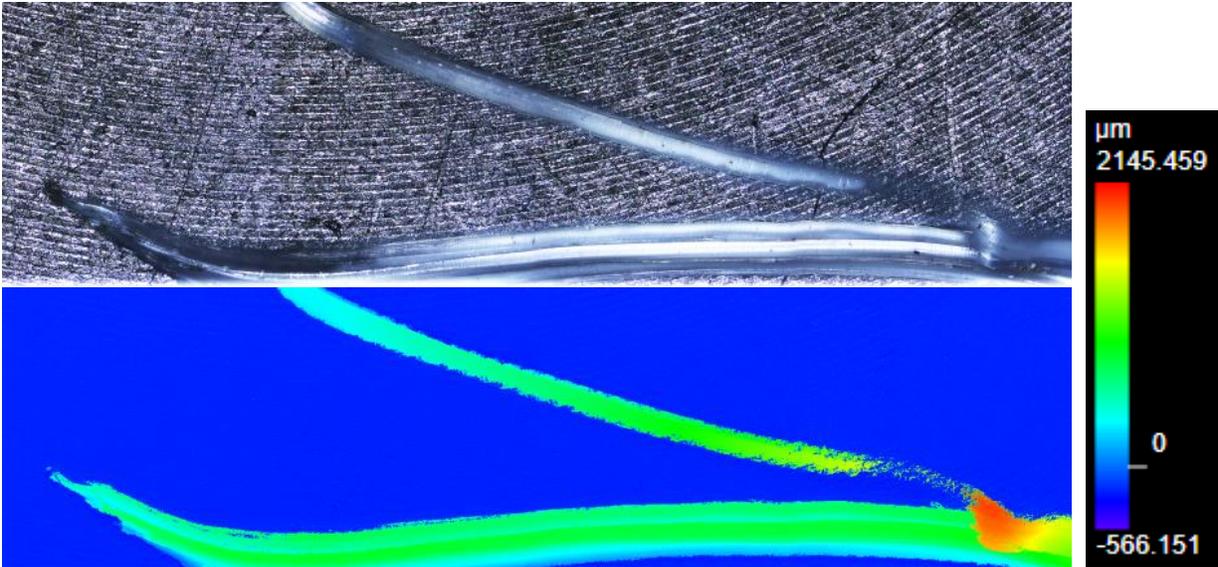
Figure S32. Laser microscope ($\times 10$) of the formation of 2 fibers in the PP filament during the tensile test.

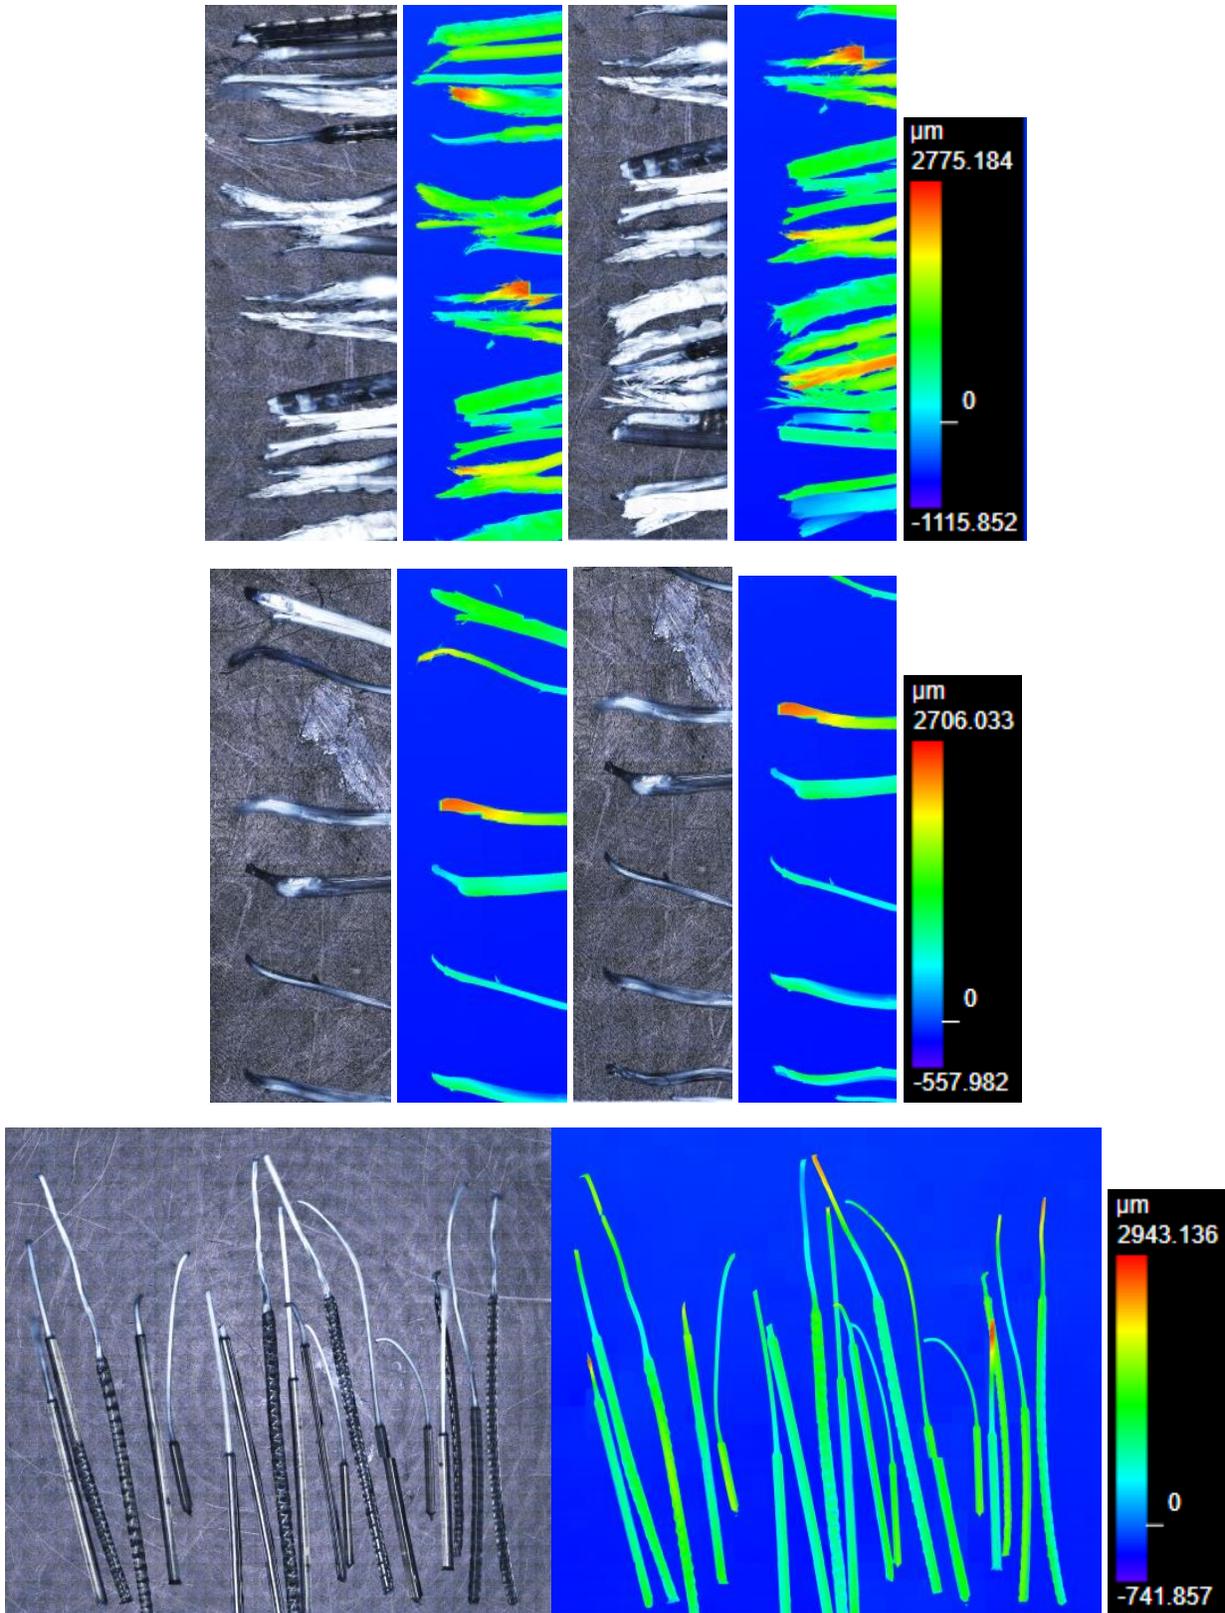
Figure S33. Laser microscope images (x5) of the neck formation in the filaments of 50 % PP + 50 % PLA during the tensile test.

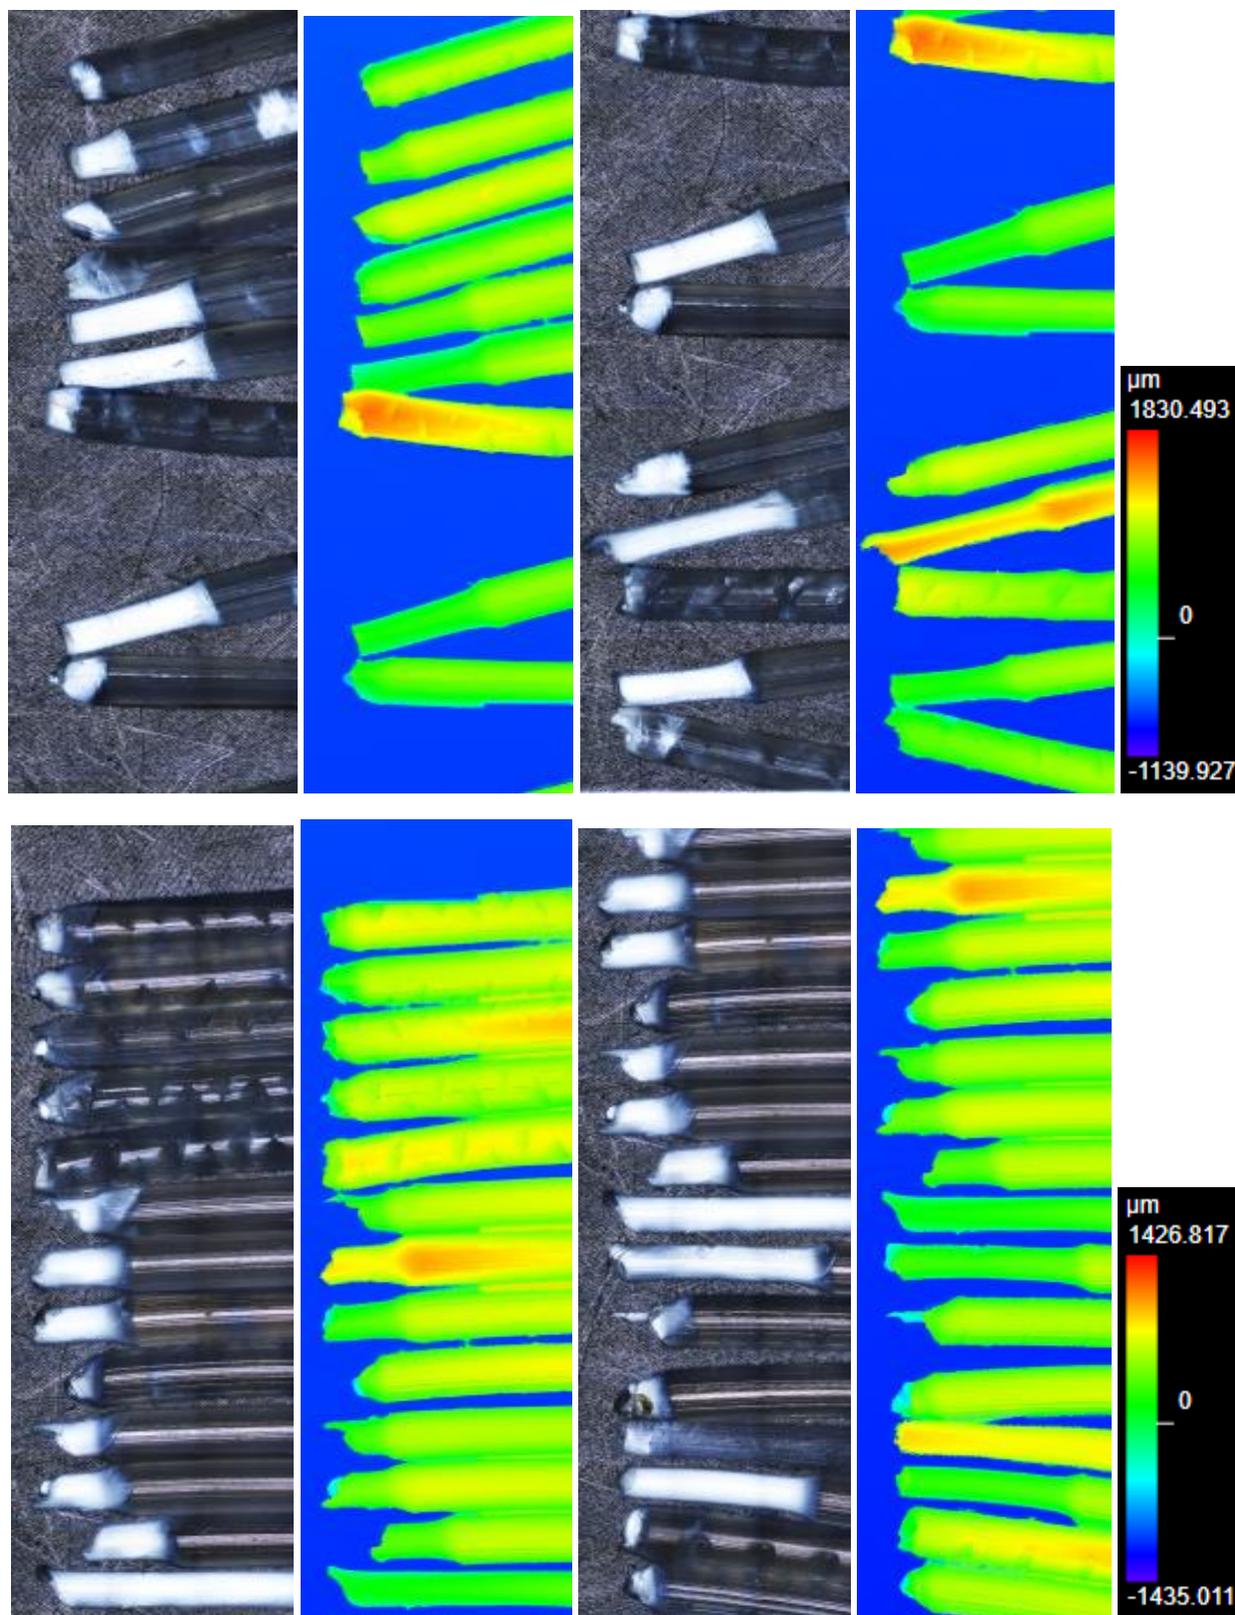
Figure S34. Laser microscope images (x5) of the failure of the filaments of 10 % PP 90 % PLA in the tensile test.

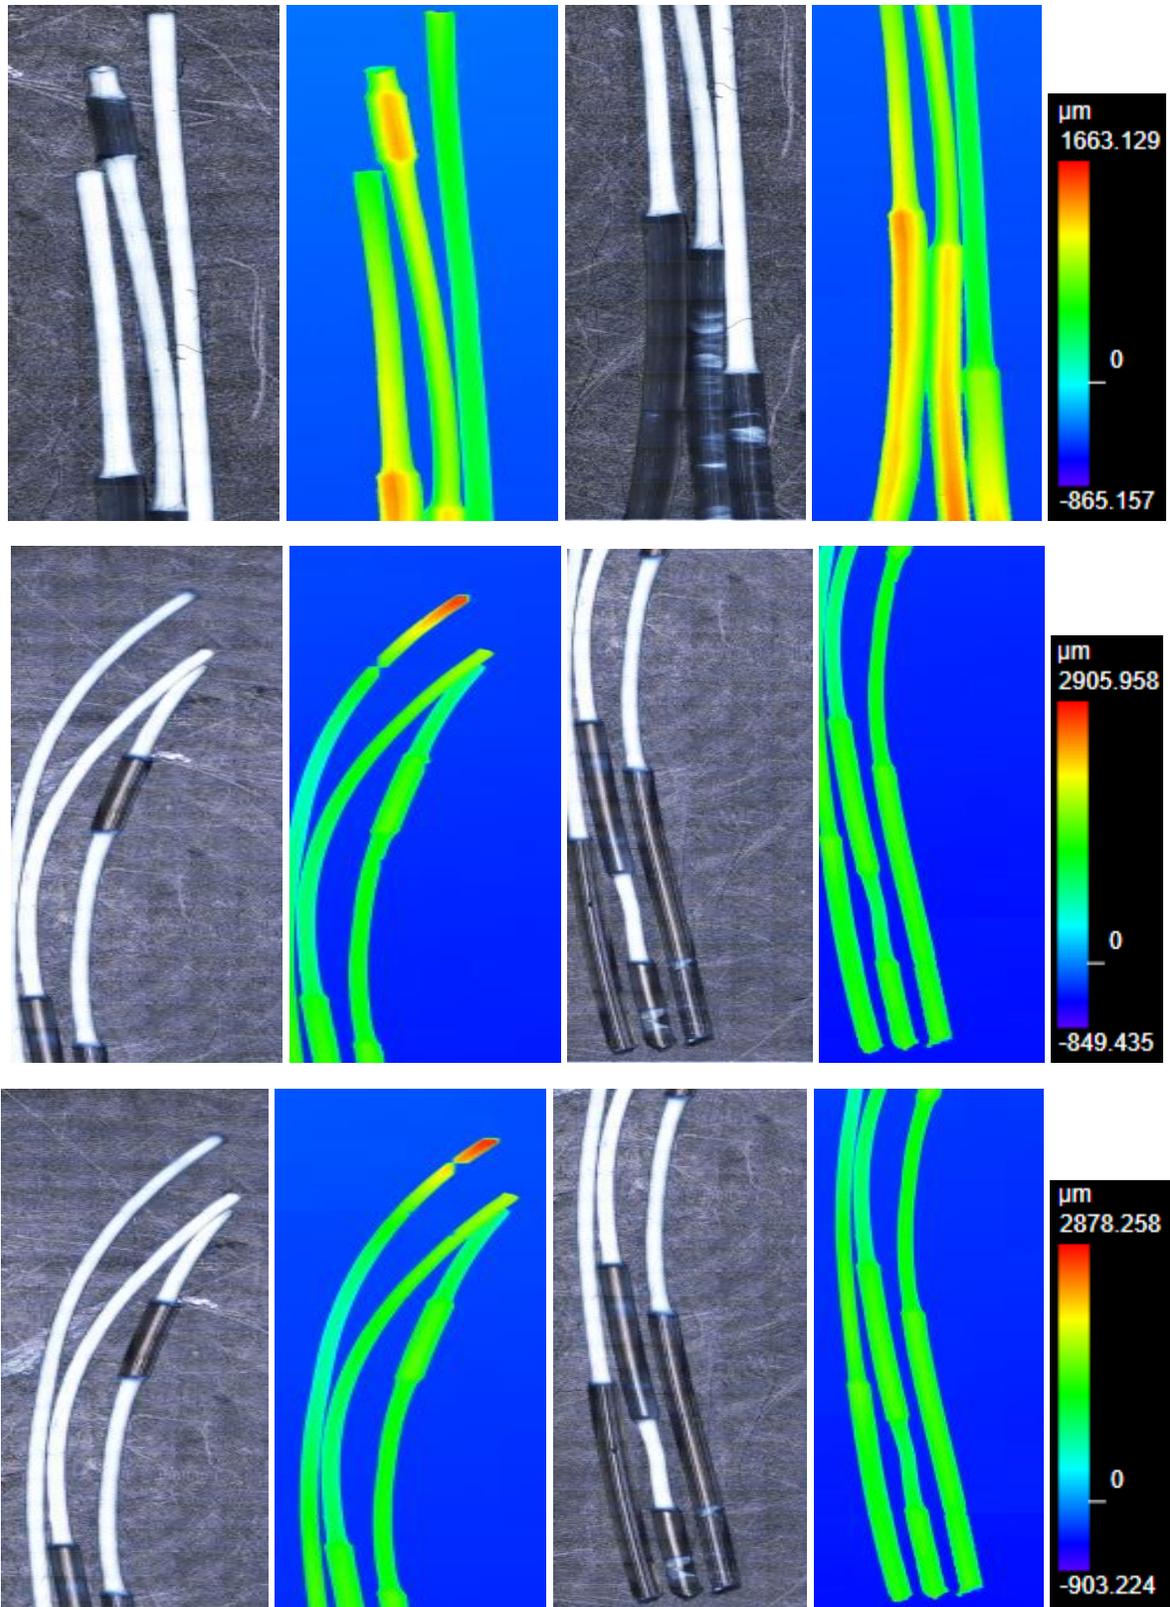
Figure S35. Laser microscope images (x5) of the neck formation in the filaments of 10 % PP 90 % PLA during the tensile test.

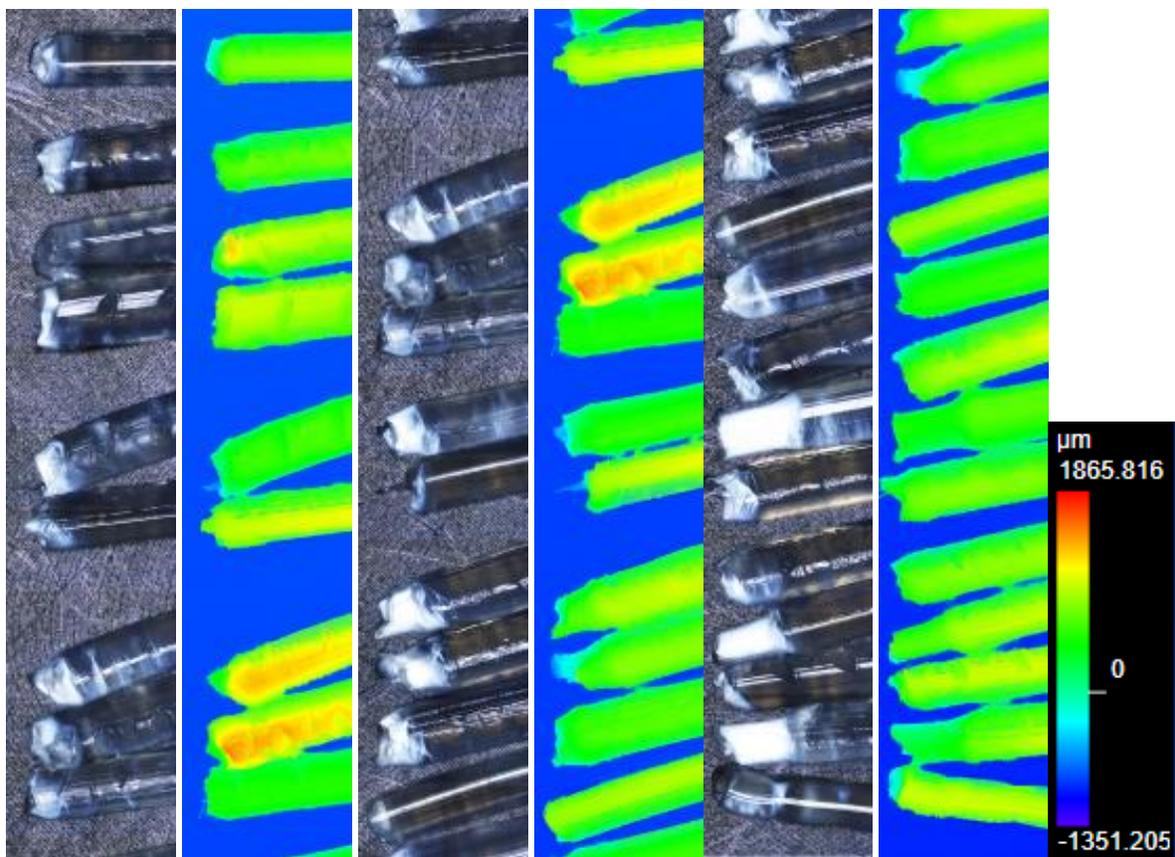
Figure S36. Laser microscope images (x5) of the rupture of the filaments of PLA.

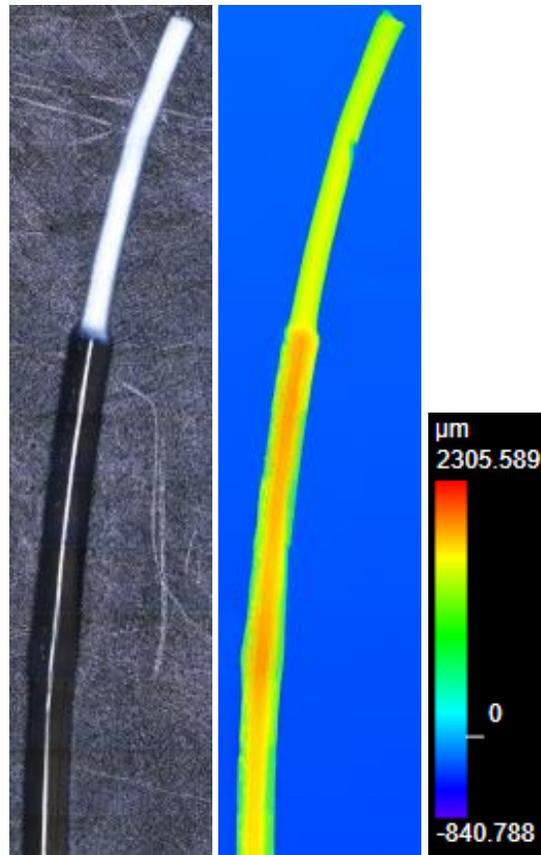
Figure S37. Laser microscope images (x5) of the failure of the filaments of PLA (with neck formation).

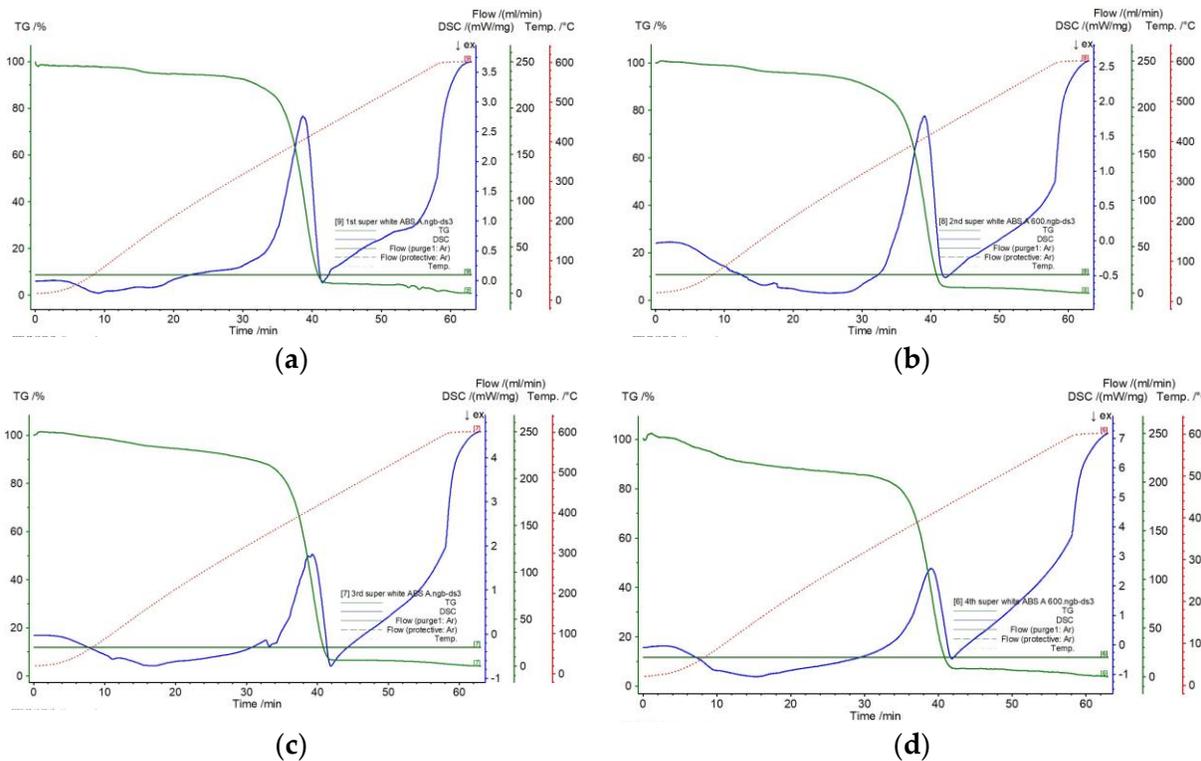
Figure S38. TGA/DSC profiles of the fraction of white ABS isolated with the acetone extraction: (a) 1st supernatant, (b) 2nd supernatant, (c) 3rd supernatant, and (d) 4th supernatant.

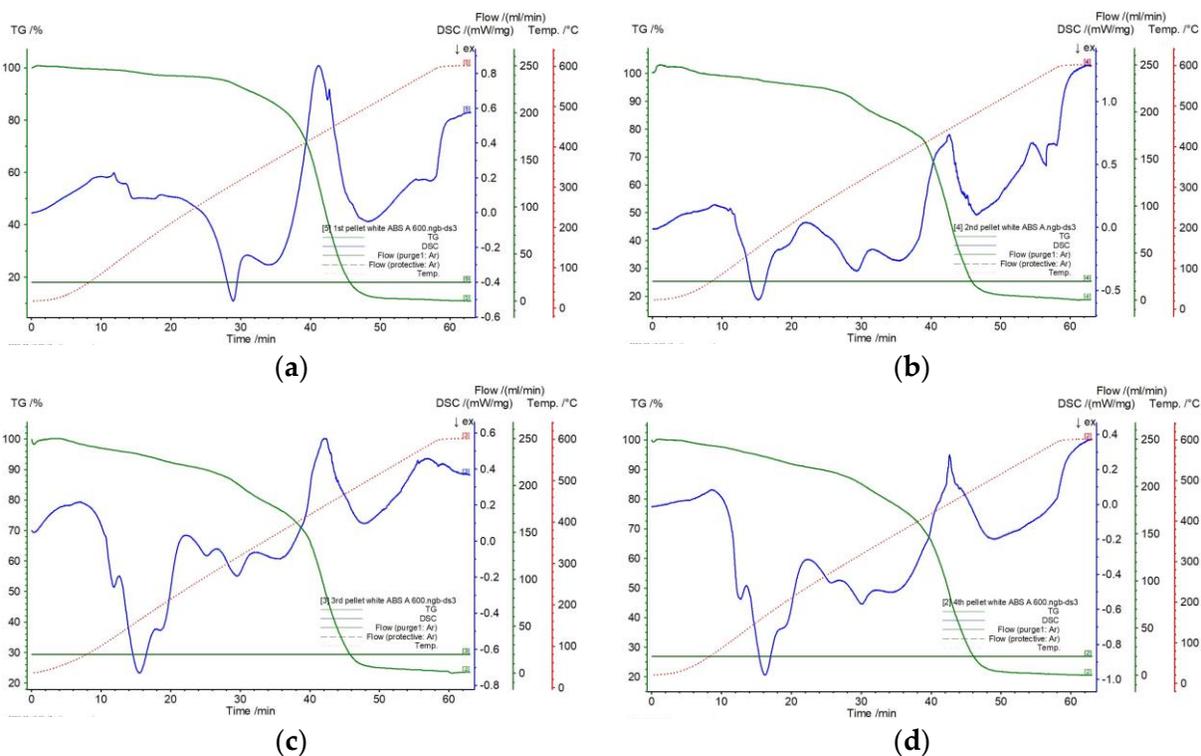
Figure S39. TGA/DSC profiles of the fraction of white ABS isolated with the acetone extraction: (a) 1st pellet, (b) 2nd pellet, (c) 3rd pellet, and (d) 4th pellet.

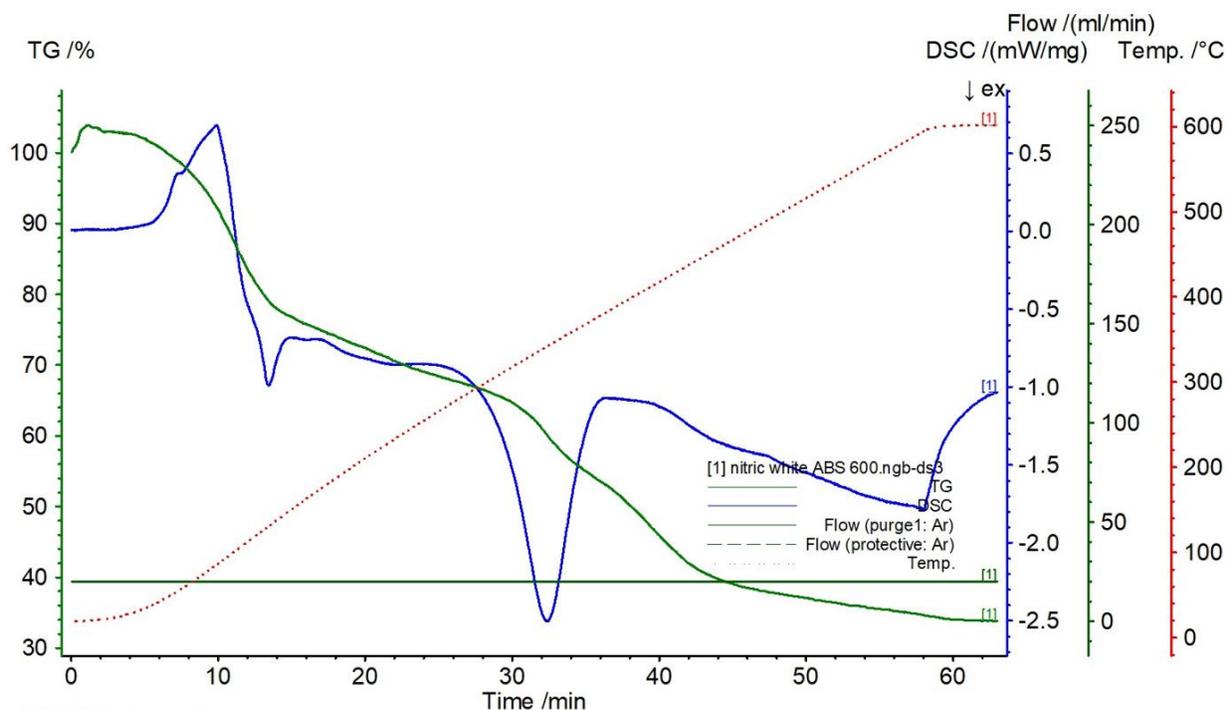
Figure S40. TGA/DSC profiles of the fraction of the white ABS soaked for 2 weeks in nitric acid (70 wt.%) with intermittent shaking.

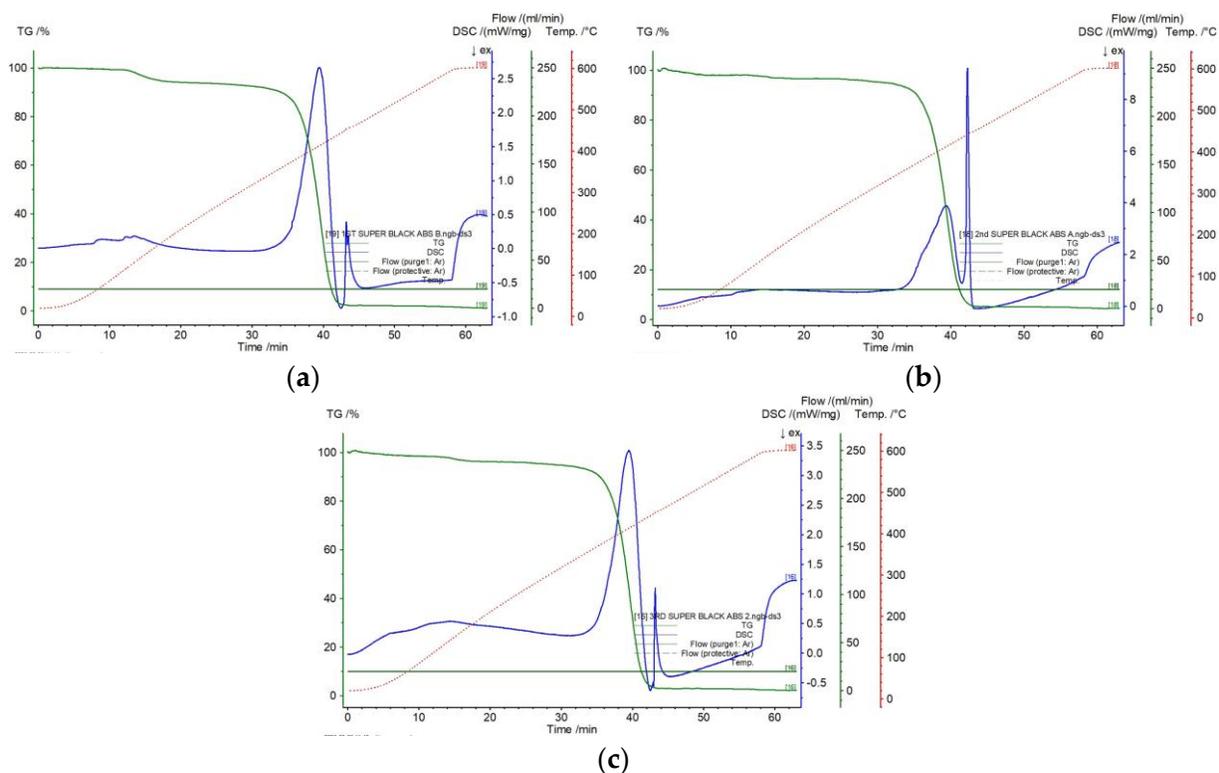
Figure S41. TGA/DSC profiles of the fraction of black ABS isolated with the acetone extraction: (a) 1st supernatant, (b) 2nd supernatant, and (c) 3rd supernatant.

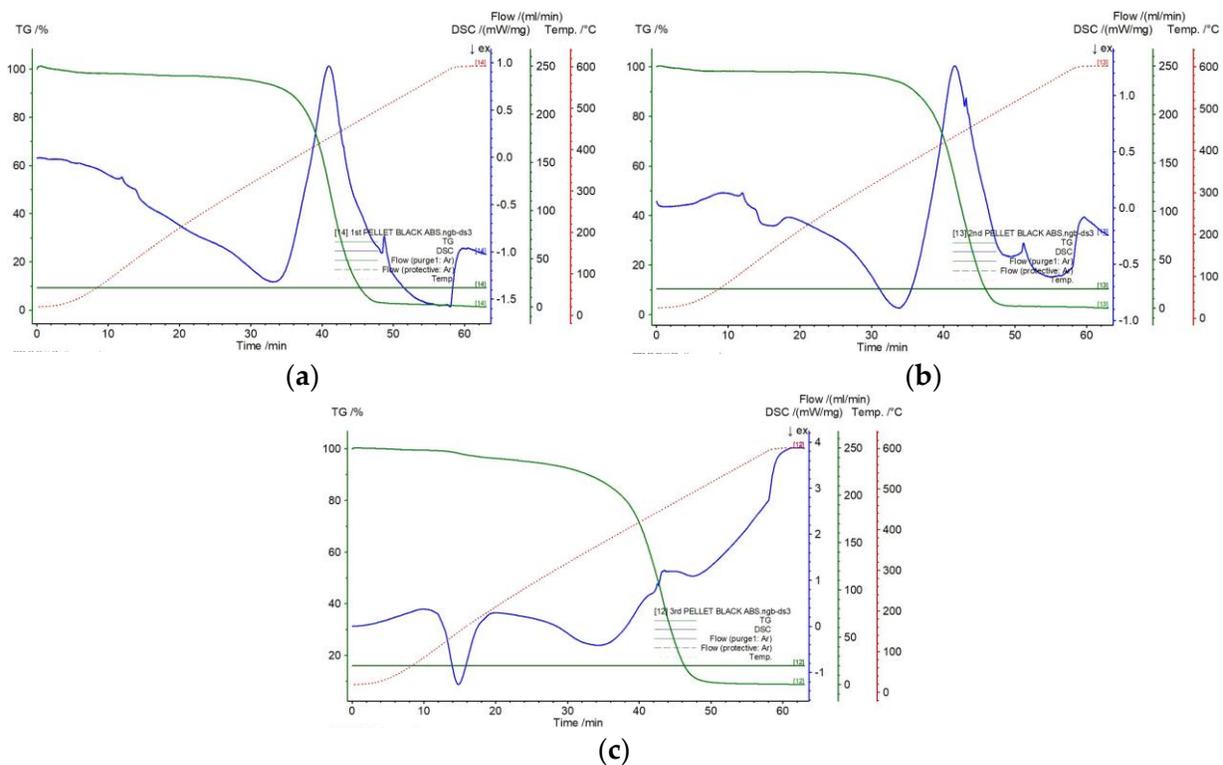
Figure S42. TGA/DSC profiles of the fraction of black ABS isolated with the acetone extraction: (a) 1st pellet, (b) 2nd pellet, and (c) 3rd pellet.

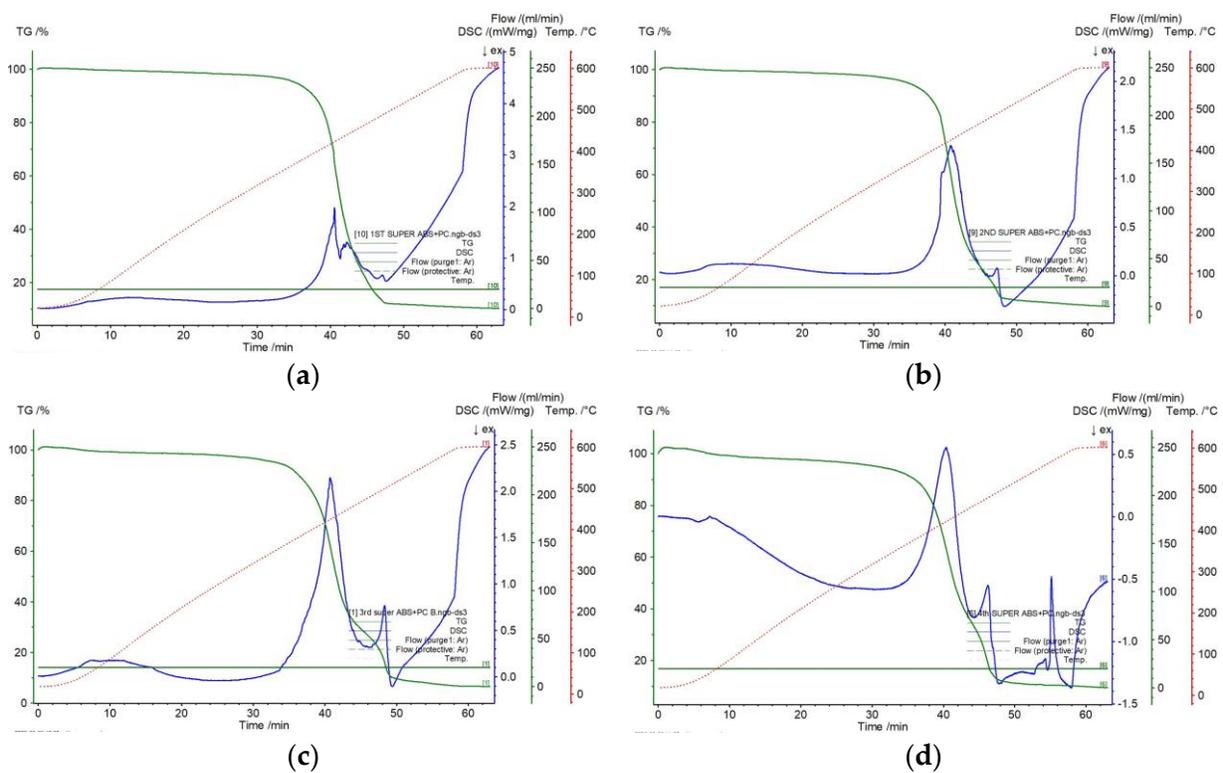
Figure S43. TGA/DSC profiles of the fraction of ABS+PC isolated with the acetone extraction: (a) 1st supernatant, (b) 2nd supernatant, (c) 3rd supernatant, and (d) 4th supernatant.

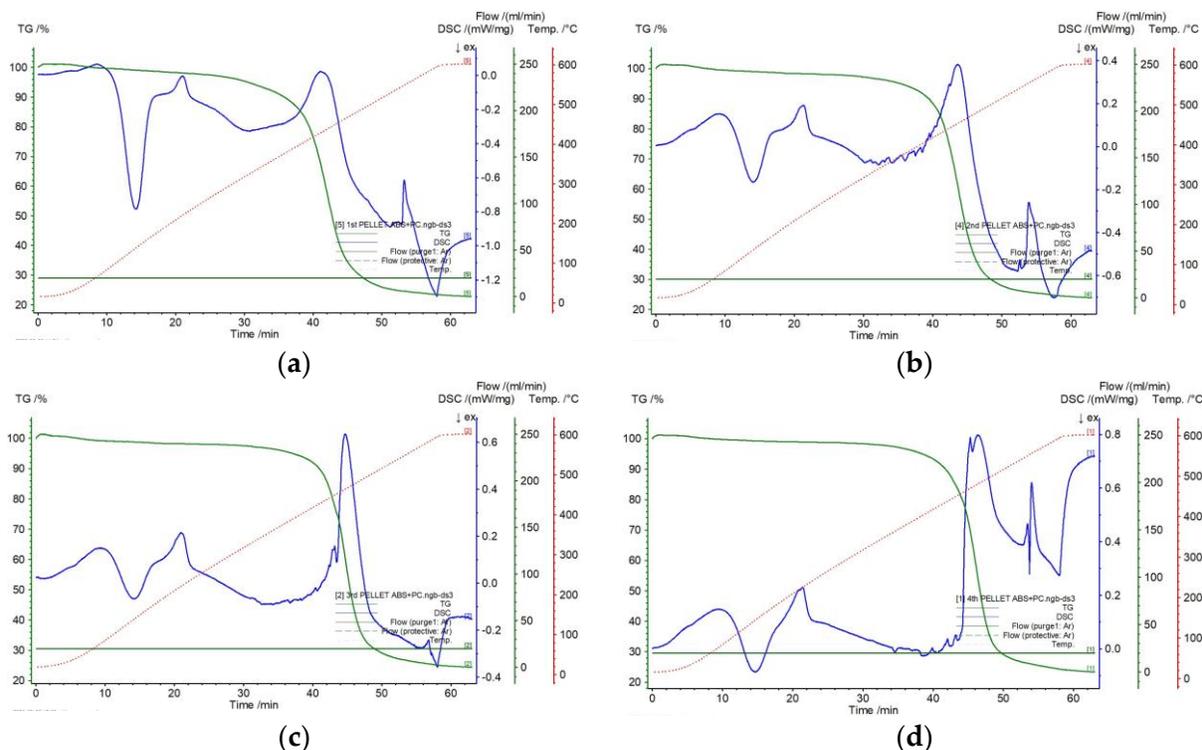
Figure S44. TGA/DSC profiles of the fraction of ABS+PC isolated with the acetone extraction: (a) 1st pellet, (b) 2nd pellet, (c) 3rd pellet, and (d) 4th pellet.

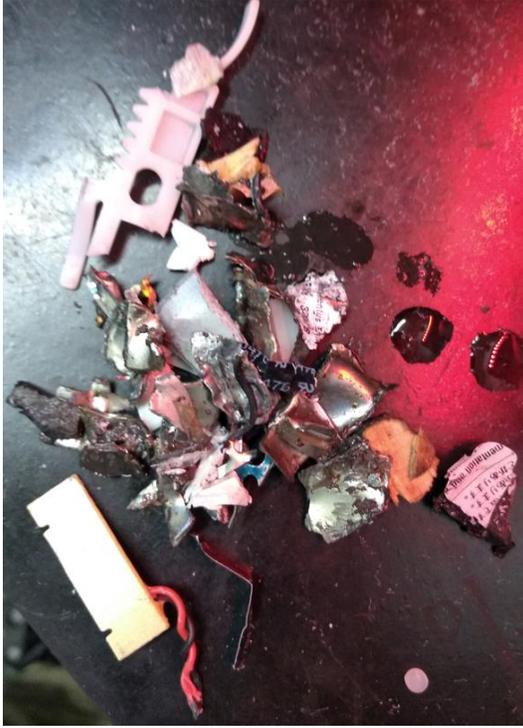
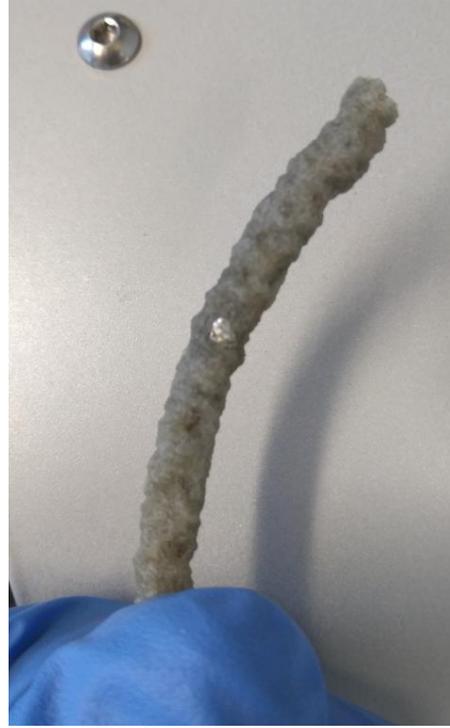
Figure S45. (a) Material that was found among the plastic e-waste. (b) Metal parts that remained inside the melt-blend extruder and they needed to be purged with Devoclean MidTemp (polyethylene).

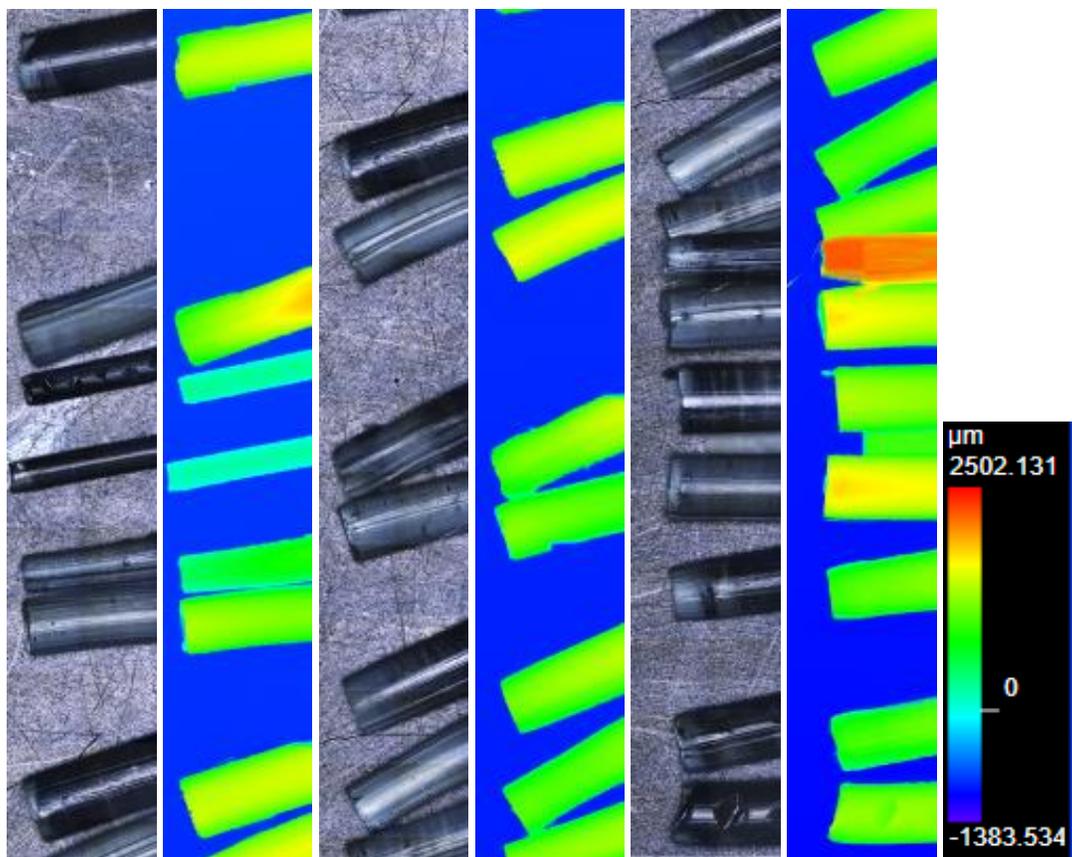
Figure S46. Laser microscope images (x5) of the rupture of the filaments of clogging ABS 100 % in the tensile test.

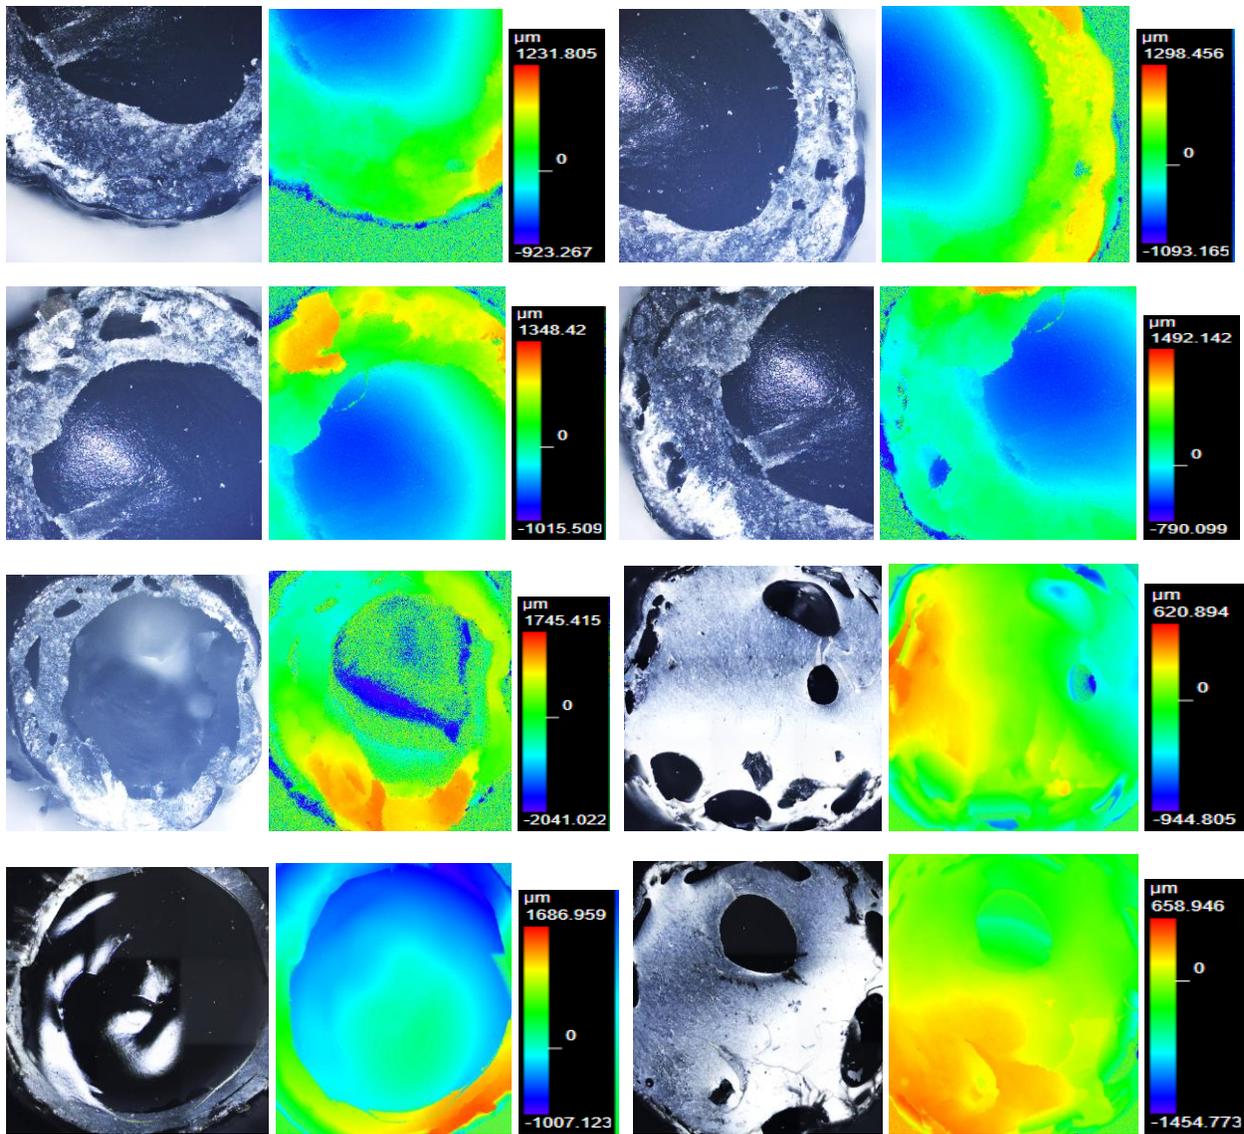
Figure S47. Laser microscope images (x10) of the failure of the filaments of Clogging ABS 100 % in the tensile test.
