Microfactory for valorization of e-waste plastics (acrylonitrile-butadiene-styrene, polycarbonate, and polypropylene) on additive manufacturing sector

Alejandro Moure Abelenda ^{1,*} and Farid Aiouache ^{1,*}

School of Engineering, Lancaster University, Lancaster, LA1 4YW

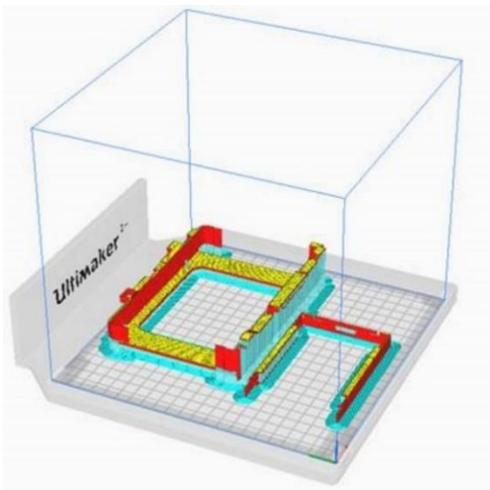
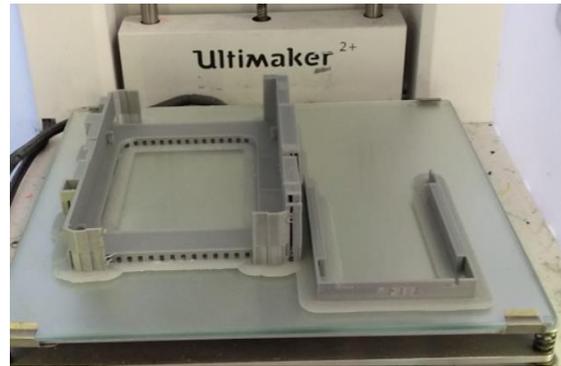
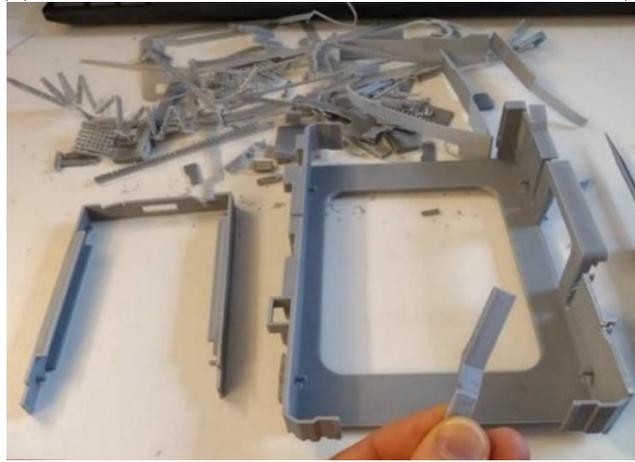
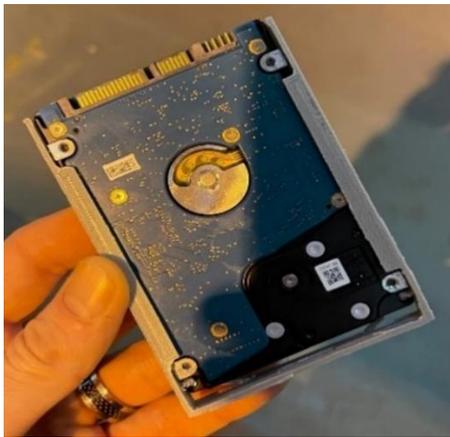
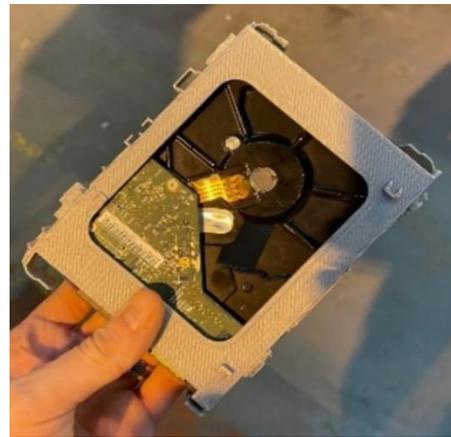
Figure S48. (a) UltiMaker Cura visualization of the supportive material (blue color) that will be required to print the hard drive caddies with ABS. (b) Printed hard drive caddies with ABS. (c) Removal of the supportive material (30 % of the total ABS) from the hard drive caddies printed with ABS. (d) Proof that the small hard drive caddy fits for purpose. (e) Proof that the big hard drive caddy fits for purpose.
