Experimental Study on Seismic Performance of CFRP Strengthened Recycled Concrete Columns with Different Levels of Seismic Damage

Shuai Song ^{*} , Zhen Tian , Zhenyu Zhao , Xi Li , Jianfeng Zhao , Baishun Xu

Abstract: To study the strengthening effect on recycled concrete columns by carbon fiber composite materials (CFRP) under different levels of seismic damage, four column specimens were designed for pseudo-static tests. The four specimens were respectively non-destructive without strengthening (prototype), non-destructive strengthening, medium seismic damage strengthening and severe seismic damage strengthening, according to the replacement rate of recycled aggregates and the level of seismic damage. The characteristics of the deformation damage and seismic performance indicators of each specimen were compared and analyzed. A decrease was observed in the initial stiffness of the seismically damaged recycled concrete column specimens strengthened with CFRP, while the ductility, peak bearing capacity and energy dissipation capacity of the specimens were improved. On the other hand, with the reduction of seismic damage and the increase of recycled aggregate replacement rate, the

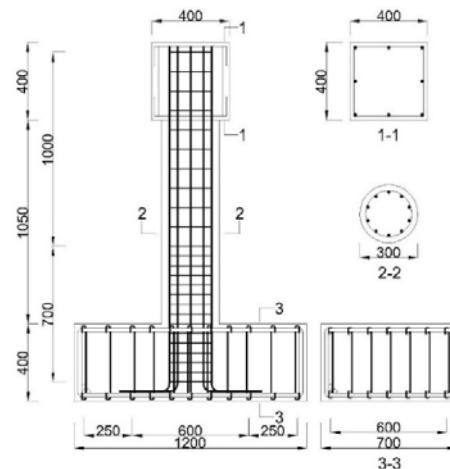
The geometric dimensions and reinforcement of the four specimens are the same. Take RC0 as an example, the design schematic is shown in Figure 1. The cross-sectional diameter of the column is 300mm, the height of the column is 1050mm, the cross-sectional size of the column head is 400mm×400mm, and the cross-sectional size of the specimen cap is 400mm×700mm. The longitudinal reinforcement and the hoop reinforcement are both HRB400 steel bars with diameters of 12mm and 8mm respectively. The material property parameters of the reinforcement were obtained from the material property test, as shown in Table 4.

Figure 1. Schematic diagram of specimen design.

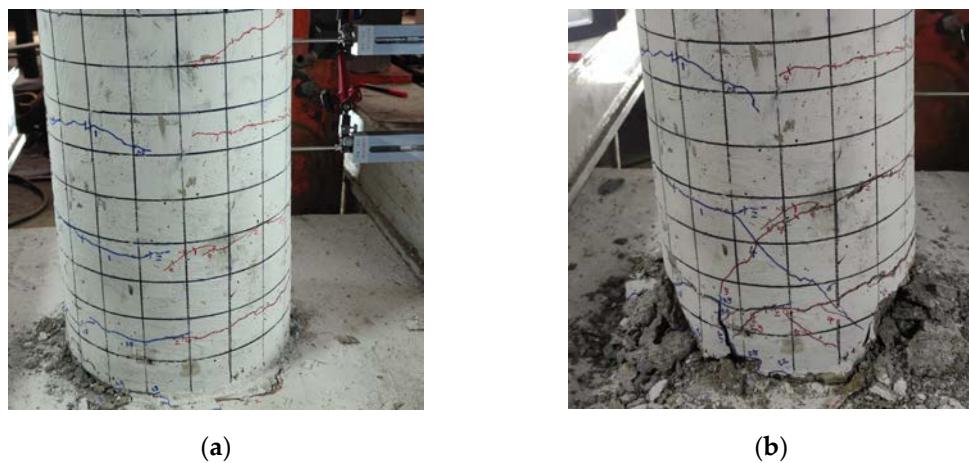
The simulation and control of the seismic damage states of the specimens were mainly achieved by pre-damage treatment. The damage caused by the earthquake was simulated by loading the specimen repeatedly at low circumference[35,36]. The level of seismic damage was determined based on the test phenomena and data of the specimen loading. The guidelines are summarized as follows: the initial state of the specimen is non-destructive; the state when the crack width of the specimen reaches 1~2 mm and the beginning of concrete spalling is defined as the medium seismic damage state; the state when the concrete spalling of the specimen is large, the reinforcement is exposed and the horizontal bearing capacity of the specimen reaches the peak value and enters the descending section is defined as the severe seismic damage state[37–39]. Consequently, the pre-damage loading displacement of the column specimen in the medium seismic damage state is 36 mm (displacement ratio 3%), as shown in Figure 2(a). The per-damage loading displacement in the state of severe seismic damage is 54 mm (displacement ratio 4.5%), as shown in Figure 2(b), and the pre-damage parameters of each specimen are shown in Table 6.

Figure 2. Specimen pre-damage phenomena

RRC2	Medium seismic damage	The crack width is 1~2mm, and the concrete begins to peel off.	36
RRC3	Severe seismic damage	A large number of concrete peeled off, steel bars were exposed, and the horizontal bearing capacity reached the peak and then entered the descending section.	54

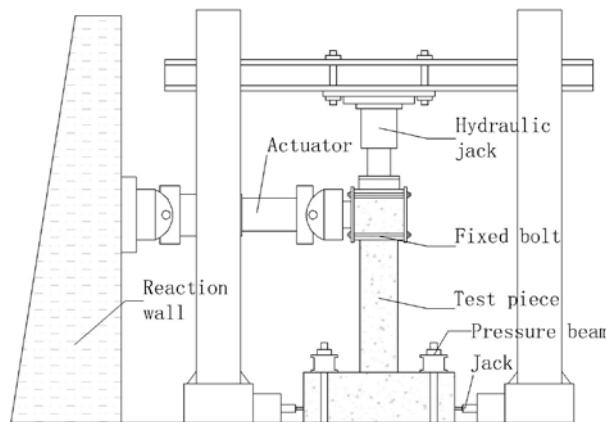
The test loading device is shown in Figure 3. The specimen cap was rigidly anchored to the ground by high strength bolts. When the test was carried out, the vertical load was applied to the top of the column by a hydraulic jack. The design axial pressure ratio is 0.2. The horizontal load on the top of the specimen was applied by an electro-hydraulic servo actuator.

Figure 3. Test loading device

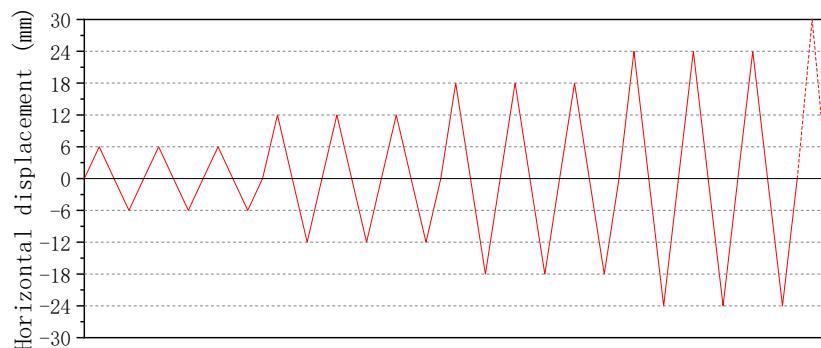
The loading system used full displacement control loading. The loading amplitude was 6 mm, and each loading cycle was performed 3 times. The first four levels of loading were shown in Figure 4. When the bearing capacity of the specimen was reduced to 85% of the maximum horizontal load or when the reinforcement was pulled out and the core concrete was crushed in a large area, the loading was stopped.

Figure 4. Test loading system

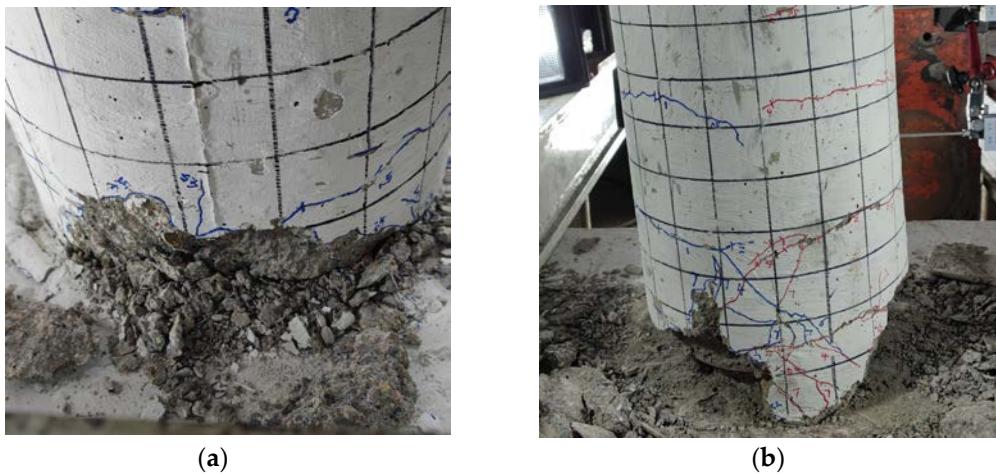
The damage phenomena of the non-strengthened and strengthened specimens at final load moment are shown in Figures 5 and 6.

Figure 5. Non-strengthened specimen test phenomena.

Summarizing the test phenomena of each specimen loading process, in the elastic phase, there was no obvious deformation of each specimen, and the reinforcement and concrete maintained elastic working condition. In the yielding stage, with the increase of the number of cycles, concrete cracking and slight spalling appeared on both sides of the non-strengthened specimens, as shown in Figure 5(a). The strengthened specimen showed slight bulge on the compressed side, and there was no obvious change on the tensile side, but a slight sound of CFRP tearing could be heard. When the horizontal displacement was loaded in reverse, the original compressed side became the tensile side, and cracks appeared at the junction of the column bottom and the specimen cap, as shown in Figure 6(a), and the overall deformation of the specimen was gradually becoming obvious. As the loading continued, the concrete cracking and spalling on both sides of the non-strengthened specimen became more serious. The cracking at the bottom of the column of the strengthened specimen was obvious. The compression side was clearly bulging outwards, and the cracking of the CFRP on the tensioned side was clearly visible. The cracks were gradually developed due to the accumulation of damage, and finally, the concrete spalling of the non-strengthened specimen was serious and the longitudinal tendons and hoops were exposed, as shown in Figure 5(b). For the strengthened specimen, through cracks formed at the junction of column bottom and specimen cap, and the surrounding concrete was crushed, and the CFRP continued to tear, as shown in Figure 6(b). Eventually, the bearing capacity of the specimens dropped sharply and were completely destroyed.

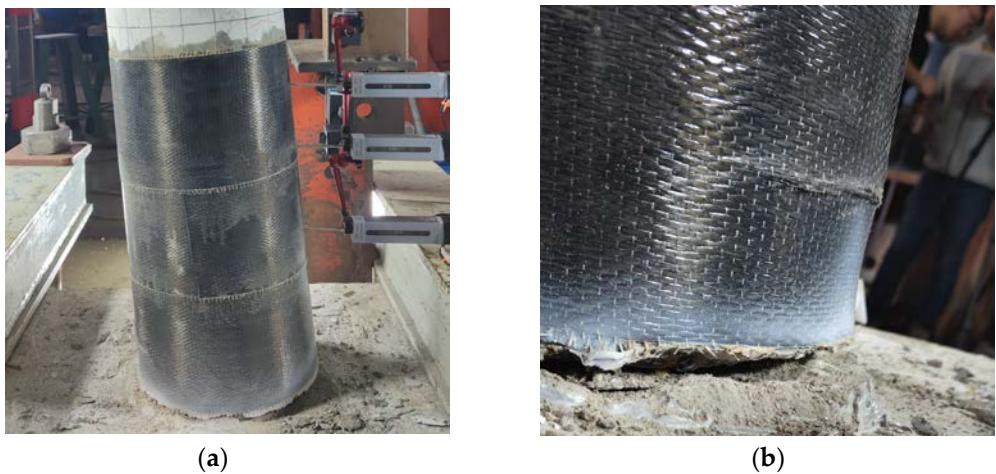
Figure 6. Strengthened specimen test phenomena.

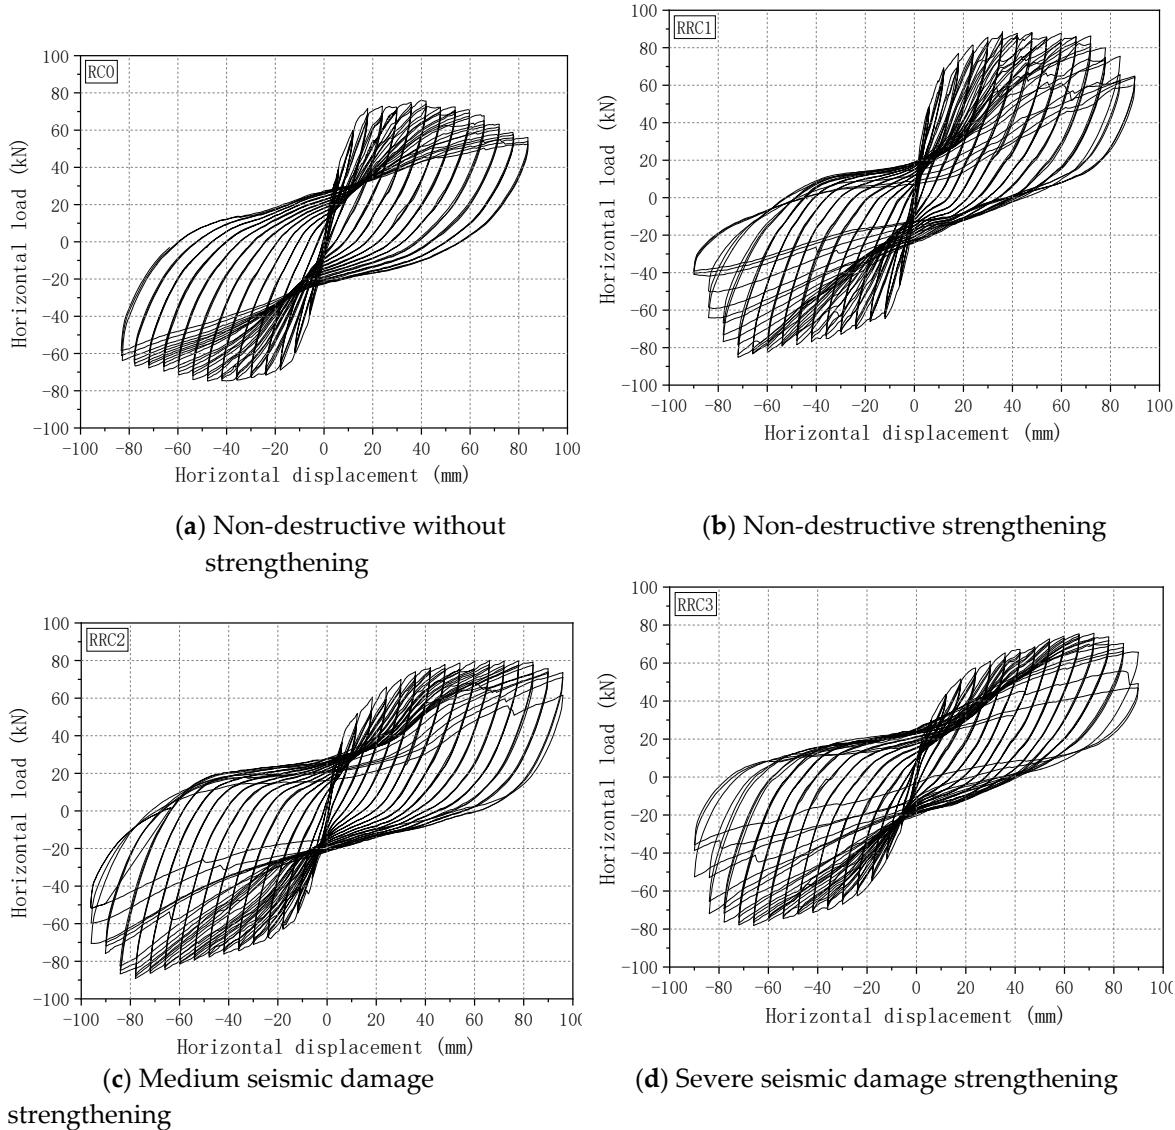
The measured hysteretic curves of each specimen are shown in Figure 7.

Figure 7. Hysteretic curves of the specimens

The hysteresis curves of the column specimens had some commonalities (Figure 7). At the initial stage of loading, the specimens were in an elastic state. The area enclosed by the hysteresis curve was small, the energy consumption capacity of the specimen was weak. The stiffness degradation and residual deformation were not obvious. As the loading proceeding, the area enclosed by the hysteresis curve gradually increased, the energy consumption capacity increased, and the stiffness degradation and residual deformation were more obvious. In general, the hysteresis curves of the recycled concrete column specimens strengthened by severe seismic damage were narrower and longer.

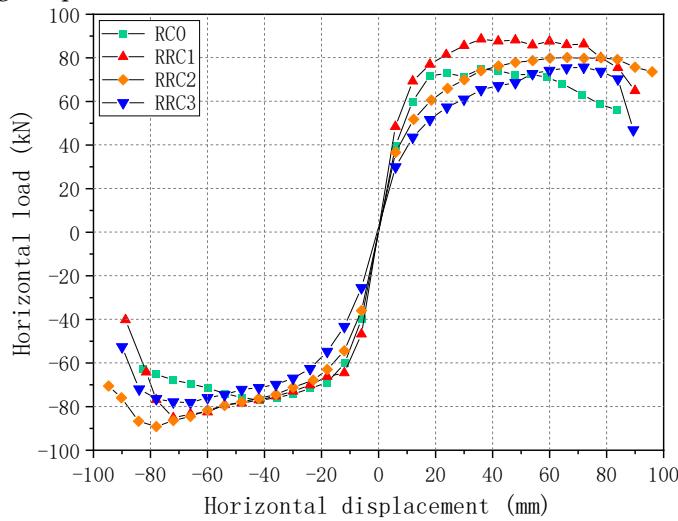
The comparative skeleton curves of each specimen are shown in Figure 8. The skeleton curves of the four specimens were basically similar in shape, and all included rising section, peak point and falling section. Compared to the prototype specimen, the initial stiffness of the damaged strengthened specimens decreased, the yield displacement increased. The damaged strengthened specimens

entered the yield state later than the prototype specimens with a larger difference in the location of the peak point. The yield displacements of the damaged strengthened specimens were relatively close to each other, and the bearing capacity had a long rising phase. Overall, the bearing capacity of the strengthened recycled concrete column specimen with severe seismic damage decreased most rapidly after reaching the peak load.

Figure 8. Specimen skeleton curve comparison.

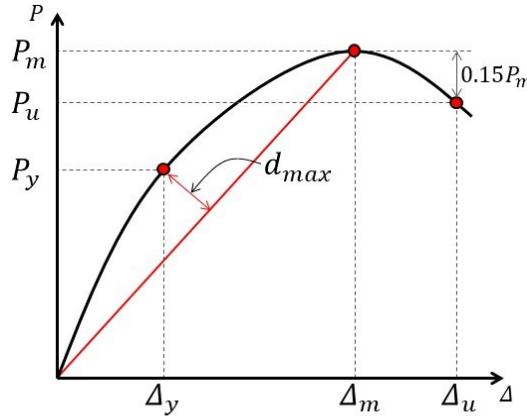
We use the "furthest point" method[40] to determine the yield point, peak point and limit point of the skeleton curve, which are shown in Figure 9.

Figure 9. "Farthest point" method.

The relevant indexes corresponding to the yield point, peak point and limit point of the skeleton curve were shown in Table 7. Compared to RCO, the peak bearing capacity of RRC1, RRC2, RRC3 increased by 14.3%, 11.4% and 1.19%, respectively. The yield displacement of RRC1, RRC2, RRC3 increased by 0.4%, 52.9% and 76.1%, respectively. The limit displacement of RRC1, RRC2, RRC3 increased by 10.7%, 26.3% and 15.9%, respectively. The peak load bearing capacity of RRC2 is increased 10.1% compared to RRC3. Therefore, CFRP had a significant effect on the recovery of the bearing capacity and ductility of the damaged recycled concrete columns. The level of seismic damage had a significant effect on the strengthening effect of CFRP.

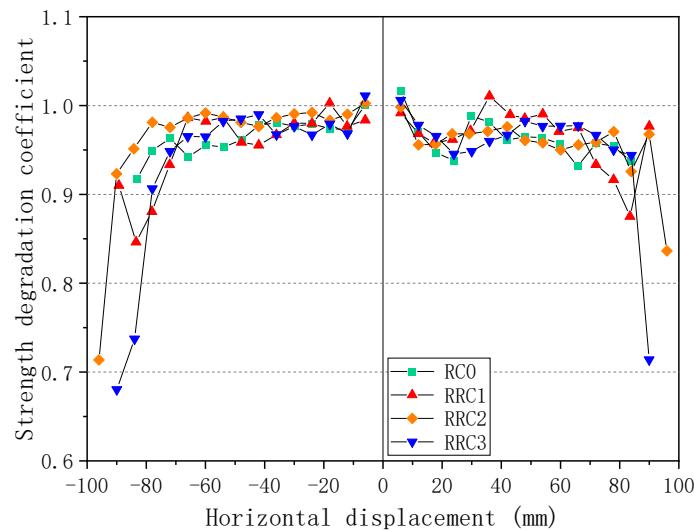
curve of each specimen is shown in Figure 10. On the whole, the strength degradation coefficients of each specimen were concentrated between 0.9 and 1.0.

Figure 10. Strength degradation curve comparison

The bearing capacities of the four specimens were generally degraded with the loading. RRC1, RRC2 and RRC3 were more stable in bearing capacity even if the horizontal displacement increases before reaching the peak load. The bearing capacity degradation curve was relatively smooth and showed good ductility, which indicating that CFRP had a good strengthening effect on the recycled concrete column specimens with different levels of seismic damage under large lateral displacement conditions (Figure 9). After reaching the peak load, the bearing capacity of RRC2 and RRC3 degraded more rapidly, which may be due to the bulging and tearing of the outsourced CFRP and the weakening of the restraint on the concrete in the core area. In general, the level of seismic damage of the recycled concrete column specimens had a large influence on the strength degradation coefficient. The lower the initial seismic damage of the specimens, the more stable the CFRP strengthened bearing capacity was and the easier it was to maintain the strength.

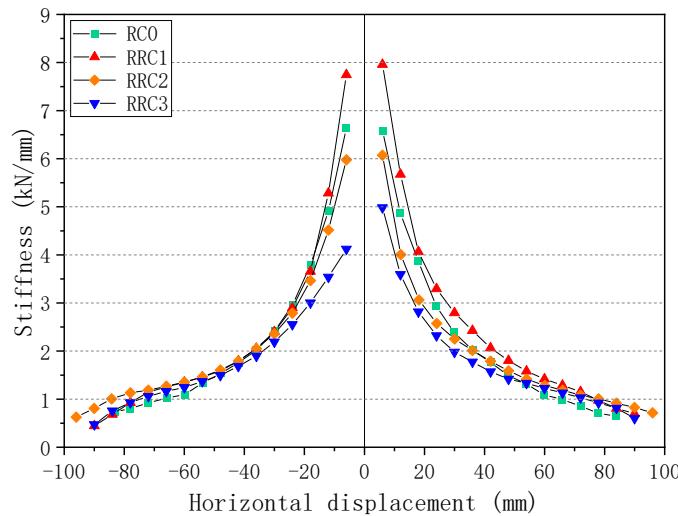
The stiffness degradations of the four specimens are shown in Figure 11.

Figure 11. Stiffness degradation curve comparison.

The stiffness degradations of the four specimens were similar as the load proceeding (Figure 11). With the displacement increases, the stiffness becomes smaller. The initial stiffness of RC0 was 6.61 kN/mm. The initial stiffness of RRC1 was 7.85 kN/mm, RRC2 was 6.03 kN/mm, and RRC3 was 4.55 kN/mm. The more severe the seismic damage, the lower the initial stiffness. The CFRP strengthening did not significantly enhance the initial stiffness of the specimens. As the load proceeding, the stiffness degradation of the specimens slowed down, which indicating that the effect of CFRP on the stiffness of the recycled concrete column specimens with seismic damage will gradually appear as the load proceeding. Overall, the stiffness improvement was most significant after strengthening of non-destructive recycled concrete column specimens. The stiffness of the medium seismic damage recycled concrete column would be effectively improved and restored after strengthening. The stiffness was recovered but not significantly after strengthening of severe damage recycled concrete column. The stiffness restoration and improvement of damaged recycled concrete columns strengthening with CFRP were more evident for the medium damage and non-damage recycled concrete columns.

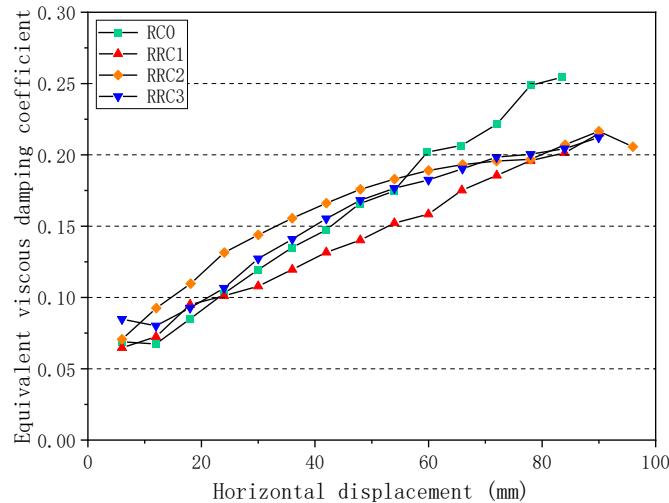
The equivalent viscous damping coefficients of the specimens are shown in Figure 12. The equivalent viscous damping coefficients of the specimens showed an increasing trend. In most of the loading stages, the equivalent viscous damping coefficients of RRC2 and RRC3 were higher than those of RC0, and RRC2 and RRC3 had good energy consumption capacity. As the specimens were continuously loaded, the CFRP was torn and damaged, and the restraint effect on the core concrete was weakened, the rising trend of the equivalent viscous damping coefficient at the end of loading slowed down. The equivalent viscous damping coefficient of RRC2 had significantly improved compared to RRC3. The CFRP had better strengthening effect on the medium seismic damage specimen. In general, the use of recycled concrete improved the energy consumption capacity of specimens to a certain extent. The level of initial seismic damage had a great influence on the equivalent viscous damping coefficient of the specimens. CFRP strengthening was beneficial to the improvement of the energy consumption capacity of the specimens.

Figure 12. Equivalent viscous damping coefficient comparison.

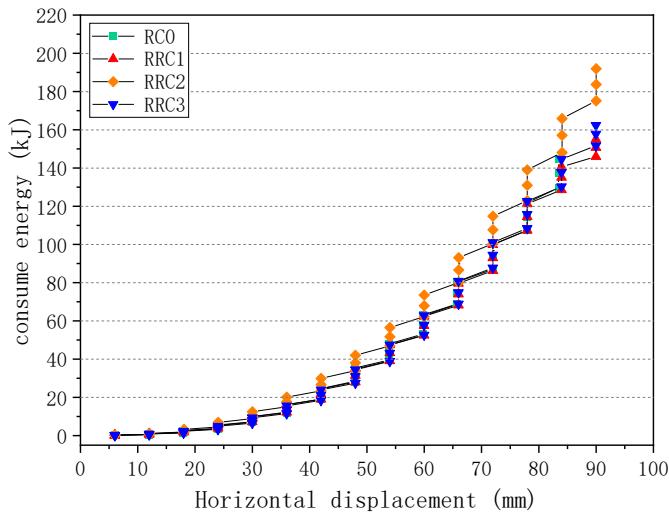
The trends of cumulative energy consumption of the specimens are shown in Figure 13. The energy consumption capacities of the CFRP strengthened recycled concrete column specimens had increased with different levels compared to the prototype specimen. Especially for the medium seismic damaged specimen, the energy consumption increased more significantly. The energy consumption trend of the severely damaged strengthened specimen was almost the same as that of the prototype specimen.

Figure 13. Cumulative energy consumption change.

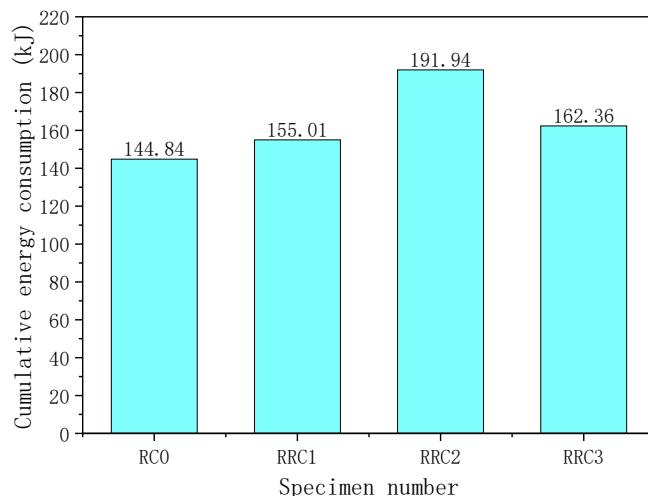
The comparison of the cumulative energy consumption of the four specimens is shown in Figure 14. Compared to RC0, the cumulative energy consumption of RRC1, RRC2, and RRC3 were increased by 7.1%, 32.5%, and 12.1%, respectively. The cumulative energy consumption of RRC2 increased by 18.2% compared to RRC3. In general, the use of recycled concrete and CFRP strengthening showed the most significant improvement in cumulative energy consumption for the recycled concrete column specimen with medium seismic damage.

Figure 14. Cumulative energy consumption comparison

Compared to the intact prototype specimen, the cumulative energy consumptions of RRC1, RRC2 and RRC3 increased by 7.1%, 32.5% and 12.1%, respectively. The cumulative energy consumption of RRC2 increases by 18.2% compared to RRC3, which indicated that the recycled concrete, CFRP and the level of seismic damage of the specimens all affected the energy consumption capacity of the strengthened specimens. Overall, the CFRP strengthening significantly improved the cumulative energy consumption capacity of the recycled concrete column specimens with medium seismic damage.
