Evaluation of a Ground Subsidence Zone in an Urban Area Using Geophysical Methods

Posted Date: 26 May 2023

Keywords: GPR; ERT; urban area; ground subsidence risk; limestone cavity

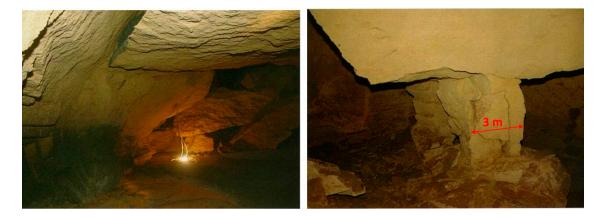
Figure 2. The internal part of the calcarenite quarry.

The discovery depth of the calcarenite deposit varies between 2 m and 25 m. The mining activity developed through large halls with randomly arranged square pillars with sides equal to 2 or 3 m (Figure 2). The deposit was reached through vertical wells commonly called bell-shaped due to their shape. At the end of the exploitation, the quarries were abandoned and often used as waste deposits, and the relative accesses were blocked and buried until they lost consciousness and memory. At the end of March 2007, there was an important collapse event of the roadway (Figure 3) [2,3].

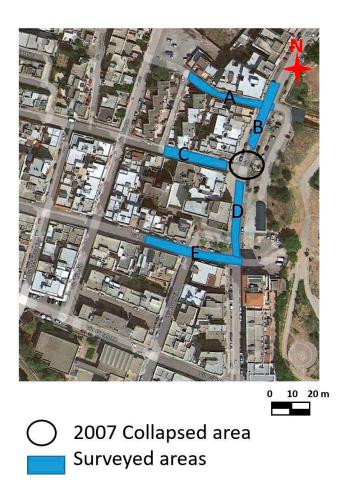
Figure 5. GPR surveyed areas in 2007.

For the first geophysical surveys, those of 2007, the georadar of Mala geoscience with a 250 MHz antenna was used. GPR measurements were performed in areas A, B, C, D and E (Figure 5).

GPR data were acquired in a grid with parallel profiles spaced 0.5 m.

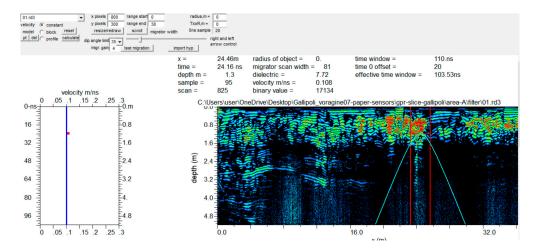
Figure 6. EM wave velocity analysis on 2D radar section. The esteemed EM velocity was 0.108 m/ns.

The two-way time window was 100 ns (nanoseconds). The sample interval and the trace interval were, respectively, 512 samples per scan and 0.02m. GPR data were processed using GPR-Slice Software (GPR-SLICE Software (gpr-survey.com)). The 2D data have been processed as the following processing steps: (i) bandpass filter to eliminate both low and high-frequency noise components; (ii) manual adjustment of the gain to try to improve the vision of the deepest reflection events; (iii) background removal filter to eliminate the horizontal components of the signal present on the radar sections and due to ringing; (iv) Kirchhoff migration using an average velocity value of the electromagnetic wave equal to 0.108 m/ns. Electromagnetic (EM) wave velocity can be estimated from GPR data in several ways; the conventional method involves common depth-point (CDP) and wideangle reflection and refraction (WARR) data sets. Both methods require two antennas in separate units and relatively long acquisition times [9,10]. The EM wave velocity can be more quickly and easily determined from the reflection profiles acquired in continuous mode, using the characteristic hyperbolic shape of reflection from a point source (diffraction hyperbola) [9-12]. This is a very common method for the EM velocity estimation and based on the phenomenon that a small object (the dimensions of the object are smaller than the wavelength of the EM wave introduced in the ground), reflects EM waves in almost every direction. Figure 6 shows an example of application of the above described method applied to the data acquired in the investigated areas.

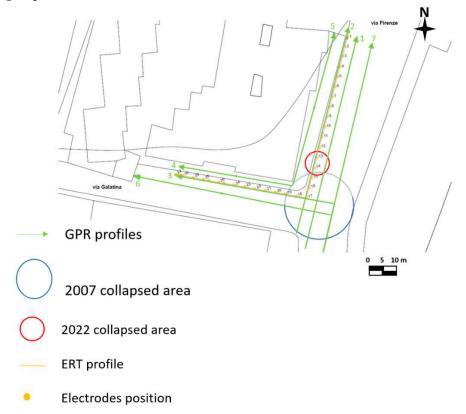
Figure 7. GPR and ERT surveyed areas in 2022.

For the second geophysical survey of 2022, the georadar Ris Hi-mod with a dual-band antenna of 200-600 MHz was used. The location of GPR profiles is shown in Figure 7. Also, in this case, GPR data were processed using GPR-Slice Software (GPR-SLICE Software (gpr-survey.com)) with the same processing steps.

The ERT investigation was necessary to understand the possible development of the cavity underneath the buildings. For this reason, the acquisition geometry shown in Figure 7 was adopted. The 2D distribution of electrical resistivity as a function of the depth are shown in Figure 22.

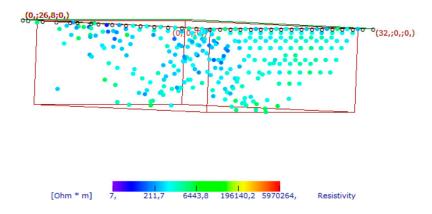
Figure 8. Apparent resistivity measured points. White circle represents the electrode location.

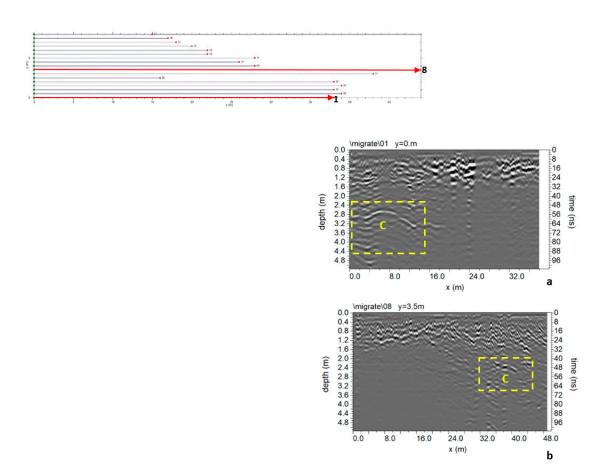
In the area, A (Figure 5) were acquired, 17 parallel profiles 0.5 m spaced. The processed data (Figure 9) presents several reflection events. It presents a subsoil with backfill material for the first meter of depth. An interesting reflection event is denoted "C" in Figure 9a. It is evident in the first four profiles acquired in area A. The size is about 15 m wide and the depth of the top is between 2.6 and 3.2 m (with an average electromagnetic wave velocity of 0.108 m/ns).

Another interesting reflection event "C" (Figure 9b). The size is about 8 m wide, and the depth of the top, is between 2.4 and 2.8 m. Some considerations can be made to try to understand what C may be due to. Observing them on the radar sections, a change in the polarity of the electromagnetic wave (EM) is noted. An inversion of polarity is produced when the reflection coefficient is negative [10,11]. So, for materials where the wave velocity depends only on dielectric permittivity when radar waves are reflected in a material with a higher dielectric permittivity. A typical case is reflections from air to any other material [10,11]. All these considerations lead to interpreting these anomalies as being due to cavities.

Figure 9. Area A: GPR processed data: a) profile n. 1; b) profile n. 8; C indicate a probable cavity.

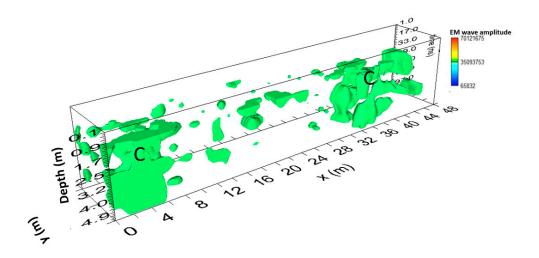
Figure 11 shows the iso-surfaces amplitude with a threshold value equal to 65% of the total amplitude. Anomalies C can be visualized in their 3D development.

Figure 11. Area A: GPR iso-sufaces; C indicate a probable cavity.

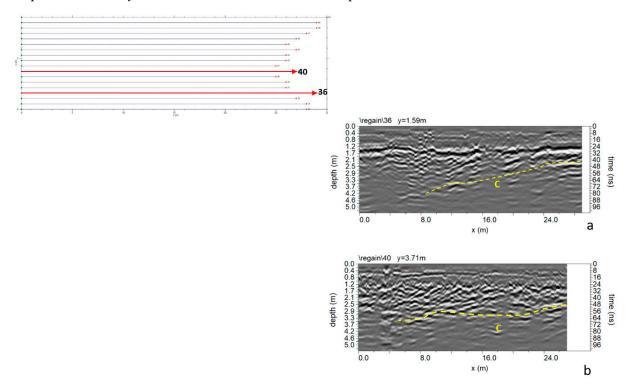
In the area, B (Figure 5) were acquired 18 parallel profiles 0.5 m spaced. At the end of area B is the collapsed part of the road surface. Here the processed data shows an interesting reflection event "C" in Figure 12. It develops along the entire radar section at a depth between 2.0 m and 4.0 m. An inversion of polarity is noted and therefore this anomaly was probably due to cavities.

Figure 12. Area B: GPR processed data: a) profile n. 36; b) profile n. 40; C indicate a probable cavity.

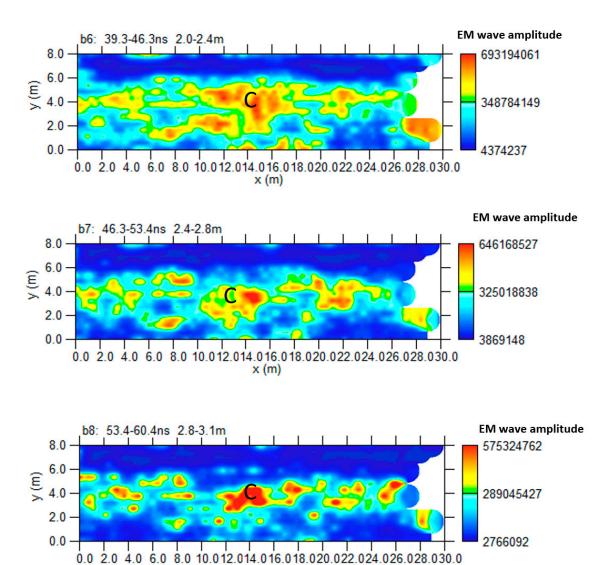
Figure 13 shows the most significant time slices. The slices at depths between 2.0 m and 3.1 m are considered. In fact, at these depths, it is possible to highlight the reflected event linked to the anomaly C.

Figure 13. Area B: GPR time slices; C indicate a probable cavity.

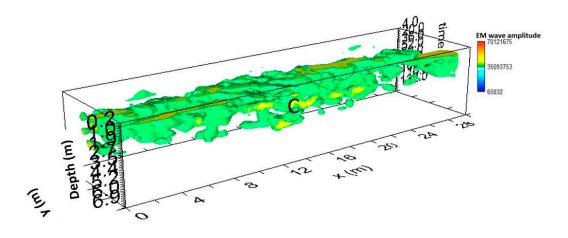
Figure 14 shows the iso-surfaces amplitude with a threshold value equal to 70% of the total amplitude. Anomaly C can be visualized in its 3D development.

Figure 14. Area B: GPR iso-sufaces; C indicate a probable cavity.

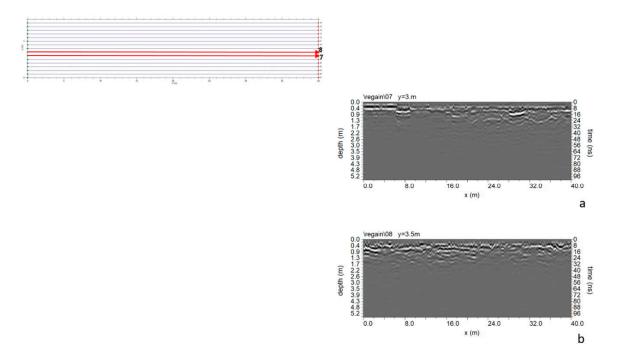
In the area, C (Figure 5) were acquired 16 parallel profiles 0.5 m spaced. The GPR data analysis did not reveal any anomalies attributable to the presence of cavities (Figure 15).

Figure 15. Area C: GPR processed data: a) profile n. 7; b) profile n. 8.

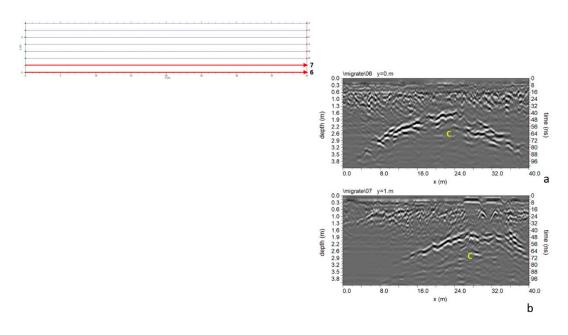
In the area, D (Figure 5) were acquired 8 parallel profiles 1.0 m spaced. The processed data shows an interesting reflection event "C" in Figure 16. It develops a depth between 1.6 m and 3.0 m. An inversion of polarity (Figure 17) is noted and therefore this anomaly was probably due to cavities.

Figure 16. Area D: GPR processed data: a) profile n. 6; b) profile n. 7.

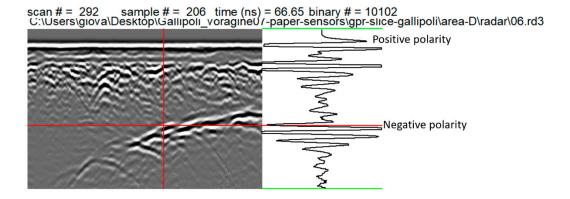
Figure 17. Area D: inversion of the polarity in the reflection event.

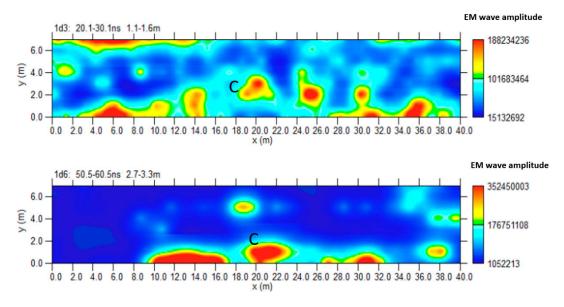
Figure 18 shows the most significant time slices. The slices at depths between 1.1 m and 3.3 m are considered. In fact, at these depths, it is possible to highlight the reflected event linked to the anomaly C.

Figure 18. Area D: GPR Time slices; C indicate a probable cavity.

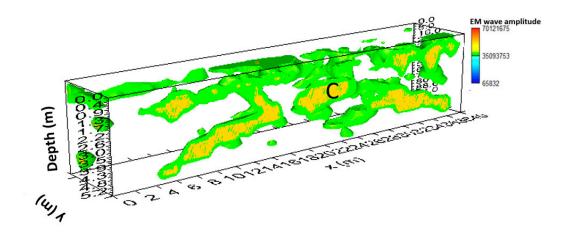
Figure 19 shows the iso-surfaces amplitude with a threshold value equal to 70% of the total amplitude. Anomaly C can be visualized in its 3D development.

Figure 19. Area D: GPR iso-surfaces; C indicate a probable cavity.

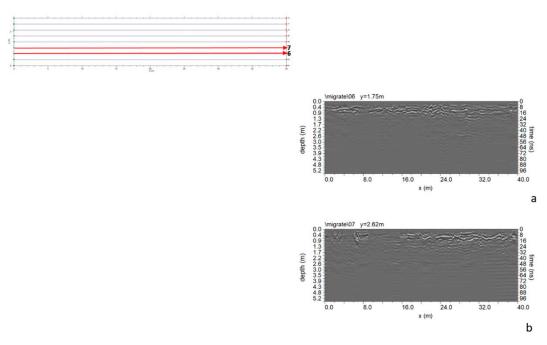
In the area, E (Figure 5) were acquired 9 parallel profiles 0.85 m spaced. The processed data did not reveal any anomalies attributable to the presence of cavities (Figure 20).

Figure 20. Area E: GPR processed data: a) profile n. 6; b) profile n. 7.

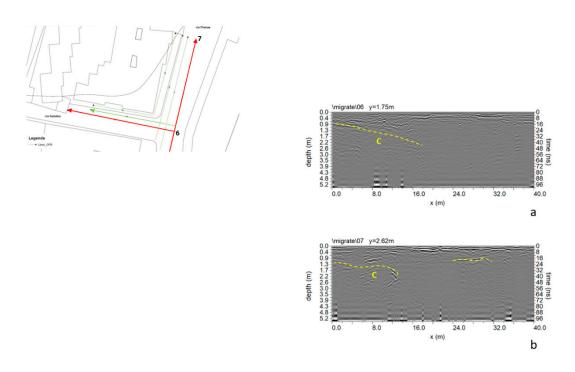
The second subsidence event which occurred 15 years after the first made a second campaign of measures necessary. In this case some GPR profiles were performed to understand the extent of the phenomenon. Therefore the investigations were carried out only in the area affected by the second instability event. From the analysis of the data (Figure 21) it is possible to notice reflected events "C" which confirm the presence of the cavity. In fact here it is possible observe a polarity inversion of the reflected EM wave [10,11,20]

Figure 21. GPR processed data: a) profile n. 6; b) profile n. 7; C indicate a probable cavity.

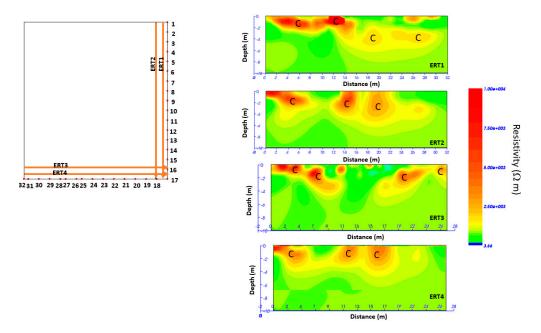
From the 2D resistivity distribution (Figure 22) the presence of a heterogeneous subsoil with resistivity values between 2000 Ω m and 10000 Ω m is evident. In particular, is possible to note the presence of areas (indicated with C) with resistivity values between 2500 Ω m and 10000 Ω m which suggests the probable presence of cavities. These cavities seem to extend to a depth of about 4 m.

Figure 22. 2D resistivity distribution; C indicate a probable cavity.

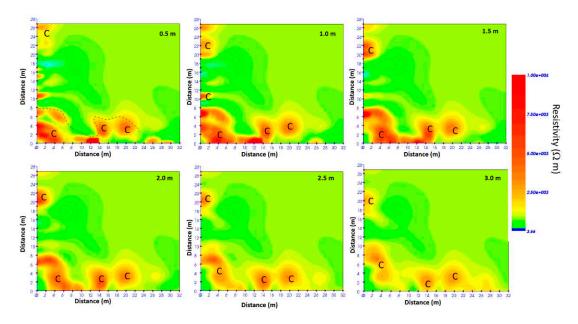
From the analysis of the depth slices (Figure 23) is possible to see the distribution of the resistivity anomalies C below the investigated area.

Figure 23. ERT depth slices; C indicate a probable cavity.

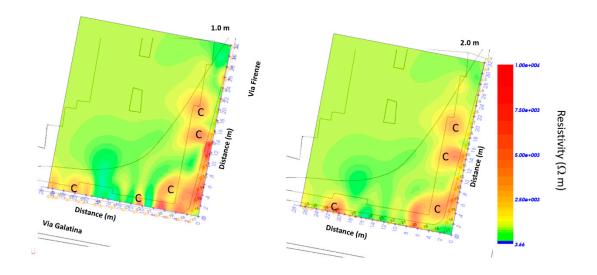
Figure 24 shows the superimposition of the ERT results on the plan of the investigated area showing the position of probable cavity C.

Here it is possible to see how the cavity develops dangerously underneath the buildings.

Figure 24. ERT depth slices overlapped to the planimetry; C indicate a probable cavity.

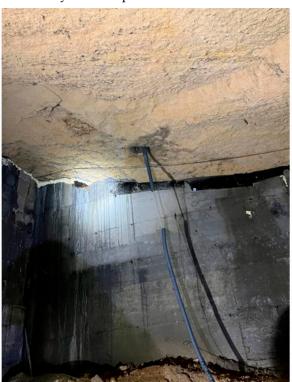
Figure 25. Photos of the consolidation interventions.

Apart from the area affected by the collapse which was made safe, the geophysical investigation in the adjacent areas had the aim of understanding the stability conditions of the unexplorable cavities. The serious problem is found in areas where the roof thickness of the cavity was less than 5 m (areas A, B and D). In fact, as shown in Figures 7, 10 and 14, the thickness of the roof varies from 2.4 m (Figure 7), 2.9 m (Figure 9) to 1.9 m Figure 14. In this case, the buildings located near these areas could be in danger. Areas C and E were the most suitable for heavy vehicles to travel through for the first consolidation works. The area affected by the collapse was made safe with a consolidation intervention consisting of filling the cavities with concrete and strengthening of the pillars with the use of spritz - beton (shot concrete) inside which a filling of loose material (stone) was inserted. In Figure 25 the photos of the cavities after the intervention are shown.

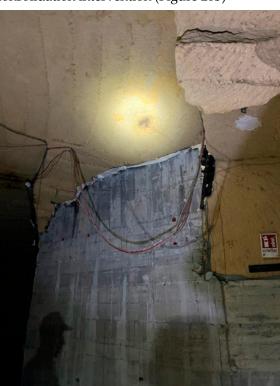
survey was decided to be limited to the area affected by the phenomenon. The GPR results show the presence of the cavity with a thinning of the roof thickness ranging from 0.9 m to 1.3 m (Figure 19). Very interesting are the ERT results that help us understand what happens underneath the building. Here we note the presence of cavities already at a depth of 0.5 m (Figures 20 and 21). The inspection of the cavity shows a probable deterioration of the consolidation intervention (Figure 26b)

Figure 26. Photos: a) The December 2022 phenomenon; b) the cavity below the building after the consolidation interventions.

Subsequently, to make the cavity safe, a series of reinforced concrete pillars were built inside which a filling of loose material (stone) was inserted. Over the years this material (due to the abundant rains) has probably disintegrated causing the second instability event in December 2022. In this case, the integrated geophysical surveys ERT and GPR have highlighted the presence of voids where the fill had been made. Such voids are also present under the houses.
