# Surface Waterproofing Techniques: A Case Study in Nova Lima, Brazil

*Case Study*

A case study was conducted in residence located in Nova Lima, Minas Gerais, Brazil. The construction in question comprises structural masonry, two floors (Figure 12 and Figure 13), and a waterproofed slab roof. The project included solar and photovoltaic heating, air conditioning infrastructure, a sound system, an electric car charging point, a swimming pool, and a fireplace.

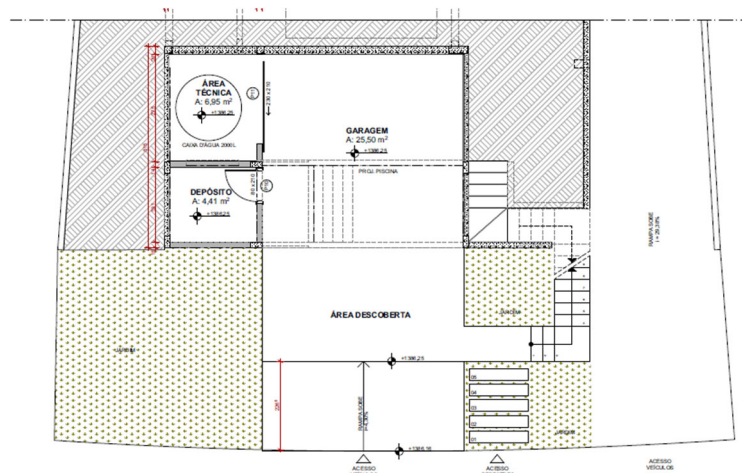
**Figure 12.** First-floor plan of the residence under study.

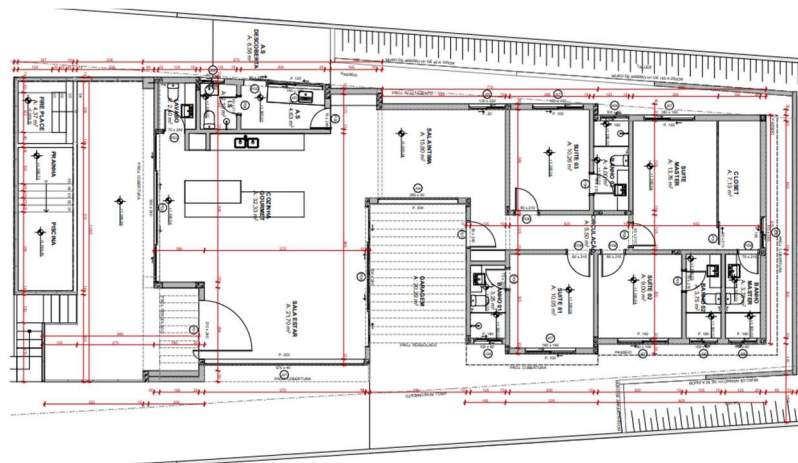
**Figure 13.** Plan of the 2nd floor of the residence under study.

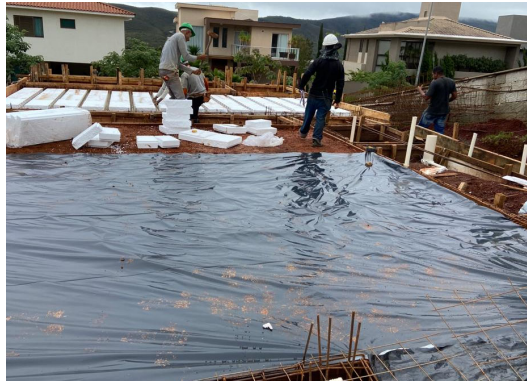
**Figure 14.** Application of tarp on the floor before the concreting.

When the first Slab was made, supported on the ground at the beginning of the project, it was necessary to waterproof the contact between the concrete and the soil to avoid the capillarity phenomenon. The first waterproofing was done using a 150-micron tarp (Figure 14), thicker than the ordinary tarp, usually with 50 to 100 microns, and, therefore, has a better performance and useful life. After applying the tarp, EPS (expanded polystyrene) sheets were also placed over it (Figure 15) to increase the distance between the ground and the concrete and take advantage of the characteristics of EPS, which is highly resistant to mold and moisture. The tarp method was also used under the concrete ramp for vehicle access to the upper garage (Figure 16) to avoid capillarity between soil and concrete.

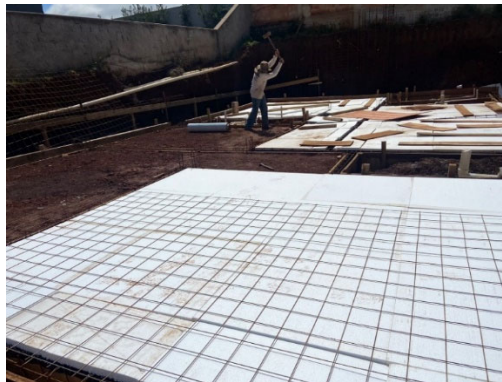
**Figure 15.** Positioning of EPS plates.

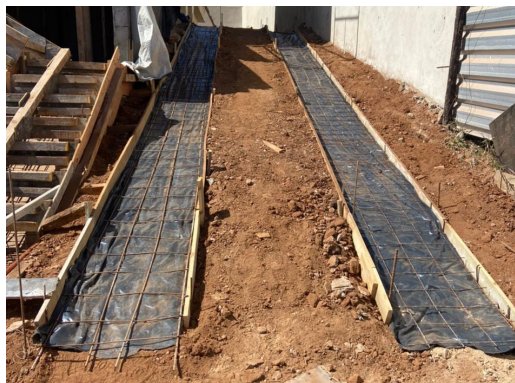
**Figure 16.** Application of tarp on the ramp floor before concreting.

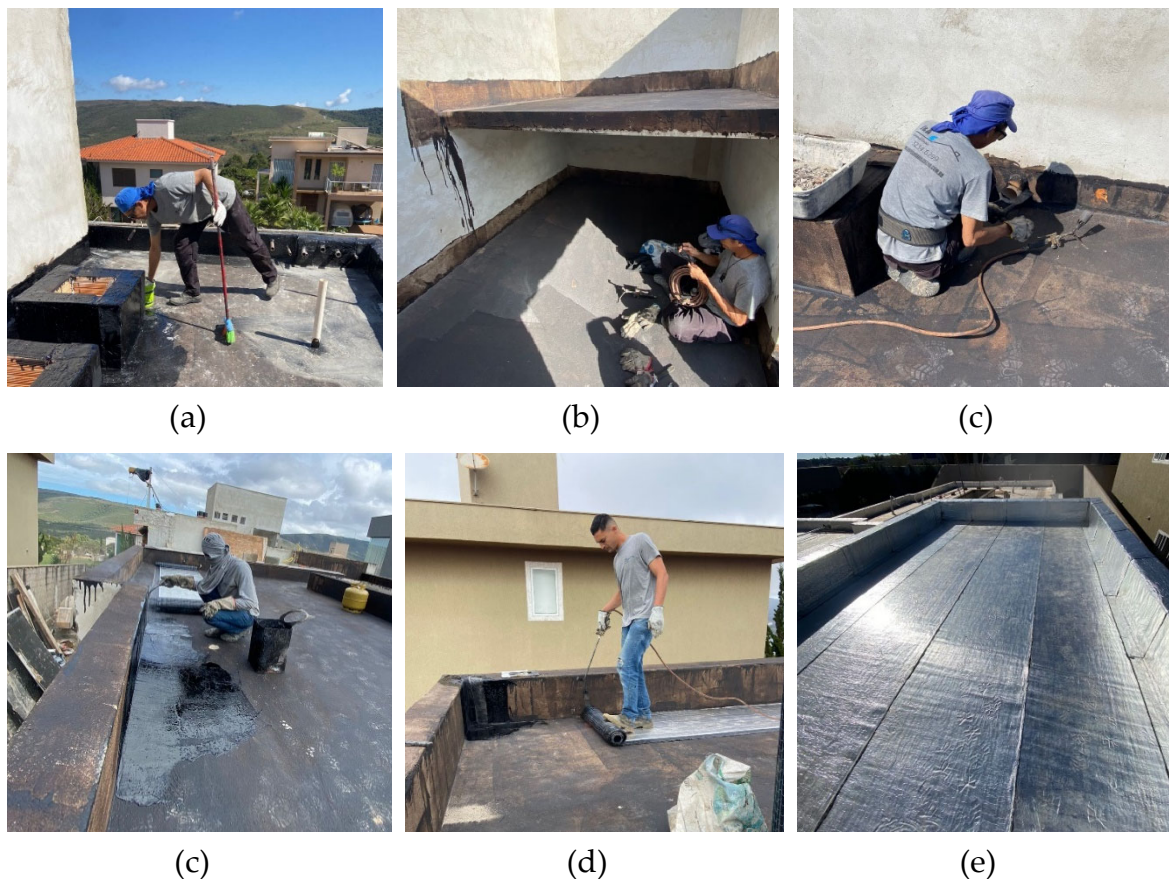
**Figure 17.** (a) Primer application on the Slab; (b) Primer application in water tank room; (c) Use of a blowtorch to melt the modified asphalt; (d) Application of modified asphalt to receive the blanket; (e) Positioning of the blanket roll on the slab; (f) Aluminumized asphalt blanket applied on the slab.

After this process, a primer composed of polycondensed asphalt cement diluted in solvents is applied (Figure 17a and Figure 17b), which increases the adhesion between the asphalt-based waterproofing system and the surface. With the primer applied, modified asphalt sheets are heated to dissolve and apply them, thus beginning the process of adherence of the asphalt mats to the surface (Figure 17c and Figure 17d). The professional distributes the roll of the mat on the Slab and uses a blowtorch to ensure the adherence of the mat and the modified asphalt to the surface (Figure 17e).

After the blanket application is completed on the entire Slab (Figure 17f), it is necessary to wait for drying time and perform the water tightness test. This test aims to verify the effectiveness of the blanket applied and correct any details, if necessary. The water tightness test consists in filling the Slab with water and checking whether any leakage will occur. If any leakage is found, it will be evident by moisture stains under the Slab, and the responsible team must correct this failure and perform the test again, ensuring no more leaks.

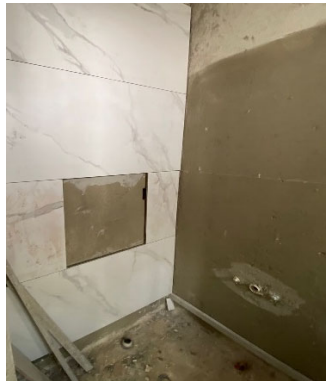
**Figure 18.** Bathroom after applying waterproofing.

Applying the waterproofing material followed the manufacturer's recommendations and the NBR 9574 standard [21]. First, the liquid component was mixed with the powder component using a metal rod attached to a drill. Then, using a brush, the first layer of the mixture was applied on the floors and walls (up to a height of approximately 1.80 m) of the bathrooms (Figure 18) and then reapplied after drying in the opposite direction to the application of the first coat. This way, the bathrooms were released for the finishing stage, covering floors and walls with ceramic tiles and protecting them from humidity.

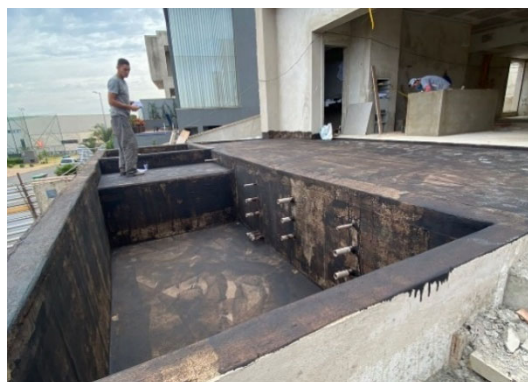
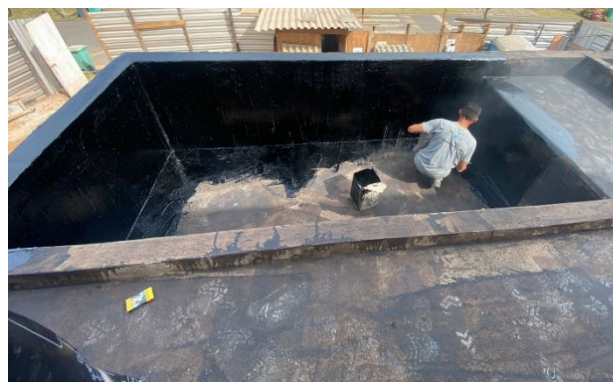
**Figure 19.** (a) Pool with primer applied; (b) Use of modified asphalt on the pool surface.

The waterproofing process of the deck, pool, and fireplace surfaces started with verifying the drainage system and testing the water flow toward the area's drains. After this verification, these areas were cleaned using brooms and vacuum cleaners. Then the primer was applied to the pool, fireplace, and deck surfaces (Figure 19a), preparing them to receive the asphalt. Then, a layer of modified asphalt was applied and melted with a blowtorch to adhere the mat to the surface (Figure 19b).

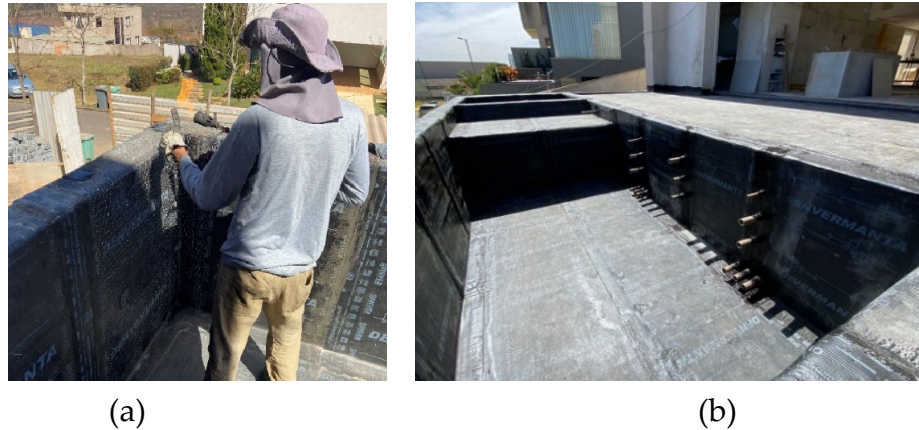
**Figure 20.** (a) Application of blanket in the swimming pool; (b) Swimming pool with polyethylene asphalt blanket applied.

Then, applying the polyethylene asphalt blanket on the surfaces was started, using a blowtorch to melt the modified asphalt and ensure the adherence of the blanket (Figure 20a). After finishing the application of the blanket on the pool surfaces (Figure 20b), deck, and fireplace, the water-tightness test was performed, as was done on the Slab, to verify the waterproofing guarantee. Next, the pool, fireplace, and deck were filled with water up to the limit of the edges (Figure 21).

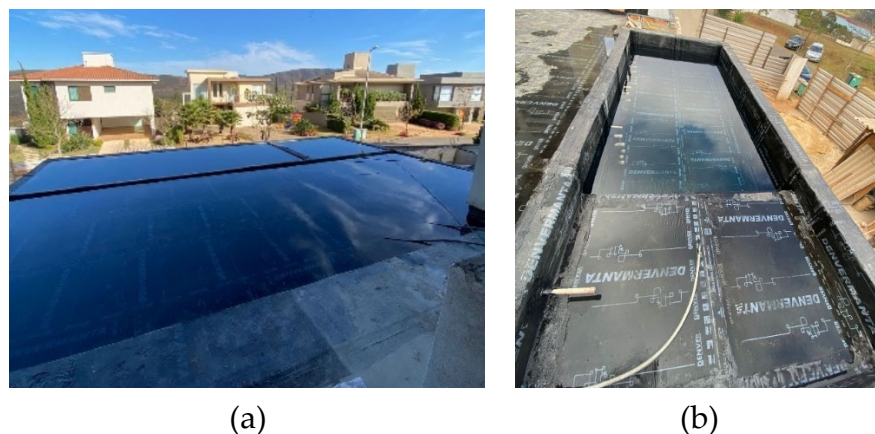
**Figure 21.** (a) Pool, fireplace, and deck in the water-tightness test; (b) Pool in the water-tightness test.

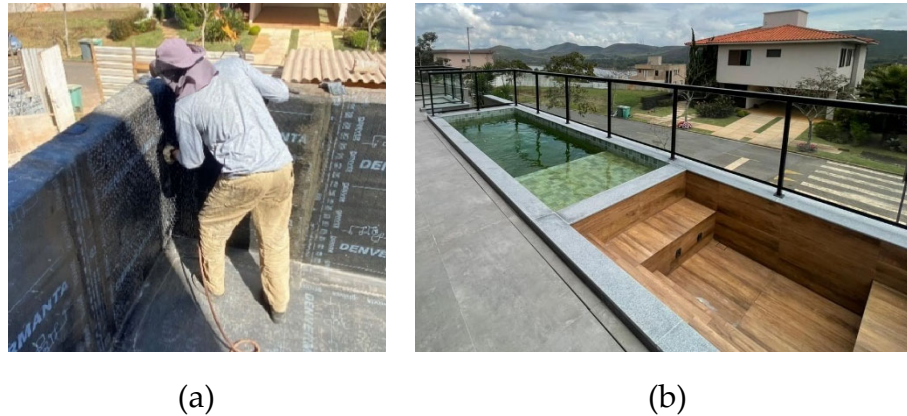
**Figure 22.** (a) Application of chicken wire over pool blanket; (b) Pool, fireplace, and deck.

As proven to be watertight after the test, the next step would be plastering the pool and fireplace and the counter flooring of the deck to apply the lining later. For this type of blanket used, before receiving the lining, the chicken wire was applied to the entire surface of the pool and fireplace (Figure 22a) using mortar to facilitate the adherence of the plaster to the blanket and prevent future detachment of the ceramic linings. After the preparation with the chicken wire and the mortar on the polyurethane asphalt blanket, the pool and the fireplace were plastered, and the counter-flooring was done on the deck. Then these surfaces were covered with porcelain tiles or ceramic pieces (Figure 22b).
