# On the Safety of Implanted Breast Prostheses in Accidental Impacts

Keywords: breast implants; silicone prosthesis aging; accidental impacts; crash test; compression tests

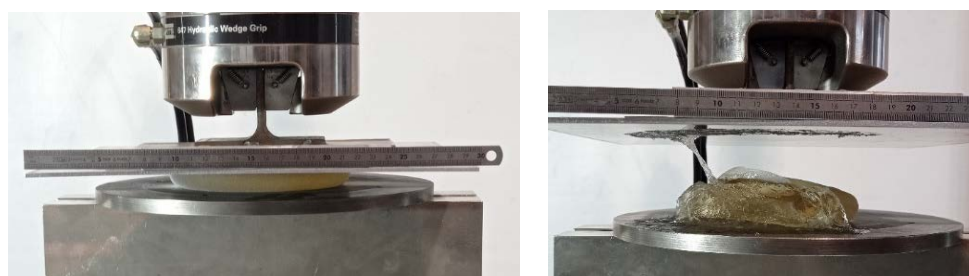
Figure 3 shows the compression set-up during the tests and at the end, when the prosthesis shows clear rupture. Throughout the tests, load, plates positions and contact area between deformed prosthesis and plates were recorded to evaluate the internal pressure and stress at rupture. In Figure 4 the load-displacement curves are reported, for the test done on a new prosthesis and on a prosthesis aged in saline solution at 37 °C, for three months, six months and ten months compressed up to 70% of previously measured rupture load. After each test, the aged prosthesis was placed again in the heated bath to continue the aging process. The compression test is being periodically repeated, with the same loading condition (up to 70% of rupture load) until failure, to verify the possible influence of ageing on the overall behaviour of the prostheses, in particular over shell rupture strength and elongation.

**Figure 3.** Compression test set-up.

The measured rupture load for the new prosthesis was 7650 N, reached at a final prosthesis thickness of 8,44 mm. The internal pressure at rupture was about 2.35 bar. It is also to be noted that for the new prosthesis, rupture was reached at an internal pressure similar, but somewhat higher, to that (about 2 bars) previously measured with prostheses explanted from living patients [19]. Although, for the latter, the implantation time-period was not known, it is likely that such difference is consequence of ageing.

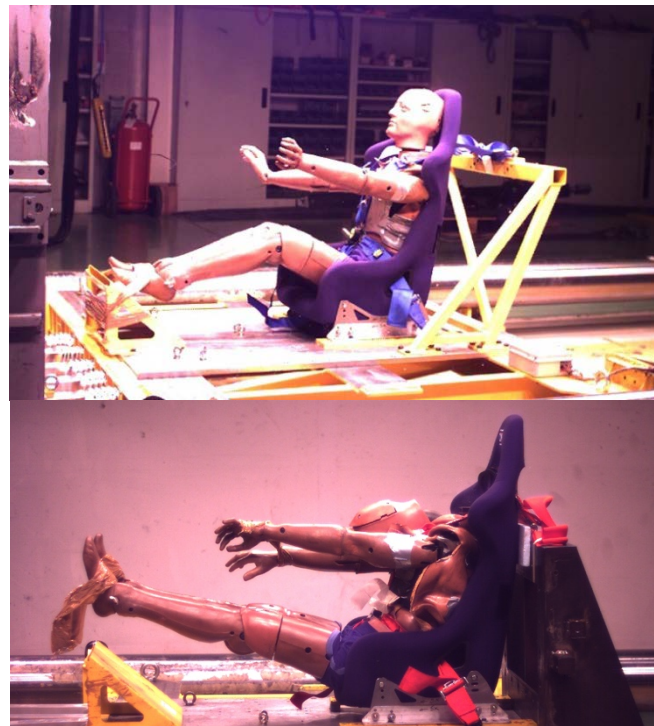
Figure 7 shows two frames from the video recordings of the seat/dummy during the crash tests: a relevant compression of the prosthesis was evident. A visual inspection after the impacts showed that at the lower speed no clear damage of the prosthesis was observed; on the other hand, after impact at 90 km/h a rupture with some, although limited, internal gel leakage was clearly evidenced (Figure 8).

**Figure 7.** Instant frames of the sled/dummy during impact event.

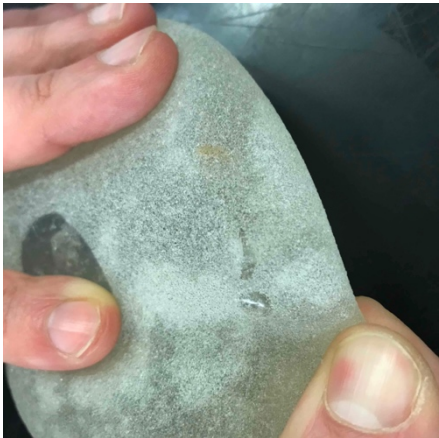
**Figure 8.** Rupture of the silicone shell and gel leakage after impact at 90 km/h.
